# Conceptual Design Recommendations for Improving Steelhead Migration at Cliff Drive Apron on Arroyo Burro

June 25, 2004

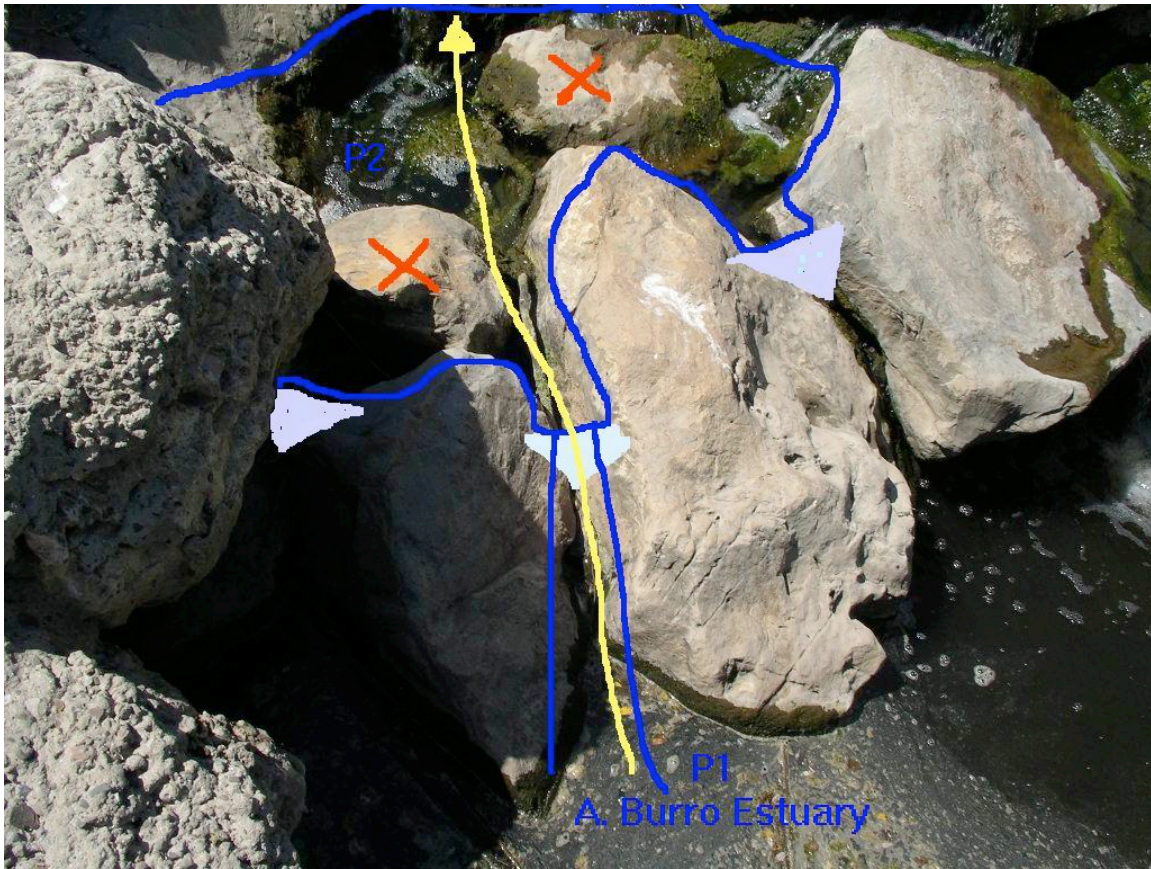
**Estuary (Pool #1), Jump #1, Pool #2**

The Arroyo Burro estuary P1 provides sufficient jump depth to allow steelhead to jump into P2 during the encountered base stream flows. During moderate and high stream flow conditions or with elevated sandbar development, the estuary water surface elevation can rise several feet and submerge the lower portion of the apron. Two boulders limit the size and depth of P2. Removal of these boulders (marked with red X's) would increase the pool depth to a maximum depth of at least 27 inches. Removal of these boulders may provide additional depth depending on extent of the lower buried portion. Both boulders appear to be resting on top of other boulders. The modified pool would measure approximately 50 inches longitudinally and 72 inches wide. The potential addition of reinforced concrete sills, as shown, should be determined following the completion of curb notching and upstream modifications described below. Once upstream modifications are made and 12 inch hydraulic drops are determined then the water surface elevation of P2 should be determined and sills developed to direct outflows at the yellow fish migration location. It is likely that these sills would be developed mainly to focus flows the outlet location shown and to seal off subsurface flows between boulders, but not to raise the pool surface elevation of P2. With these modifications and redirected flows, the new jump height for Jump #1 should be 12 inches or less (depending on estuary water elevation) to the new P2 outflow location.

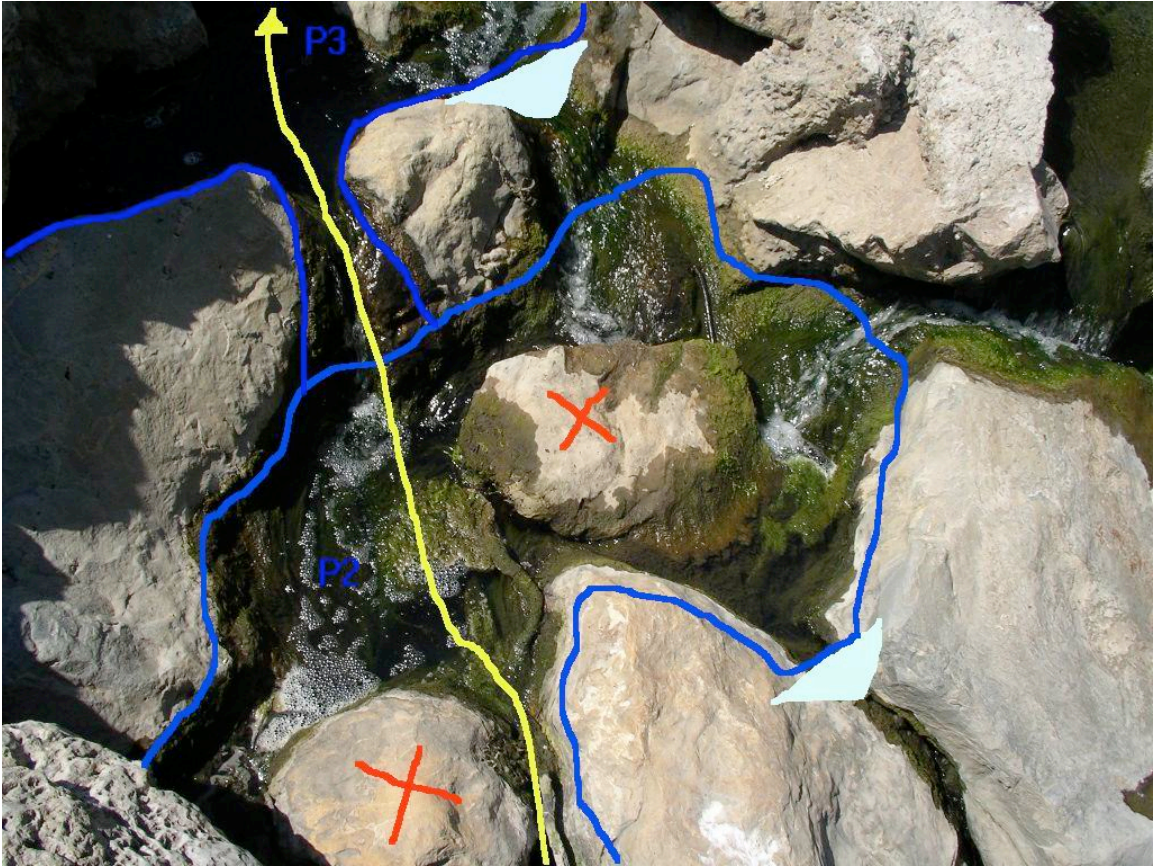
**Pool #2 and Jump #2**

See previous summary for Estuary (Pool #1), Jump #1, Pool #2. Note: Flows entering the photograph from the right side would be refocused into the upstream end of the step pools with a concrete sill described in the summary for Pool #4 and Jump # 4 (Notched Concrete Curb).

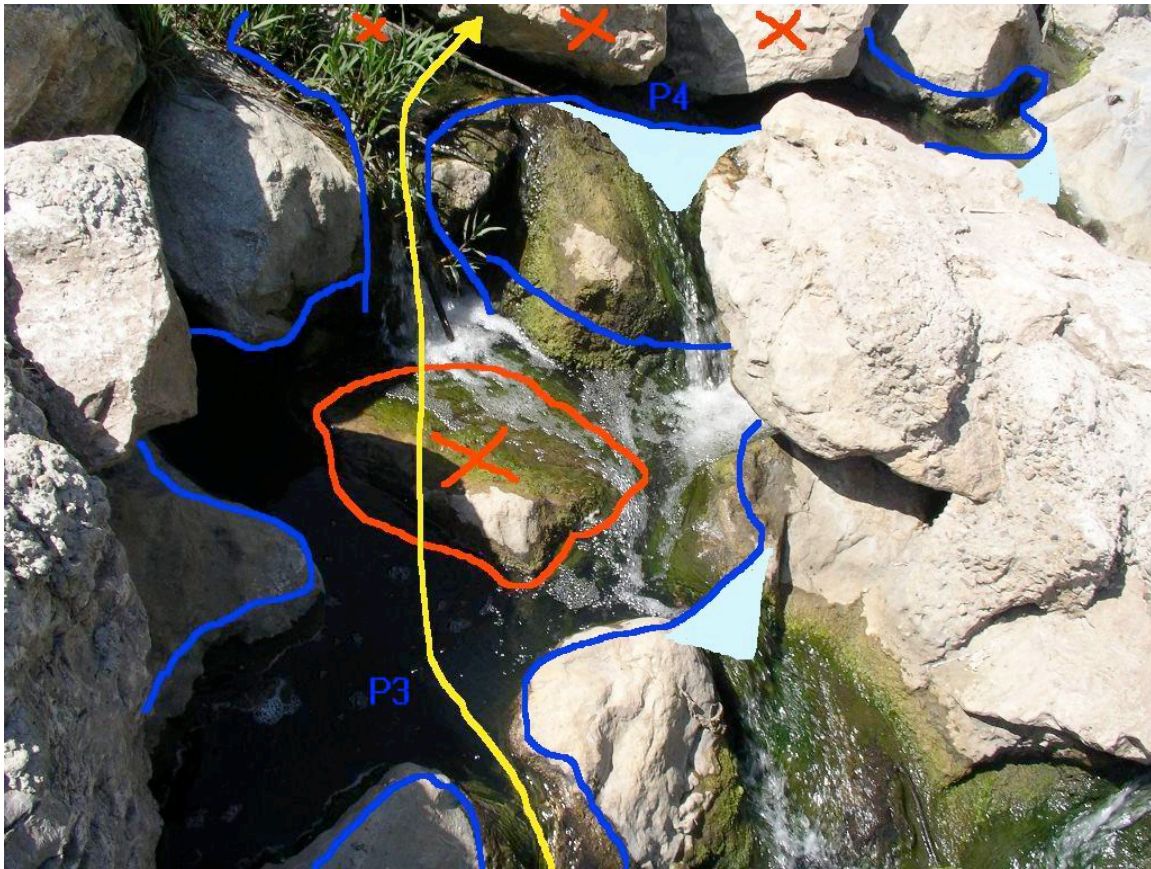
**Pool #3 and Jump #3**

P3 had a maximum measured depth of 29 inches, an upstream downstream length of 36 inches, and width of 54 inches. Jump #3 measured 16 inches between the water surfaces of P3 and P4.

Remove a significant downstream portion of the boulder marked with a red X by cutting out the approximate circle shown to increase pool depth in P3 and remove this jump obstacle. This large boulder provides structural support for upstream and adjacent boulders and the extent to which portions can be removed will need to be determined by a qualified structural professional. The addition of concrete and/or other reinforcement to the pool bottom may be needed following boulder cutting. Identify the elevation for the tailwater control for P3 at 12 inches below the elevation of the top of the Jump #3 upstream following curb notching and upstream modifications. The outlet elevation for P3 should be close to the existing elevation control where the yellow steelhead migration line occurs. Construct one concrete sill near shown location to ensure that flows are focused down the yellow fish migration line outlet location. The concrete sills should be approximately 4 inches higher in elevation than the outlet elevation at the yellow line location.

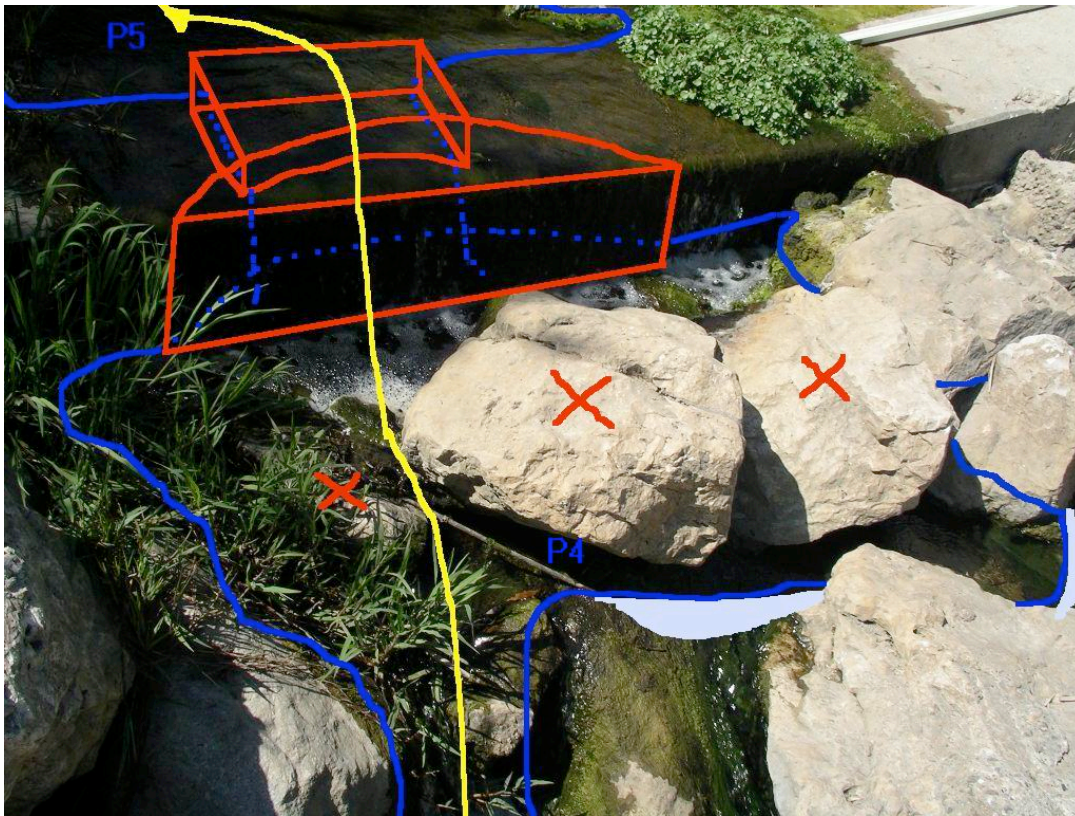
**Pool #4 and Jump # 4 (Notched Concrete Curb)**

P4 had a maximum measured depth of 12 inches, an upstream downstream length of 30 inches, and width of 66 inches. Jump #4 measured 16 inches between the water surfaces of P4 and P5. This jump occurs over the concrete curb.

Removal of a half-oval section of the concrete curb as shown will expand the size of jump pool P4 and reduce the horizontal jump across the notch in the curb. This half-oval should measure approximately 5 feet across on the downstream side and extend 15 inches upstream into the curb to the center/apex of the half-oval. If structurally feasible, the removed half-oval will comprise the entire thickness of the curb (24 inches). Remove a notch from the remaining concrete curb at the upstream side of the removed half-oval section. The notch should be centered at the apex of the removed half-oval and measure approximately 3 feet wide, 10 inches deep, and be aligned in a perpendicular manner from the upstream edge of the curb. Removal of the three boulders marked with red X's will allow development of 24-inch pool depth in P4 and eliminate obstacles to upstream migration. If boulder removal does not add 12 inches of pool depth and create the desired 24-inch minimum pool depth then excavate slightly to develop desired pool depth. Following curb modification, boulder removal, and pool development identify the location for the tailwater control elevation for P4 at 12 inches below the downstream edge of the notch cut in the concrete curb. This outlet location and elevation should be close to the existing elevation control where the yellow steelhead migration line occurs. The tailwater elevation may need to be lowered slightly by cutting into existing rock and producing an outlet flow notch. Construct two concrete sills near shown locations to ensure that low flows are focused down the yellow fish migration line location. These concrete sills should be approximately 4 inches higher in elevation than the elevation of the outlet location at the yellow line.

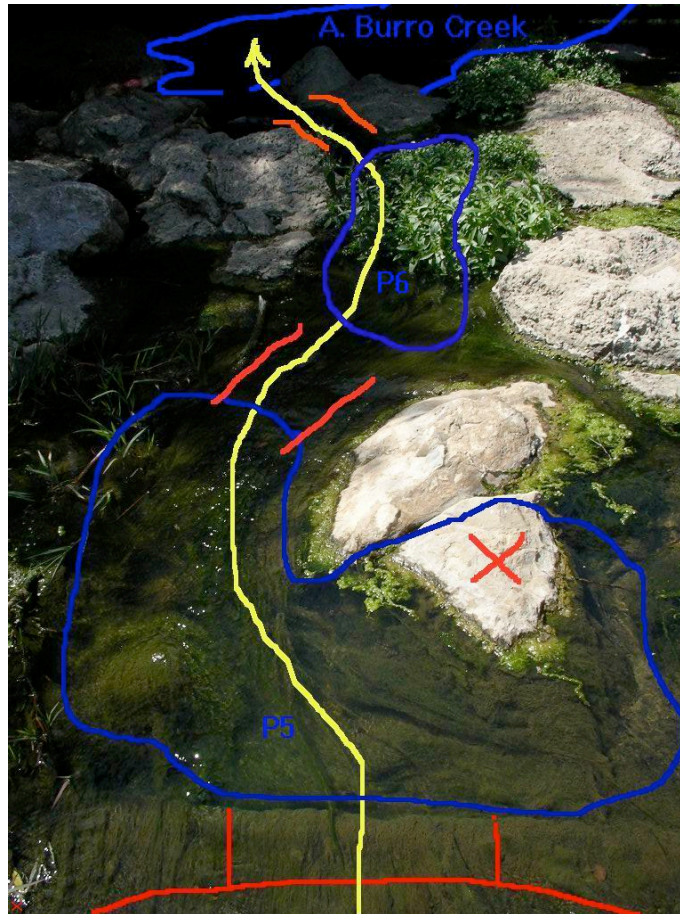
**Pool #5 and #6 (Upstream of Notched Curb)**

Upstream of the concrete curb a pool extends approximately 5 feet upstream with variable depths up to 15 inches. Upstream of P5 a short, shallow area 2 inches deep occurs between P6, which has a maximum depth of 11 inches. Flows are confined in several small concrete-lined channels upstream of the concrete curb to a deep natural-bottom pool under Cliff Drive.

Upstream from the completed concrete curb notch, the pool P5 should be enhanced to ensure adequate landing and resting depth for steelhead jumping over the curb from P4. Notching of the curb will lower the water surface elevation upstream of the curb and reduce water depth within P5 and P6. Following notching of the curb, the depth of P5 immediately upstream from the notch should be lowered to the new notch elevation and allowed to gradually gain depth to the lowest portion of the pool. Additional depth could be created in P5 if structurally feasible. Due to the low gradient of the apron upstream of the curb, a low-flow channel could be cut between P5 and P6 and upstream of P6 to the natural pool under Cliff Drive Bridge. The depth of this low-flow channel and additional development of depth in P5 and P6 will need to be determined by qualified professionals following assessment of the apron depth and impacts to structural stability. Ideally the channel and pools P5 and P6 will all have depths of at least 12 inches. The low-flow channel and pools can be cut and lined with concrete to protect undercutting of the apron. Removal of the rock marked with the red X would increase the size of P5, increase pool depth, and eliminate the likelihood of upstream migrating steelhead landing on the rock. Once upstream of the concrete curb, steelhead have several options for migration across the low gradient apron with its variable roughness, resting areas, and existing channel that offer various upstream migration options under different flow scenarios.
