City of Santa Barbara Existing Conditions Report- Fisheries

Draft Sections for Inclusion in Final Report

May 2005

4.8 City-Wide Watershed-Fisheries

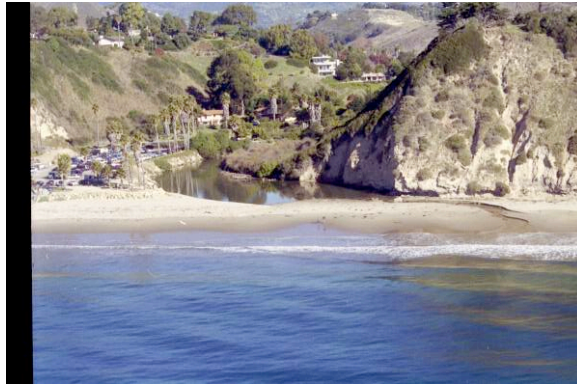
The Arroyo Burro lagoon has been significantly reduced in size and is constricted by adjacent parking lots and the Cliff Drive Bridge. The lagoon does retain some heterogeneity with riparian vegetation along the upper north side and native banks along the east side. A recent study by ECORPS Consulting noted that the Arroyo Burro lagoon has the highest quality lagoon habitat in the City and greatest density of tidewater goby. Lower Arroyo Burro retains surface flows throughout the summer and fall due to the prolific systems of springs near Veronica Springs. This summer flow could provide adequate rearing conditions for salmonids and other fish species and helps to sustain the lagoon water elevation.

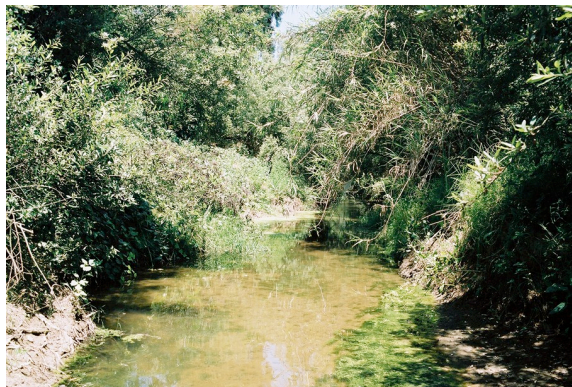
Upstream of Cliff Drive the exotic giant reed becomes extremely dense. Failed pipe and wire revetment is present. Increased bank erosion and high siltation in the streambed occur. Silt and sand deposits over 2 feet deep occur in some stream reaches. Significant migration barriers to all fish species occur at the Cliff Drive grade control structure and a private grade control structure 0.33 miles upstream of Cliff Drive.

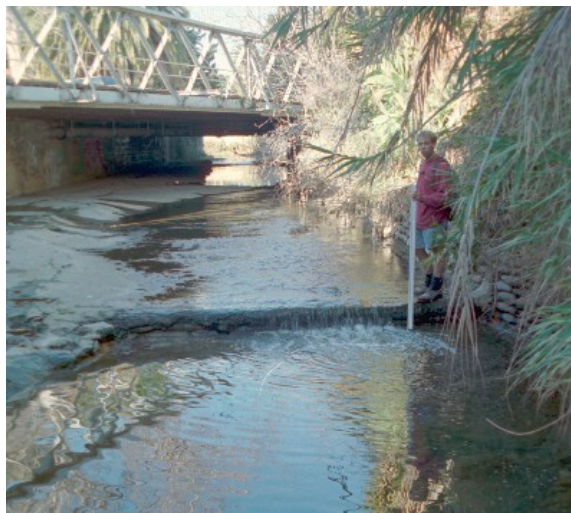
Two CALTRANS concrete-lined channels occur upstream. The downstream trapezoidal channel measures 0.74 mile. The slope of the downstream 200 feet of the channel measured less than 1%. Near the Anapamu pedestrian bridge crossing, Highway 101 crosses over a portion of the concrete channel where it enters a large box culvert. Upstream fish passage is not possible during low-flows due to the unconfined, shallow water depth across the channel. Upstream steelhead passage is prevented during moderate to high flows due to the lack of adequate resting areas and excessive water velocities. Steelhead spawning has been observed in recent years downstream from the first CALTRANS channel, but marginal habitat conditions, limited summer surface flows, and poor water quality likely do not permit juvenile fish to survive. Approximately 88% of the Mission Creek watershed occurs upstream of the downstream-most impassable CALTRANS channel. Alternative designs for providing steelhead passage within the CALTRANS channels are currently being developed and reviewed.

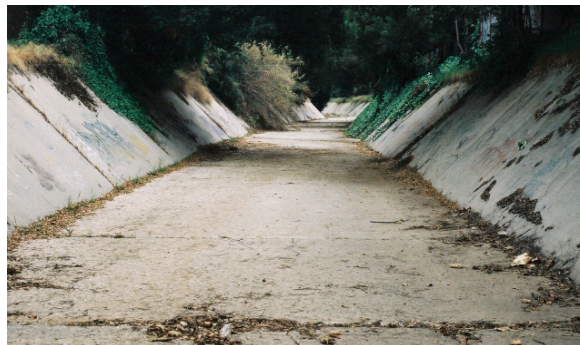
The second CALTRANS channel measures 0.27 mile. This concrete trapezoidal channel is similar to the downstream CALTRANS channel. A 2-foot drop occurs at the channel outlet. After this short jump upstream migrating steelhead would encounter

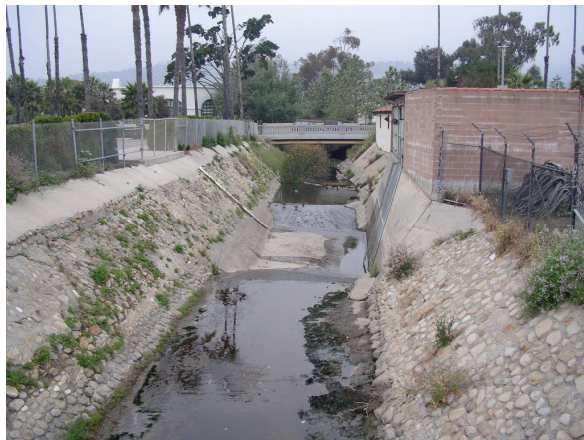
This channelized pumping station complex is intended to prevent the expansion of tidal water upstream and the accumulation of creek floodwaters upstream. The Laguna Creek streambed between the Highway 101 freeway and the pump house is reportedly lower in elevation than the high tide elevation and without the tidal gate dam tidal flows would migrate upstream. Combined high creek flows and culvert discharge do not drain to the ocean well and can flood adjacent buildings and streets. The pump house periodically pumps flows to the lagoon preventing water from backing up in the upstream channel.

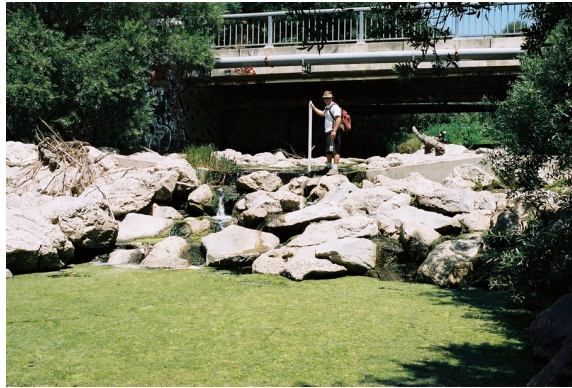
This concrete and boulder grade control structure occurs immediately downstream of the Cliff Drive bridge. This structure represents a severe barrier to upstream fish migration and limits estuary size and function. Short-term steelhead passage modifications are currently being planned at this site. A series of resting/jumping pools are scheduled to be created within the apron during the summer of 2005. Complete removal of the structure and bridge should be coordinated with a long-term lagoon restoration planning effort.

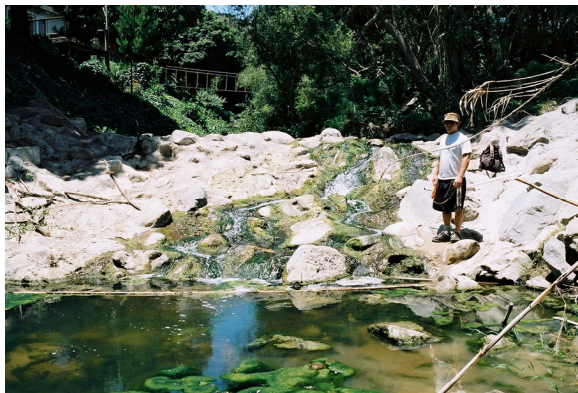
This concrete and boulder grade control structure measures 6 feet 2 inches tall and contains slopes between 20-30%. This dam-like structure is completely filled with sediment on the upstream side. Due to the excessive slopes encountered and lack of resting areas, upstream steelhead passage is likely not possible during all stream flows. An estimated 91.1% of the watershed occurs upstream of this structure. The most effective, self-sustainable solution for ensuring effective fish passage at this site is to remove all or most of the structure, reinforce adjacent stream banks using bioengineering techniques and stabilizing the stream grade. A detailed assessment of this structure needs to be conducted to determine potential implications of removal. Several homes adjacent

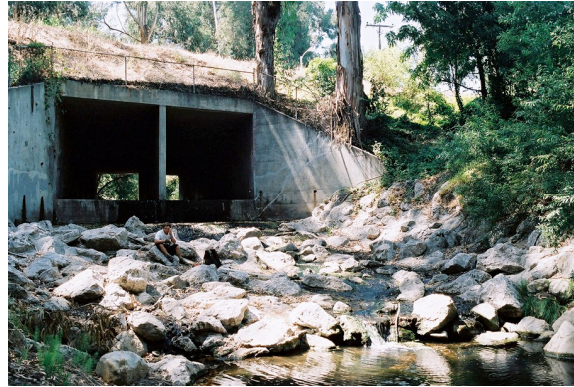
This concrete double-box culvert measures 117 feet in length with a slope of less than 1%. Each culvert box measures 11 feet 10 inches tall by 12 feet wide. The outlet of the culvert drops vertically 2 feet 9 inches to a smooth concrete apron that extends downstream 11 feet with a slope of 2%. This concrete apron transitions into a boulder and concrete riprap apron that extends downstream 35 feet with a slope of 15%. The outlet of the apron drops 1-foot to the downstream natural substrate. This double box culvert is a complete barrier to fish passage due to the steep slopes encountered on the apron, lack of resting areas on the upper reach of the apron, excessive jump height at the culvert outlet, and shallow water depth or excessive water velocities encountered inside the apron. The most effective fish passage project at this site would be to remove the entire structure and replace it with a wide-span bridge that does not impact the stream channel.

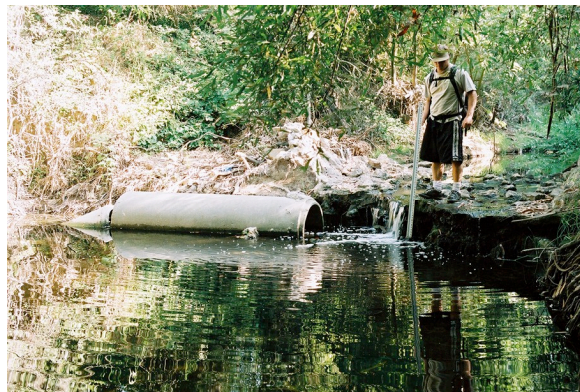
Broken Grade Control Structure

This small concrete and boulder grade control structure occurs near the 100-foot elevation and spans 17 feet across the creek. The old structure is in poor conditions with adjacent failed concrete culverts and bank erosion on river-right. During low stream

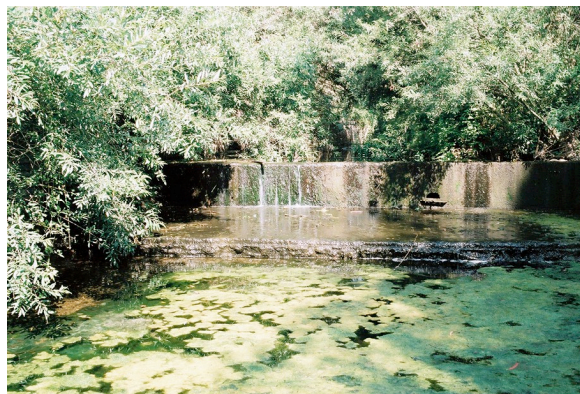
This concrete structure spans 41 feet across the stream channel and drops flows 3 feet onto a concrete apron that extends 12 feet downstream. This structure would prevent any upstream fish passage during low and moderate flow conditions. The structure could

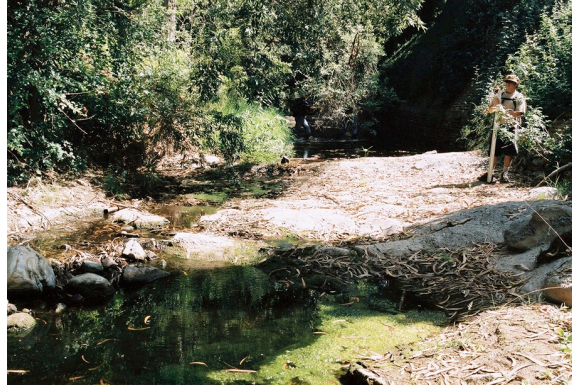
These two small concrete grade control structures are approximately 80 feet apart from each other and occur downstream 0.2 miles from Highway 101. Neither structure represents a severe fish migration barrier, but both could be notched at center or removed to improve low-flow fish passage conditions.

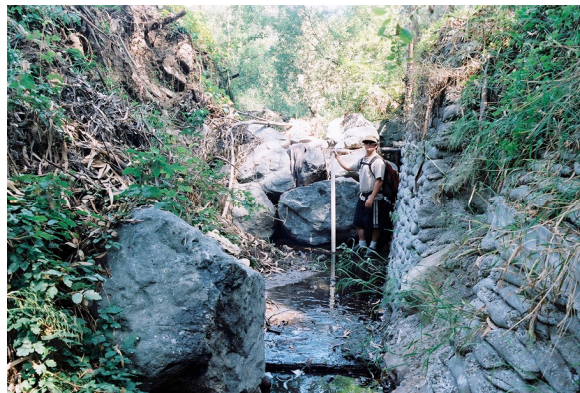
This failed pipe and boulder occurs 0.17 miles downstream of Highway 101 and severely confines the stream channel. Metal pipes span across the channel and are partially buried by large imported boulder. A 14-foot long flat concrete slab occurs downstream and a near vertical sacrete bank revetment occurs on river-left. The boulders extend over 6 feet tall above the downstream concrete slab. During lower stream flows all water is conveyed under the boulders and upstream sediment deposits. The concrete slab prevents downstream pool formation and the excessive jump height of the pipe and boulder blockage would prevent upstream salmonid passage during most or all flows, depending on configuration and higher flow routing. Failed pipe and wire revetment

upstream is further confining the creek and causing bank failure and a high amount of erosion. This barrier and adjacent reaches needs to be further assessed to determine the feasibility of removing much of the modifications within the channel, providing effective fish passage, expanding channel flow capacity, reducing bank erosion, and stabilizing the stream channel using bioengineering approaches.

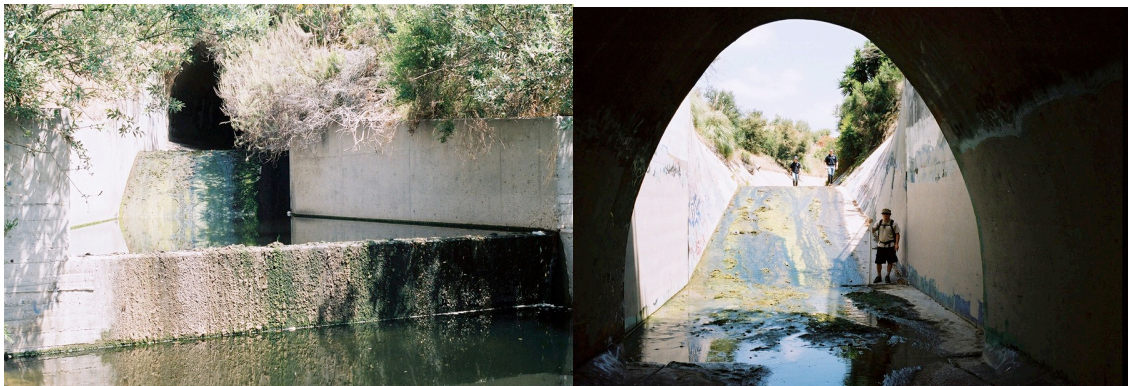
This complex culvert crossing contains a steep inlet apron that connects to upstream concrete channelization and a steep outlet apron that connects to a downstream concrete scour box. The downstream concrete wall of the scour box rises 3 feet above the downstream pool surface. The scour box measures 20 feet wide by 30 feet long and contains 9-foot tall sidewalls. The culvert outlet apron extends into the scour box, which has a maximum water depth of 4 feet. The outlet apron rises 5 feet above the box with a slope of approximately 45% to a mild sloping apron that extends 16 feet upstream to the culvert outlet. The concrete arch culvert measures 12 feet 6 inches tall by 13 feet wide at the base. The culvert length is approximately 0.08 miles. The inlet apron extends 51 feet to the upstream concrete channel with a steep slope of 18%. This culvert structure is impassable to all salmonid life stages during all flows due to excessive velocities and/or shallow water depths encountered on both inlet and outlet aprons and through the culvert. Providing fish passage at this site needs to be coordinated with the upstream concrete channel and requires a detailed assessment.

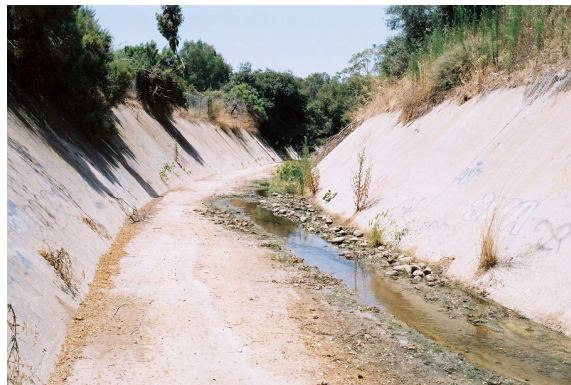
A concrete channel extends from the inlet apron at the Highway 101 culvert upstream and connects to a culvert under Hope Avenue. The combined structures confine the creek to approximately 0.28 miles of concrete bottom upstream to the confluence of Arroyo Burro and San Roque Creek. The trapezoidal concrete channel measures 15 feet 6 inches across the flat bottom. The slope of the channel near the upstream end measures less than 1%. The upstream end of the channel connects to a double box culvert under Hope Avenue. Both boxes measure 16 feet tall by 16 feet wide. A smooth concrete inlet apron extends 50 feet with a slope of 7%. Arroyo Burro and San Roque Creek meet at the top of the inlet apron. Upstream steelhead migration is not possible during lower flows when shallow water is spread out across the channel and culvert or during higher flows when excessive velocities would be encountered on the steep culvert inlet apron. A detailed fish passage assessment is need for this entire reach in conjunction with the downstream culvert at Highway 101. Naturalization of the channel bottom and bridge replacement at Hope Avenue would provide the most effective fish passage and stream habitat restoration alternative.

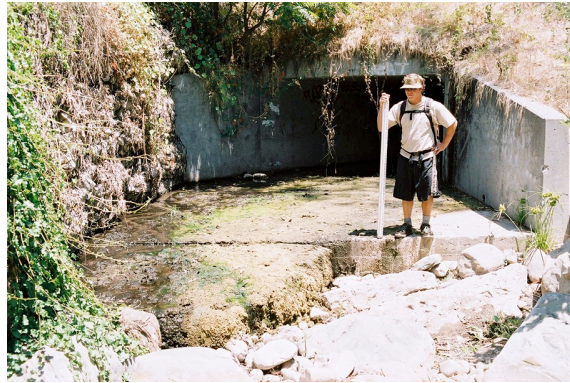
This single-box concrete culvert measures 102 feet long and 6 feet tall by 10 feet wide. The slope inside the smooth bottom culvert measured less than 1%. An outlet apron extends 17 feet 6 inches downstream from the culvert and drops 1-foot to the substrate below. This structure would prevent upstream steelhead passage during most flows due to the lack of resting areas, excessive length, shallow water conditions during lower flows, and excessive water velocities during higher flows. A detailed assessment of this structure should be conducted to determine if the culvert is adequately sized for a 100-year flow event and determine the feasibility of replacing it with a wide-span bridge. A bridge would provide increased flow conveyance, the most effective fish passage, and restored stream habitat.

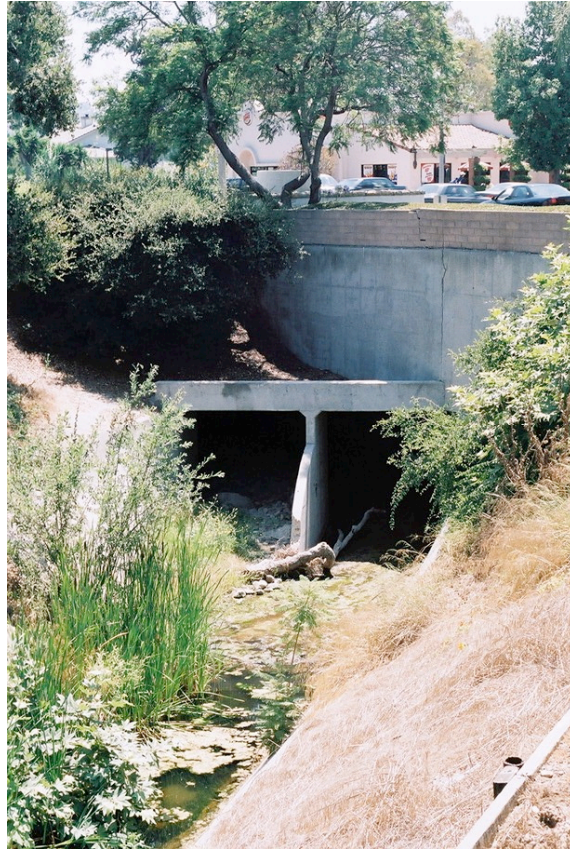
This double-box concrete culvert and inlet apron measure 189 feet long and each box measures 10 feet tall by 10 feet wide. The slope inside the smooth bottom culvert measured less than 1%. This structure would limit upstream steelhead passage due to shallow water depth during lower flows and excessive water velocities during higher flows. An assessment of this structure should be conducted to determine the feasibility of replacing it with a wide-span bridge or modifying the culvert for fish passage. A bridge would provide increased flow conveyance, the most effective fish passage, and restored stream habitat.

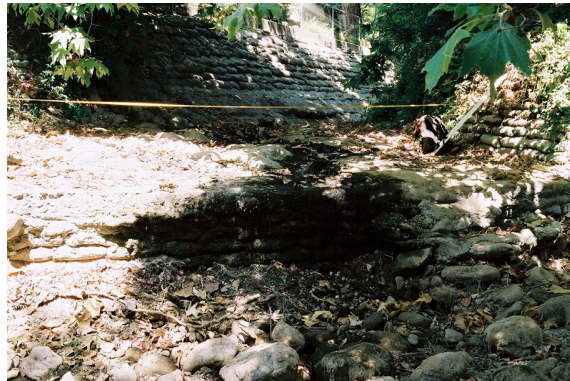
This reach of stream has been modified with sacrete bank revetment and a sacrete and concrete grade control structure to protect adjacent homes on edge of the creek bank. The grade control measures 18 feet wide across the channel and 21 long with a slope of 3.6%. The outlet of the structure drops 2 feet 4 inches to the downstream substrate. A stormwater drain 3 feet 6 inches in diameter empties onto the structure. Adjacent bank revetment is damaged and undercut in several locations and failed pipe and wire revetment occurs downstream. Upstream steelhead passage at this site would be limited due to the jump height onto the structure, shallow water depth during lower flows, and excessive water velocities during higher flows. When adequate jump depth occurs in the downstream pool during moderate flows some adult steelhead would be able to jump onto the structure and swim upstream. A study should be conducted to determine the

feasibility of removing or modifying this structure and potentially the adjacent bank revetments and establishing a stable naturalized channel. In addition, the failed pipe and wire revetment downstream should be removed and the stormdrain should be studied to determine how best to prevent direct, untreated discharge into the creek.

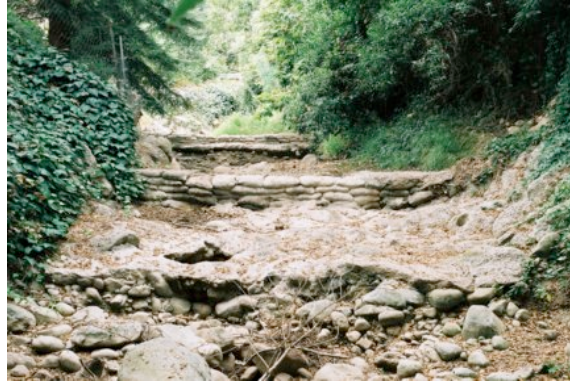
A patchwork of five concrete and sacrete grade control structures occur over a stretch of approximately 400 feet beginning approximately 700 feet upstream of the Ontare Road bridge. These structures tie into bank revetment projects of various design and condition. They range from 6 inches to 2 feet 6 inches in height and span 14 to 18 feet across the channel. Upstream migrating steelhead could jump or swim past each of these structures during moderate to high flow events, but would be limited during lower flows due to the jump height and shallow water depths encountered across the structures. Each structure should be removed or notched at center to confine lower stream flows, reduce the required jump height, and improve low-flow migration.

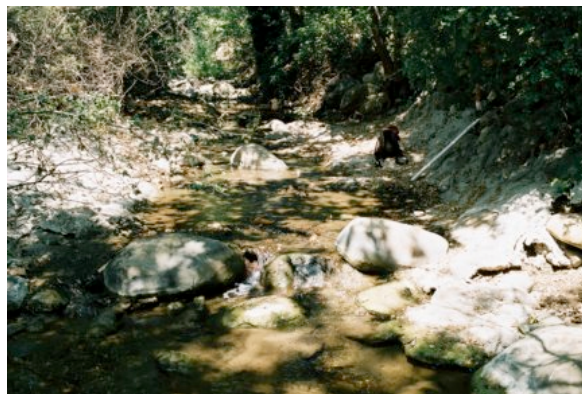
A shallow U-shaped concrete and boulder riprap grade control structure occurs under the Highway 192 Bridge. The concrete measures 21 feet wide by 27 feet long with a slope of 2.5%. Flows drop 9 inches from the outlet to the downstream substrate. Sufficient velocity breaks occur on the structure to allow upstream steelhead passage during most flow conditions, but low flow passage may be limited due to shallow water

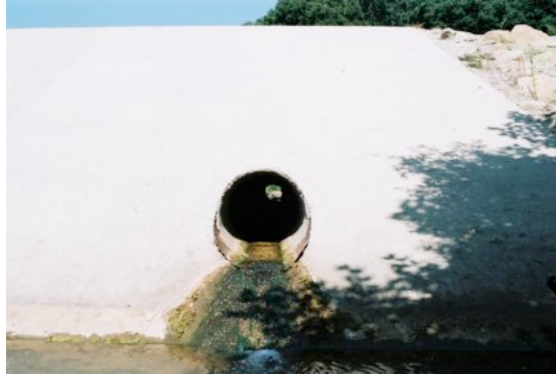
This concrete and boulder debris basin dam conveys flows through a 3-foot diameter corrugated metal culvert with a length of approximately 80 feet. The damaged, rusty culvert has been lined with a smooth concrete bottom. The culvert is completely broken through for much of the culvert length. Downstream of the culvert outlet, low stream flows drop 1-foot 8 inches down the steep concrete dam face into a 2-foot 5-inch deep downstream pool. The length of the culvert, smooth surface, and lack of velocity breaks would produce excessive water velocities that would prevent upstream steelhead passage during all flows. The upstream debris basin is routinely cleared of debris and the stream is highly exposed to direct sunlight. Native vegetation has been cleared and exotic plant species dominate the basin and are spread downstream. Additional studies are needed to assess the feasibility of modifying or removing this dam and potential impacts to the downstream environment and flood control operations.

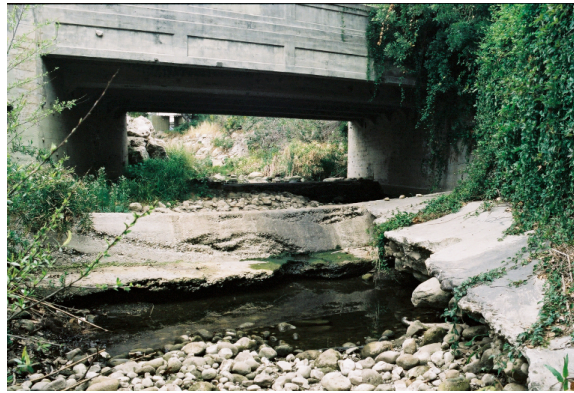
Two grade control structures occur under the Pedregosa Street Bridge. Downstream of the bridge a 1-foot thick concrete curb extends across the channel between adjacent concrete walls. The curb height measured 3 feet above the surface of a concrete apron that extends downstream. The downstream side of the structure and adjacent bank revetments are substantially undercut. This structure would impede upstream steelhead passage during moderate and low flows when the downstream pool depth is not sufficient to allow jumping the structure. The curb should be modified or removed to provide unimpeded future steelhead passage. If removal is not possible, a notch approximately 3 feet wide and 8 inches deep should be cut near the center of the curb and a wide downstream-facing U-shaped notch cut in the apron immediately downstream of this curb notch. This would focus attraction flows, reduce the horizontal and vertical jump required, and help to create a deeper jump pool downstream. A small concrete grade control structure measuring 4 feet 6 inches thick extends 34 feet across the channel under the bridge. This structure is partial buried with substrate. Upstream fish passage over this structure would have a minimal degree of difficulty. If modifications to the curb downstream occur, removal of this structure should be considered or a notch should be cut at the center of the structure to concentrate low flows.

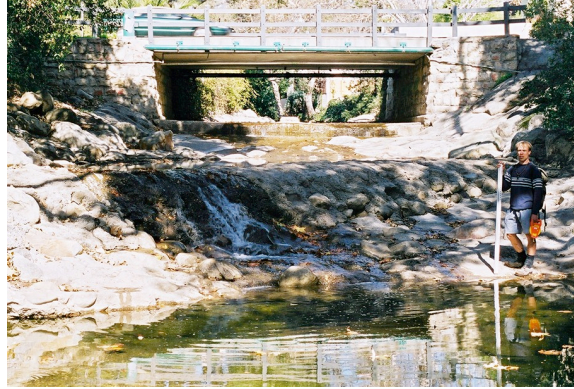
Underneath the Tallant Road Bridge a complex series of concrete-lined bottom and grade control features extend for 126 feet. The grade control structure measured 4 feet 2 inches in height above the downstream pool and flows dropped at an angle of approximately 45 degrees to a relatively flat 10-foot long apron. Upstream of the grade control, a mild sloping concrete bottom extends 42 feet upstream. A concrete apron with a slope of 8% extends 22 feet upstream to the base of a 17 inch tall curb. Concrete extends under the bridge for 41 feet with a slope of 2.6% to natural substrate upstream. The structure has significant undercutting on the downstream end and adjacent banks due to scour. Upstream steelhead migration at this crossing would not be possible during all flow conditions due to the excessive jump heights, lack of jump pool depth at the concrete curb, and excessive water velocities over the concrete apron and bottom. The most effective fish passage project is to remove the entire structure and install a wide-span bridge that does not impact the stream channel. Additional studies are needed to assess the feasibility of removing this structure and stabilizing the upstream banks and private property. Replacement would also increase the channel flow capacity and reduce flooding potential at the bridge.

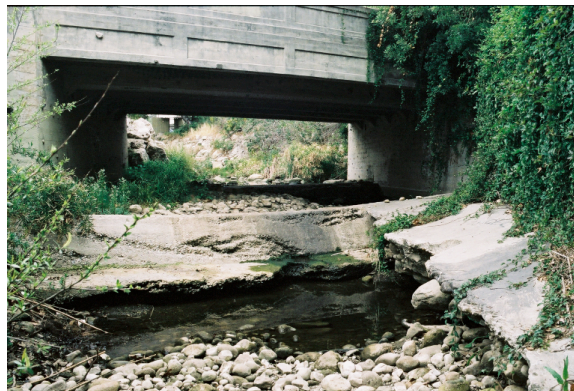
This concrete and boulder grade control structure is keyed into a stone revetment wall on the river-right stream bank and measured 24 feet across the channel. The downstream pool depth measured 2 feet 2 inches during low flow conditions and is limited by a concrete-lined bottom. The jump height from the pool surface to the top of

the structure measured 3 feet 2 inches during low flows. During moderate and low stream flows the structure limits upstream passage for smaller salmonids due to the limited depth of the concrete-lined pool downstream, moderate jump height, and significant horizontal jump distance. Increased jump pool depth during higher stream flows would enable upstream passage for most salmonids. Cutting a notch in the structure approximately 3 feet wide and 8 inches deep slightly toward the river-left side would improve upstream passage conditions for juvenile salmonids and future adult steelhead migration during lower flows. This action would reduce the jump height, length and steepness of the top of the structure, and concentrate flows toward the deepest part of the downstream pool for an increased jump depth.

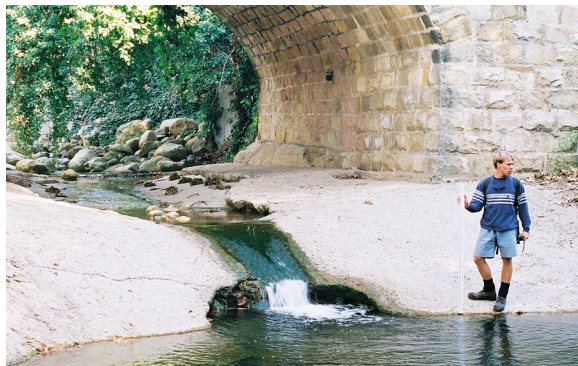
This stone arch bridge has been reinforced with a concrete bottom and sloping apron that are significantly damaged. The concrete bottom and apron measured 58 feet in length. The smooth concrete apron measured 6 feet 11 inches in length with a slope of 31%. The jump height from the downstream pool surface to the top of the apron measured 2 feet 9 inches. During low flows the downstream pool jump depth measured 3 feet 4 inches. A small 7-inch deep pool in broken concrete exists at the upstream end of the sloping apron and extends upstream 16 feet. The upper 35 feet of concrete bottom has a slope of less than 2%. The concrete bottom is in poor condition with significant damage throughout its length. During moderate migration flows the downstream pool has sufficient depth to allow a moderately difficult adult steelhead jump upstream to the shallow pool and concrete channel. During high stream flows migration may become more difficult as stream velocities are accelerated along the concrete-lined bottom and down the sloping apron, pushing the jump location further back in the downstream pool. Additional analysis of this structure is needed to evaluate potential fish passage alternatives. Removing the entire structure and replacing it with a wide-span bridge that does not impact the stream channel would accomplish the most effective fish passage. Depending on the structural integrity of the bridge, portions of the concrete bottom may be able to be removed and bridge supports reinforced. Removal of the apron and creation of resting pools in the concrete bottom may be a cost effective solution.

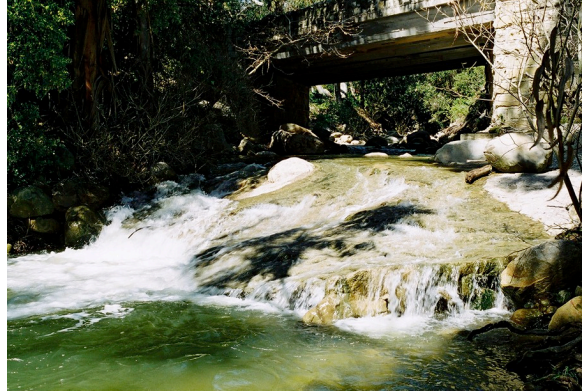
Immediately downstream of the bridge a long concrete and boulder riprap apron extends 34 feet downstream with a slope of 11%. Flows drop vertically 9 inches off the apron into the downstream pool, which has a jump depth of over 4 feet. Exposed, damaged metal re-bar at the downstream end of the apron presents a significant hazard to upstream migrating salmonids. The apron is in poor condition with significant wear and undercutting on the downstream side. The apron is also causing major scour and bank erosion that appears to be contributing to loss of property on both downstream banks and undermining of the road fill. The downstream pool has sufficient depth to allow an easy jump onto the apron, but from there upstream migrating salmonids encounter excessive water velocities and/or shallow water depth that prevents upstream passage. Effective passage at this site is essential to providing upstream access to existing o. mykiss populations and for future steelhead recovery upper Mission and Rattlesnake Creeks. The most effective fish passage alternative would be the removal of the apron and either stabilize the existing bridge or replace it with a wide-span bridge out of the stream channel. Additional analysis is needed to determine suitable design alternatives.

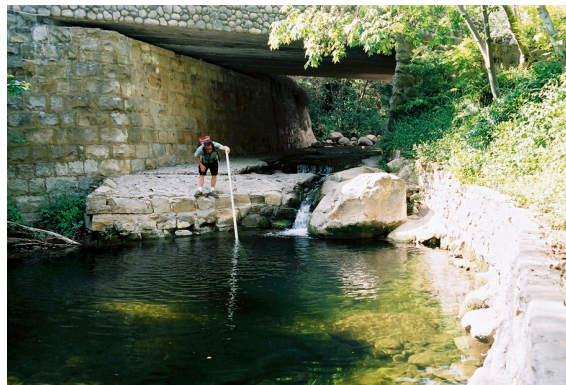
This bridge has a stone block and concrete bottom that measured 66 feet long with an overall slope of 5%. The downstream end is extremely damaged with a large, irregular-shaped hole eroded completely through the concrete. A confined chute is eroded on the downstream 12 feet into the downstream pool. The downstream end of the

structure and adjacent bank revetments are significantly undercut and damaged. The downstream pool has sufficient depth to allow a moderately difficult jump upstream onto the concrete channel by an adult steelhead. Shallow water depth during low flows and excessive water velocities during high flows will limit the window of opportunity to upstream salmonid passage. Additional analysis is needed to assess the feasibility of naturalizing the streambed under the bridge and reinforcing the bridge supports should be studied. Complete replacement of the bridge with a wide-span bridge out of the stream channel would have the greatest benefit for fish passage and may help to increase the flow capacity and reduce or eliminate downstream erosion of the structure and adjacent private property.

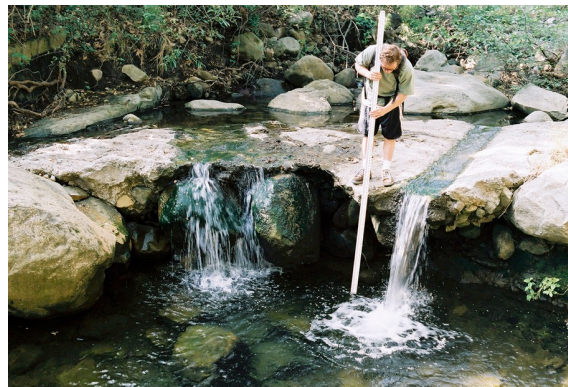
This concrete and boulder structure spans the entire stream channel and apparently was built to protect a subsurface pipeline. The jump height of the structure measures 3 feet 7 inches from the outlet lip to the downstream the pool surface. The structure is extremely undercut on the downstream side and at risk of failure. During moderate migration flows the downstream pool would fill sufficiently to increase the jump depth and reduce the jump height and allow limited upstream steelhead migration. This structure would present a significant impediment to juvenile salmonid migration during all flows and adult migration during low flows. Additional studies are needed to assess the feasibility of removing the structure and running the pipeline overhead out of the channel. This aerial conversion is a desirable modification and has been successfully implemented on Alder Creek in Santa Barbara County.

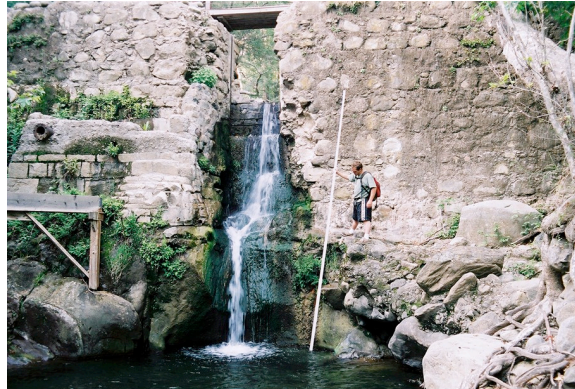
This 1807 dam historically diverted stream flows into an aqueduct that carried the water to a storage reservoir near the Mission. The total height of the dam from the downstream substrate to the top of the structure measured 27 feet 9 inches. The dam shows significant signs of wear, downstream scour, and adjacent bank erosion. Upstream passage of all salmonid life stages during all stream flows is prevented due to the excessive height of the dam. A detailed alternatives analysis should be conducted that looks at several fish passage options, including full and partial dam removal, to make the most informed decision about restoring future steelhead runs upstream. Dam removal would reestablish the aquatic connectivity of Mission Creek, open access to upper Mission Creek for eventual steelhead recolonization and restore surface flows upstream of the dam that often go subsurface into the sediment backed up behind the dam. A fish ladder is not encouraged due to their susceptibility to clogging and limited effectiveness under low flow conditions. The subsurface flow conditions that exist upstream of the dam for much of the year presents a significant problem for any fish passage project that leaves the dam in place.

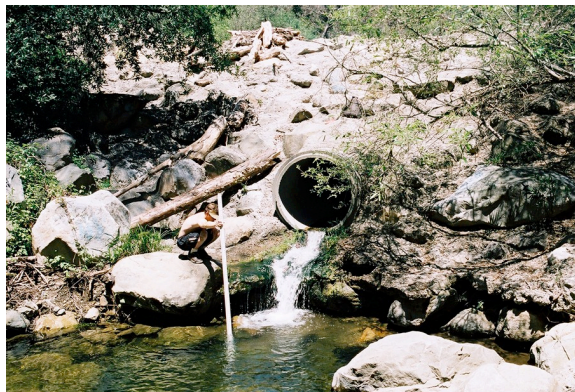
This County operated concrete and boulder debris basin dam conveys flows low flow through a smooth concrete culvert with a length of 68 feet 8 inches and slope of

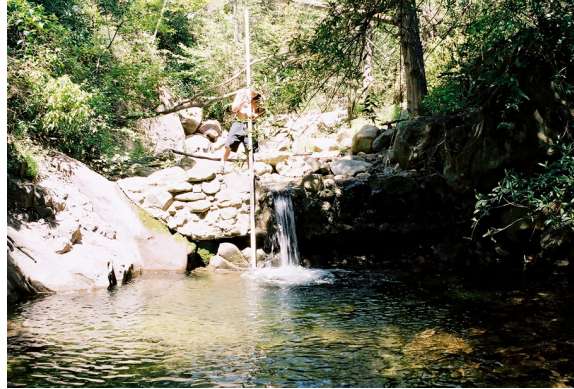
This stone dam measures 16 feet 6 inches across the stream channel with a height of 4 feet 2 inches above the downstream pool, which had a jump depth of 4 feet 11 inches. The structure is extremely undercut on the downstream side. The downstream pool has sufficient depth to allow a moderately difficult jump over the dam during ideal moderate flow conditions. Passage for juveniles and adult steelhead during low stream flows will be difficult or impossible depending on the depth of the downstream pool. This old dam does not appear to serve any purpose and no adjacent development would be impacted by its removal. This dam can be broken apart with relative ease, low cost, minimal consequence, and would provide significant benefit to future salmonid passage.

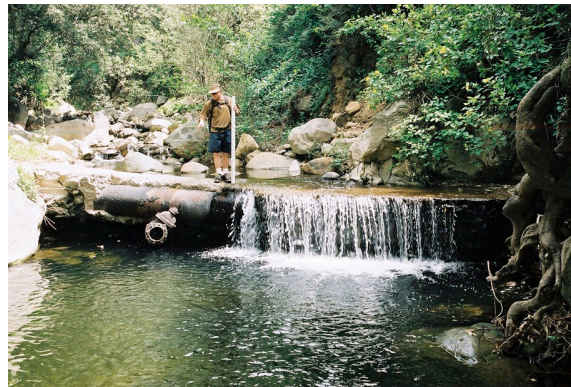
A 20-inch diameter pipeline crosses the creek with damaged concrete across the top. The height from the surface of the downstream pool to the top of the pipe and

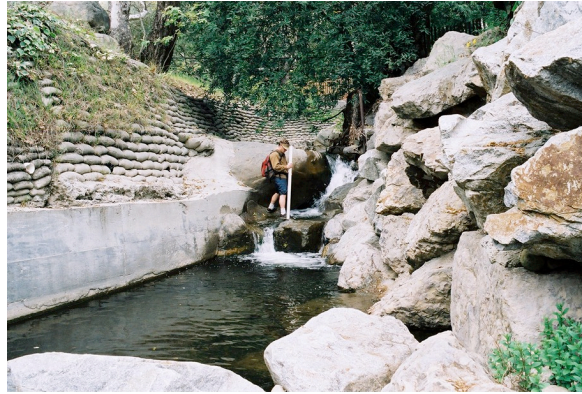
This channelized reach of Rattlesnake Creek measures approximately 30 feet in length and consists of concrete, imported boulders, sacrete riprap. The creek channel is confined to 10 feet in width for sections of this channelized reach. A large boulder keyed into the bank revetments on both sides produces a two-step drop approximately 6 feet in height above the downstream pool surface. This structure was likely built to protect the adjacent residences, which are precariously close to the stream channel on the adjacent banks. This patchwork of revetment projects has been built into the channel of the creek, reducing the flow capacity and width. Excessive jump heights and water velocities through this confined stream reach prevent all upstream fish passage. A detailed study of this stream reach is needed to formulate fish passage alternatives that also protect adjacent residences.

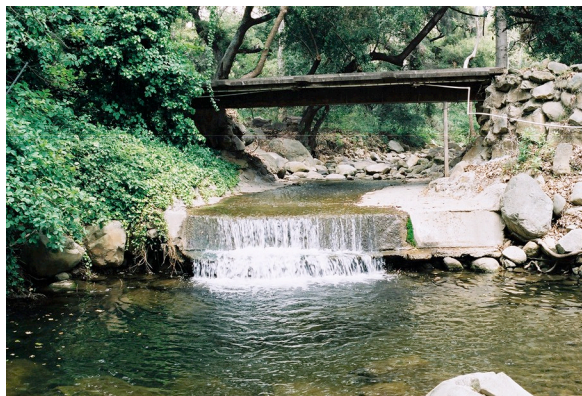
A concrete apron extends approximately 40 feet under a private driveway and drops a total of 4 feet to the downstream pool. The structure appears to be in fair condition with significant downstream undercutting and adjacent bank erosion. During low flows, the spread out and shallow water depth across the smooth concrete prevents all upstream fish passage. During moderate to high stream flows, excessive water velocities across the concrete and lack of resting areas would preclude upstream fish passage. The most effective fish passage option and traffic safety is to remove the entire structure and replace it with a wide-span bridge that does not impact the stream channel. Obtaining landowner support and conducting a detailed analysis of the bridge replacement is needed.

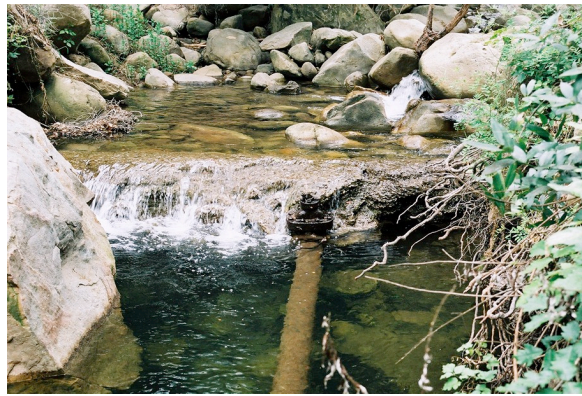
This old concrete diversion dam and 7-inch diameter pipe are no longer functioning. The pipe intake is buried by sediment upstream. The height of the dam above the surface of the downstream pool measures 1 foot 6 inches during low flows and the downstream pool measured 4 feet 1 inch deep. The structure is in poor condition with major undercutting on the downstream side due to scour. The downstream pool provides sufficient depth to allow upstream salmonid passage with a minimal to low degree of difficulty during all flows. This obsolete structure should be broken up and the metal pipe removed to prevent potential downstream pipe blockage with a structural failure and to improve upstream fish passage during low stream flows.

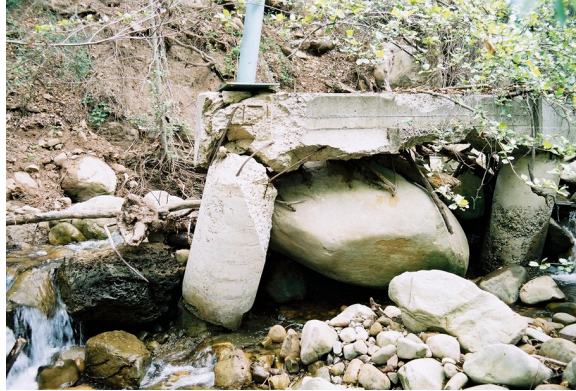
This aerial pipeline crossing has two separate structural supports in the stream channel that have blocked large boulders and debris creating several waterfalls and steep cascades over 6 feet in height with minimal jump pool depths. The pipe crossing supports are failing, with the concrete bases separated from the streambed. The boulders and debris backed up behind the failing pipe supports have excessive jump heights and steep sloping cascades that produce extremely difficult or impassable upstream migration for salmonids, depending on the seasonal configuration. The aerial pipeline crossing should be redesigned to eliminate structures within the streambed that impede sediment transport, restrict upstream fish migration, and present a blockage hazards.

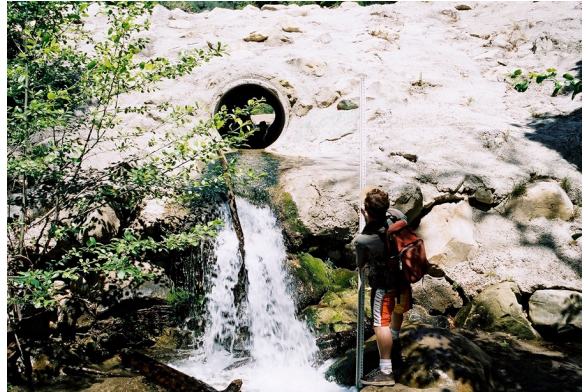
This County owned concrete and boulder debris dam conveys low flows through a smooth concrete culvert with a measured length of 65 feet and slope of 5.4%. Downstream of the culvert outlet, a smooth concrete apron with an overall slope measured at 11.4% extends 13 feet 10 inches. The apron ends abruptly and stream flow falls vertically 5 feet 7 inches to the substrate below. There is no developed jump pool downstream and flows fall directly onto woody debris and gravel with a water depth of 3 inches. The dam appears to be in fair condition with significant downstream scour and only moderate concrete damage. Upstream passage of salmonids at this site is not possible during all stream flows due to the lack of a downstream jump pool, excessive jump height, steep apron, and high velocities and/or shallow water depth throughout the long, relatively steep culvert. Additional studies are needed to assess the feasibility of modifying or removing this dam and potential impacts to the downstream environment and flood control operations.

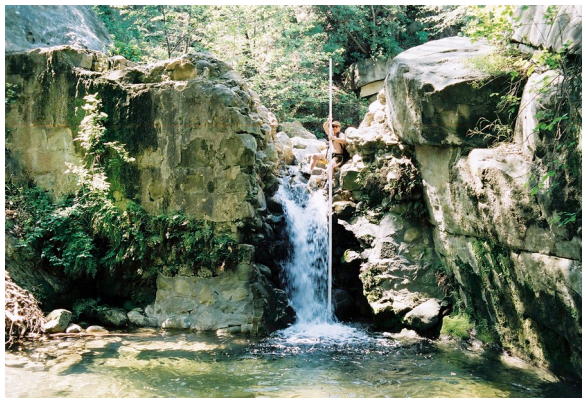
This old 1808 mission dam is composed of cut stones, cobbles, and likely lime mortar. The dam no longer functions and is naturally being broken apart. The dam measured 35 feet across the channel and is keyed into bedrock walls on both sides. The total height of the dam from the downstream substrate to the top of the dam measured 21 feet 10 inches. A major portion of the dam has blown out and stream flows now fall 11 feet 6 inches from the damaged notch to the surface of the downstream pool, which measured 4 feet 10 inches deep. The dam is in extremely poor condition with massive structural failure and significant undercutting on the downstream side. Sediment is backed up to the top of the failed notch. Recent unpermitted efforts to repair parts of the dam have occurred and should be deterred. The excessive height of the dam prevents upstream salmonid migration during all flows. The dam will likely blow out on its own, but if fish passage efforts at downstream barriers allows steelhead to migrate upstream to this site and passage is still significantly impeded, the rest of the dam should be broken apart.

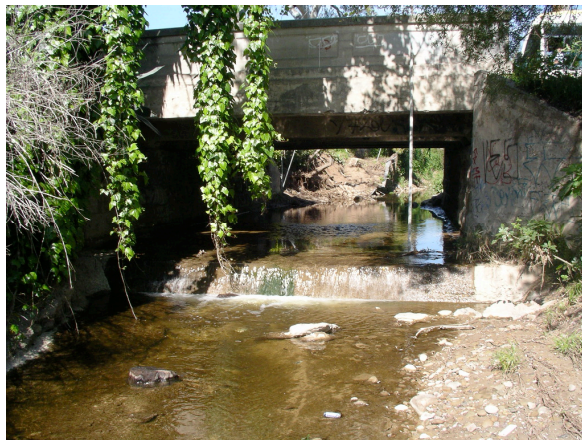
This bridge appears to be undersized and in poor condition with extensive upstream river-right bank erosion. The bridge limits upstream fish passage due to the presence of a concrete bottom and apron at the downstream end. The downstream apron measured 4 feet 6 inches in length and rises 2 feet 4 inches in height to the concrete bottom under the bridge. The concrete bottom extends 12 feet under the bridge and is then buried by substrate. This structure would limit upstream fish passage during lower flows due to the moderate jump height and shallow, and unconfined water depth across the concrete bottom. The most effective fish passage option is removal of the structure and replacement with a wide-span bridge that does not impact the stream channel.

Determine when the Road Department is considering protection measures or bridge replacement at this site and coordinate improving fish passage at the same time.

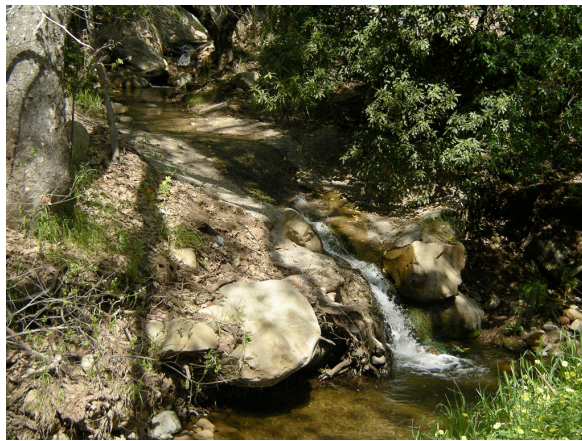
Approximately 40 feet upstream from the Stanwood Drive/Highway 192 Bridge crossing of Coyote Creek, this concrete chute conveys stream flows into a large pool at
