Santa Clara River Steelhead Trout: Assessment and Recovery Opportunities

December 2005

The Santa Clara River Trustee Council and The Nature Conservancy

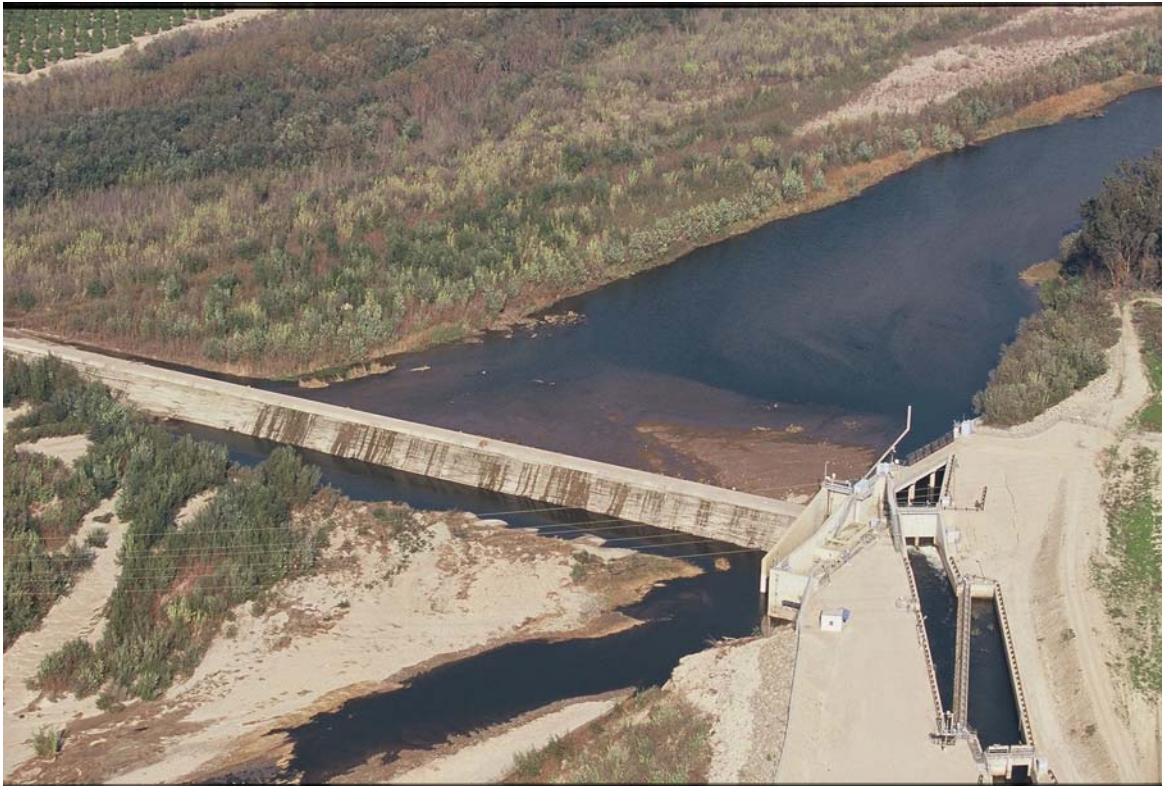
Description: The structure is owned and operated by Bureau of Reclamation and United Water Conservation District (UWCD). The current dam measures 1200 feet across and 20 feet tall from the crest to the downstream concrete apron. The dam extends an additional 50 feet down through the substrate and keys into bedrock. The current Vern Freeman Diversion Dam and associated Denil Fishway were built in 1990. Prior to the construction of this concrete dam, various temporary earthen diversion dams existed and occurred upstream from the current diversion dam location. These older dams diverted flows into an earthen channel built along the side of the river and water moved downstream to near the existing holding ponds by gravity. Murray McEachron of UWCD reported that the first company to divert water started operation in 1875. UWCD bought the operation in 1927 and at this time surface flows were generally only diverted during lower flows encountered in the summer and fall with a temporary earthen dam that blew out during the winter. In the 1940's winter flows started being diverted and a steel and piling diversion structure was built in 1968 to increase the ability to withstand the high winter flows and expand the diversion season. The flood of 1969 reportedly destroyed this new structure. From 1970 to 1990, UWCD reportedly operated an earthen dam that could survive mainstem flows up to 2000 cfs at which point the dam was blown out. This dam reportedly diverted all steelhead smolts into the diversion channel when operating and was also impassable to upstream migrating adult steelhead due to the excessive outlet drop. For twenty years upstream steelhead passage could only occur during high flow years that exceeded 2000 cfs and destroyed the dam.

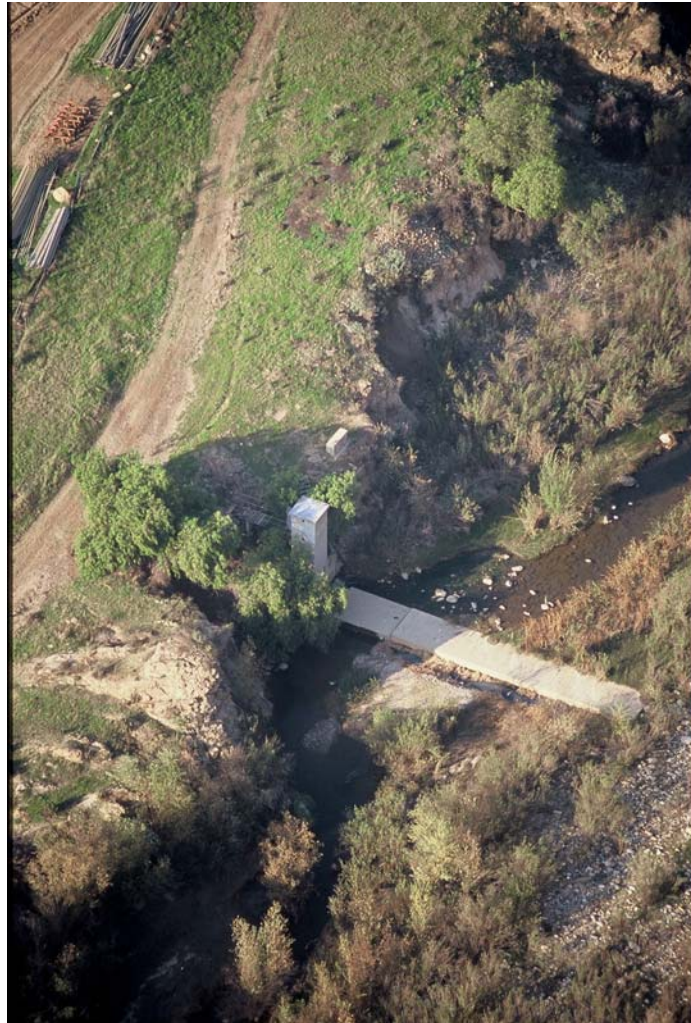
Description: Access to survey this structure was not obtained and limited observations were made from the air. This structure appears to be a gaging weir with a tall gaging-type structure occurring adjacent to the concrete weir on the river-right bank. Surface flows were observed to be focused across the weir on the far river-right side. Flows appeared to drop at least 2 feet 6 inches from the weir outlet to the surface of the downstream pool.

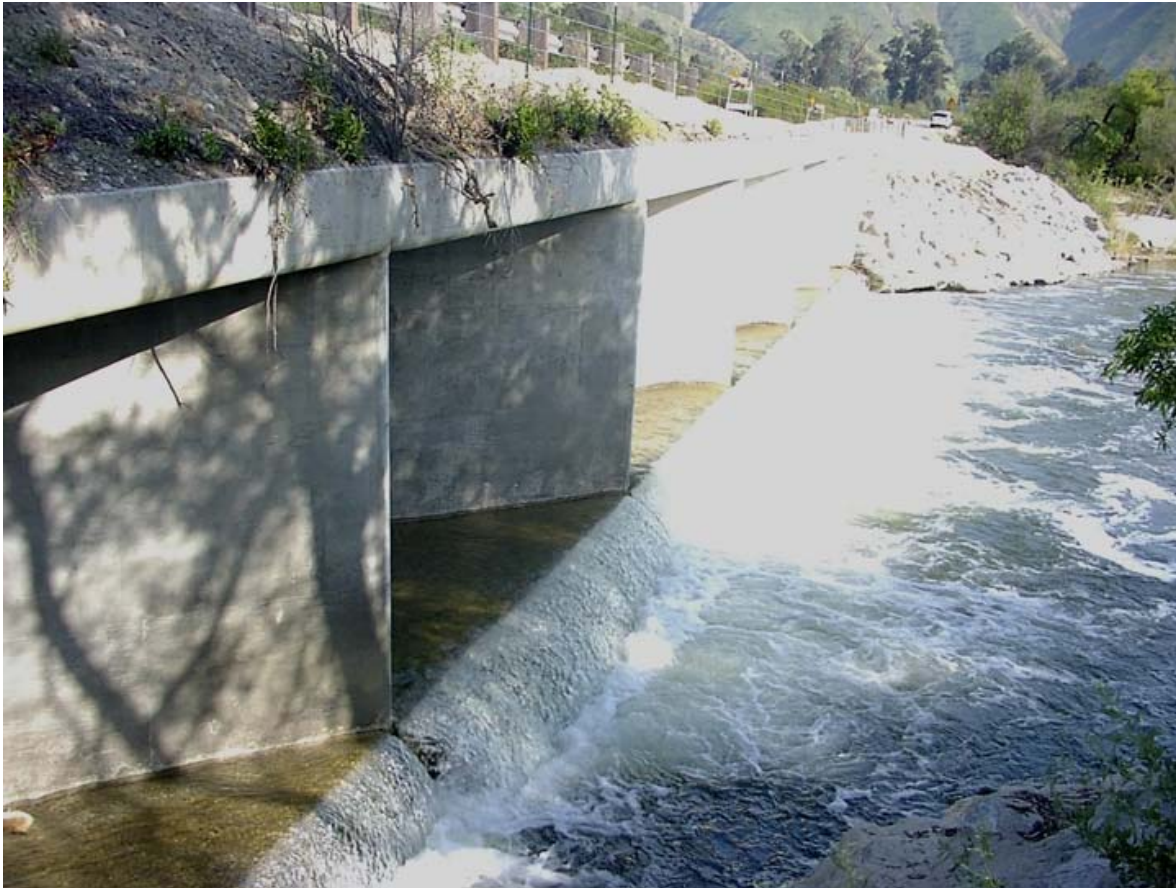
Description: Due to lack of access to adjacent private land, limited observations of this culvert were made. This 6-box concrete culvert appears to have a mild gradient and approximately 12-inch outlet drop during the fall of 2004. The structure appears to be in good condition.

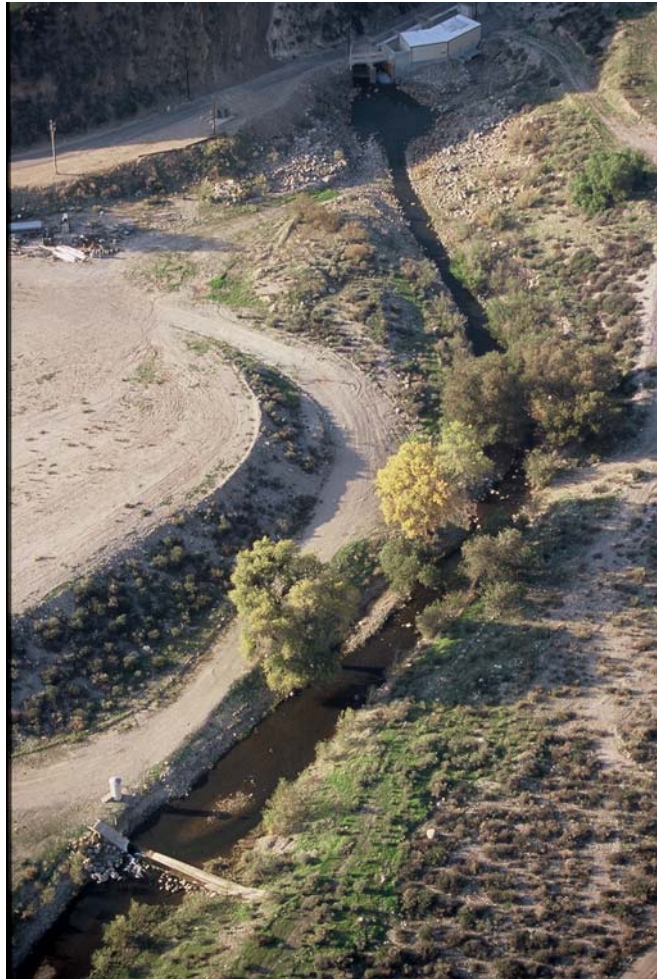
Description: Access to survey this structure was not obtained and limited observations were made from the air. This structure appears to be a concrete weir or possible obsolete diversion dam. An outlet pipe was observed on the downstream side. The structure is approximately 4 feet thick with 6 feet of boulder rip-rap protection forming a cascade-like apron on the downstream side. The total height of the structure from the downstream pool surface to the outlet lip of the dam is approximately 4 feet 6 inches.

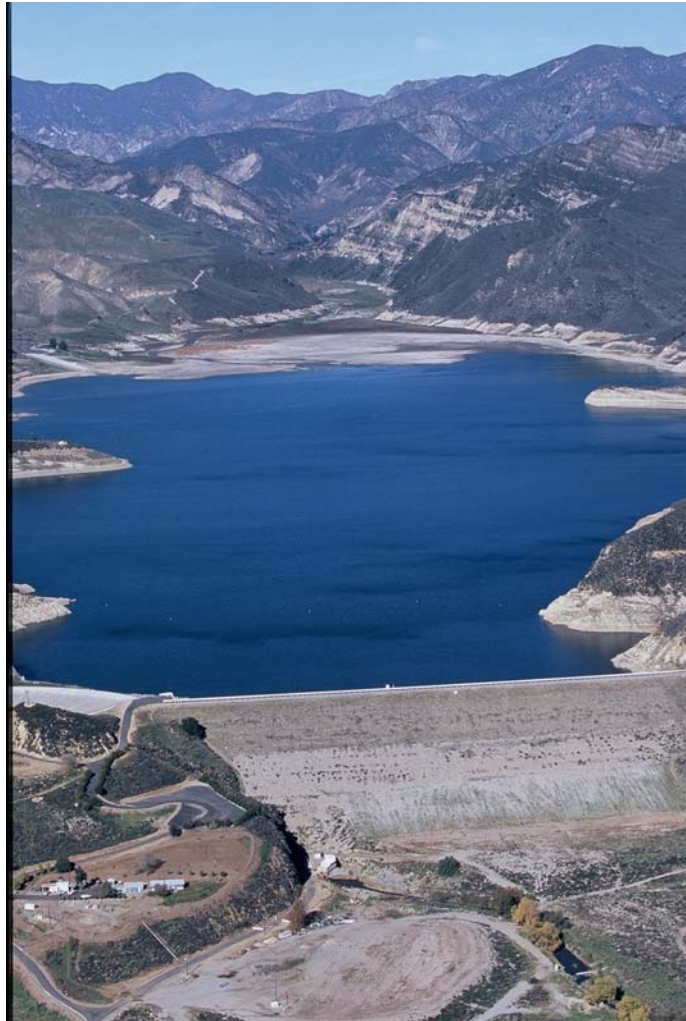
Description: Santa Felicia Dam was built in 1954. United Water Conservation District (UWCD) operates the Santa Felicia Dam in conjunction with the California State Water Project (Pyramid Dam) located upstream and the Vern Freeman Diversion Dam located approximately 15 miles downstream on the mainstem of the Santa Clara River (USDC-NOAA, 2005). This large dam was constructed without fish passage facilities and currently does not have any facilities or programs to allow upstream fish passage. A small hydro-project is associated with the facility.

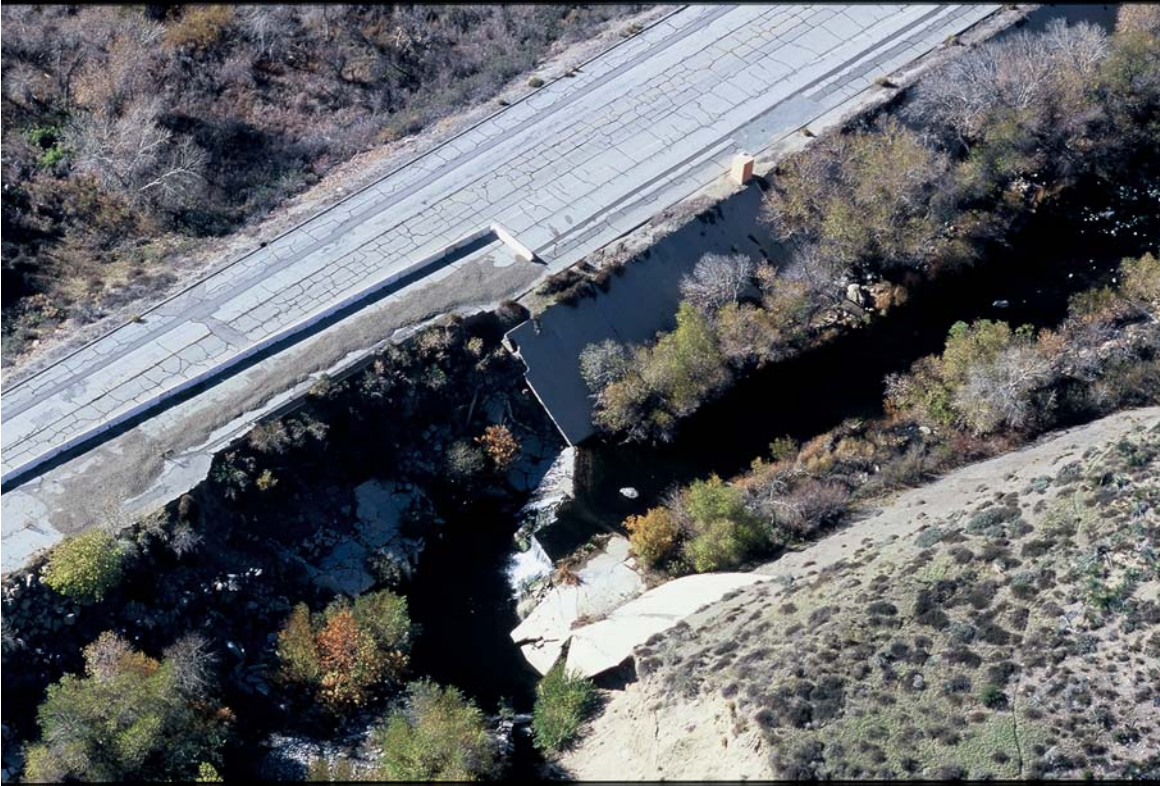
Description: Access to survey this structure was not obtained and limited observations were made from the air. This concrete channel appears to be several hundred feet long and is in poor condition with sediment deposits and riparian vegetation occurring within the channel. Concrete appears to be broken in several locations and an outlet drop of at least 5 feet has considerable downstream scour associated with it that has eroded adjacent banks and undercut the concrete channel.

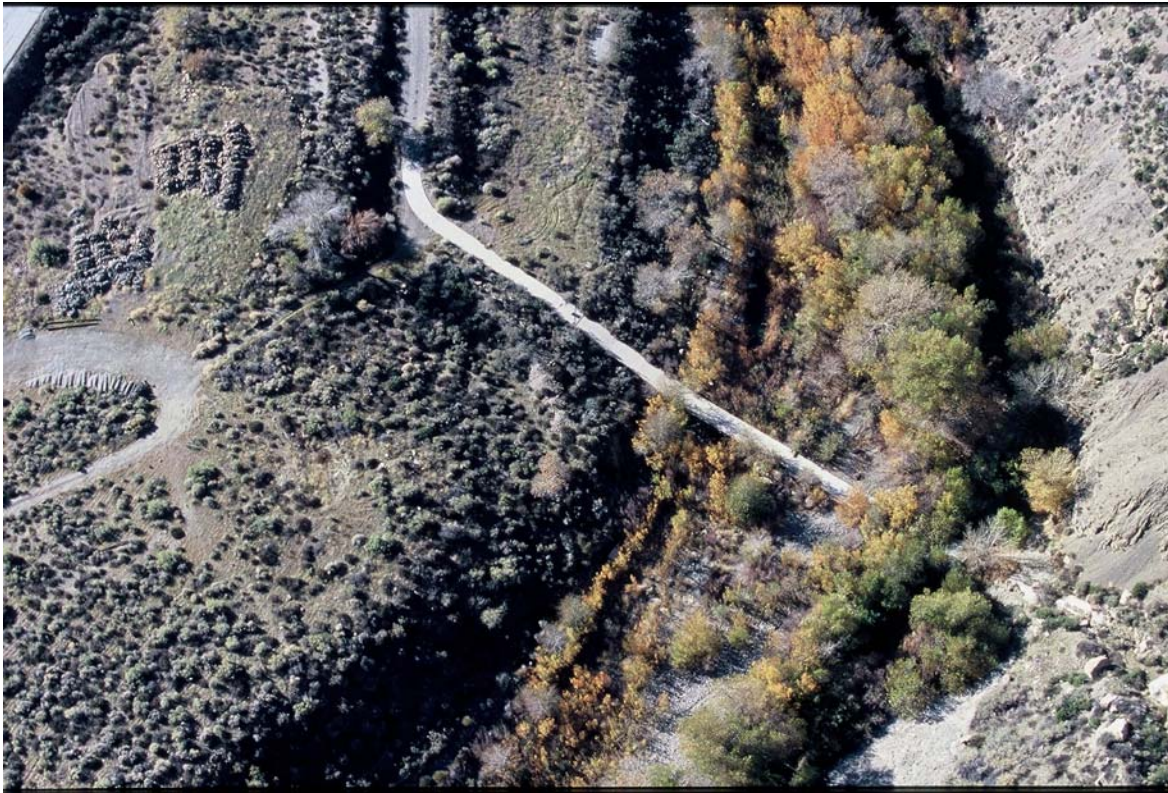
Description: Access to survey this structure was not obtained and limited observations were made from the air. The exact purpose of this structure could not be determined, but it appears to be a concrete crossing or some type of grade control structure or utility protection.

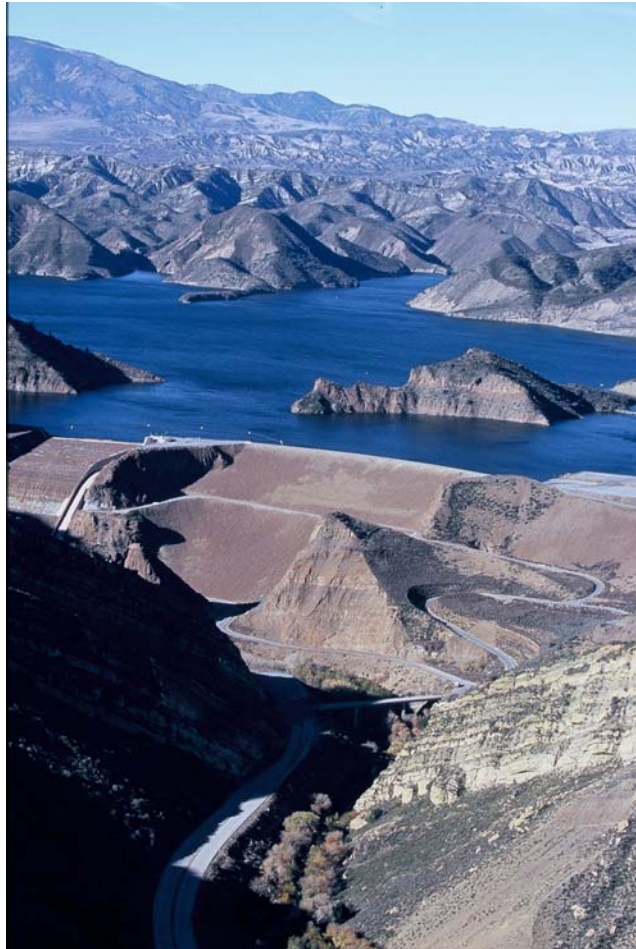
Description: Pyramid Dam was built in 1973 and is owned and operated by California Department of Water Resources. This large dam was constructed without fish passage facilities and currently does not have any facilities or programs to allow upstream fish passage.

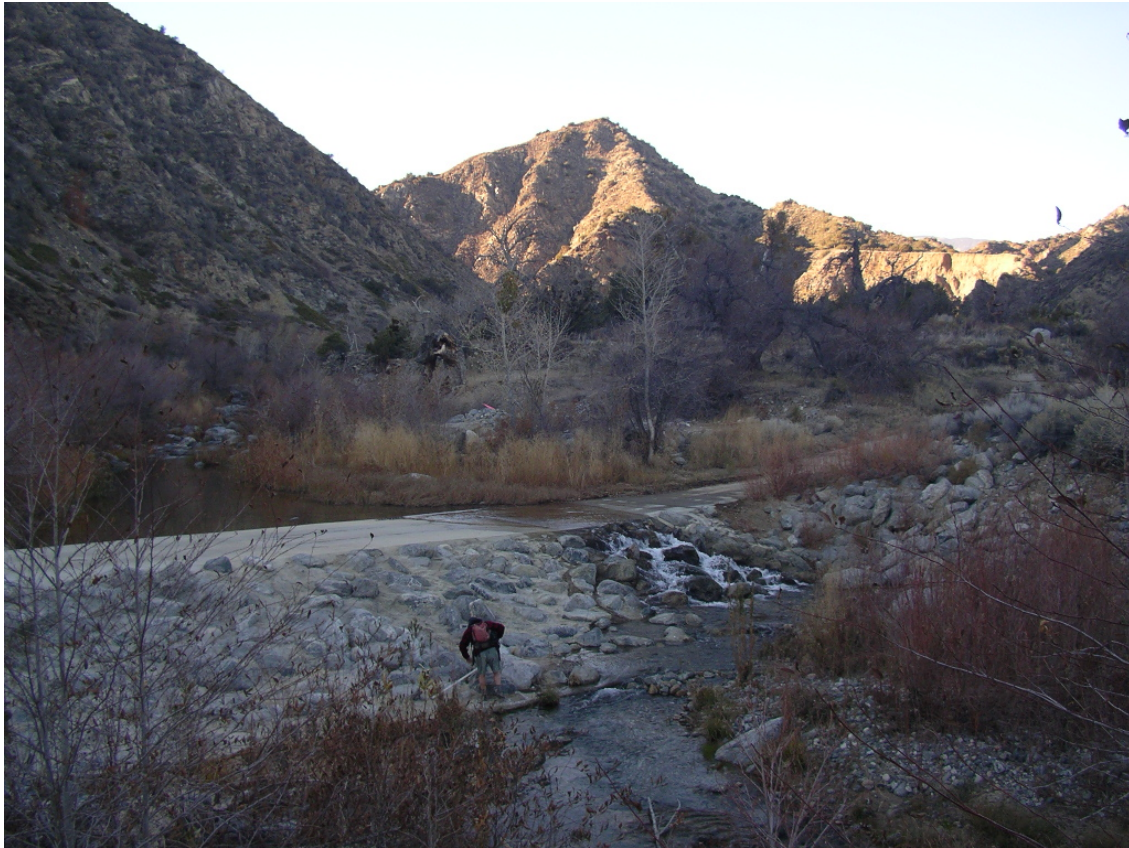
Description: This concrete crossing measured 135 feet across the channel and 46 feet wide including the downstream concrete and boulder apron. The slope of the 16-foot wide road surface crossing measured 1% and the slope of the 30-foot long downstream apron measured 18%. All surface flows are conveyed on top of the crossing and apron and then drop 10 inches to the surface of the downstream 1-foot deep pool. The total height of the crossing from the downstream pool surface to the top of the road crossing measured 6 feet 3 inches.

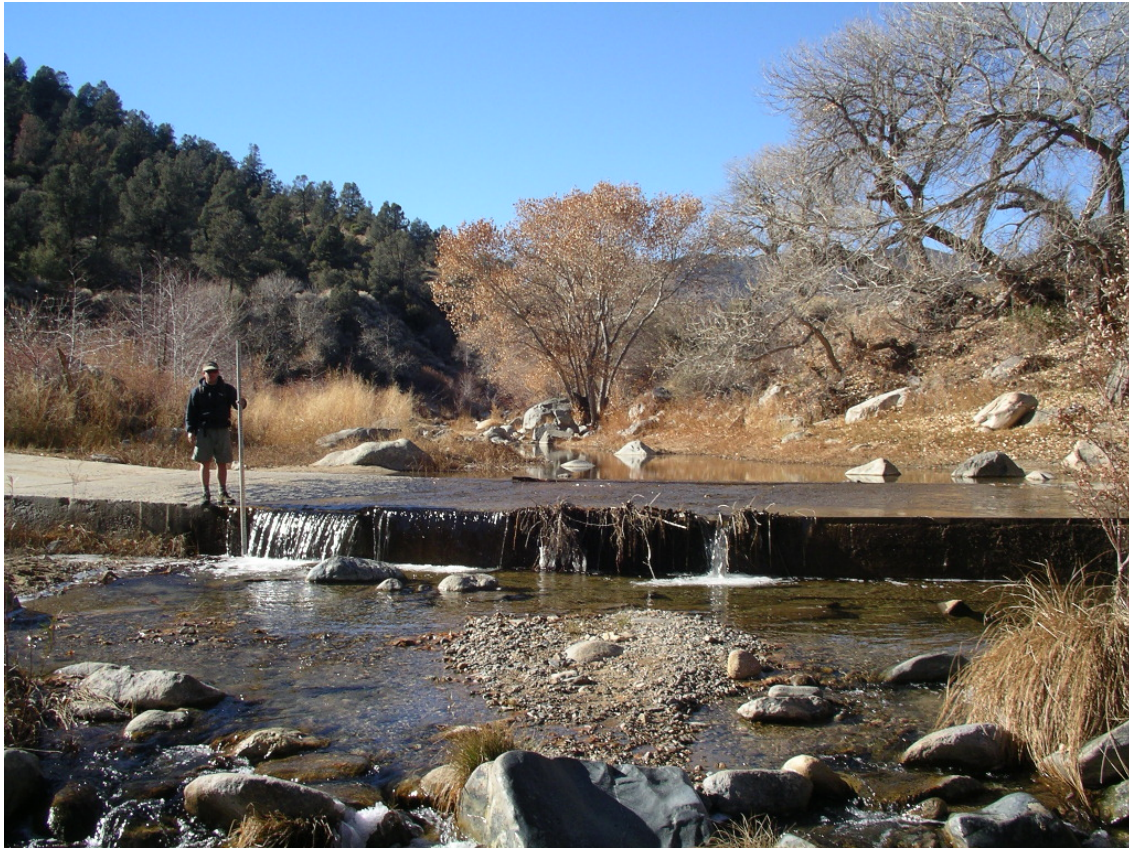
Description: The concrete crossing measured 19 feet wide with a slope of 1.3%. All surface flows are conveyed on top of the crossing and then drop 1-foot 9 inches to the surface of the downstream 8-inch deep pool. Exposed re-bar was observed on the downstream side of this crossing that appears to be in fair condition.

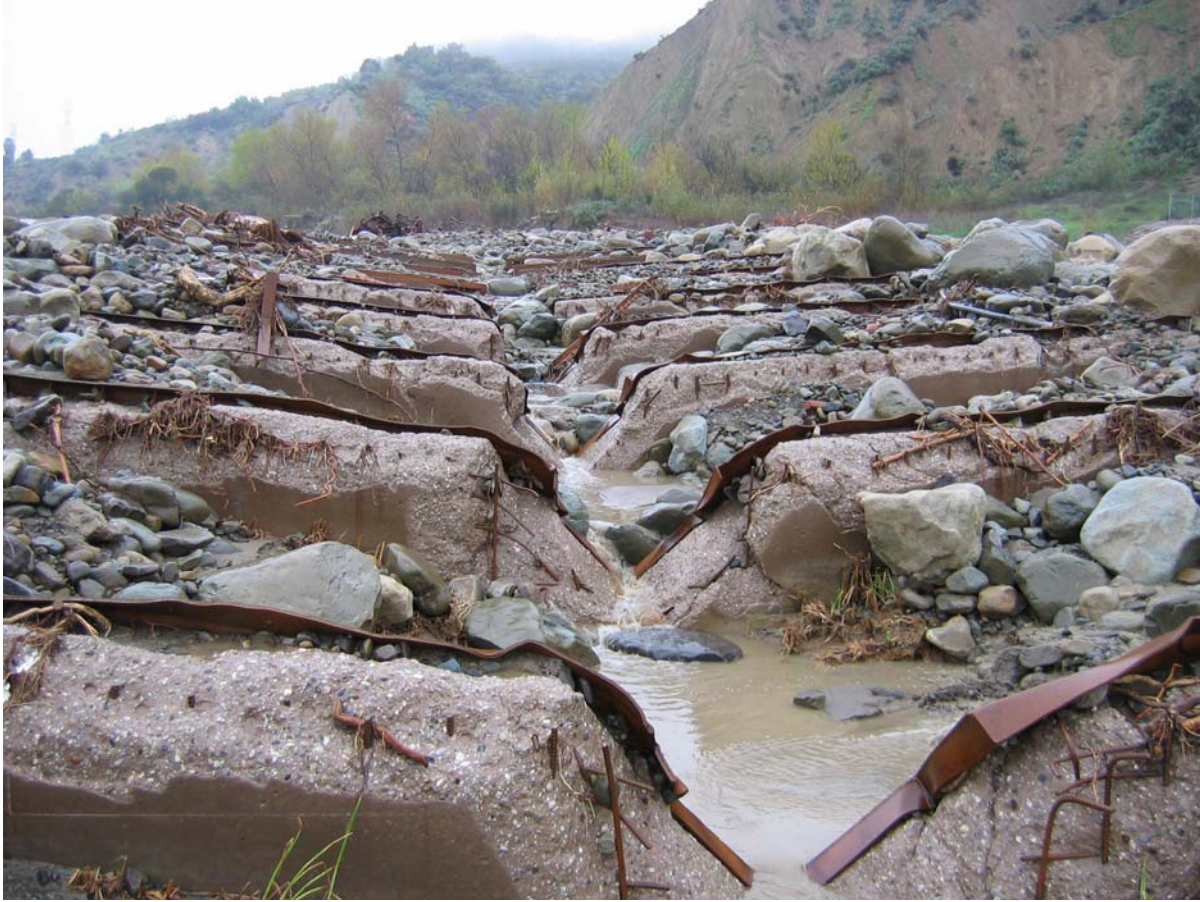
Fishway failure following January 2005 flows

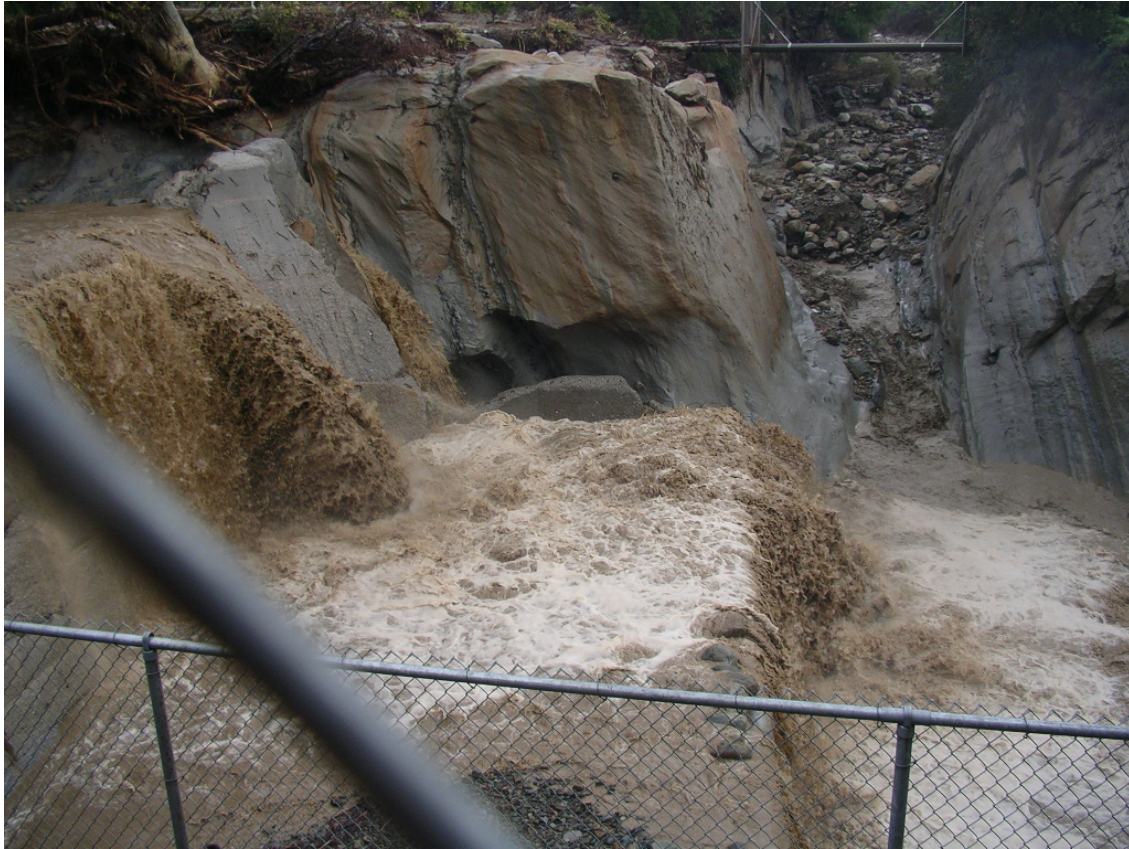
Damage to dam during 2005 flood

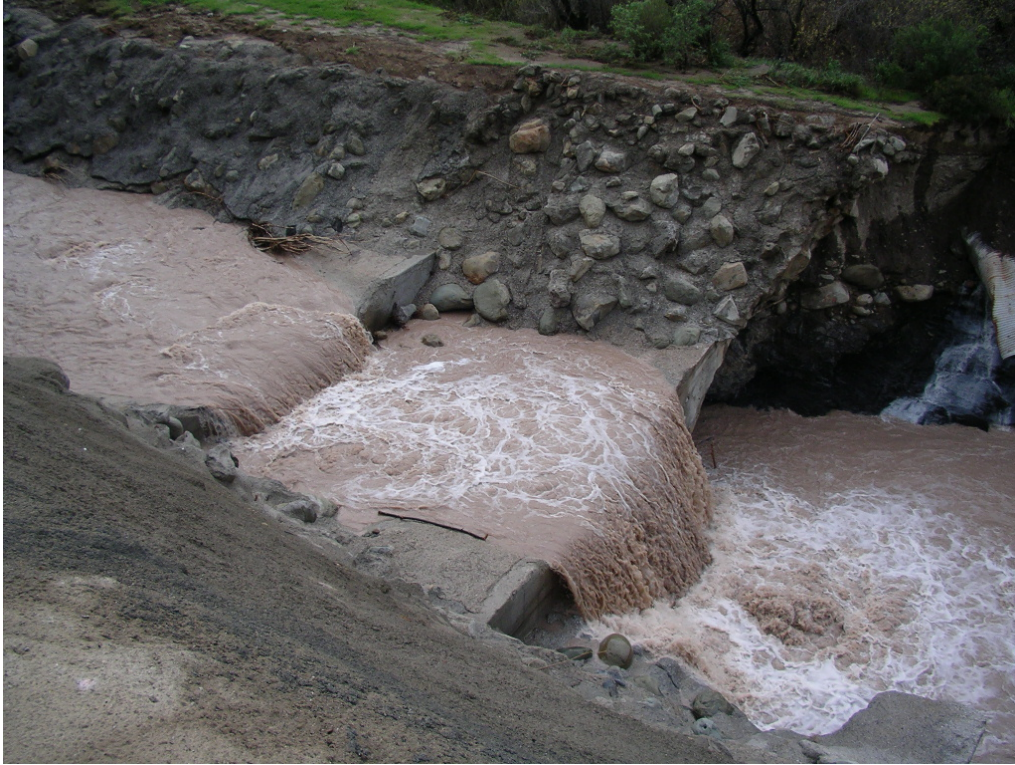
Failure of downstream grade controls following 2005 flood

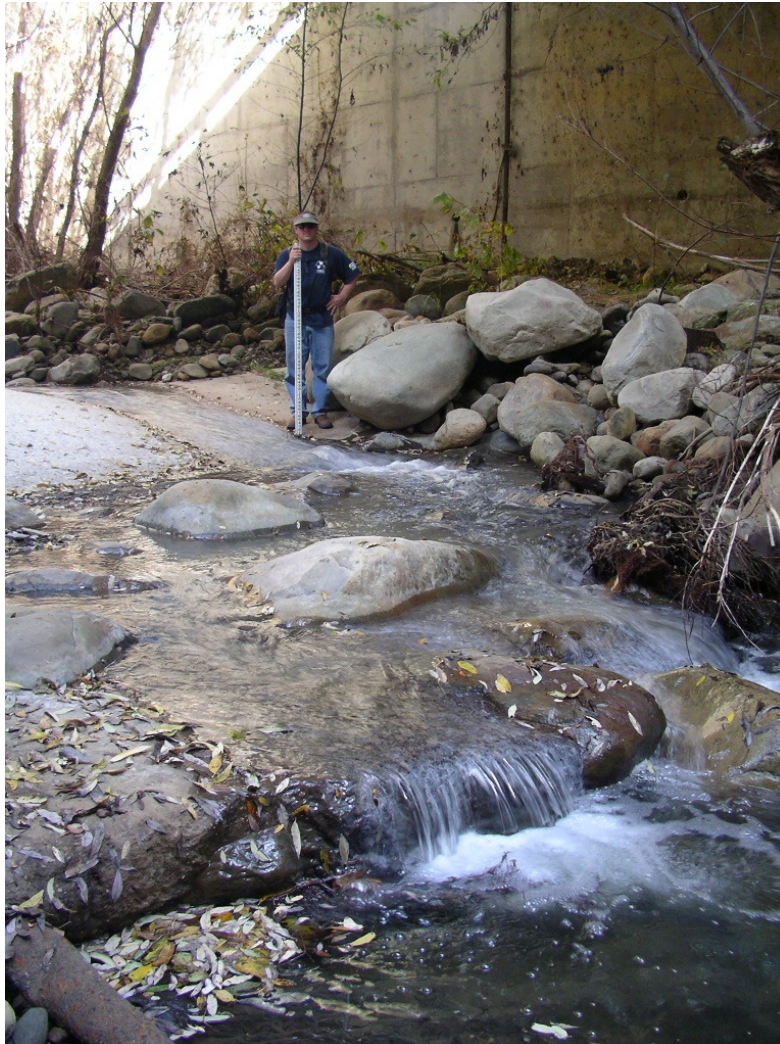
Description: This concrete grade control structure occurs under the Highway 150 Bridge and extends 25 feet 6 inches from the upstream lip to the sill of the downstream concrete and boulder apron. The upstream portion of concrete extends 13 feet with an elevation change of 1-foot 4 inches and a slope of 10%. The lower apron extends a maximum of 12 feet 6 inches and is relatively flat with numerous large embedded boulders. Flows drop 1-foot 2 inches off the apron into a pool with a maximum depth of 1-foot 2 inches. The structure ties into the vertical concrete bridge supports. Substrate occurs on top of the river-left side of the grade control structure.

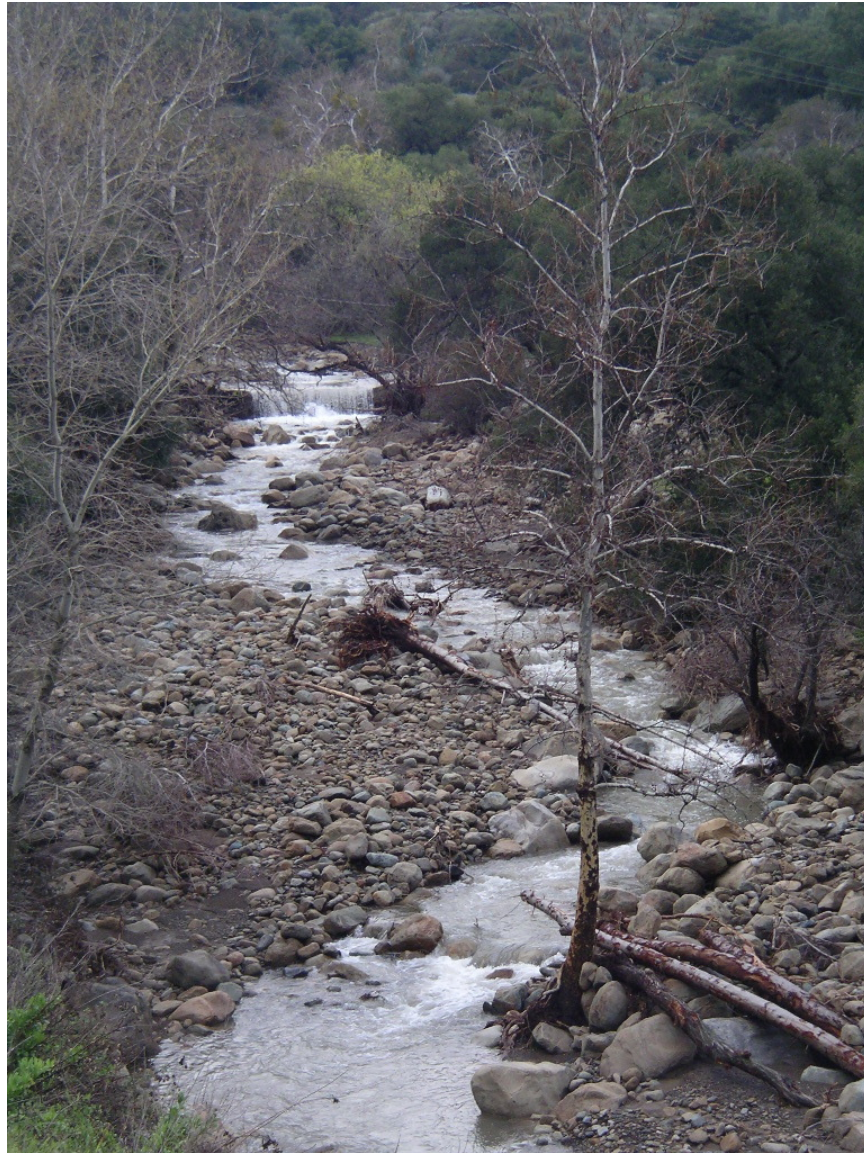
Description: Permission to survey this crossing was not obtained and observations were limited from Highway 150. Following the high stream flows of January 2005, an outlet drop of greater than 5 feet was observed on the downstream side of the concrete crossing.

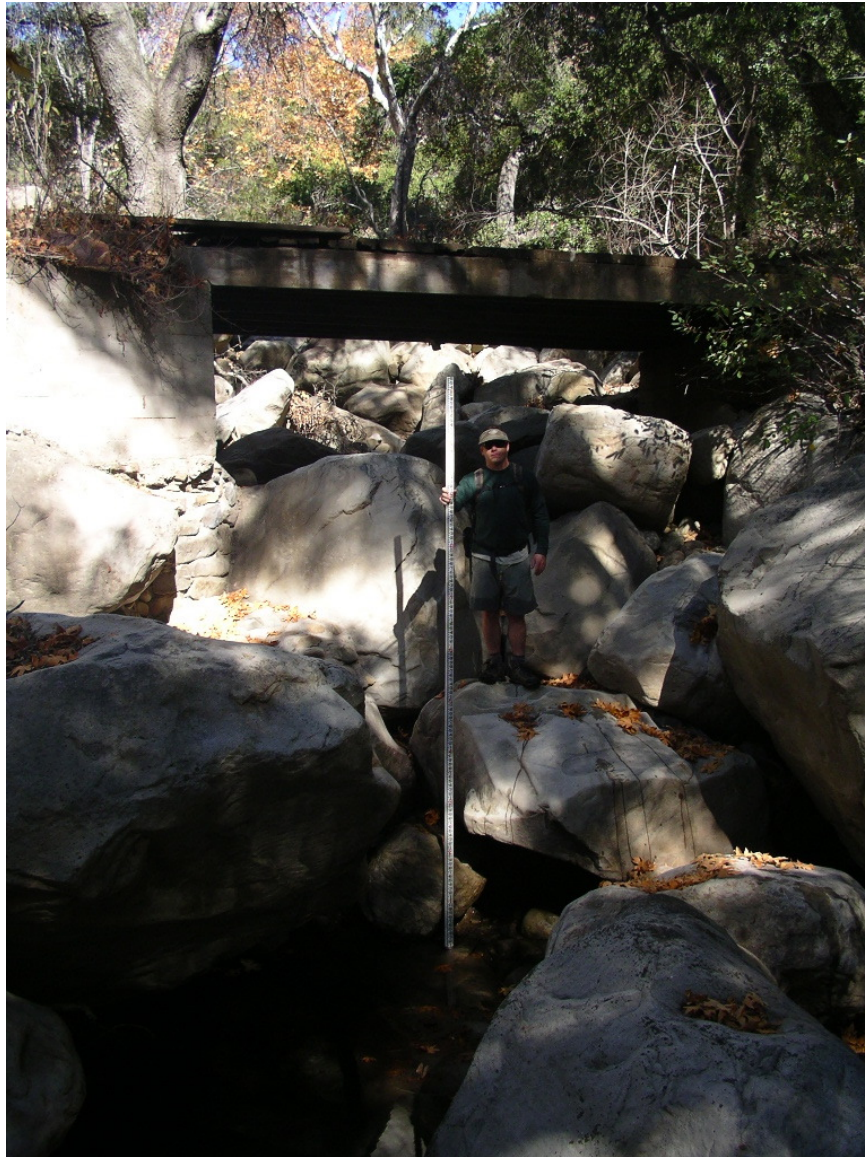
Description: This old, wood bridge spans 18 feet between concrete footings that are poured on large boulders within the stream channel. While the channel is natural underneath the bridge, the active channel width of the creek upstream and downstream is 24 to 28 feet across and the constricted bridge footings appear to have created a boulder blockage barrier. The concrete footings may be preventing large substrate mobility and exacerbating the steep boulder cascades occurring upstream and downstream of the bridge. Clearance under the bridge is only 5 feet 6 inches and the owner informed us that during the 1969 floods large boulders and flow by-passed the bridge on the river-right (pers. comm. B. Dron 2004). The original bridge was reportedly built in the 1930's. Surface flows also subside immediately upstream of the bridge for over 100 feet further indicating that substrate is being deposited upstream of the bridge. Downstream of the bridge a drop measuring 8 feet 8 inches occurs to a small 2-foot 1-inch deep pool. The bridge is partially burned from local fires and is in poor condition.

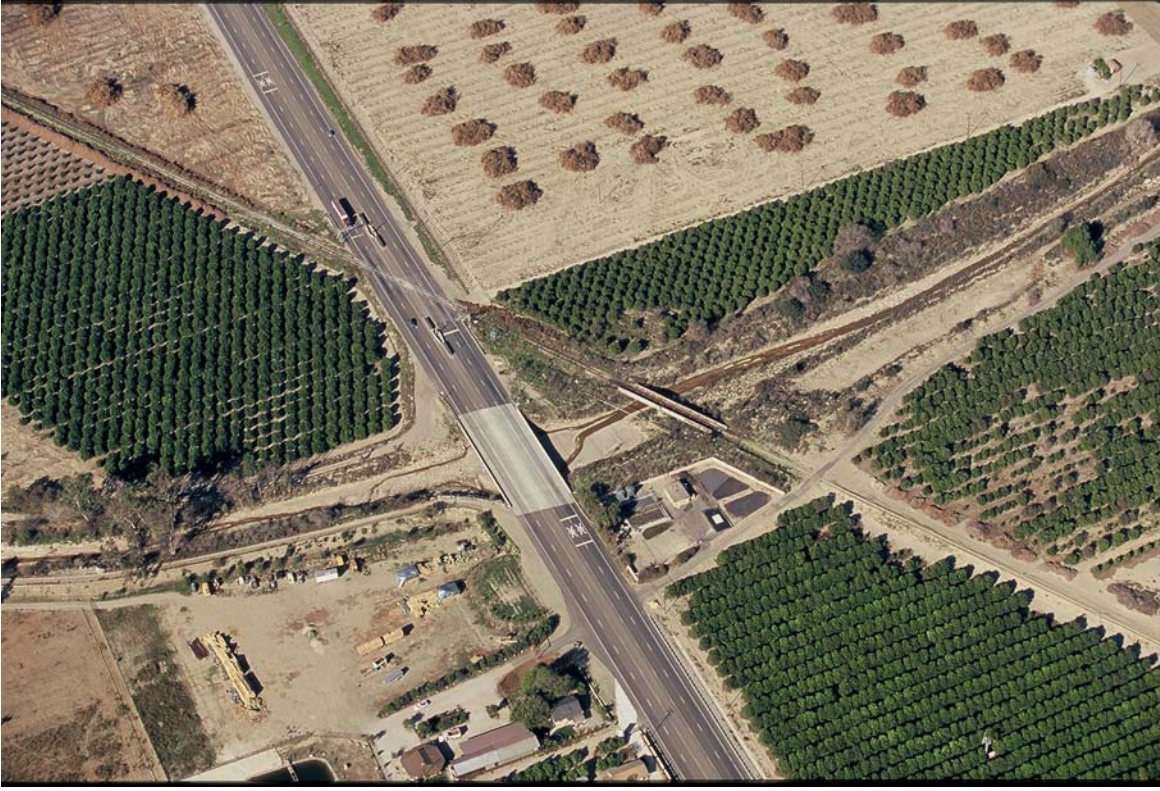
Description: Permission to access adjacent private lands to survey this crossing was not obtained and observations were limited from the bridge and air. The concrete apron occurs just upstream of the bridge and continues under the bridge. No drops were observed and the slope of the apron could not be determined.

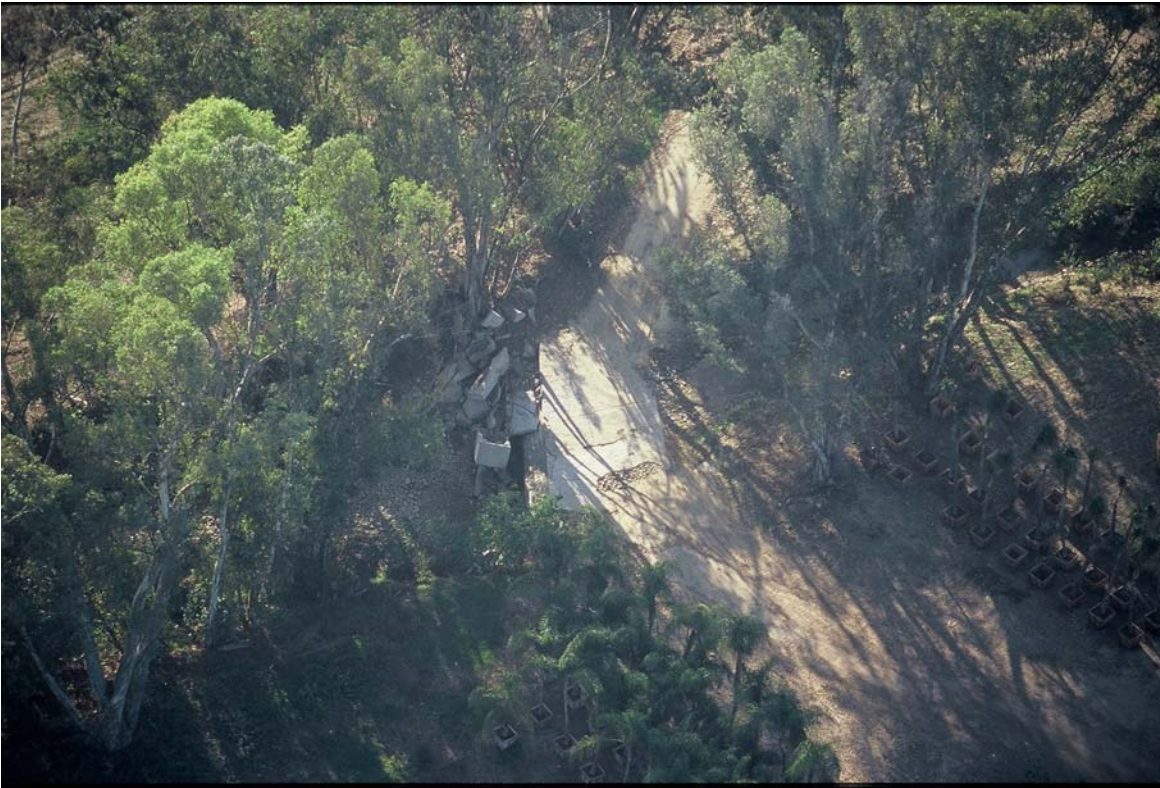
Description: Permission to survey this crossing was not obtained and observations were limited from the air. The concrete crossing occurs adjacent to a nursery just upstream from the confluence with Sespe Creek and the Santa Clara River flood plain. This private crossing appears to be in extremely poor condition with noticeable concrete failure and downstream scour and undercutting observed. An outlet drop of at least 5 feet occurs. The crossing appears to be approximately 12 feet wide and no culvert was observed from the air.

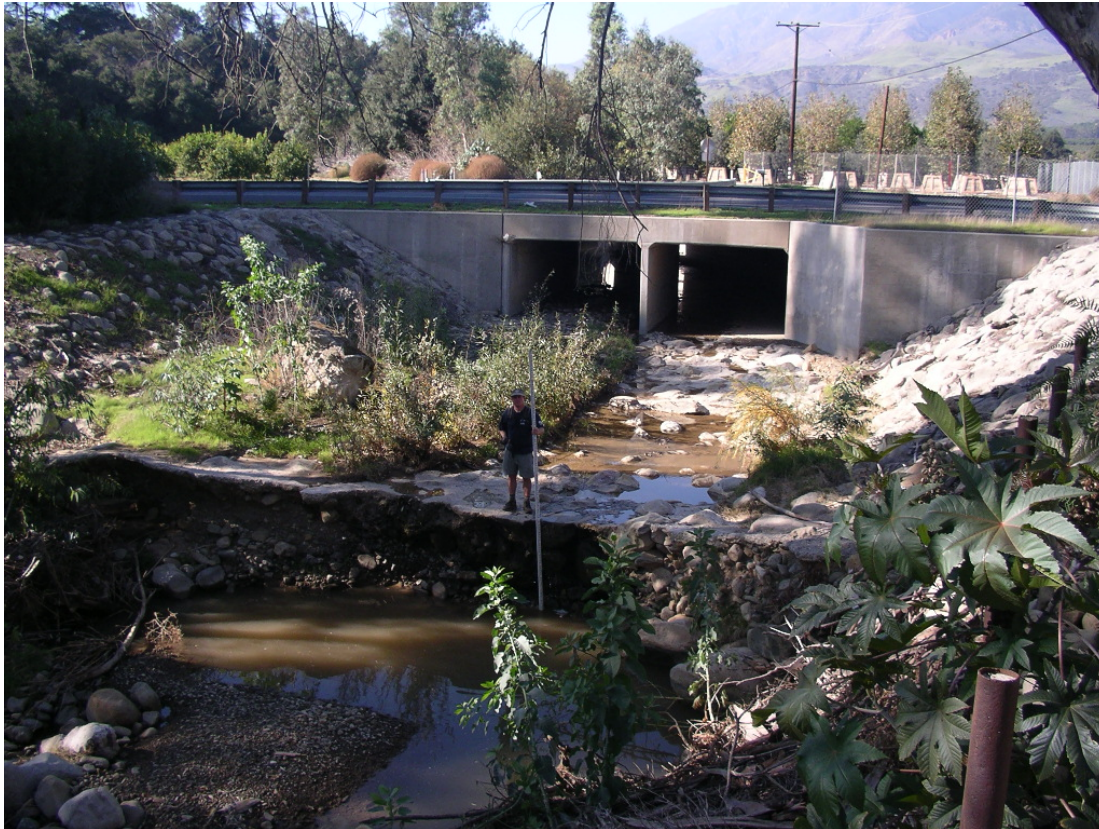
Description: This barrier's total length measured 191 feet from the inlet apron to the sill of the downstream apron. The inlet apron measured 18 feet long with a rise of 4 feet above the culvert inlet bottom and a steep slope of 22.2%. The double-box culvert measured 115 feet long with a slope of approximately 1%. Each box culvert measured 7 feet 11 inches tall by 12 feet wide. Downstream of the culvert, a concrete and boulder rip-rap apron extends 58 feet and spans 39 feet across the channel to the base of sloping concrete and boulder bank revetment. Downstream of the apron, the flow drops 4 feet 2 inches into a 3-foot deep scour pool that is undermining the apron.

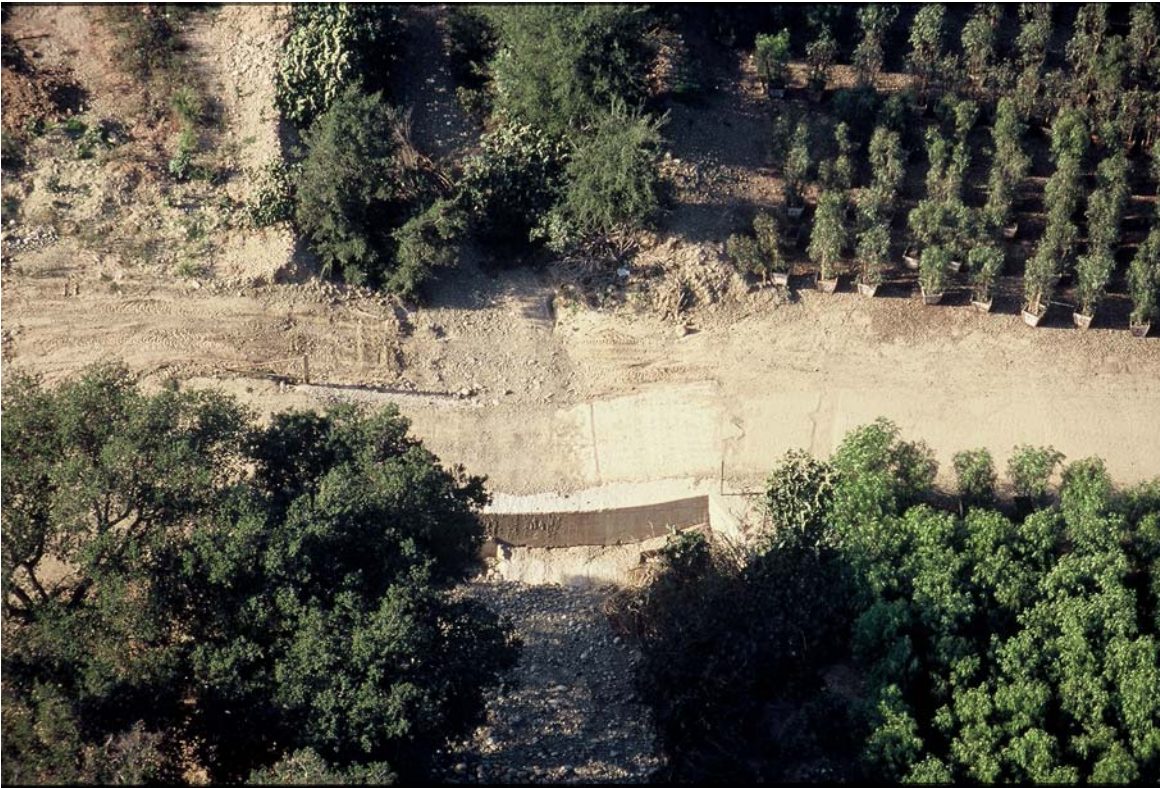
Description: Permission to survey this crossing was not obtained and observations were limited from the air. The crossing occurs just downstream from the railroad crossing culvert. This private crossing appears to be in poor condition. An outlet drop of at least 5 feet occurs. The crossing appears to be approximately 12 feet wide and no culvert was observed from the air.

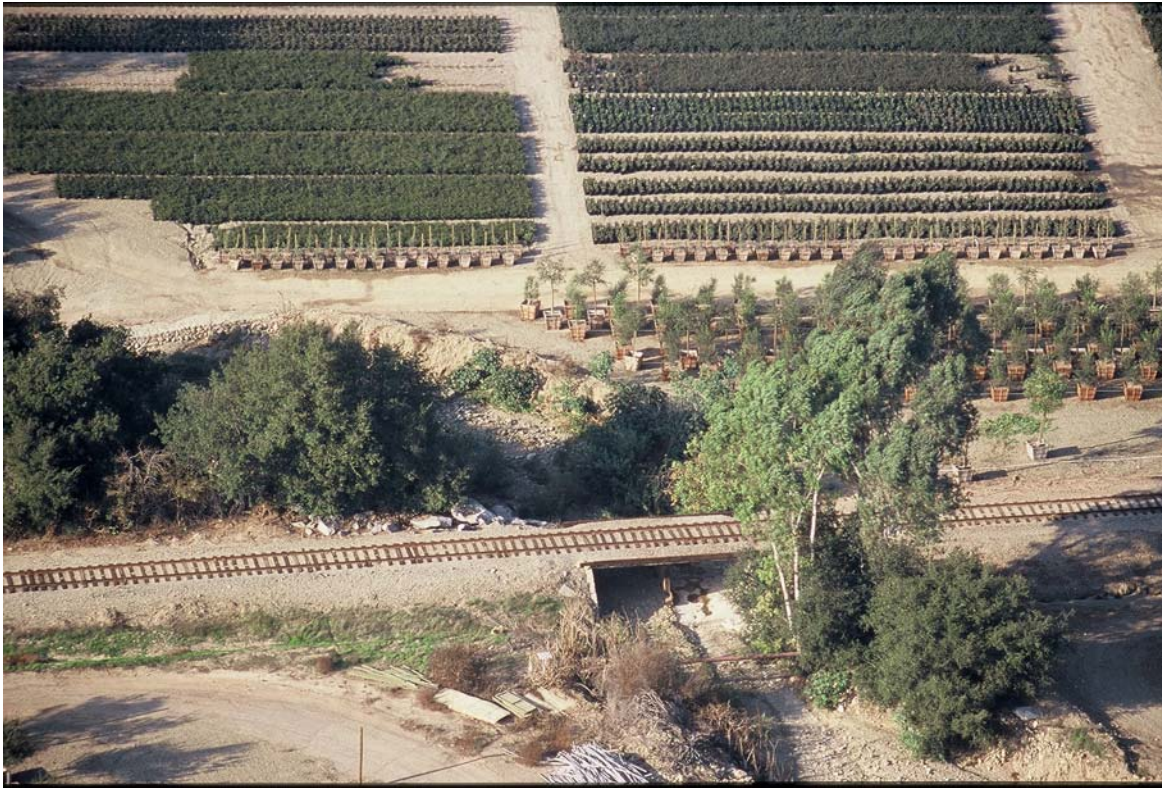
Description: Permission to survey this crossing was not obtained and observations were limited from the air. A concrete double-box culvert occurs under the railroad crossing. An outlet drop of approximately 1-foot occurs. The crossing appears to extend at least 25 feet underneath the railroad.

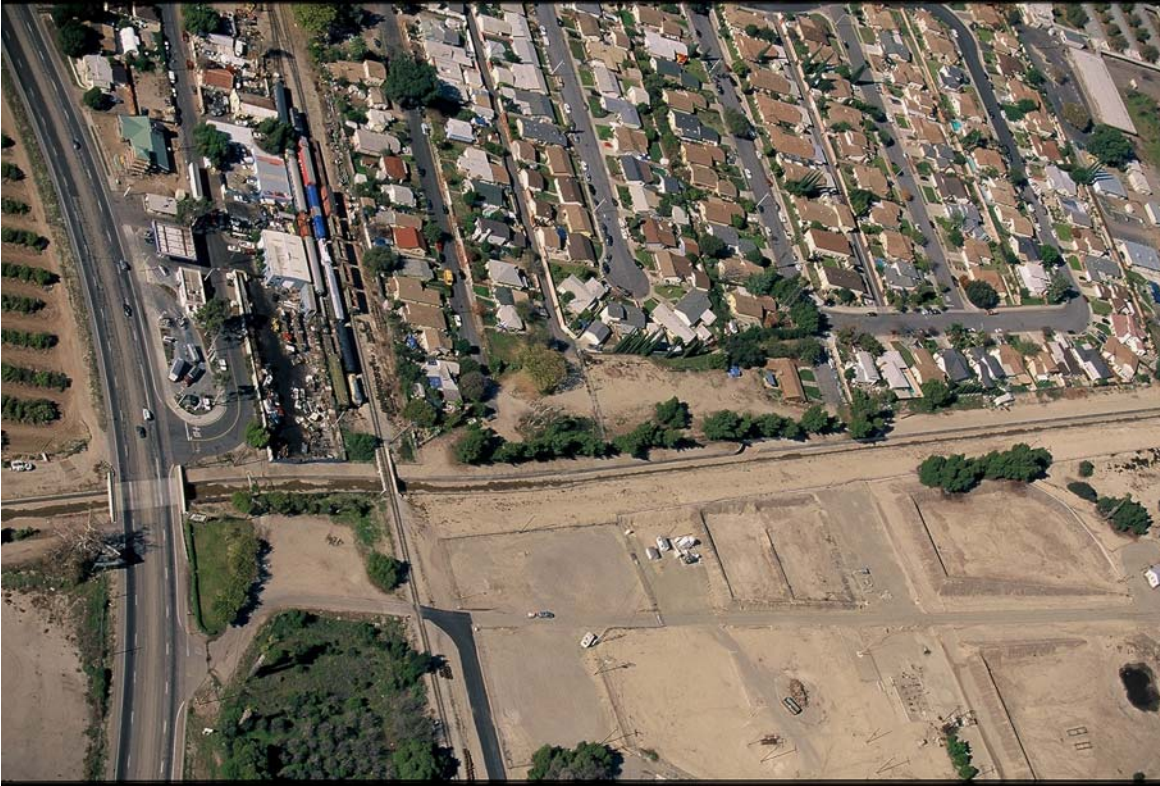
Description: Project budget and scope precluded ground surveying efforts on Pole Creek, but limited observations were made from the air. This concrete channel extends approximately 6,500 feet in length from the Santa Clara River upstream adjacent to the eastern end of Fillmore. The lower portion contains earthen levees, while the upper portion is a concrete box culvert with a steep inlet apron. The earthen and concrete channels appear to have mild gradients with deposited substrate present. The concrete inlet apron appears to be steeply sloped.
