Santa Clara River Steelhead Trout: Assessment and Recovery Opportunities

December 2005

The Santa Clara River Trustee Council and The Nature Conservancy

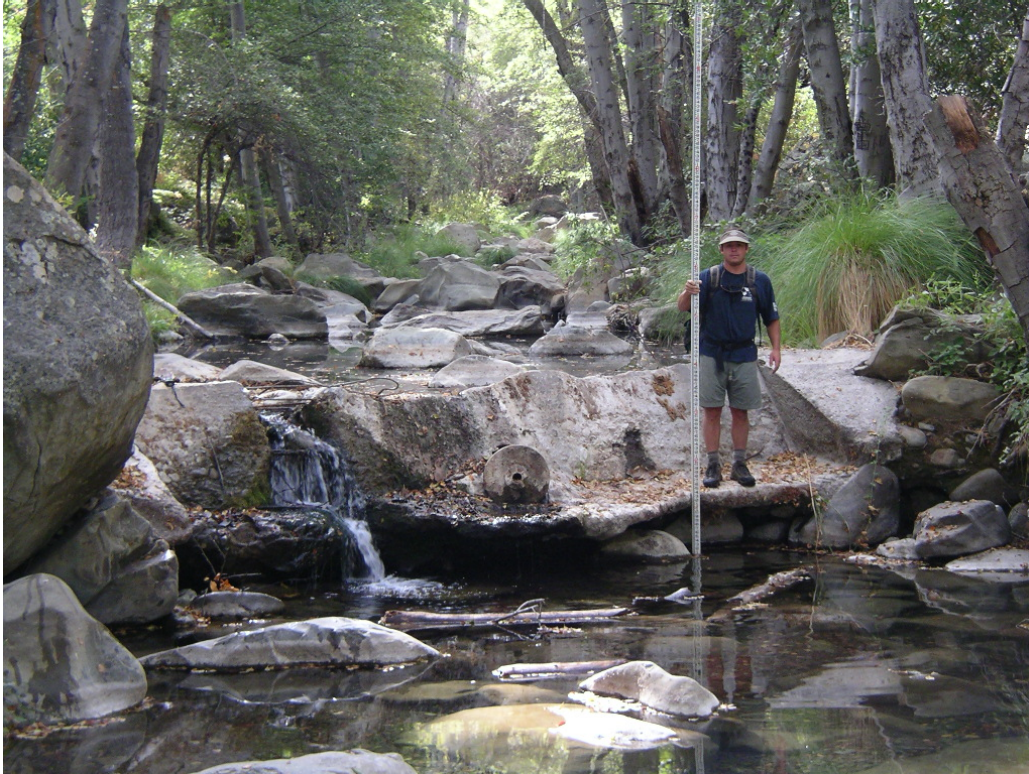
Description: This abandoned old diversion dam has an inscription in the concrete that appears to read “6/22/37 CO 2925”. It appears that this dam was built to divert water along the river-left banks downstream to Lower Lion Campsite almost 70 years ago. Remains of old metal pipes can be seen downstream. The dam measured 4 feet tall from the downstream tail-water control to the top of the dam. The dam measured 25 feet across the channel and 6 feet thick at its maximum point. The downstream pool measured 1-foot 9 inches at its maximum depth. A 12-inch diameter metal diversion pipefitting passes through the dam and is capped on the downstream side and buried with deposited substrate on the upstream side.

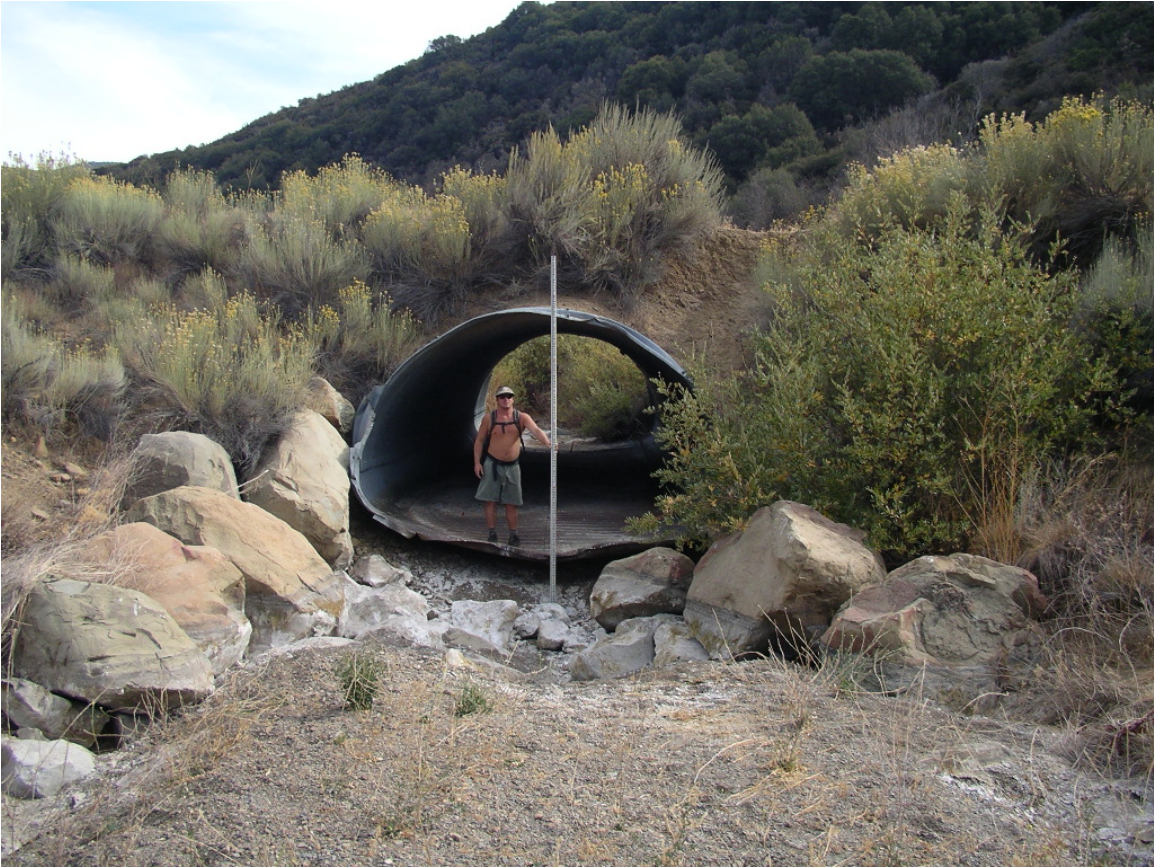
Description: This corrugated steel pipe-arch culvert measured 54 feet 8 inches long with an 8-inch rise and overall slope of 1.2%. The culvert outlet occurs at the same elevation as the outlet pools thalweg. The dry outlet pool's maximum depth measured 2 feet 3 inches below the thalweg elevation. The culvert measured 13 feet at the widest point and 7 feet 6 inches tall. No inlet or outlet aprons occur and the outlet of the culvert is significantly undercut. The culvert has significant rust and a damaged metal bottom.

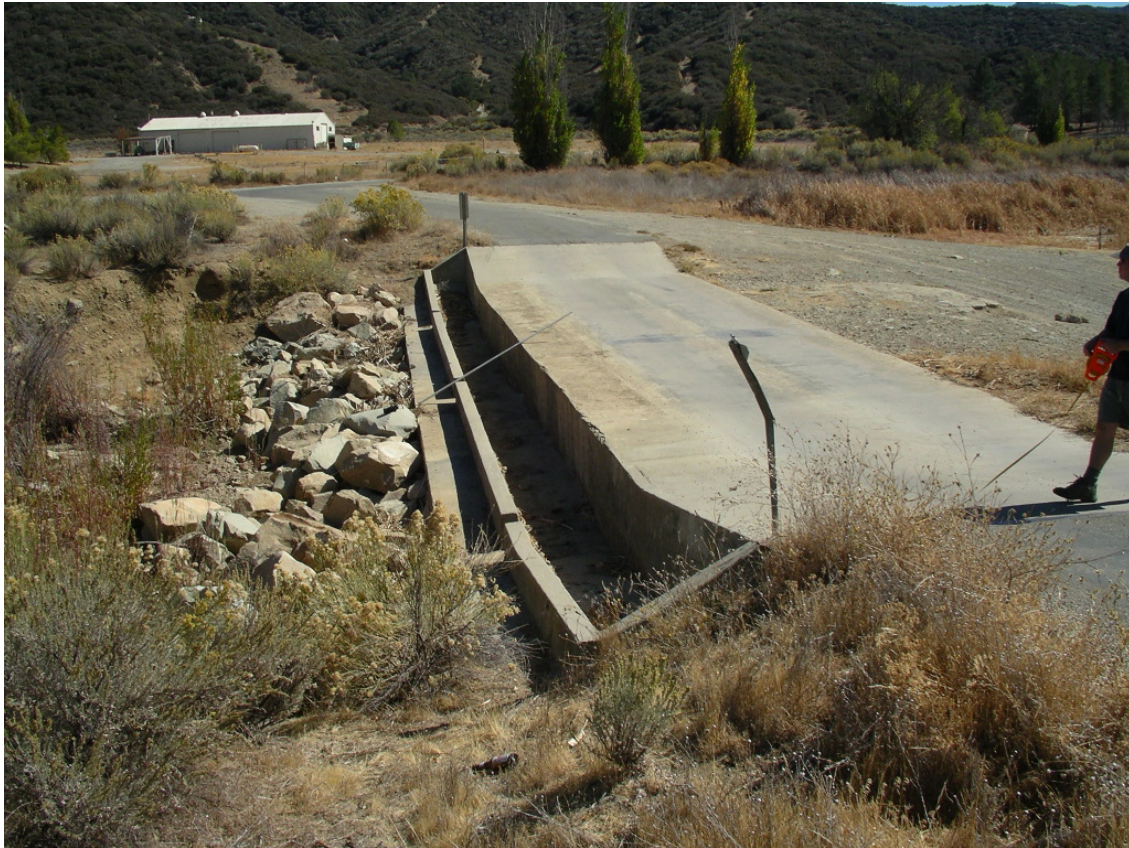
Description: This earthen dam has a concrete spillway that also serves as a road crossing. This spillway road measured 14 feet wide and 70 feet across. The total height of the dam measured 5 feet 3 inches from the spillway inlet to the downstream substrate. The slope on the spillway measured 2.3% and drops flows 2 feet 6 inches to a concrete shelf measuring 2 feet 7 inches out from the spillway. This shelf contains a 1-foot tall 6-inch wide concrete curb with 3 notches down to shelf level. Flows then drop 1-foot 9 inches to another concrete shelf and then spill onto a downstream boulder apron. This boulder apron measured 12 feet downstream from the concrete with an average slope of 40%.

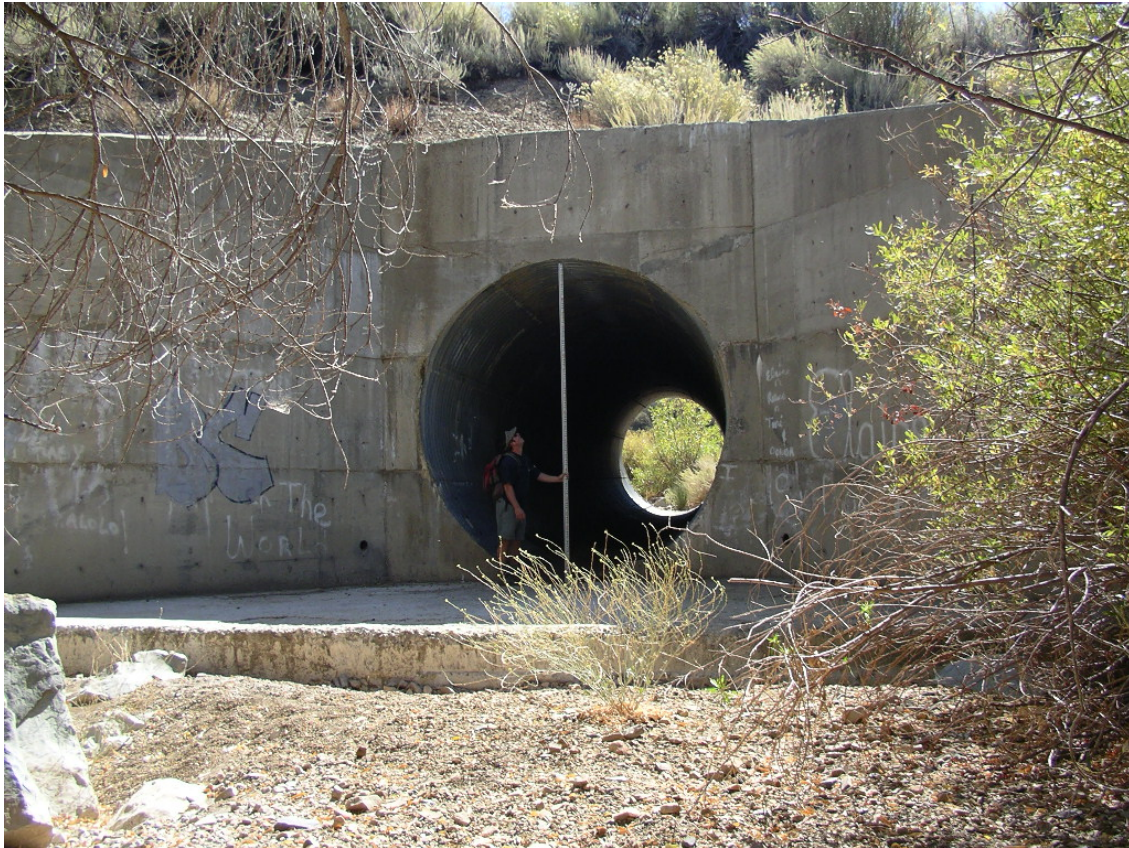
Description: This corrugated metal culvert pipe measured 84 feet long with 16-foot long concrete aprons at the inlet and outlet giving a total length of 116 feet. Concrete headwalls and wingwalls encase the culvert pipe and aprons. The culvert slope measured 3.3% with similar slopes occurring at both aprons. The culvert width measured 11 feet and the height measured 11 feet 8 inches. During dry survey conditions, a 1-foot 2-inch outlet drop occurred from the outlet apron to the downstream substrate. This loose downstream substrate is mainly smaller sand and gravel and will mobilized during moderate stream flows and scour may produce a greater outlet jump height for fish.

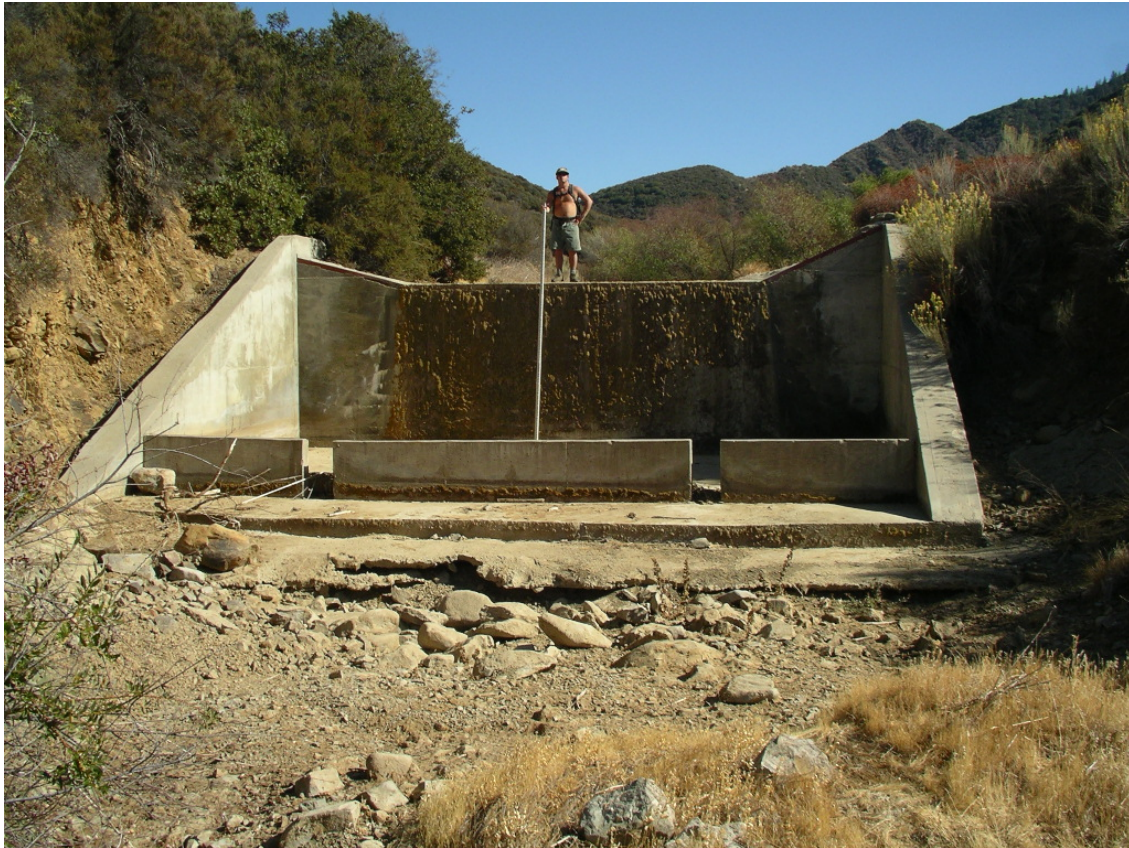
Description: This concrete dam measured 27 feet across the channel. The total height of the dam measured 10 feet 4 inches from the spillway inlet to the downstream substrate. The spillway drops 7 feet 8 inches to a concrete shelf measuring 21 feet out from the spillway. This shelf contains a 2-foot tall 6-inch wide concrete curb with 2 notches down to shelf level. Flows then drop 8 inches to a 5-foot long concrete apron and then spill 2 feet onto the downstream substrate.

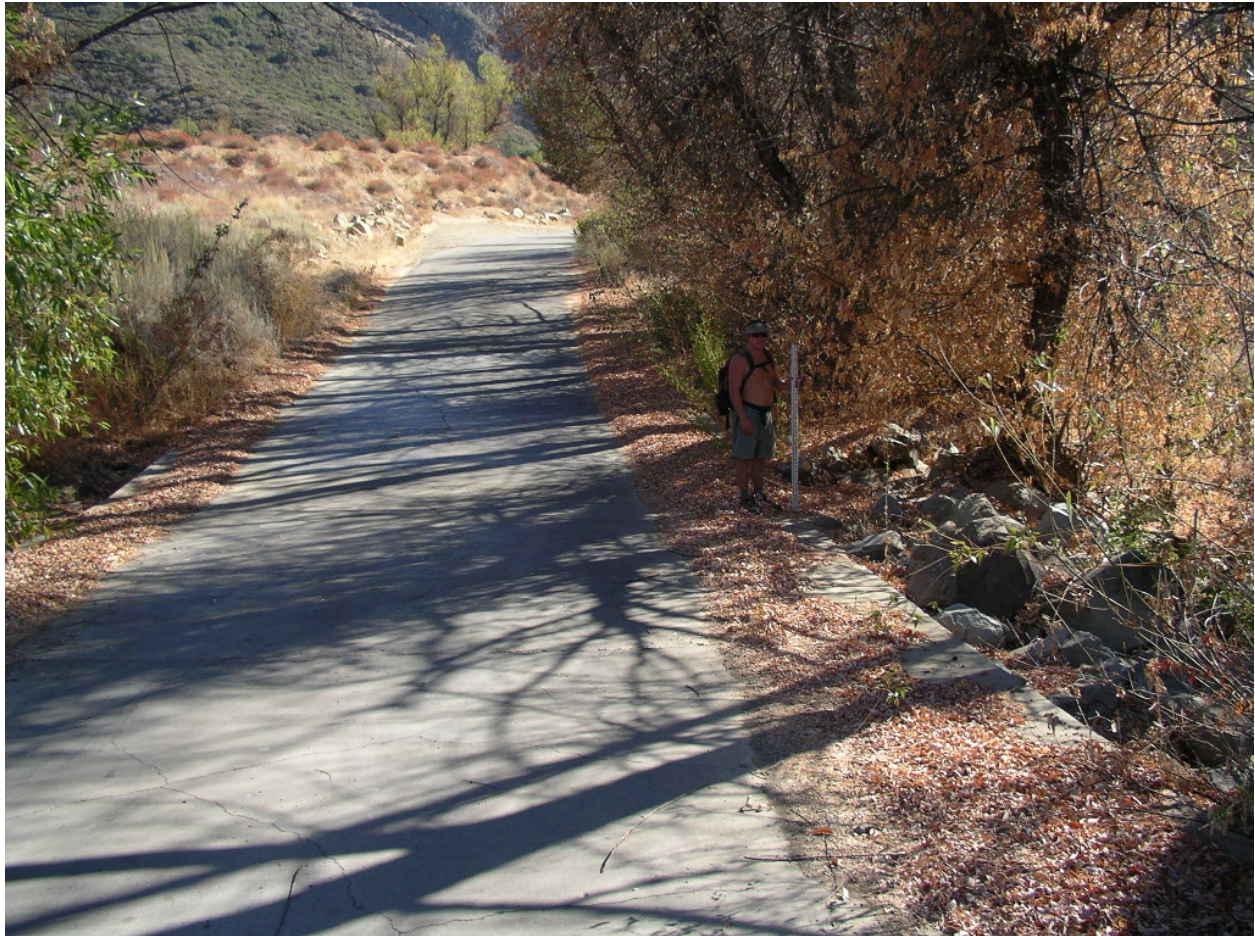
Description: The concrete crossing measured 67 feet 6 inches across the channel and 20 feet wide. The slope of the crossing is 1.5%. Surface flows are conveyed on top of the crossing and drop 3 feet onto the downstream substrate. Large boulders occur on a portion of the outlet and produce a 10-foot long apron with an average slope of 25%.

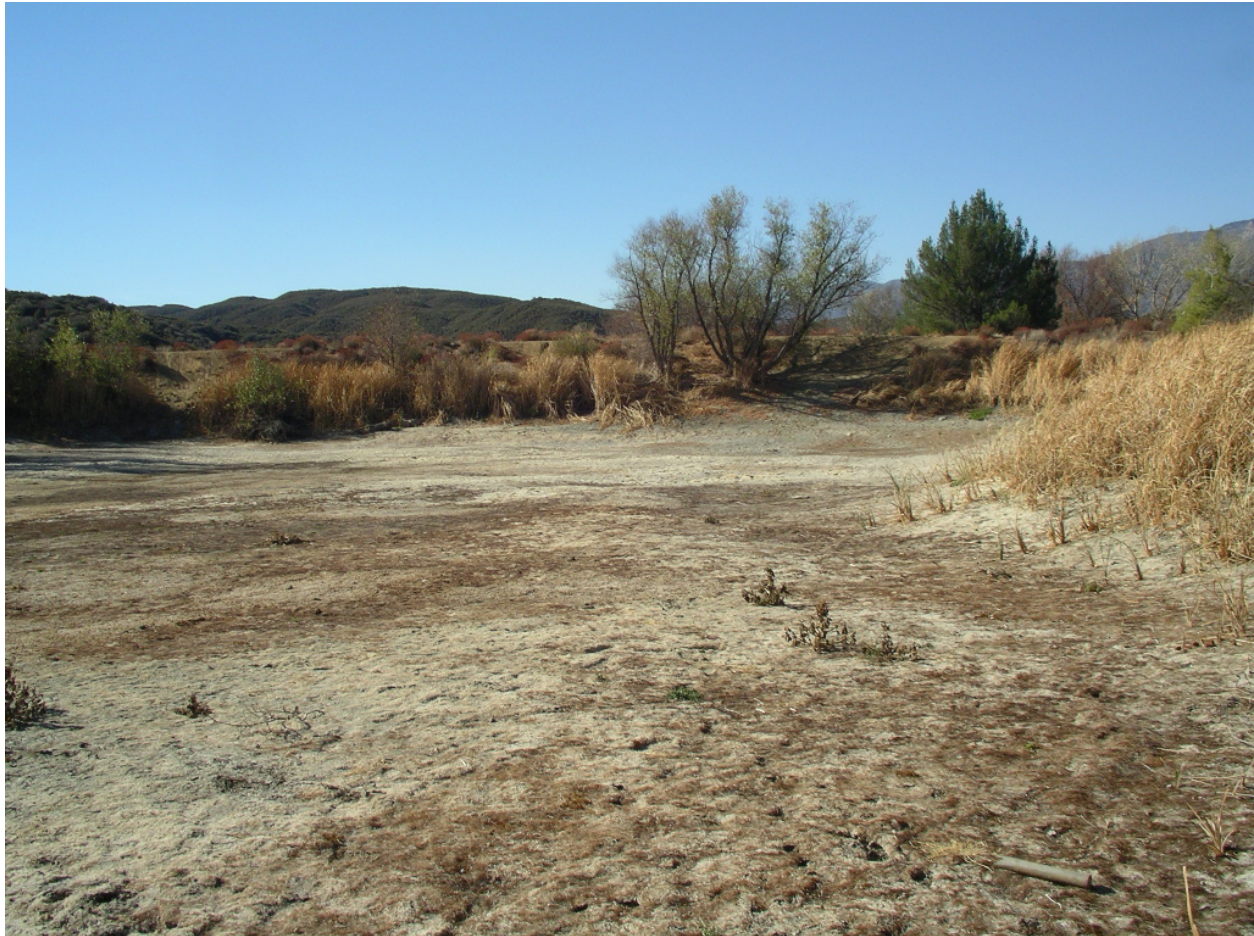
Description: This earthen dam does not have a concrete spillway similar to the downstream dams. Apparently the dam was built across Rose Valley Creek and then an outlet channel was dug around the east side of the dam. This new channel contains one significant drop that measured 8 feet tall with a dry downstream pool that likely fills up to 3 feet in depth. The side channel also appears to lack perennial flow due to its exposed location.

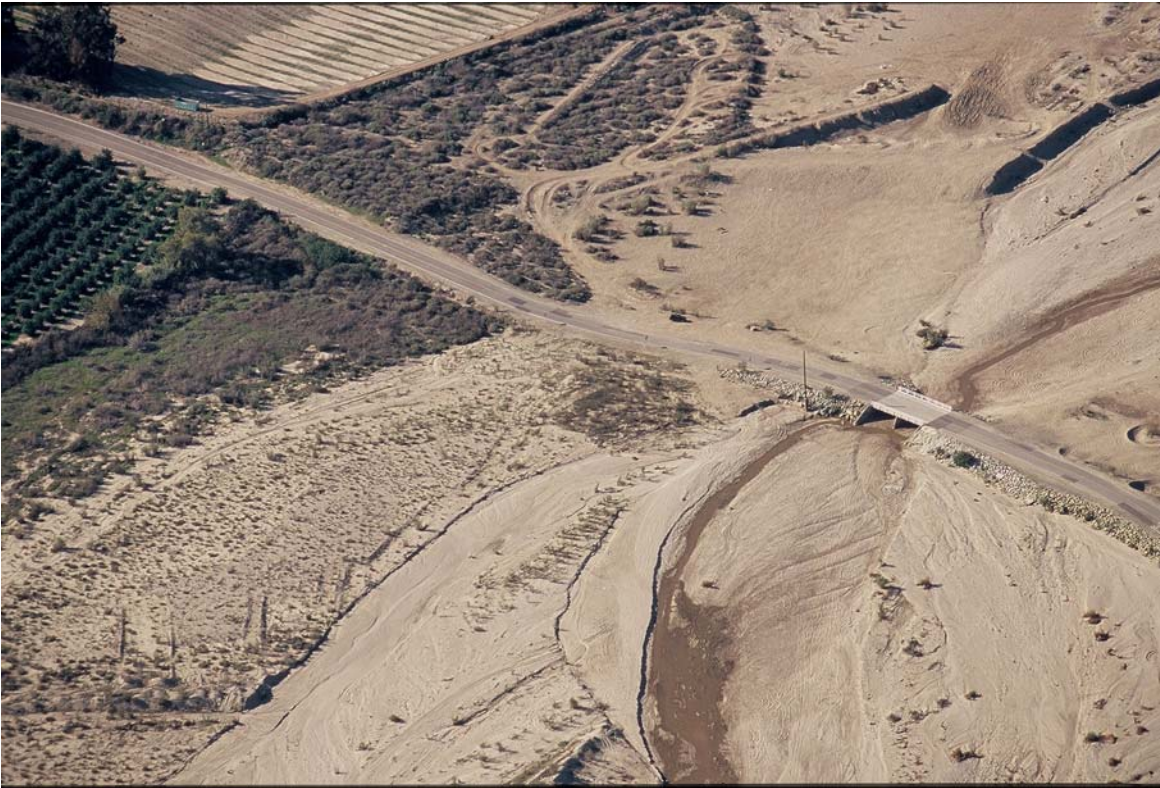
Description: This short-span bridge crossing occurs downstream from Piru Creek. Elevated dirt road fill occurs across much of the Santa Clara River channel on either side of the Torrey Road Bridge.

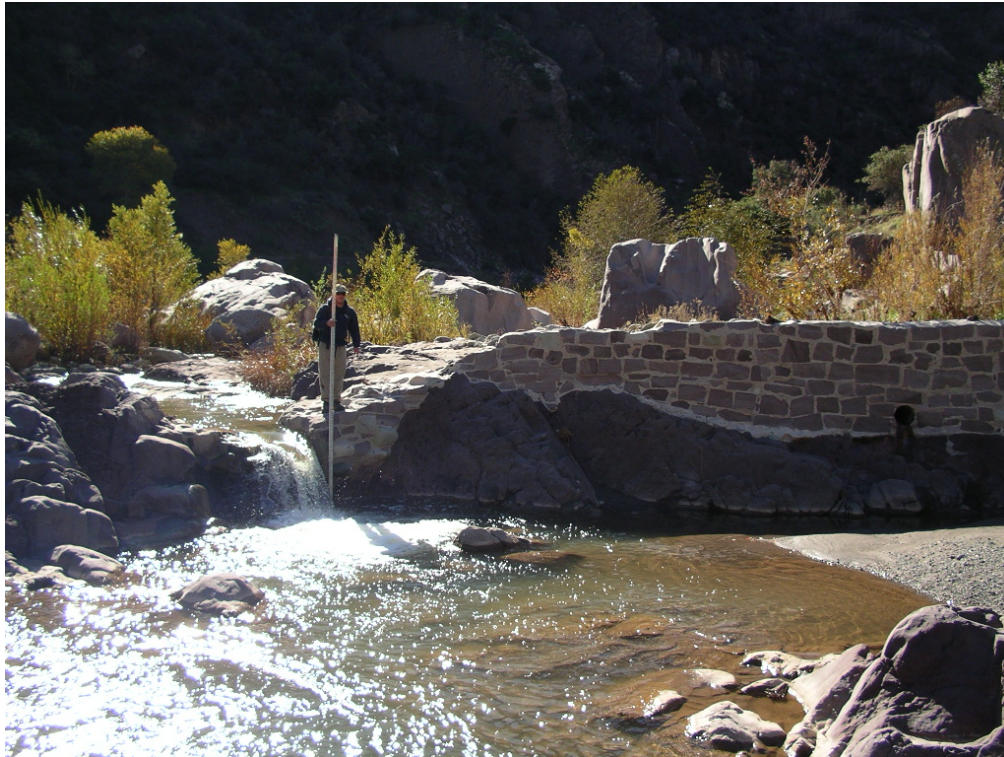
Description: James Van Trees, whose family has owned the lands adjacent to this dam for several generations, informed me that this historic, failed dam was built in the 1930's or 1940's by Los Angeles water figure William Mulholland (pers. comm. Van Trees 2004). The stone block and concrete diversion dam reportedly was destroyed in the 1969 flood and only remnants of the dam survived. The dam remains were reportedly buried by sediment for many years following 1969 and then were uncovered in recent decades. The original dam spanned approximately 200 feet across the stream channel and measured 5 feet thick and at least 10 feet in height above the substrate. Only 80 feet of the dam still remains on the river-left side and a small, stream-polished section occurs on top of a native boulder near the river-right side of the channel. Two 10-inch metal diversion pipes occur within each remaining part of the dam. Metal rebar anchors can also be observed protruding from some of the native boulders where the dam once stood.
