# **Steelhead Migration Barrier Assessment and Recovery Opportunities for the Sisquoc River, California**

Prepared by:  
Matt Stoecker and Jim Stoecker  
Consulting Biologists  
P.O. Box 240  
Santa Barbara, Ca. 93102  
and  
Community Environmental Council  
930 Miramonte Drive  
Santa Barbara, Ca. 93109

**January 23, 2003**

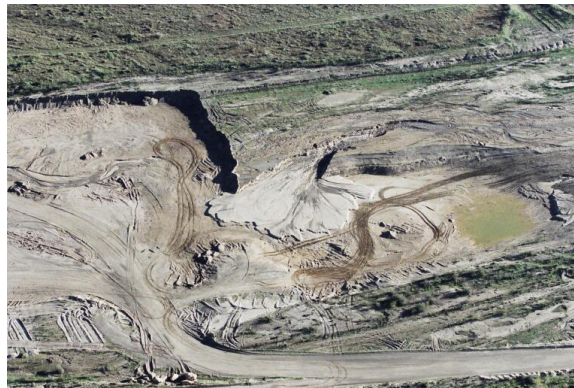
Gravel extraction operation, Santa Maria River, 0.5 miles downstream of the Sisquoc River

**Description:** Access to ground survey this stream reach was not obtained. Observations were made from the air and adjacent roads; and are limited in detail. Gravel extraction operations are present within the streambed of the upper Santa Maria River and lower Sisquoc River. Note: the term “gravel extraction” is used here to describe all extraction of streambed material from the river channel. This limited discussion applies to multiple gravel extraction operations that occur throughout the described reach. Please see the *Final Environmental Impact Report (96-EIR-004) Coast Rock Products, Inc. and Kaiser Sand and Gravel, Inc. Mining and Reclamation Plans and Santa Maria / Sisquoc Rivers Specific Plan* (1997) for more detail about this reach and the gravel operations. Long reaches of riverbed have been highly manipulated throughout this reach. Streambed substrate has been extracted and moved by heavy equipment. Heavy machinery also utilizes the streambed as a transportation route. Large gravel pits and elevation drops, where substrate material is extracted, have been dug in various locations along this reach. Surface flows become backed up and isolated in the dugout gravel pits. Piles of substrate have also been deposited in various locations and configurations. Hauling trucks travel in the streambed and multiple in-stream crossings and irregular tracks occur throughout the reach. Most crossings have natural bottoms and are close to streambed level, unless described elsewhere in this report. Some crossings have moderate berms on the upstream and/or downstream side and may impede steelhead migration at lower stream flows and/or act as small dams. The crossing pictured below occurs approximately 1.0 mile upstream of the Garey Bridge on the Sisquoc River and backs up surface flows.

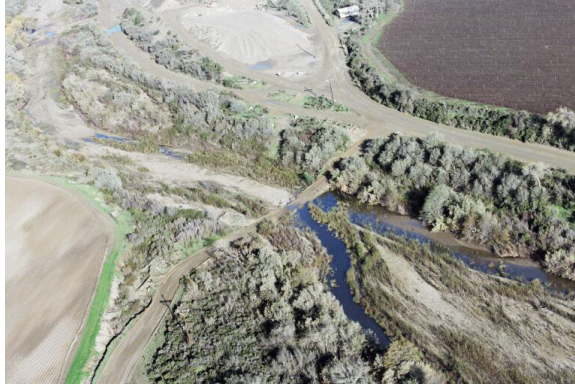
Gravel operation hauling road crossing, Sisquoc River, approximately 1.0 mile upstream from Garey Bridge

**Diagnosis:** In their *National Gravel Extraction Policy (1996)* report, the NMFS lists impacts to anadromous fishes and their habitat from gravel extraction: “loss or degradation of spawning beds and juvenile rearing habitat; migration blockages; channel widening, shallowing, and ponding; loss of hydrologic and channel stability; loss of pool/riffle structure; increased turbidity and sediment transport; increased bank erosion and/or stream bed downcutting; and loss or degradation of riparian habitat” (Fusaro, 1996). In addition to gravel operation road crossings that may directly impede or block steelhead migration, other impacts may negatively impact both upstream and downstream steelhead migration. The extensive gravel pits and steep elevation changes in the streambed may negatively impact steelhead migration. Gravel pits in the streambed have been observed to trap rainbow trout as far downstream as Garey, where local anglers have fished for them in recent times (pers. comm. G. Czarnecki 2002). It is likely that some of these salmonids are out-migrating smolts and that adult steelhead are also occasionally trapped during out-migration.

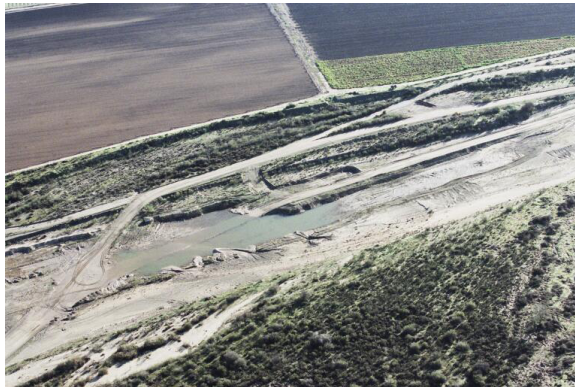
Gravel extraction pit, Sisquoc River, 300 feet downstream from Garey Bridge

Stream flow duration is also likely affected. It seems possible that these major streambed disturbances would increase the permeability of the streambed. This would result in a higher rate of surface flow to groundwater percolation, leading to shorter durations of surface flow, reduced downstream extent of surface flow, and reduced aquatic habitat and migration opportunities for upstream and downstream migrating steelhead. According to the 1997 EIR mentioned previously, the gravel operations also pump ground water that would further reduce the amount of surface water flow. In addition to the hydraulic impacts that such activities have on steelhead migration, these activities may increase the river’s turbidity and suspended sediment load during migration periods. This action may cause migration difficulties and/or direct physical harm to steelhead by

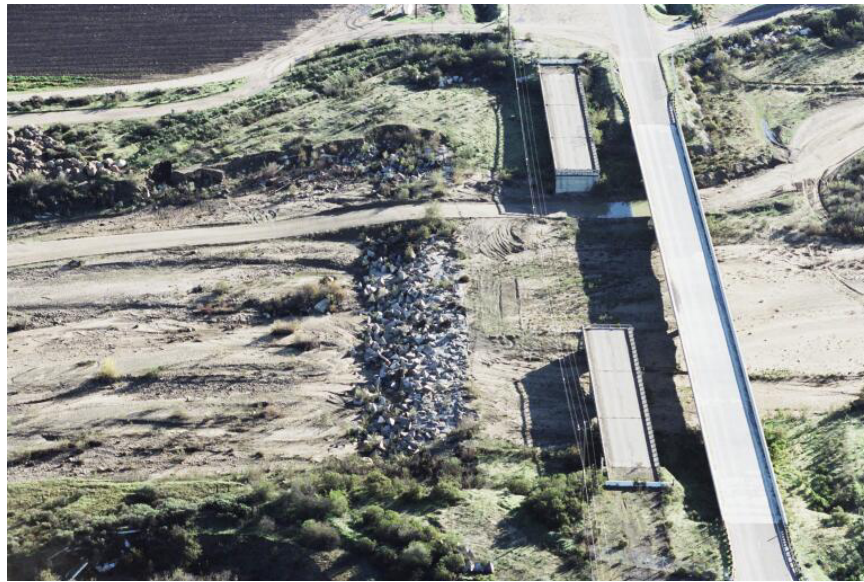
**Description:** A ‘check dam’ exists just downstream of the old Garey Bridge (Santa Maria Mesa Road) crossing. John Storrer identifies this structure as an “oil pipeline and check dam structure” in a report titled, *Natural Environmental Study Report- Garey Bridge Replacement Project Santa Barbara County, California* (Storrer 1994). See this report for a detailed description of the Garey Bridge, bridge replacement project, and surrounding environment. Santa Barbara County Public Works replaced the old Garey Bridge with a new one that now spans the Sisquoc River just upstream from the older decommissioned bridge. Access to ground survey this check dam was not obtained. Observations were made from the Garey Bridge and from the air and are limited in detail. This check dam structure is constructed of concrete slabs and boulder riprap that runs perpendicular across the river channel. Figure 2 in Storrer’s report shows the check dam’s total height measuring 8 feet tall from the downstream riverbed to the upstream substrate. The upstream substrate is backed up to the top of the check dam. The structure spans approximately 500 feet across the river channel. The 8-foot height of the dam occurs over an upstream to downstream distance of approximately 40 feet. The check dam’s downstream-facing slope is approximately 16% overall. Hauling trucks associated with commercial aggregate processing facilities (Coast Rock) periodically travel beneath the bridge and across the river-right side of the check dam structure on an existing dirt road. This dam was illegally constructed by Coast Rock (see recommended action discussion below).

**Diagnosis:** This check dam is the most downstream anthropogenic structure on the Sisquoc River and the first impediment encountered by upstream migrating steelhead. During moderate migration flows, the rough, irregular surface of the check structure reduces water velocities enough to allow limited upstream migration. However, during low flows, shallow water depths over the structure prevent upstream migration. At this particular barrier, low flow conditions are

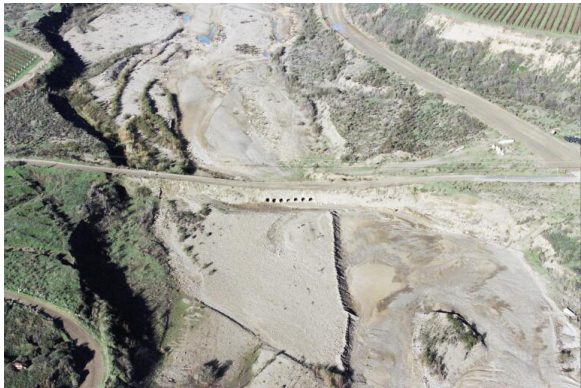
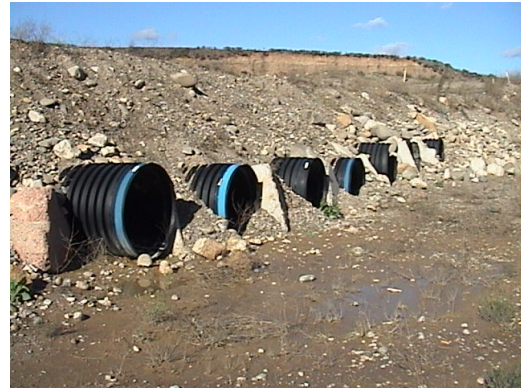
**Description:** This culvert and earth fill crossing spans the Sisquoc River channel at the mouth of Tepusquet Canyon and is designed to blow out during high stream flows and then be rebuilt. Seven 4-foot diameter plastic culverts convey lower stream flows under the earth filled road crossing. The culverts are approximately 30-35 feet in length. The road fill is composed of local material (silt, sand, gravel, cobbles) as well as concrete slabs and boulders that surround the culverts. The plastic culverts are in good condition with moderate wear and tearing. The slope of the culverts is relatively flat and all are set at streambed grade. The inside of the culverts do not have well-developed corrugations, but rather a smooth plastic lining. Small deposits of substrate exist at the inlets and outlets of several culverts.

**Diagnosis:** Due to the flat slope of the culverts and lack of elevation drops at the outlets, steelhead could migrate through the culverts during low and moderate migration flows. During extremely low flow conditions, shallow water depth in the culverts will prevent or limit upstream migration. Higher stream flows will be accelerated through the culverts and may produce excessive velocities for upstream migration, especially because of the smooth, inside linings. At some point, high flows will exceed the capacity of the culverts and will overflow the road, blowing out the structure completely. Without the road present, steelhead will have unimpeded upstream access. This structure may reduce the window of opportunity for upstream steelhead passage by producing shallow flows through the culverts during low flows, while creating excessive velocities during moderate to high stream flows prior to the crossing blowing out. The failure of the crossing will also send a significant amount of suspended and bedload sediment downstream during migration flows that may negatively impact steelhead migrating downstream. Debris and/or sediment accumulation at the culvert inlets may also impede steelhead migration.

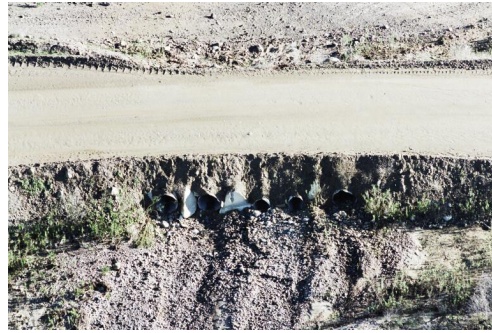
**Description:** Access to ground survey this structure was not obtained. Observations were made from the air, and are limited in detail. This culvert and earth fill crossing is designed to blow out with high stream flows and appears to be associated with adjacent gravel extraction operations and utilized by hauling trucks. Five corrugated metal culverts of varying diameter convey low stream flows under the earth filled hauling road crossing. The culverts are approximately 20-25 feet in length. The road fill is composed of local material (silt, sand, gravel, cobbles). The culverts are set at, or near, streambed grade. The two culverts on the river-right side have vertical drops of less than 12 inches at the outlet. The slopes of the culverts could not be determined, but they appear to be relatively mild to moderate.

**Diagnosis:** Assuming the slope of the culverts is not excessive and they are in good condition, steelhead could migrate through the culverts during low to moderate migration flows. During extremely low flow conditions, shallow water depth in the culverts may prevent or limit upstream migration. Moderate to higher stream flows will be accelerated through the culverts and may produce excessive velocities that limit or prevent upstream migration. At some point, high flows will exceed the capacity of the culverts and will overflow the road and blow out the crossing. Without the road present, steelhead will have unimpeded upstream access. This structure reduces the window of opportunity for upstream steelhead passage by producing shallow flows through the culverts during lower flows and excessive velocities during moderate to high stream flows prior to the crossing blowing out. The failure of the crossing will also send a significant amount of suspended and bedload sediment downstream during migration flows that may negatively impact steelhead migrating downstream. Debris and/or sediment accumulation at the culvert inlets may also impede steelhead migration.

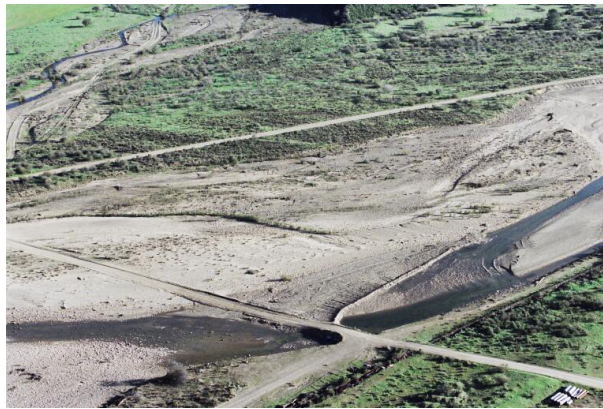
**Description:** Access to ground survey this structure was not obtained. Observations were made from the air, and are limited in detail. The culvert and earth fill portion of this crossing does not span the entire river and is designed to blow out with high stream flows. Three culverts convey low stream flows under the earth filled road crossing. An upstream berm has been built in the channel to direct flows into these culverts, preventing flows from going over the in-stream road crossing portion that passes across the Sisquoc River streambed. The culverts are approximately 10-15 feet in length. The road fill is composed of local material (silt, sand, gravel, cobbles). Water was observed to drop more than 12 inches vertically from the culvert outlets. The slope of the culverts could not be determined.

**Diagnosis:** This structure reduces the window of opportunity for upstream steelhead passage by producing shallow flows through the culverts during low flows and excessive velocities during moderate to higher stream flows. A moderately difficult jump is required for salmonids to access the culvert outlets. Debris and/or sediment accumulation at the culvert inlets may also impede steelhead migration. During moderate to high stream flows, the Sisquoc River will bypass the culverts and flow over the in-stream crossing portion at the middle of the river channel. The culverts will likely blow out during higher flows.

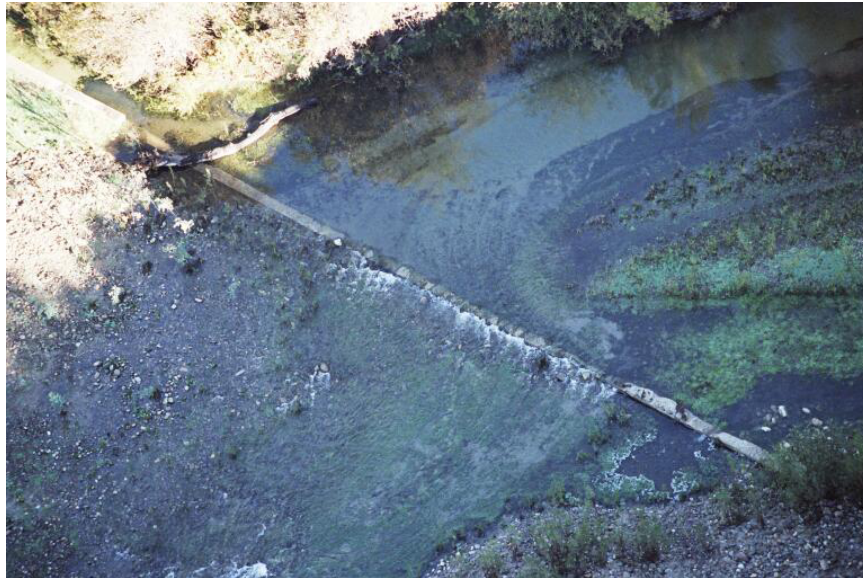
**Description:** Access to ground survey this structure was not obtained. Observations were made from the air and are limited in detail. This old concrete weir is outfitted as a USGS gaging station and may have also served to divert surface flows. During observed low flow conditions, the total height of this structure above the downstream substrate was less than 12 inches along most of the weir. At several locations, water drops less than 4 inches to the downstream water surface. The weir appears to be 1-2 feet thick and spans the entire river channel. Deposited substrate has accumulated upstream of the weir to the top of the structure.

**Condition:** The concrete weir is in poor condition with major cracking and concrete wear. This structure will continue to erode over time and eventually break apart if not maintained.

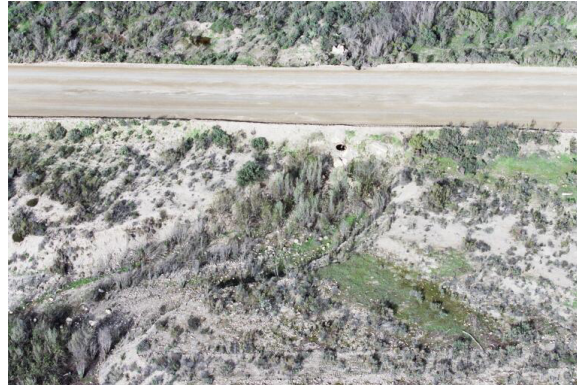
View Looking North (upstream) at SC\_TT\_1 culvert

**Description:** Access was not obtained to survey this culvert from the ground. Observations were made from the air and adjacent roads; and are limited in detail. The natural alignment of Tepusquet Creek, immediately upstream from the confluence with the Sisquoc River, has been significantly altered by nearby roads. A dirt-hauling road utilized by gravel operation vehicles runs along the north river bank of the Sisquoc River and two separate culverts convey flows from Tepusquet Creek under this road into the Sisquoc. The primary stream channel appears to hit the earth fill of the hauling road and runs west along the north side of the road, under the Tepusquet Road bridge, and continues approximately 500 feet before crossing under the hauling road via a single corrugated metal culvert. This culvert passes under the hauling road and drops stream flow approximately 4-6 total feet onto several large boulders and natural substrate. No downstream pool was observed. The inlet configuration could not be observed due to thick vegetation. The overall length of the culvert is approximately 30 feet. The condition, slope, and inside configuration of the culvert could not be determined. A second culvert crosses under the same hauling road several hundred feet east of the Tepusquet Road crossing and into the Sisquoc River. Thick vegetation prevented observation of this second culvert, but it appears that it may serve as a secondary culvert or “overflow” when the primary culvert has exceeded its capacity.

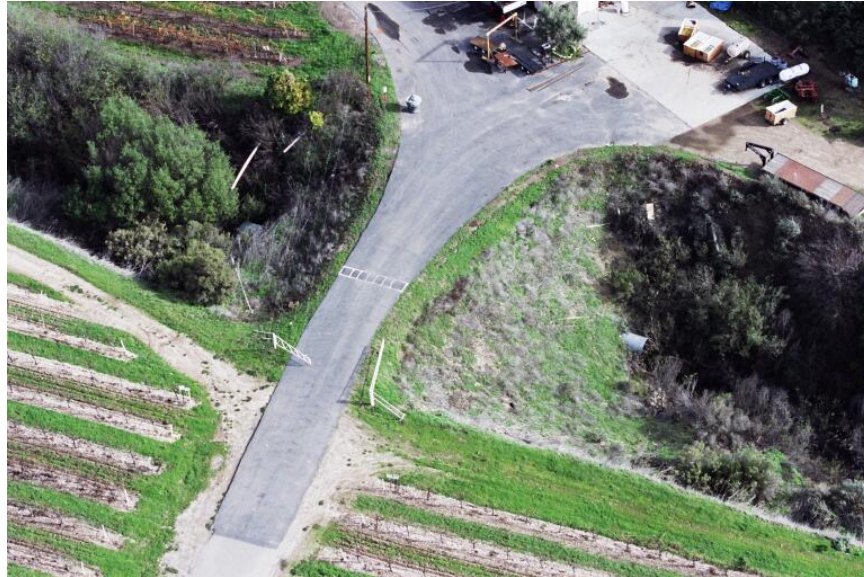
**Description:** Access to ground survey this structure was not obtained. Observations of this culvert crossing were made from the air and are limited in detail. This private road crossing consists of a single metal culvert that conveys stream flows underneath the earthen road fill. A paved road crosses the stream on top of the road fill. The overall length of the culvert is approximately 60-80 feet. A vertical drop that appears to be over 5 feet in height occurs at the culvert outlet. The configuration of the culvert inlet could not be observed due to thick vegetation.

**Condition:** The entire crossing appears to be in fair condition with downstream scour likely. It is possible that this single culvert may not be adequately sized for a 100-flow event.

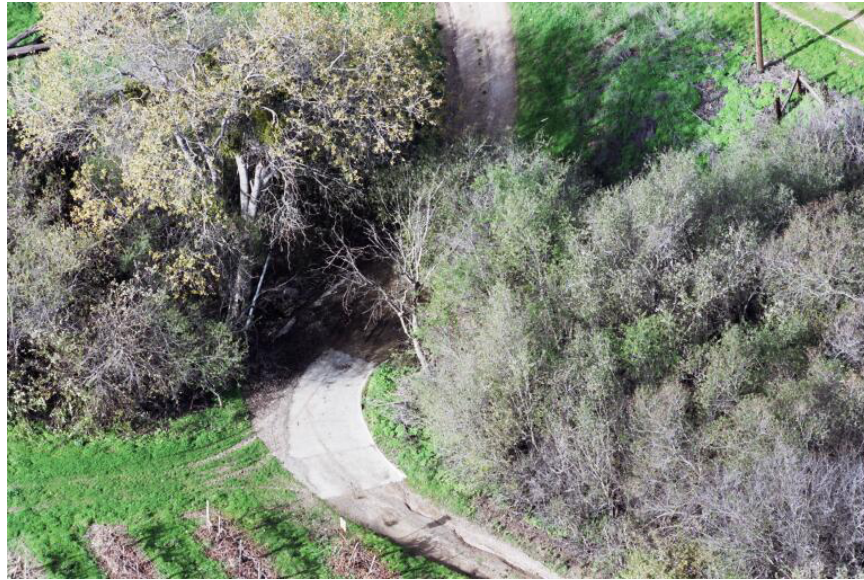
**Description:** Observations of this crossing were made from the air and are limited in detail. This private road crossing appears to convey some stream flow across the top of a concrete crossing. The configuration of the crossing could not be observed completely due to thick vegetation and it is possible that one or more culverts are present underneath the structure and that blockages at the inlet have caused water to flow over the top.

**Diagnosis:** Despite limited visual observation through the riparian canopy, it appears that a moderate drop occurs at the downstream side of the crossing. It is likely that steelhead passage at this site would be limited to some degree and potentially blocked, depending on the exact configuration.

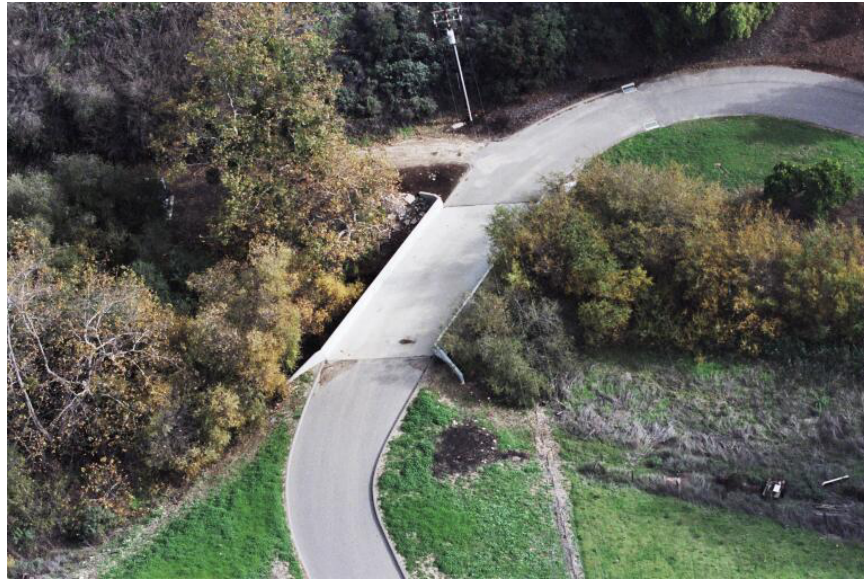
**Description:** Observations of this crossing were made from the air and are limited in detail. The structural configuration underneath this private crossing could not be observed well due to thick vegetation. Bank stabilization protection has been constructed adjacent to the bridge.

**Diagnosis:** The streambed could not be observed underneath the bridge and potential impacts on fish passage are unknown.

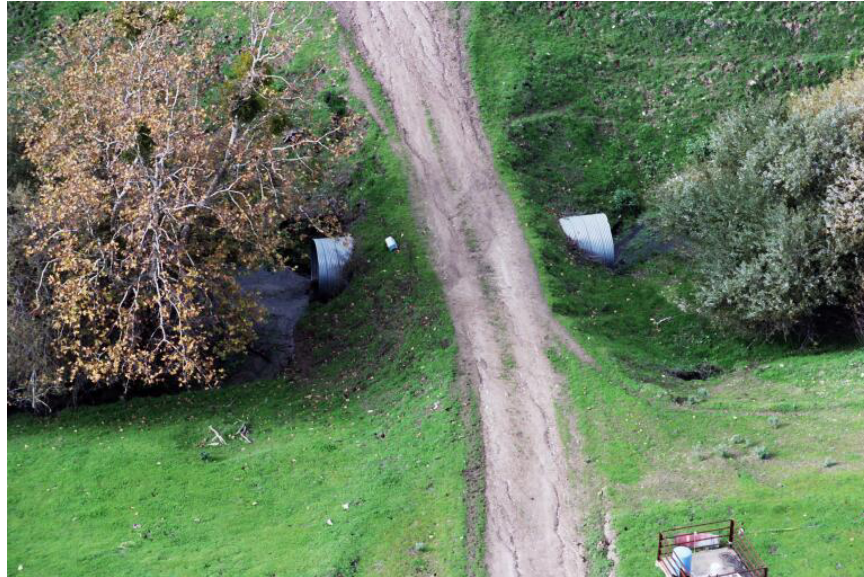
**Description:** Observations of this culvert crossing were made from the air and are limited in detail. This private road crossing consists of a single metal culvert that conveys stream flows underneath an earthen road fill that crosses the channel. This large culvert appears to be set at, or close to, streambed level. The overall length of the culvert is approximately 20-25 feet. No significant drop was observed at the culvert outlet. The slope of the culvert appears to be moderate.

**Condition:** The culvert appears to be in good condition and the crossing appears to be fairly new.

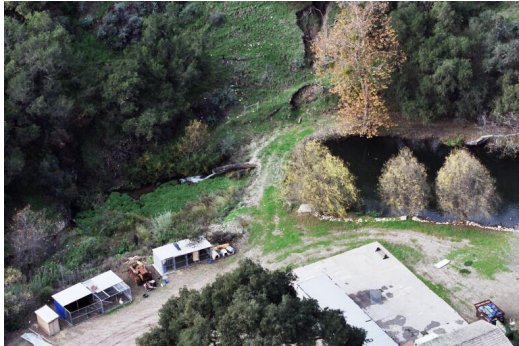
SC\_TT\_6

**Description:** Observations of these dams were made from the air and are limited in detail. Both earthen dams are constructed in a similar manner and contain one metal pipe set high on the dam. These pipes act as reservoir drains, preventing the reservoir’s water level from reaching the top of the dam. Both pipes appear to be uncorrugated and smooth. The pipe on the lower dam (SC\_TT\_6) bends downward and drops water approximately four feet in height onto the downstream substrate. The upper dam pipe (SC\_TT\_7) drops flows approximately 2-3 feet into the reservoir downstream, which backs water up to the upper dam. Both pipes are greater than 15 feet in length. Both dams may also serve as vehicle crossings. These dams may be used to divert water to surrounding agricultural operations.

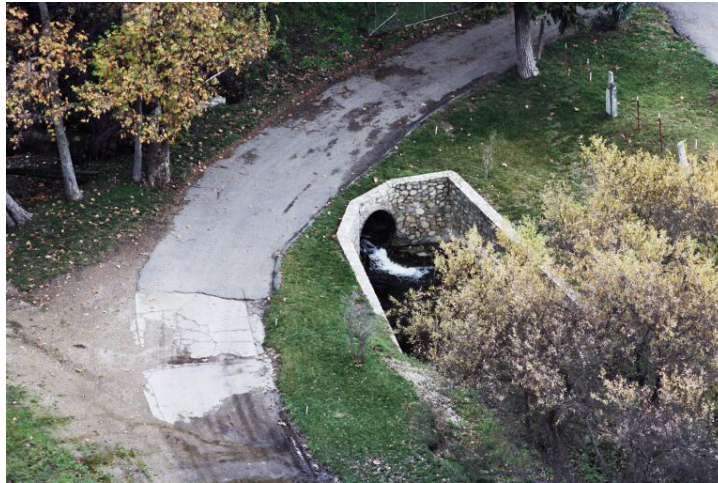
**Description:** Observations of this culvert crossing were made from the air and are limited in detail. This private road crossing consists of a single metal culvert that conveys stream flows underneath a paved road. The culvert is set inside stone wingwalls downstream that force flows to the river-right. The overall length of the culvert is approximately 20-30 feet. A near vertical drop of approximately 2-3 feet occurs at the culvert outlet and conveys flow into a well-developed downstream pool. The diameter of the culvert appears to be 4 feet. The configuration of the culvert inlet could not be observed due to thick vegetation. The culvert appears to have a moderate to steep slope.

**Condition:** The entire crossing appears to be in fair condition with downstream undercutting of the crossing likely. It is possible that this single culvert may not be adequately sized for a 100-flow event.

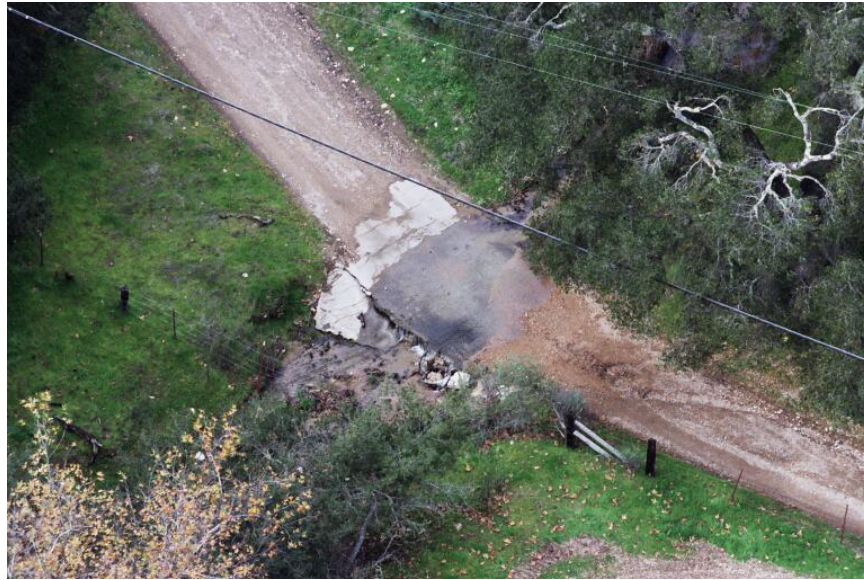
**Description:** Observations of this crossing were made from the air and are limited in detail. This private road crossing appears to convey all stream flow across the top of a concrete slab. Water flows over the smooth concrete surface and drops between 1-3 feet onto broken concrete slabs and downstream substrate. The slope of the crossing's surface appears to be mild.

**Diagnosis:** The concrete is in poor condition with noticeable cracking and undercutting on the downstream side.

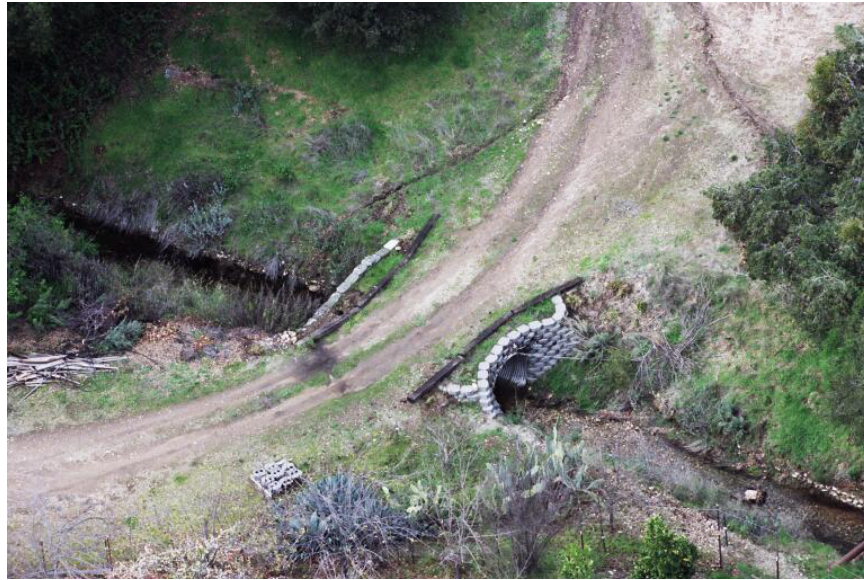
**Description:** Observations of this culvert crossing were made from the air and are limited in detail. This private road crossing consists of a single metal culvert that conveys stream flows underneath an earthen road fill that crosses the channel. This large culvert appears to be set at streambed level. Concrete blocks have been placed around the culvert at the inlet and outlet. The overall length of the culvert is approximately 12-15 feet. No significant drop was observed at the culvert outlet. The slope of the culvert appears to be relatively flat to moderate.

**Condition:** The culvert appears to be in good condition.

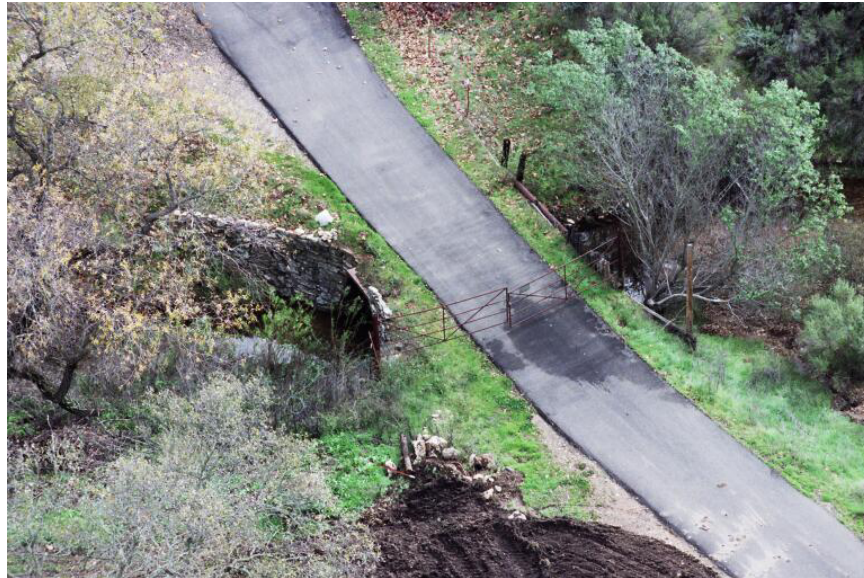
**Description:** Observations of this culvert crossing were made from the air and an adjacent public road and are limited in detail. This private road crossing consists of a unique metal culvert that conveys stream flows underneath a paved driveway. This upside down U-shaped culvert has the appearance of a mineshaft that is approximately 8 feet wide at the base and 7 feet tall from the substrate bottom to the roof. Natural substrate conditions appear to pass through the entire bottom of the culvert. This substrate may be deposited on top of a metal bottom. Concrete blocks have been placed around the culvert at the inlet and outlet. The overall length of the culvert is approximately 15 feet. No drops were observed at the culvert outlet or inlet.

**Diagnosis:** Upstream salmonid passage appears to be adequate during most, or all, stream flow situations although access should be obtained to further assess the inside configuration of this culvert. During extremely high stream flows, excessive water velocities may occur inside the culvert as flows are confined through the structure. Overall, this culvert does not appear to be a serious impediment to upstream fish migration.

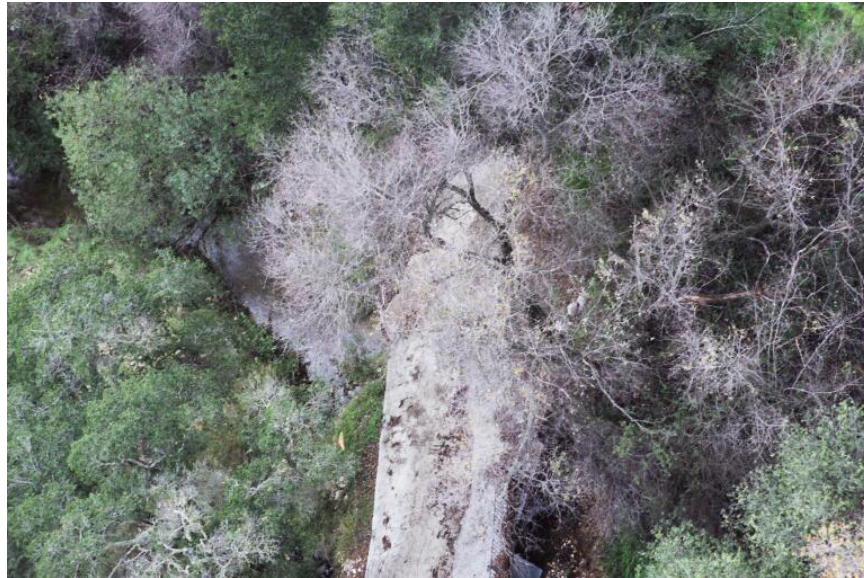
**Description:** Observations of this crossing were made from the air and are limited in detail. From observations made looking through the riparian vegetation it appears that this structure conveys stream flows through a large culvert. The inlet of the culvert appears to be set at streambed grade, though it is possible that the inside of the culvert has accumulated deposited substrate that has backed up to the inlet to give it this appearance. The dimensions and condition of the culvert could not be determined.

**Diagnosis:** The severity of this structure to fish passage is unknown. Most culverts negatively impact fish passage to some degree by producing shallow water conditions during low flows and excessive water velocities during higher flows.

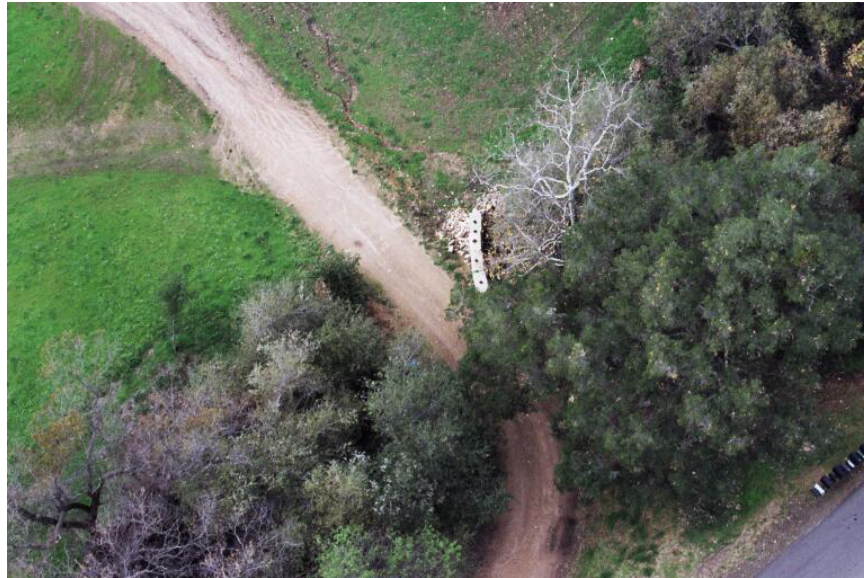
**Description:** Observations of this crossing were made from the air and are limited in detail. Through the riparian vegetation it appears that this structure conveys stream flows through a culvert. The dimensions and condition of the culvert could not be determined from the air. Concrete blocks have been placed at the upstream side of the crossing around the culvert.

**Diagnosis:** The severity of this structure to fish passage is unknown. Most culverts negatively impact fish passage to some degree by producing shallow water conditions during low flows and excessive water velocities during higher flows.

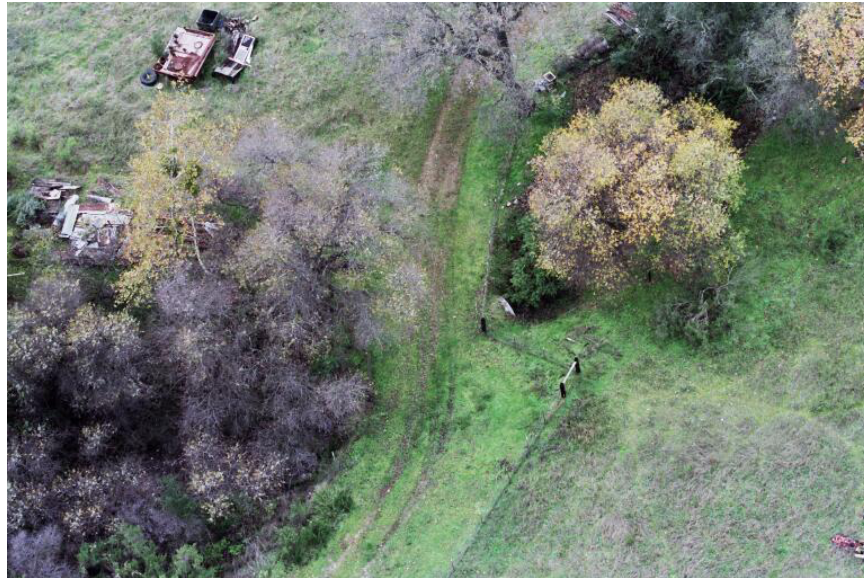
**Description:** Observations of this culvert crossing were made from the air and are limited in detail. This private dirt road crossing consists of a single metal culvert that conveys stream flows underneath the earthen road fill that crosses the channel. This large culvert appears to set at, or close to, streambed level. The overall length of the culvert is approximately 20-25 feet. The outlet configuration could not be seen through the thick riparian vegetation. This crossing does not appear to be used often and another crossing exists just upstream (SC\_TT\_15).

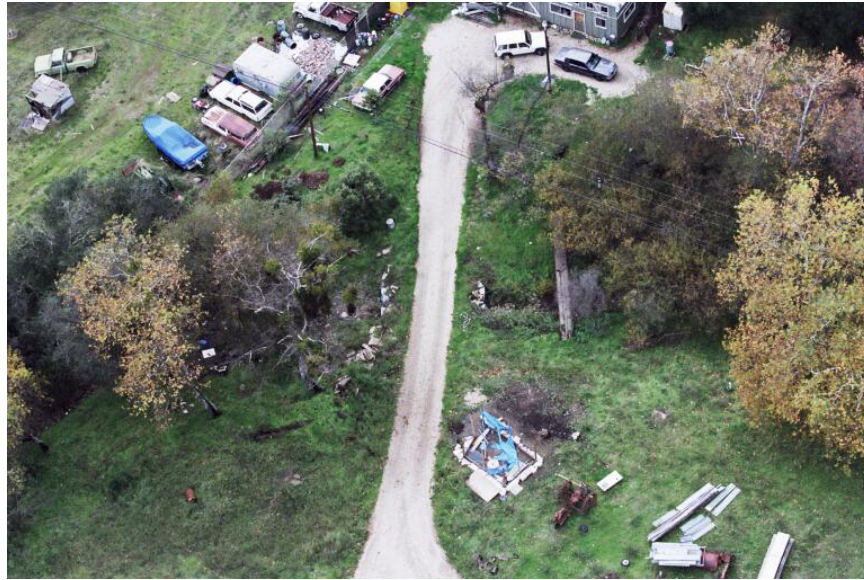
**Description:** Access to ground survey this structure was not obtained. Observations of this culvert crossing were made from the air and are limited in detail. This private gravel road crossing consists of multiple culverts that convey stream flows underneath the road fill that crosses the channel. The overall length of the culverts is approximately 12-15 feet. The outlet configuration could not be seen through the thick riparian vegetation.

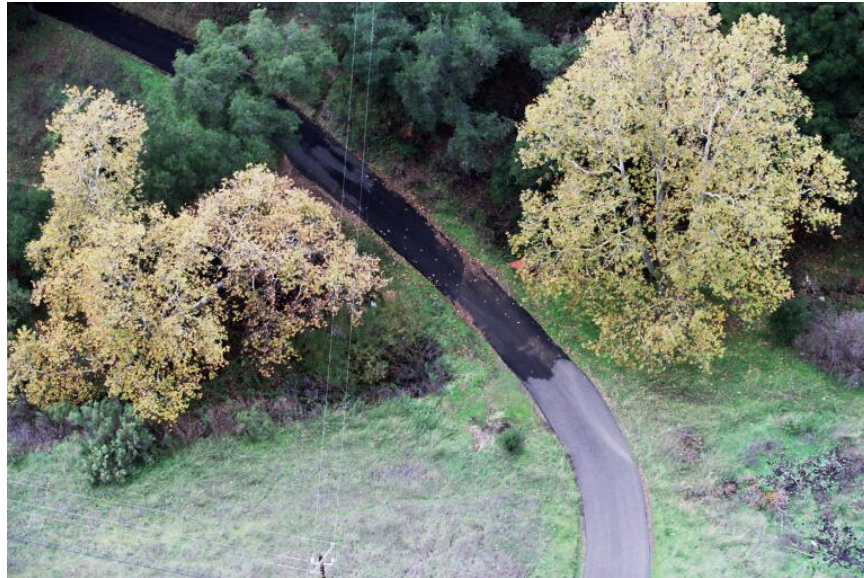
**Description:** Access to ground survey this structure was not obtained. Observations of this culvert crossing were made from the air and are limited in detail. This private, paved road crossing consists of a large culvert that conveys stream flows underneath the road fill that crosses the channel. The overall length of the culverts is approximately 15 feet. The outlet configuration and downstream pool could not be observed through the thick riparian vegetation.

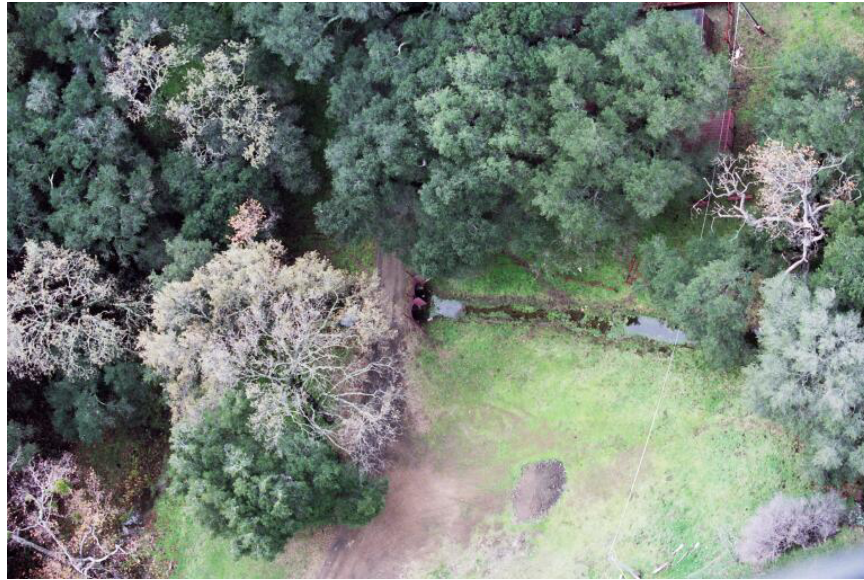
**Description:** Access to ground survey this structure was not obtained. Observations of this culvert crossing were made from the air and are limited in detail. This private dirt road crossing consists of two culverts that convey stream flows underneath the road fill that crosses the channel. The overall length of the culverts is approximately 10-15 feet. The outlet configuration could not be seen through the thick riparian vegetation.
