Steel head Assessment and Recovery Opportunities in Southern Santa Barbara County, California

**BY
Matt W. Stoecker
and
Conception Coast Project**

June 2002

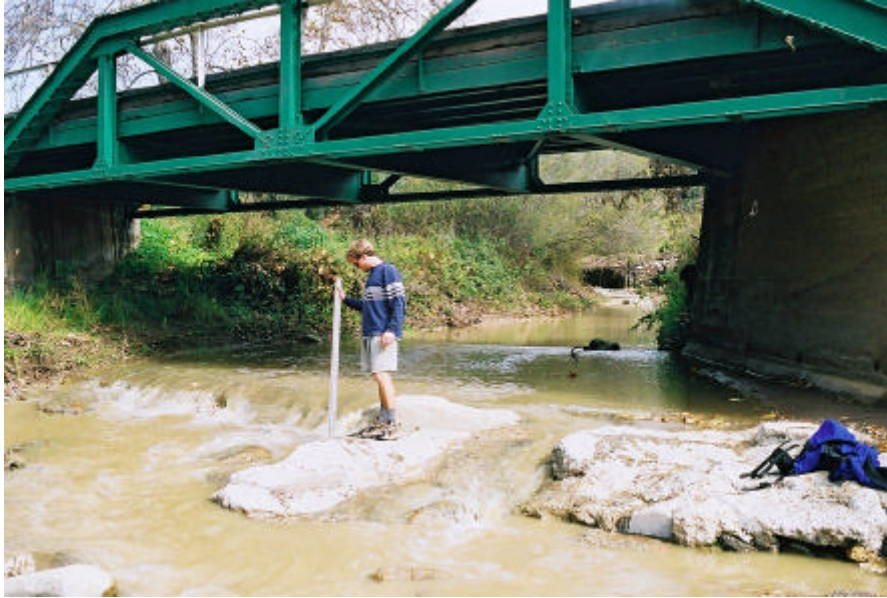
Description: Under the #2 Highway 150 Bridge the streambed is covered with smooth relatively flat concrete that extends 25 feet from the upstream end to a small, concrete and boulder riprap curb that measured 46 feet across the stream channel. The curb measured 6 inches to 2 feet in height from the downstream pool surface with a moderate downstream slope.

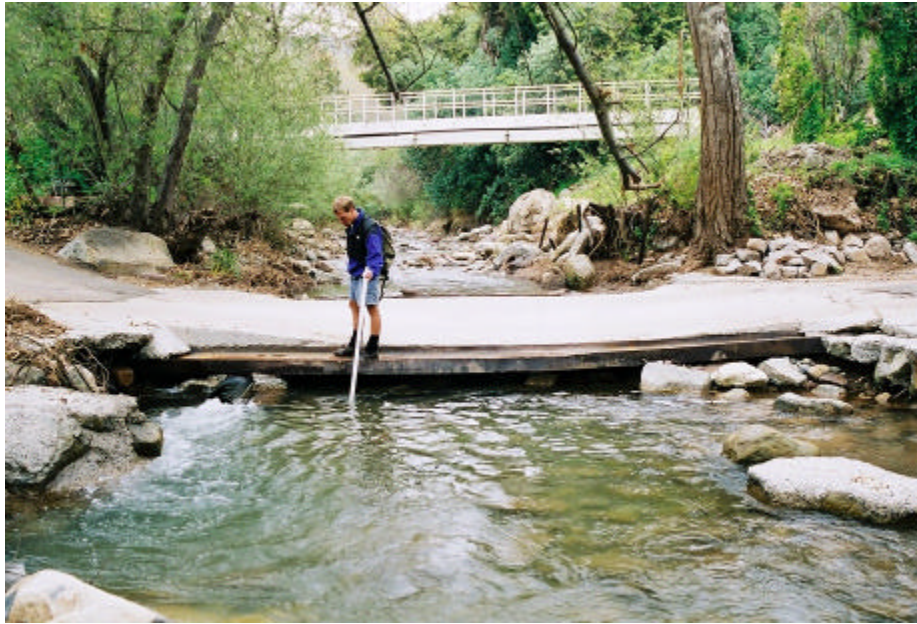
Description: This concrete and steel road crossing is similar in construction to the previous, downstream crossing (BR_RN_5) although lacks the downstream apron and contains only two visible corrugated plastic culverts with one-foot diameters. Both culverts pass under the crossing on the river-right side and convey all visible water under the crossing into the downstream pool. Both culverts were clear of substrate at the upstream end and running at full capacity. No jump exists from the downstream pool into the culverts. The maximum jump depth of the downstream pool measured 2 feet 2 inches. The height from the downstream pool's surface onto the crossing measured 1 foot 4 inches.

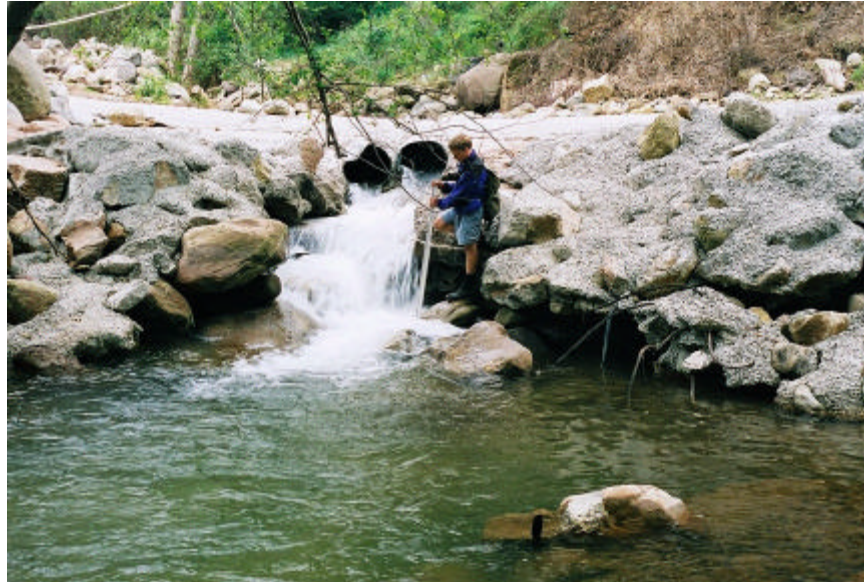
Description: This concrete and boulder riprap crossing has two 31-foot long corrugated metal culverts with 2-foot diameters conveying water through it. Both culverts are running at approximately 25% of capacity and have moderately steep slopes. Downstream of the paired culverts, water drops one-foot onto a steep boulder riprap cascade that continues to drop 6 vertical feet over 14 horizontal feet with no resting or jump pools. The downstream pool had a maximum jump depth measuring 2 feet 9 inches. The overall height of the structure from the pool surface measured 7 feet 6 inches to the downstream lip of the concrete crossing.

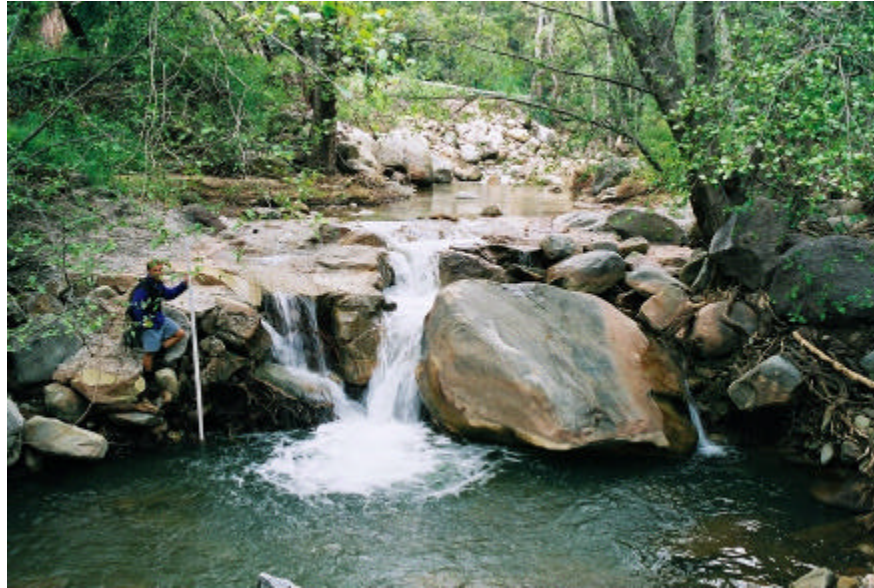
Description: This boulder and concrete structure appears to serve as equipment crossing due to the presence of tractor tracks crossing the creek just upstream. Stream flow is primarily concentrated across the center of the crossing and down a three-step cascade that flows adjacent to a large boulder. The overall vertical height of the structure from the downstream pool surface to the top of the crossing measured 8 feet 9 inches. A pool measuring 3 feet wide by 3 feet long and having a depth of 3 feet occurs on the upstream side of the large boulder. This “resting pool” is 4 feet 11 inches from the downstream pool, which has a jump depth of 4 feet 2 inches. Upstream of the above-mentioned resting pool is a 3-foot vertical jump to a shallow and turbulent second resting pool. The second resting pool measured 4 feet 6 inches across by 2 feet 6 inches long with a depth of 1 foot 5 inches. From this second resting pool, the upper-most jump rises 10 inches over 3 horizontal feet to a 2-foot deep pool on the upstream side of the structure.

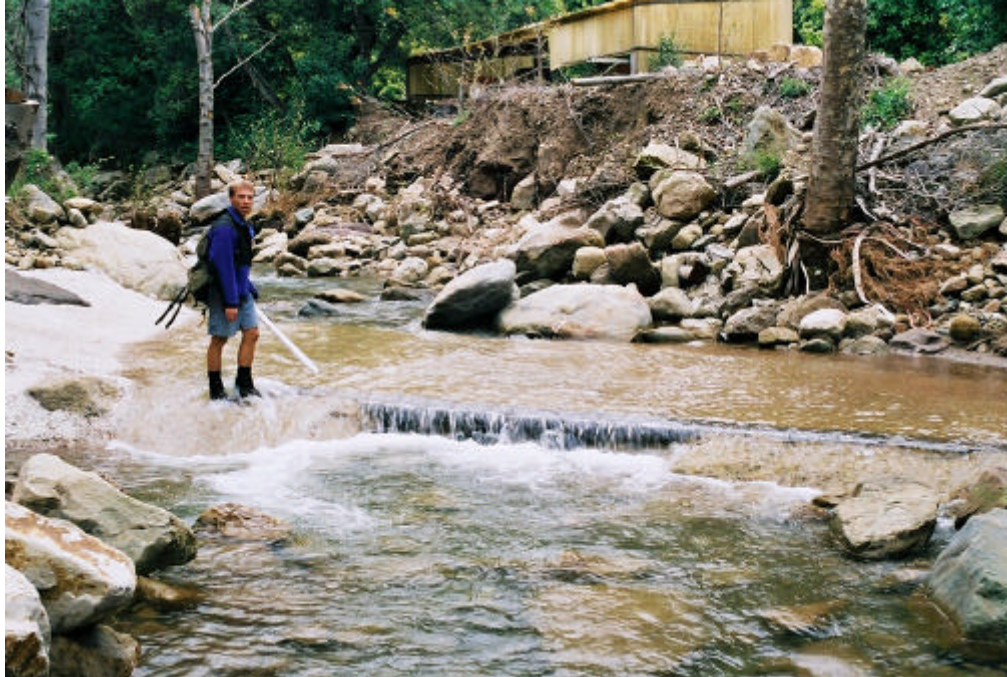
Description: This relatively flat, concrete and steel crossing appears to convey all stream flow over the surface of the road. The crossing is elevated 10 inches above the streambed with a small 11-inch deep pool downstream.

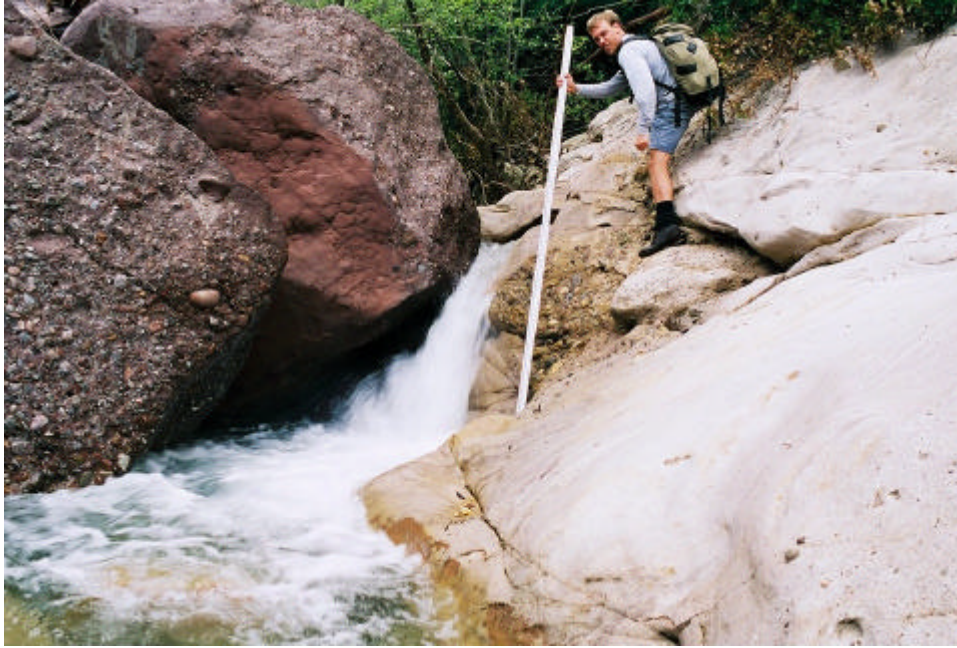
Description: This waterfall is created by two large boulders that have wedged against the adjacent bedrock wall on the river-left side of the stream. Stream flow is confined between the bedrock wall and upstream boulder. Water flows in a curved path around the side of the large boulder and along the bedrock wall before falling vertically at the base of the large boulder into a small pool that measured 2 feet 6 inch deep. The total jump height from the downstream pool surface to the top of the falls measured 6 feet 10 inches.

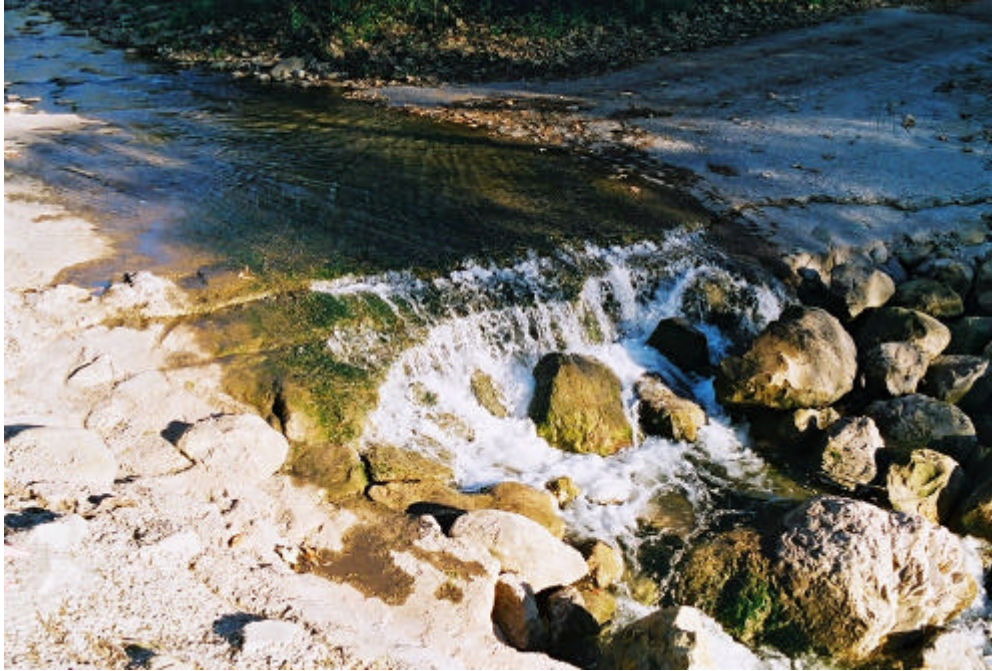
Description: This crossing consists of a concrete road that spans the entire stream channel in a mild U-shape between the bank tops. The crossing is 28 feet wide with an overall length across the creek of approximately 100 feet, depending on where measurements are taken. The overall length of the crossing from bank to bank is difficult to determine because there has been significant modification of the banks to create the gradual U-shape crossing. Downstream of the crossing, large boulders have been placed to reduce scour and undercutting of the concrete crossing. These large boulders extend downstream from the crossing 20 feet producing an irregular and moderately steep cascade. Concrete and boulder riprap extends downstream from the crossing on both banks.

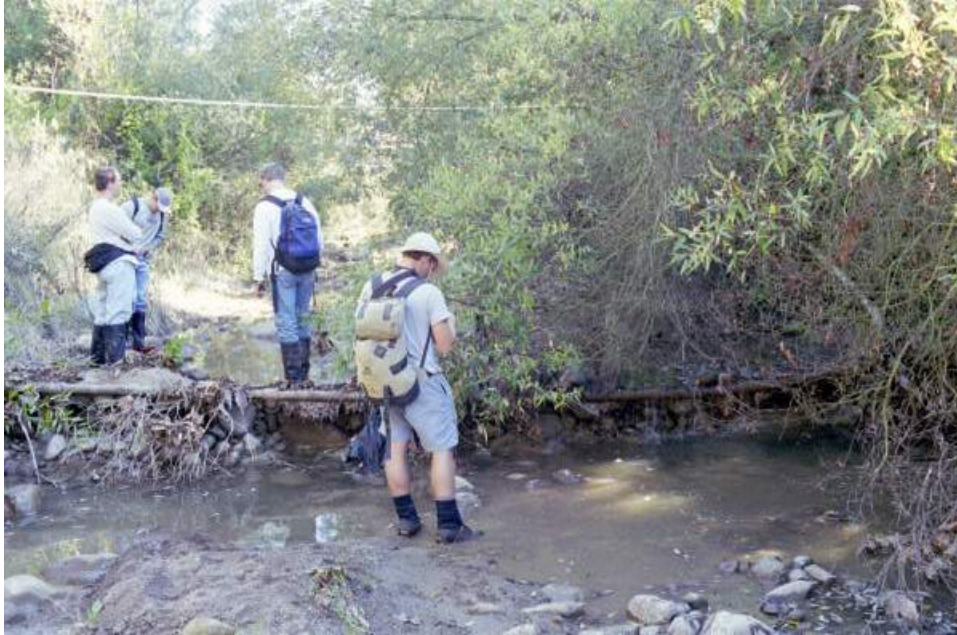
Description: A small pipe crosses the creek and traps a small amount of stream substrate upstream. The pipe has a height of 20 inches from the downstream streambed. The purpose and history of this small pipe obstruction is not known.

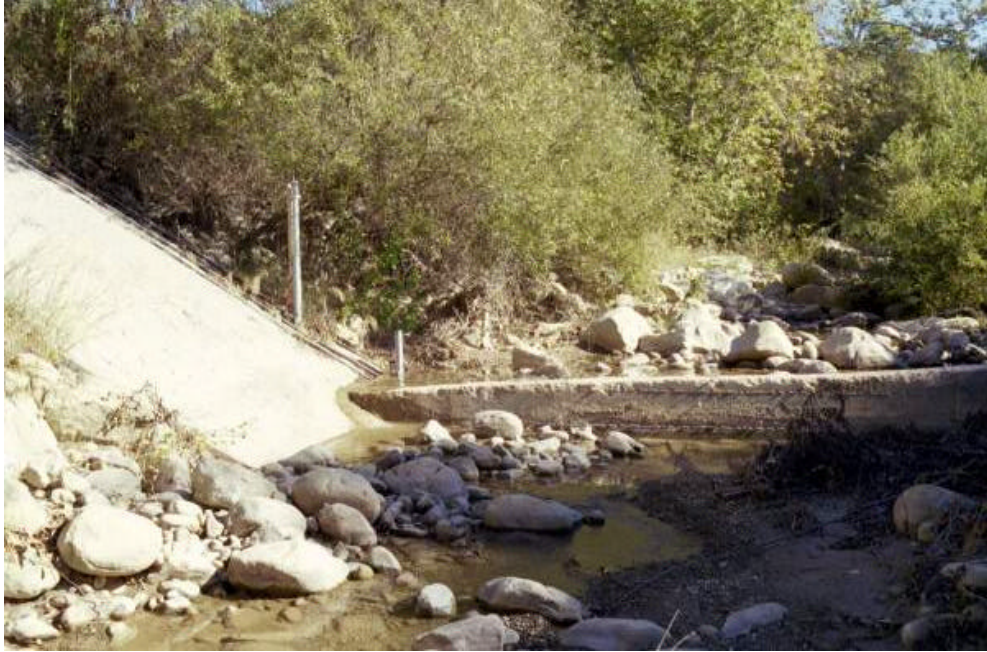
Description: This gauging station consists of a concrete curb that extends across the stream channel and is keyed into a sloping concrete wall on the river-right bank. The curb ranges in height from 12 inches to 26 inches from the downstream streambed.

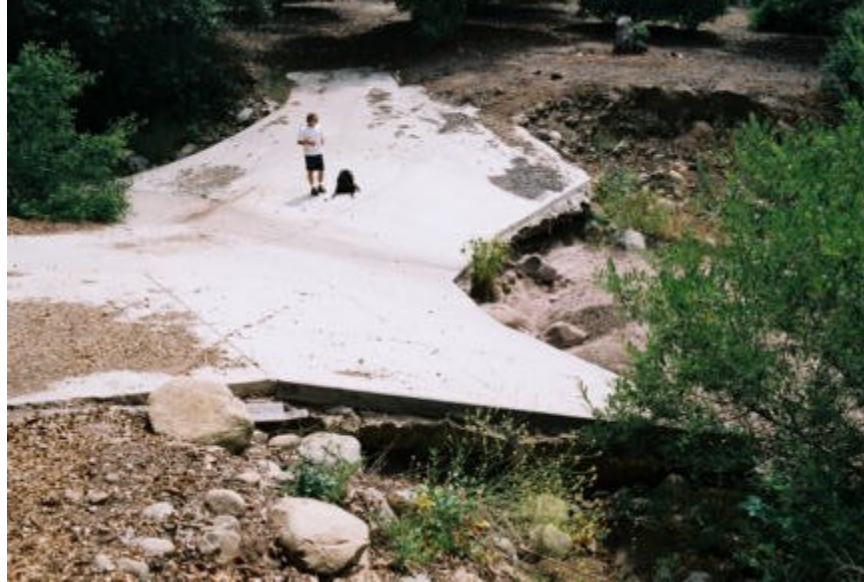
Description: This concrete crossing spans 76 feet across the stream channel and into loose silt, sand, and cobble-dominated banks. A 2-foot diameter metal pipe extends from under the structure. The crossing has a shallow concave in order to concentrate stream flows across the center of the smooth concrete surface. The centerline of this concave has three distinct slope changes along the 33 feet from the downstream lip to the upstream lip. Starting from the downstream edge, the first 9 feet had the steepest slope measured at 15.7%. The next 15 feet had a slope measured at 6.1%. The most upstream 9 feet, where vehicles would cross the structure, has the mildest slope of 3.7%. The surface of the structure rises 2 feet 8 inches over 33 feet for an average slope of 8.1%. 100 feet downstream from the crossing, the slope of the natural streambed was measured at 2.6%. The concrete measured between 2 and 2.5 feet thick from the exposed footing to the surface lip on the downstream side of the crossing. Downstream scour has produced a 4-foot vertical drop from the downstream edge of the structure to the deepest part of the streambed where a jump pool for steelhead would form during migration flows.

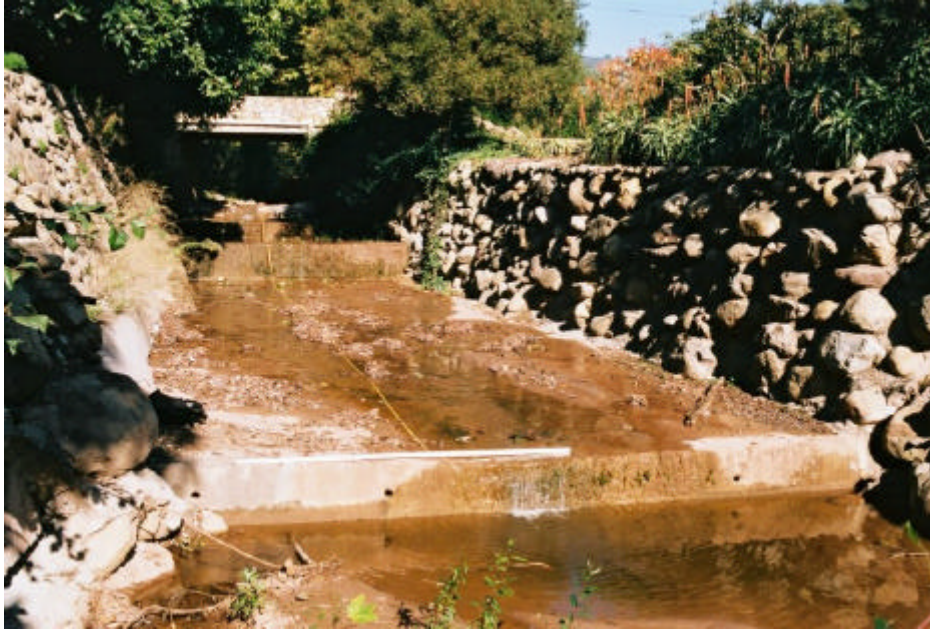
Description: A concrete channel with four separate steps separated by three reaches of concrete channel extends 93 feet 6 inches downstream from the downstream side of a private bridge. Natural streambed occurs underneath the bridge. At the downstream end, the channel is 22 feet wide with stone and concrete walls rising almost vertically on each side. The river-right wall measured 12 feet tall and the river-left wall measures 8 feet tall. At the upstream end of the structure, under the private bridge, the channel size measures 16 feet wide and 8 feet 8 inches tall to the bottom of the metal I-beams on the bridge.

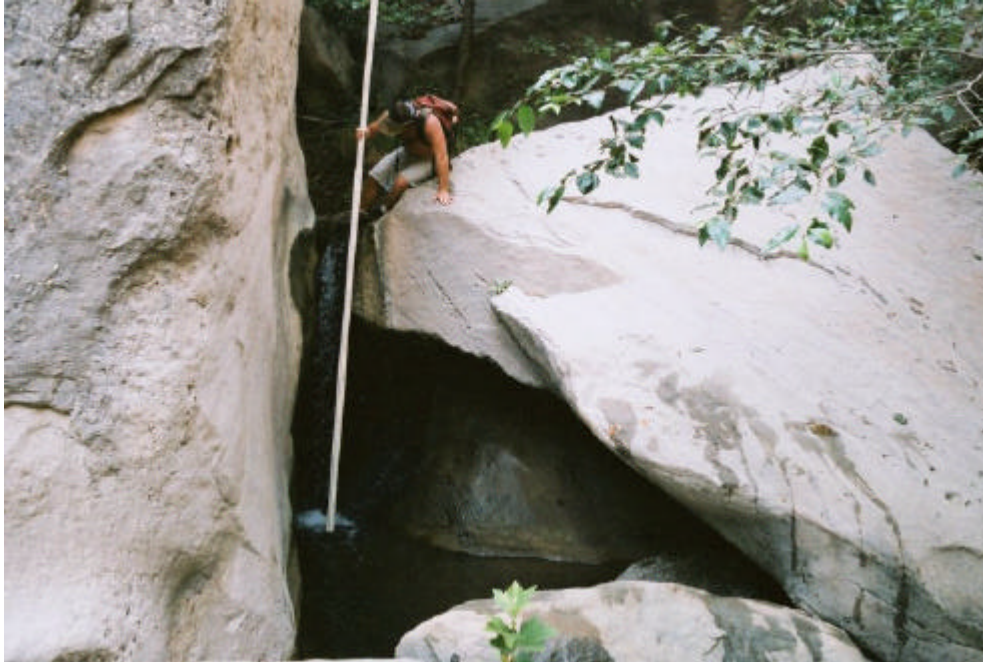
Description: Several massive boulders have wedged against the adjacent bedrock walls in this narrow gorge-like reach to create a waterfall that measured 7 feet 5 inch tall from the downstream pool surface. The maximum pool depth measured 3 feet 8 inches.

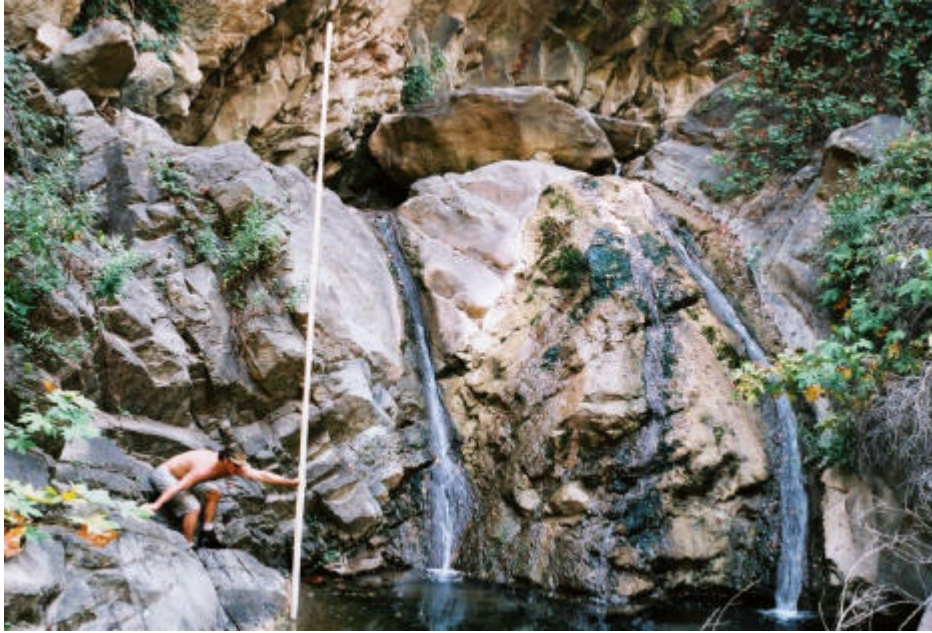
Description: At low flows this steep sloping waterfall has a vertical height of 12 feet 10 inches from the surface of the downstream pool to the lowest point at the top of the waterfall. Flows are evenly divided during low flows between the steep slope on the river-right side of the bedrock structure and a sloping chute on the river-left side. The maximum depth of the downstream pool measured 9 feet 10 inches during the low flow encountered.

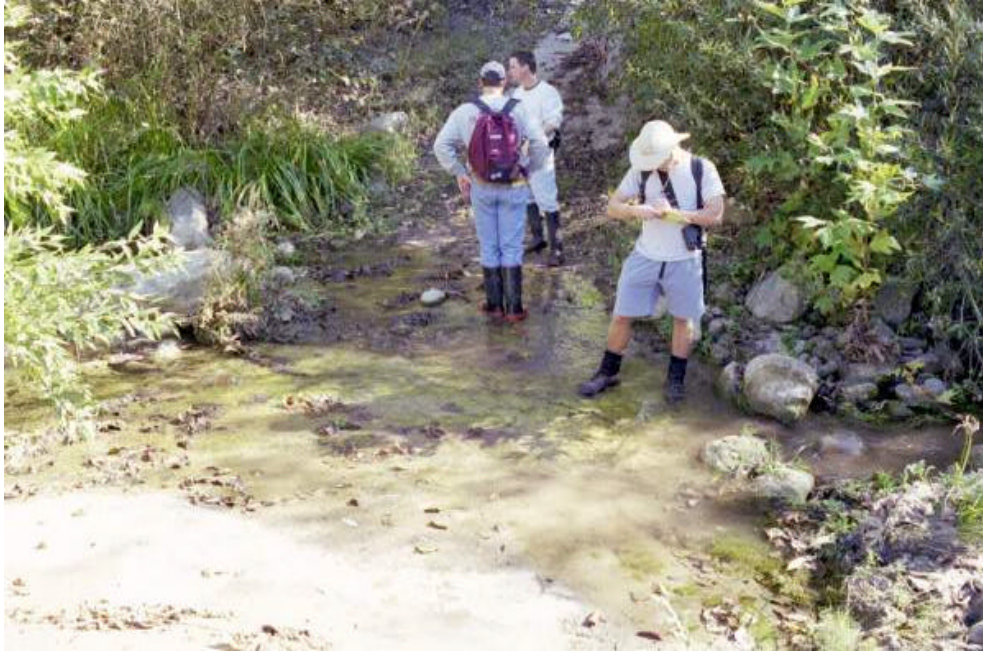
Description: This concrete low-flow crossing is at streambed grade and passes all water over the top of the structure. The relatively flat crossing spans the entire stream channel and is approximately 9 feet wide, although partially buried.

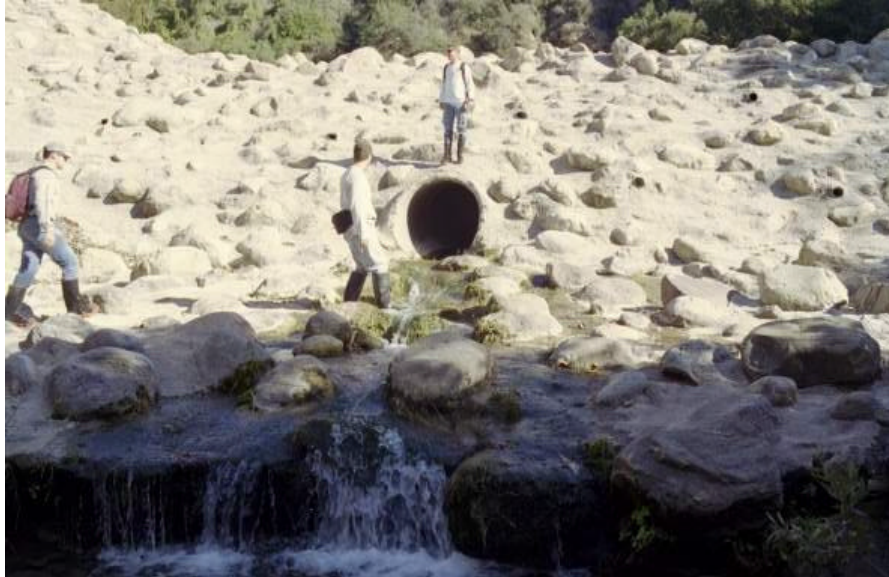
Description: This debris dam is composed of boulder and concrete riprap and conveys low to moderate stream flows through the dam in a 4-foot diameter smooth concrete culvert that measures 97 feet in length. Water discharges from the culvert onto a 25-foot long apron composed of boulder and concrete riprap with a varying slope of approximately 4%. On the downstream side of this apron, water falls vertically 30 inches off the apron into a pool with a maximum depth of 2 feet.

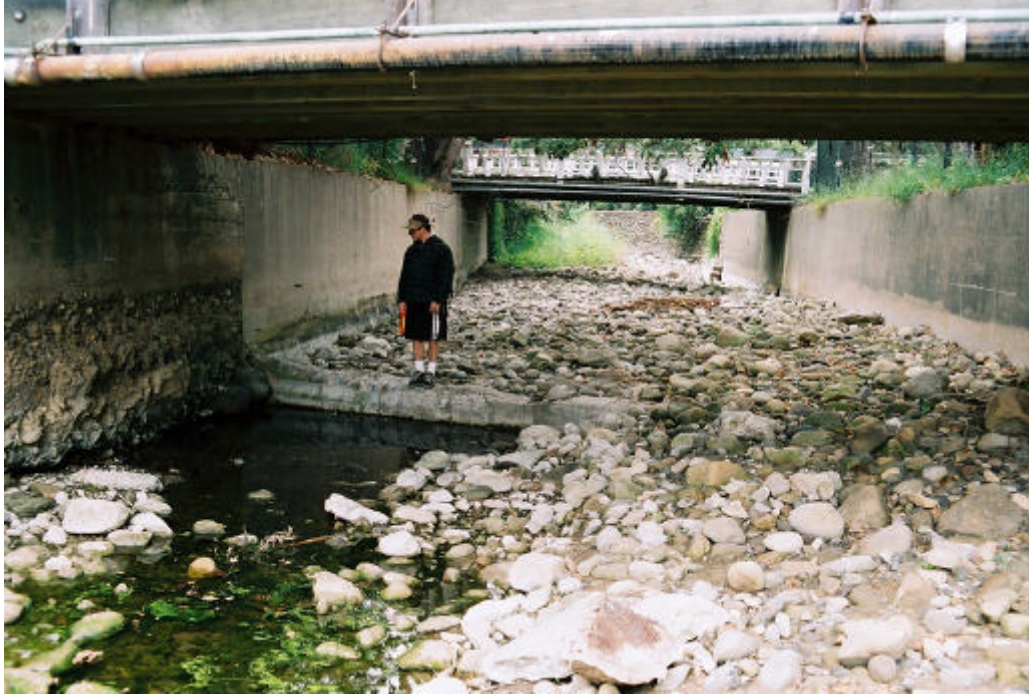
Description: This small, partially buried concrete curb has a jump height of 10 inches above a 1-foot deep pool on the river-right side under a private bridge.

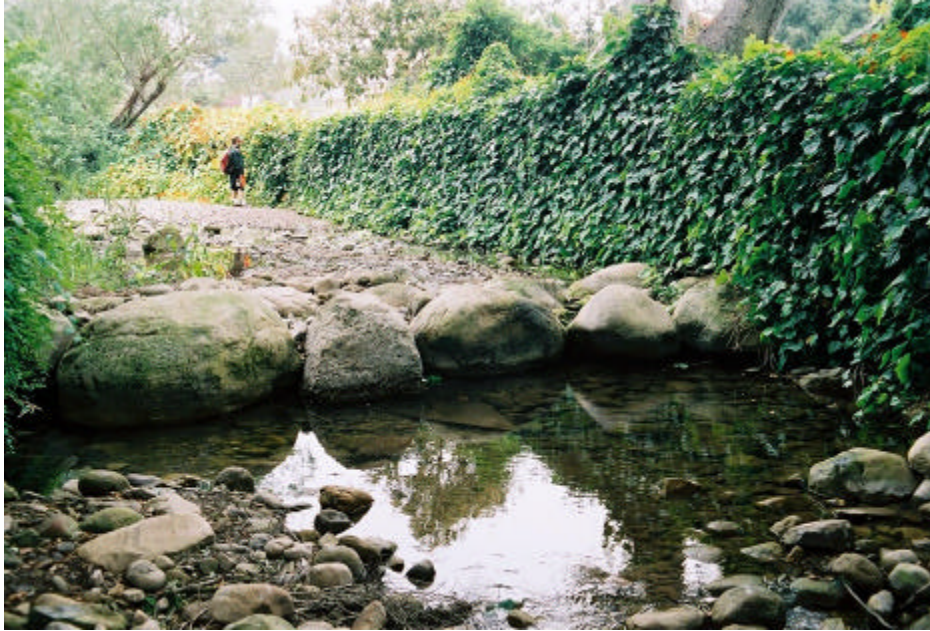
Description: This grade control is composed of 5 large boulders lined up across the stream channel. The jump height through the spaces between the boulders measured 11 inches from the surface of the downstream pool. The pool had a maximum jump depth of 1 foot 9 inches.

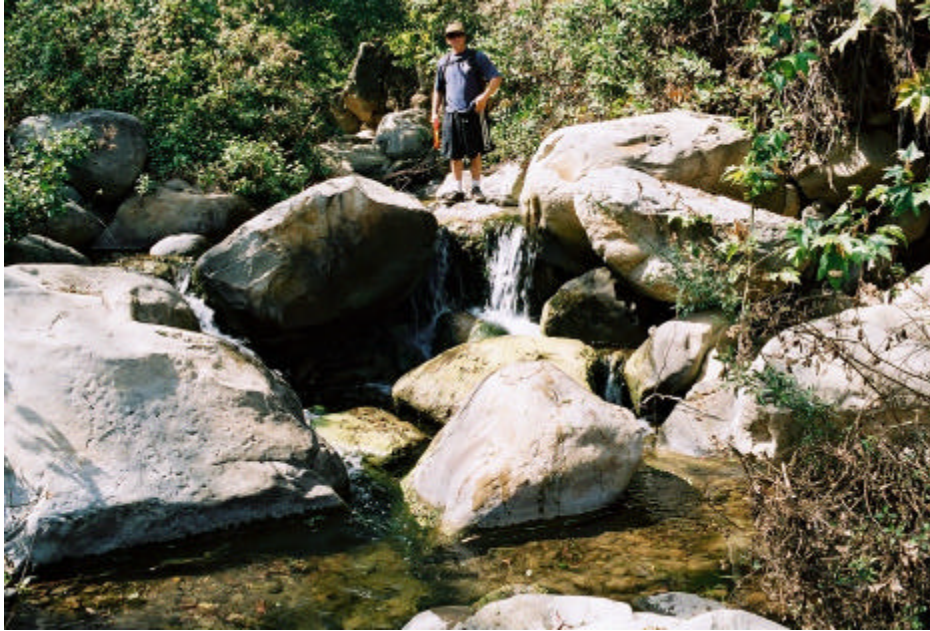
Description: This boulder cascade measured 4 feet 10 inches tall and had a downstream pool depth of 1-foot.

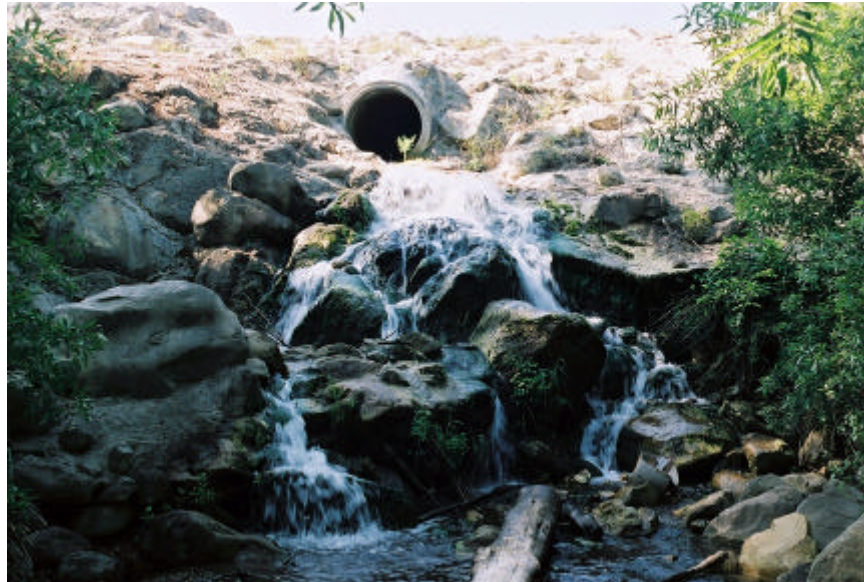
Description: This debris dam is composed of boulder and concrete riprap and conveys low to moderate stream flows through the dam in a 4-foot diameter smooth concrete culvert that measures 73 feet 6 inches in length. The slope of the culvert measured 5.33%. Water discharged from the culvert drops 13 feet 11 inches in height down the steep sloping face of the dam.

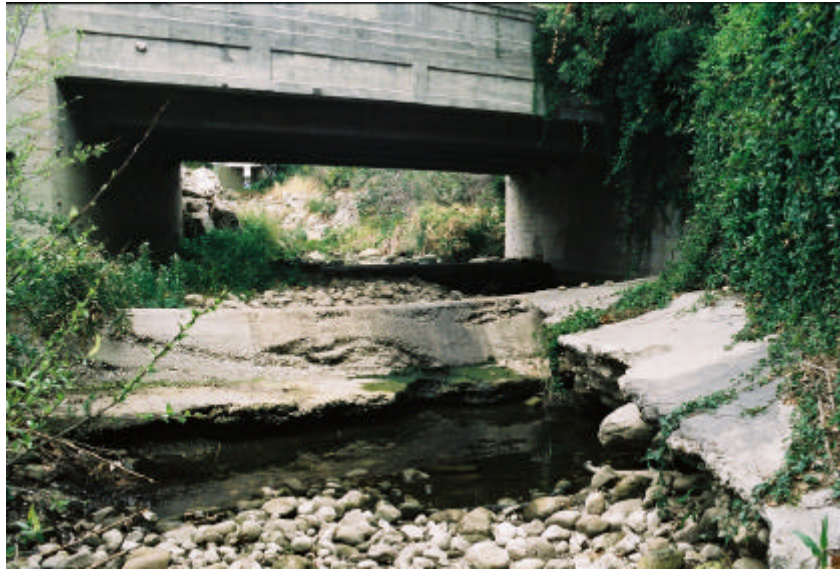
Description and Condition: Two grade control structures exist at the Pedregosa Street Bridge.

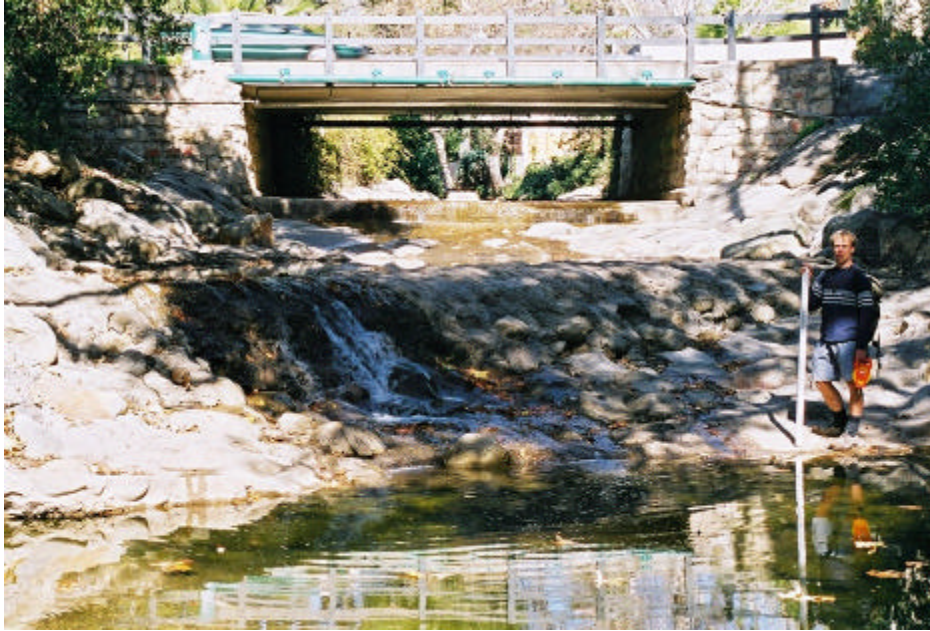
Description: This bridge crossing and complex series of downstream grade control features appear to have undergone several additions and modifications following the initial construction of the crossing. The total distance of the concrete altered bottom measured 126 feet from the upstream side of the concrete channel under the bridge to the downstream end of the riprap grade control structure. The overall height of the crossing measured 12 feet 1 inch from the downstream substrate bottom to the top of the concrete channel under the bridge. The height from the downstream end of the grade control to the upstream end measured 7 feet 11 inches. The downstream grade control structure measured 4 feet 2 inches in height and flows dropped at an angle of approximately 45 degrees to a relatively flat 10-foot long apron that flows into the downstream pool, which is often dry for much of the year. Upstream of the grade control, a mild sloping concrete bottom extends 42 feet upstream with a 16-inch deep pool occurring along most of its length. From the top of this pool, a concrete apron with a slope measured at 8% extends 22 feet upstream to the base of a 13-17 inch tall curb at the downstream end of the concrete channelized reach under the bridge. This channelized reach extends under the bridge for 41 feet with a measured slope of 2.6% to natural substrate upstream.

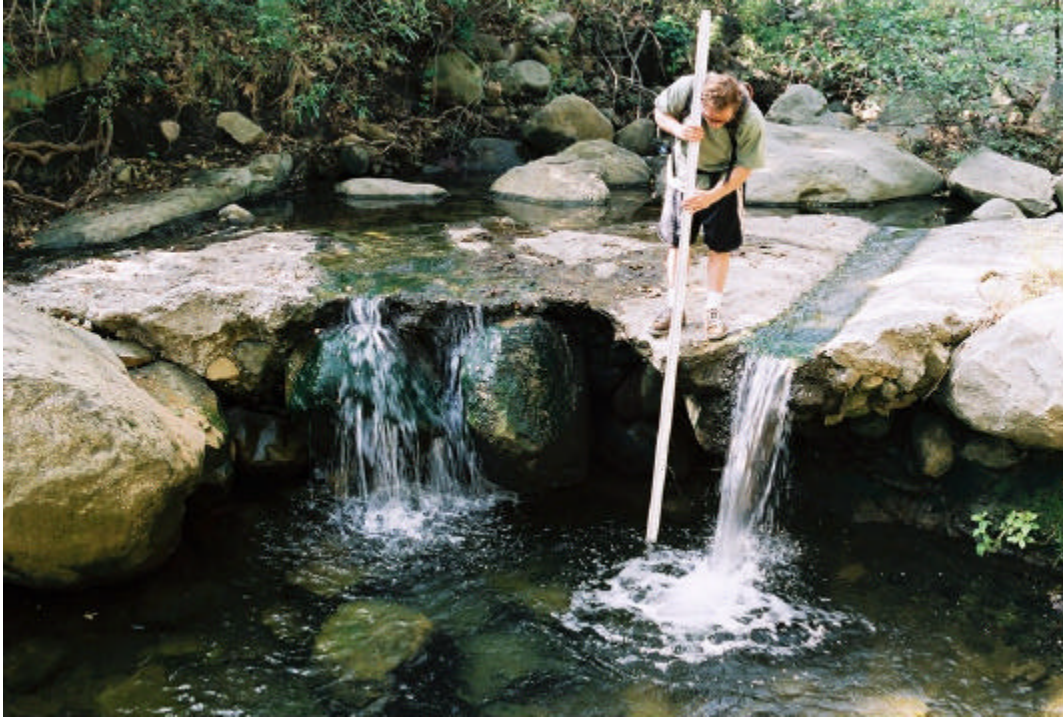
Description: This concrete and boulder structure spans the entire stream channel and apparently was built to protect a subsurface pipeline, which was not observed. Surface flows spill over the structure at three different points and are most concentrated near the river-left side in an eroded, U-shape chute in the concrete. The jump depth of the pool downstream was measured at 2 feet 5 inches. The jump height of the structure measured 3 feet 7 inches from the pool surface to the downstream edge of the eroded chute. The chute is 11 feet 2 inches long with a moderate slope along the top of the structure.

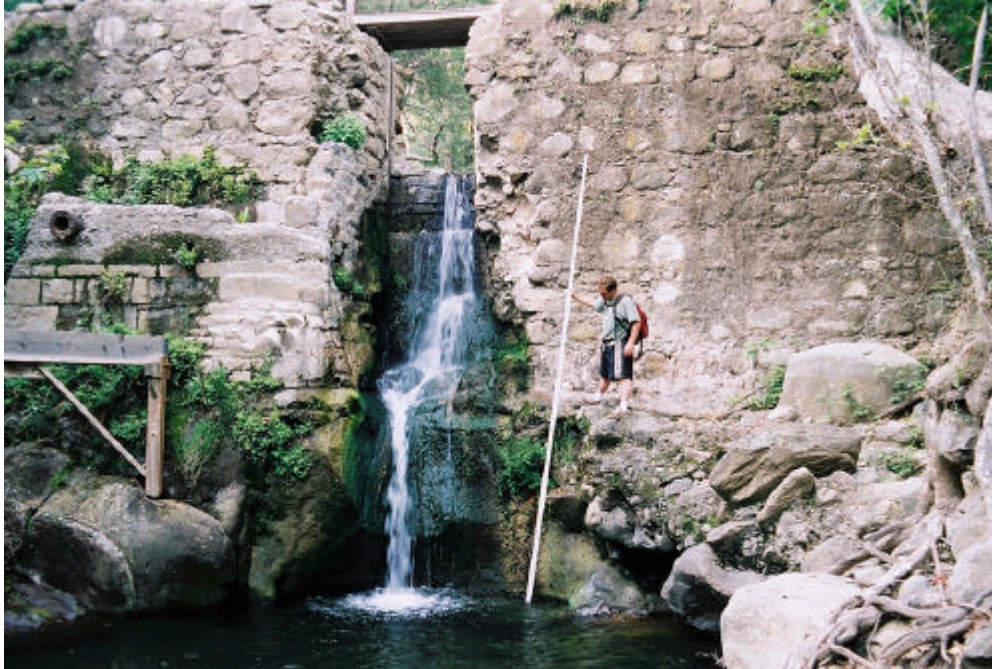
Description: Native Chumash that were enslaved by Franciscan Padres built this dam in 1807. The dam historically diverted stream flows into an aqueduct that carried the water to a storage reservoir near the Mission. According to signage next to the dam, this waterworks system apparently remained in good repair into the 1840's. Use of the Mission waterworks was discontinued after the floods of 1913-14. The Santa Barbara Botanic Garden acquired the property and dam in 1940. The dam measured 17 feet tall from the downstream pool surface to the bottom of the notch in the dam where flashboards were placed to create the upstream reservoir. The flashboard notch measured 7 feet 7 inches tall to the top of the dam surface. The total height of the dam from the downstream substrate to the top of the structure measured 27 feet 9 inches. Observations of a photograph on the signage next to the dam shows the height of the dam from the downstream substrate to the bottom of the notch at approximately 12 feet, indicating that downstream scour has significantly eroded the downstream side of this dam approximately 8 feet or more. The maximum depth of the downstream pool measured 3 feet 2 inches.

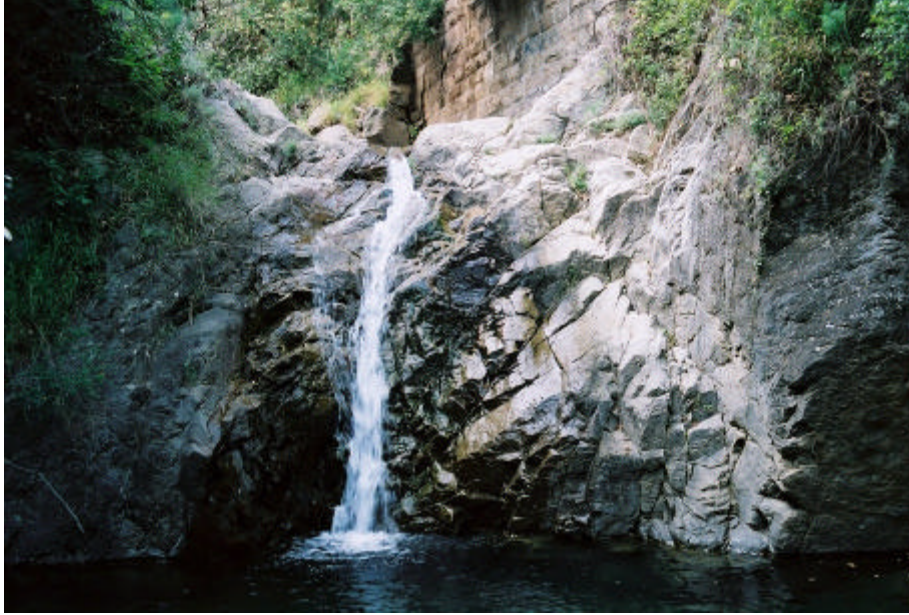
#21- This bedrock waterfall under the Tunnel Road Bridge measured 16 feet in height from the surface of the downstream pool, which had a depth of 4 feet 6 inches. This feature is completely impassable to all salmonids under all flow conditions.

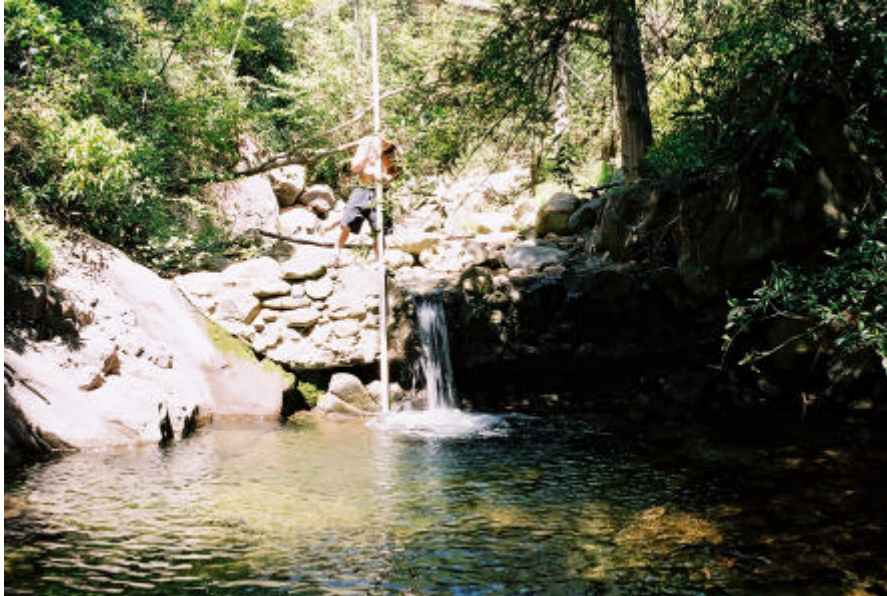
Description: This stone dam measured 16 feet 6 inches across the stream channel with a height of 4 feet 2 inches above the downstream pool, which had a jump depth of 4 feet 11 inches. Flows are currently concentrated over the center in a small notch.

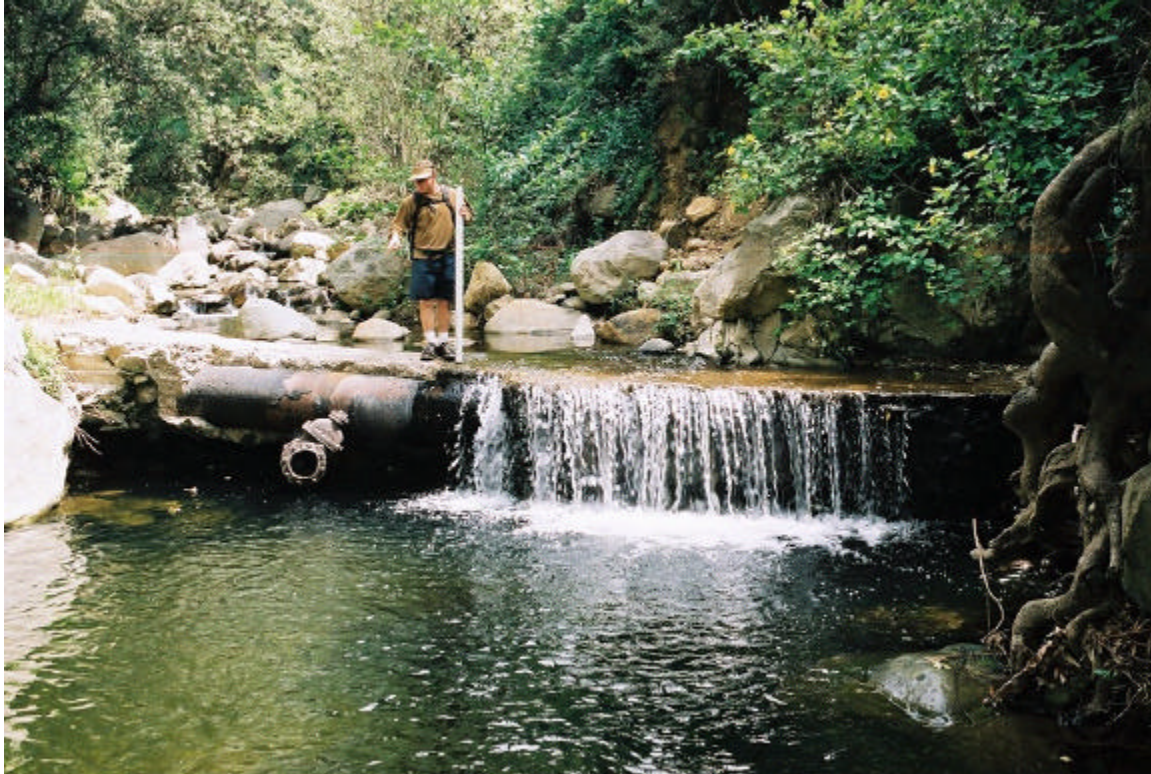
Description: A 20-inch diameter pipe crosses the creek with some damaged concrete ‘protection’ across the top. The height from the surface of the downstream pool to the top of the pipe and concrete measured 3 feet. The downstream jump depth measured 5 feet 6 inches.

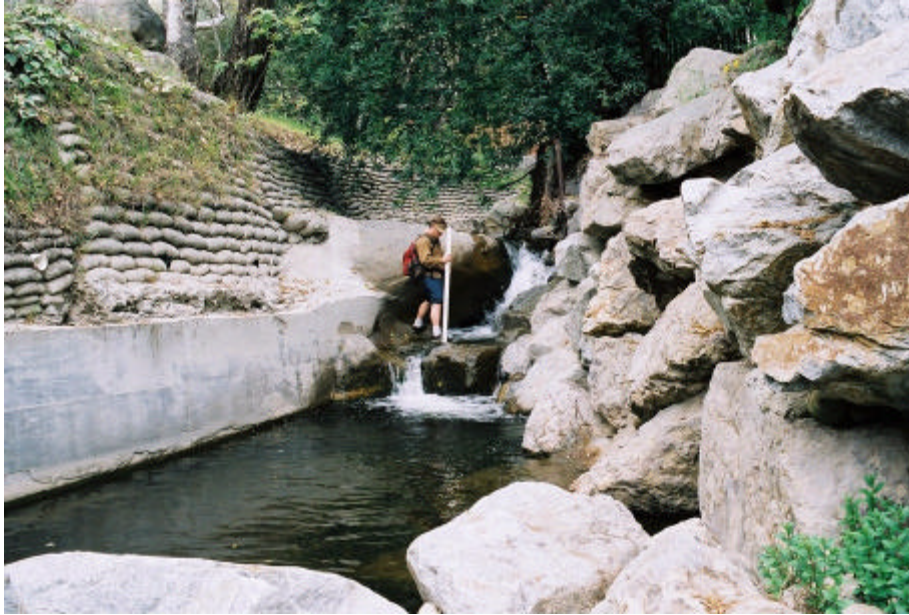
Description: The following measurements and photograph are from Kuyper 1998. This channelized reach of Rattlesnake Creek measured 30 feet in length and consists of riprap, concrete filled sacks, and low-lying concrete. The creek is confined to 10 feet in width for sections of this channelized reach. A large boulder keyed into the bank revetments on both sides produces a two-step drop approximately 6 feet in height above the downstream pool surface. The depth of the downstream pool appears to be at least 2 feet deep. This structure was likely built to protect the adjacent residences, which Kuyper notes are precariously close to the stream channel on the adjacent banks.

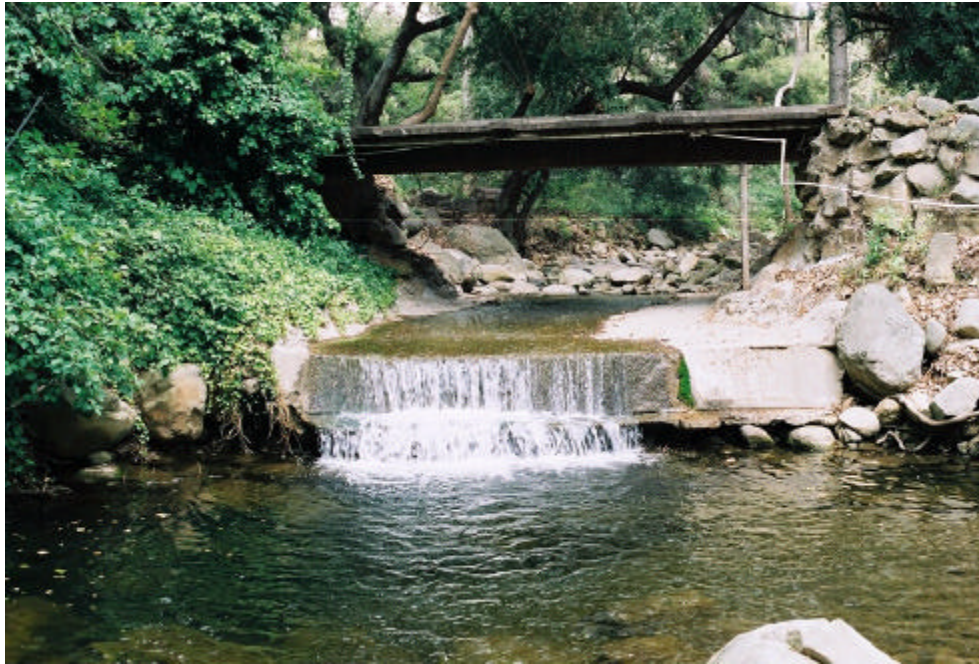
Description: The following measurement numbers and photograph are from Kuyper 1998. A concrete apron extends 40 feet under a private driveway and drops a total of 4 feet to the downstream pool. Flows drop off the apron and onto a short relatively flat concrete step before falling to the pool.

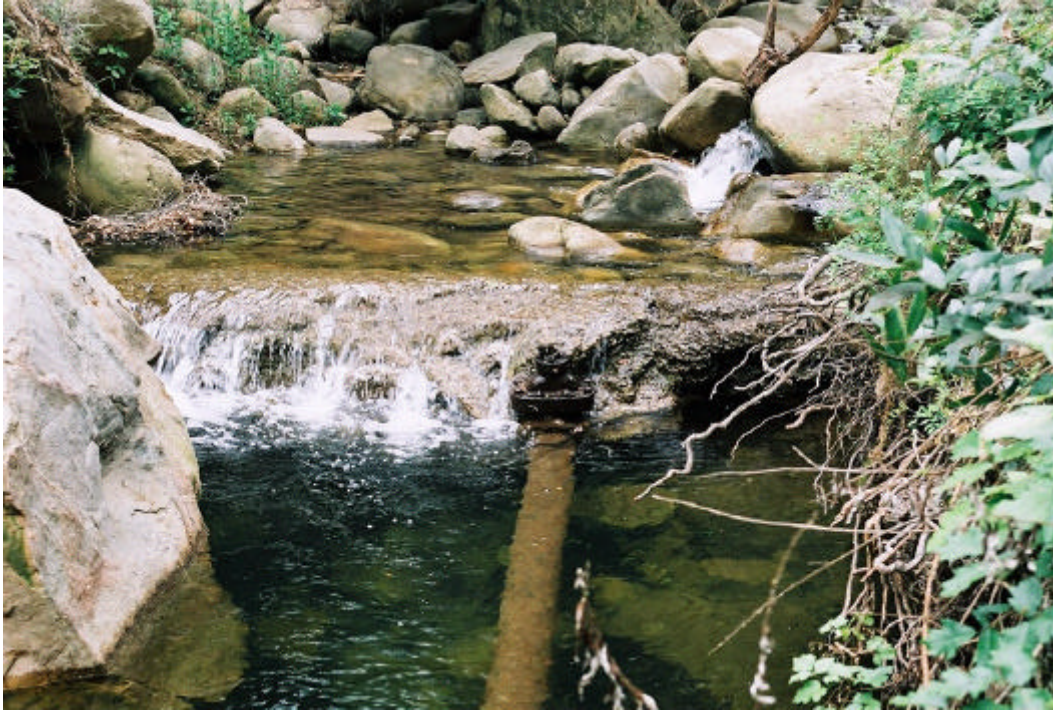
Description: This old concrete diversion dam and 7-inch diameter pipe are no longer functioning. The pipe intake is buried by sediment upstream. The height of the dam above the surface of the downstream pool measured 1 foot 6 inches. The downstream pool measured 4 feet 1 inch deep.

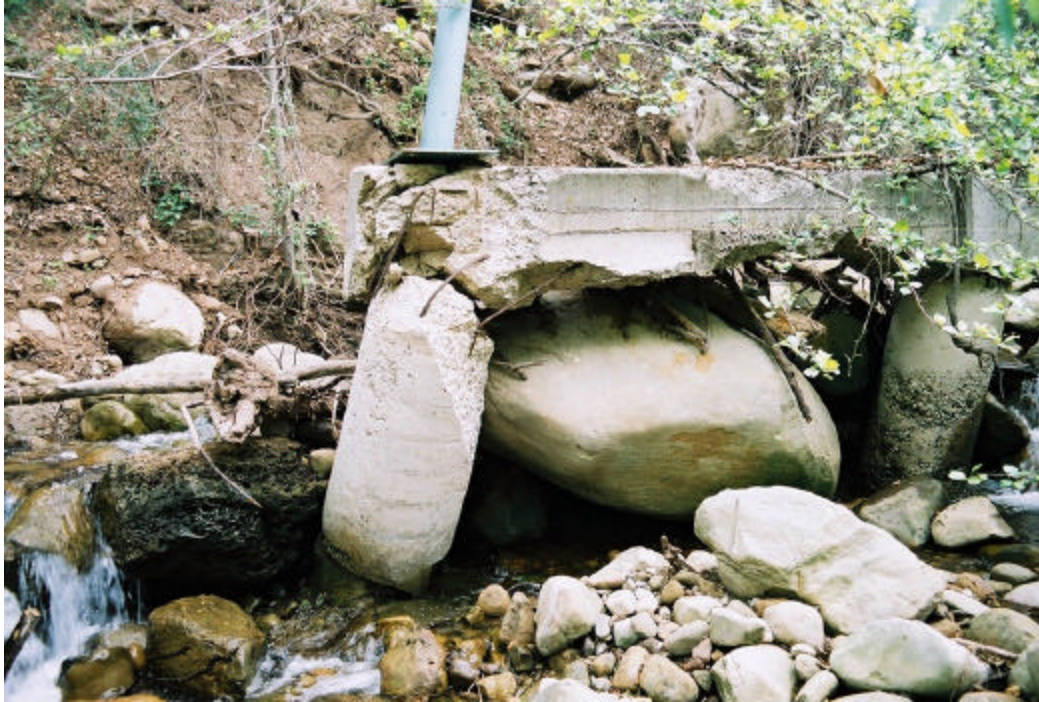
Description: This aerial pipe crossing has two separate structural supports in the stream channel that have backed up large boulders and debris creating several waterfalls and steep cascades over 6 feet in height with minimal jump pool depths.
