Steel head Assessment and Recovery Opportunities in Southern Santa Barbara County, California

**BY
Matt W. Stoecker
and
Conception Coast Project**

June 2002

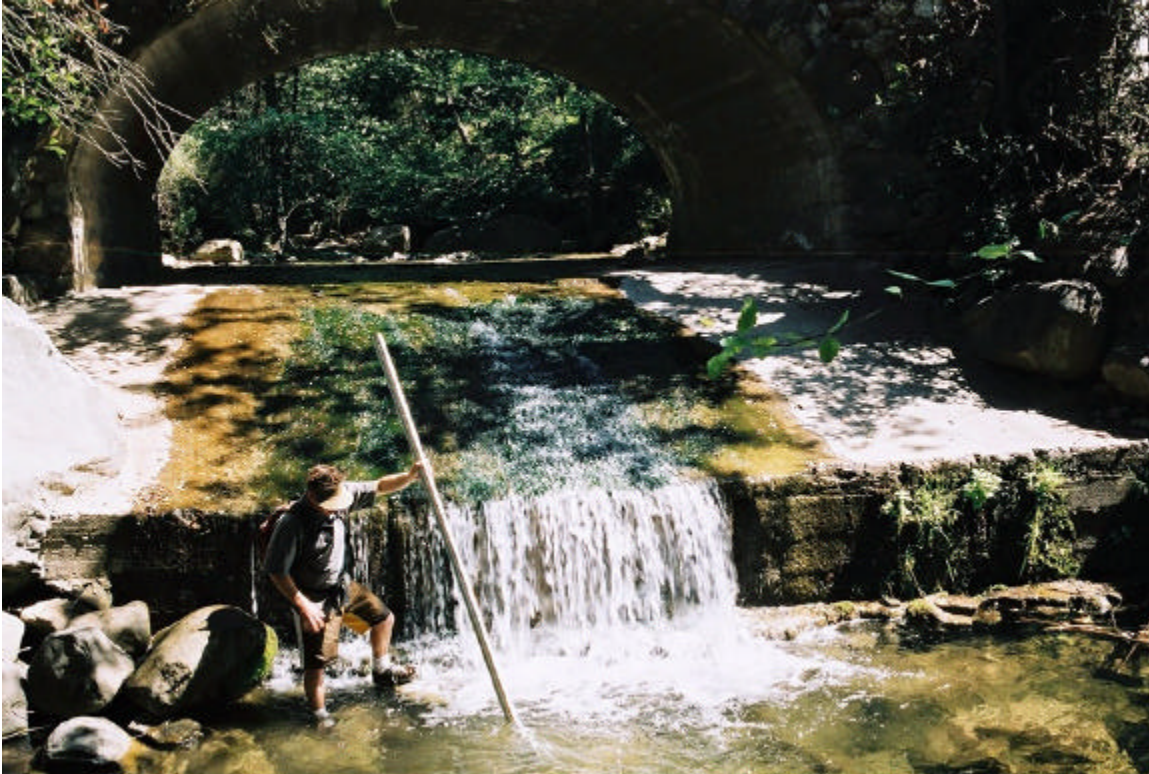
Description: A cut-stone and concrete bottom extends 37 feet 3 inches under this stone arch bridge with a slope of approximately 2%. At the upstream end of the bridge the bottom width between the bridge supports measured 27 feet 10 inches wide and the height of the arch bridge from the center of the bottom measured 11 feet 6 inches. Downstream of this relatively flat section under the bridge, a concrete apron measuring 14 feet 8 inches in length drops with a slope measured at 26.4%. The downstream end of the apron dropped vertically 2 feet 9 inches to the pool downstream. The overall height of the apron from the downstream pool surface measured 6 feet 8 inches. The downstream pool had a maximum depth of 3 feet 3 inches and a jump depth near the apron of 2 feet 3 inches.

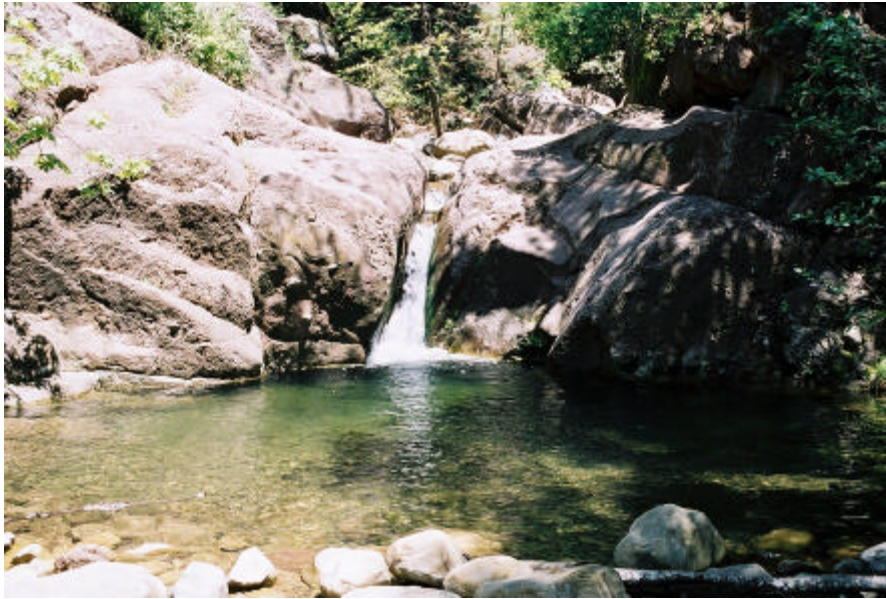
#8- This bedrock waterfall and boulder cascade occur where exposed bedrock confines the stream channel. A steep 250-foot long boulder gradient occurs upstream of the waterfall upstream. The waterfall measured 6 feet 4 inches in height from the surface of the downstream pool, which had a jump depth of 5 feet 6 inches. At the top of the waterfall, flows cut through a narrow bedrock chute measuring 3 feet wide at the top, 11 inches wide at the bottom, and 4 feet deep. The chute measured 12 feet long and had a water depth of 1 foot 9 inches. A small waterfall of 2 feet 9 inches occurs at the inlet of the chute. During moderate to high migration flows the downstream pool depth has been observed to increase over 16 inches producing sufficient depth for a steelhead to jump the waterfall and swim up the chute with a high degree of difficulty. The passage severity of the mobile boulder cascades upstream will be highly dependent on the configuration of the reach each season.

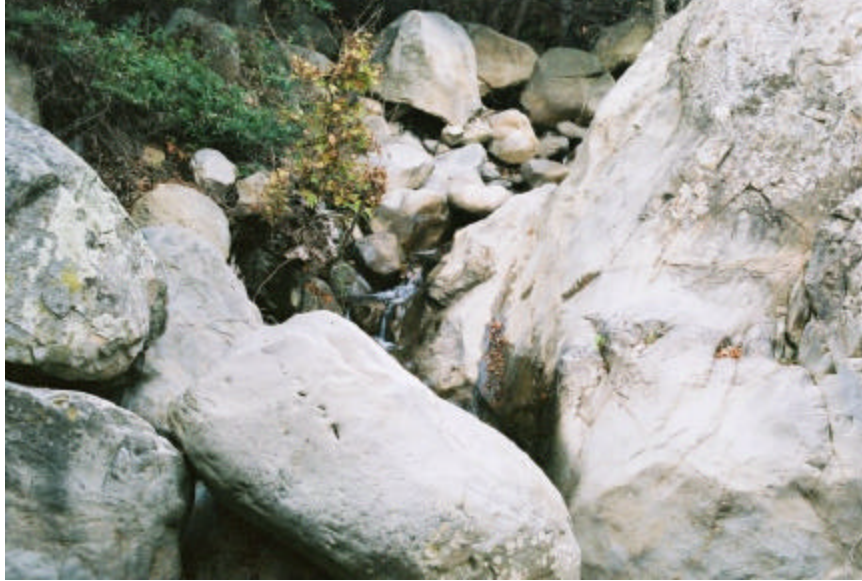
#12- This steep bedrock and boulder cascade measured 18 feet in total height with a series of 7 short waterfalls between 1 and 3 feet in height dropping down the cascade with small 6 to 14 inch deep pools associate with them. The overall slope of the cascade was estimated at 35%. Upstream passage at this site is highly unlikely in its current configuration due to the lack of adequate jump pool depths associated with the series of small falls and highly turbulent conditions encountered during elevated stream flows. The small boulders in this cascade do appear to be seasonally mobile and adequate passage conditions may occasionally occur.

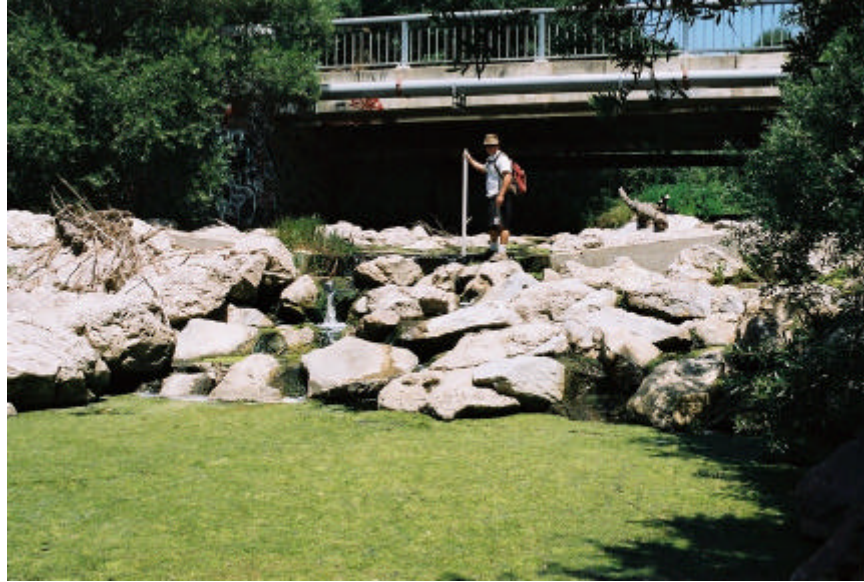
Description: This grade control structure occurs downstream from the Cliff Drive Bridge and a large culvert outlet on the river-left stream bank. The upstream extent of the Arroyo Burro lagoon occurs at this structure. The uppermost portion of the grade control structure consists of a concrete curb spanning the length of the stream channel with a thickness of 2 feet 6 inches. The curb has a shallow flat-bottom notch cut into it with a bottom length of 8 feet 6 inches. This notch concentrates lower flows that drop 1-foot onto the concrete and boulder riprap apron below that conveys stream flows 18 feet to the lagoon downstream. The overall slope of the riprap apron, from the curb lip to the lagoon surface downstream, measured 23%. The jump depth of the downstream lagoon was measured at 4 feet 2 inches.

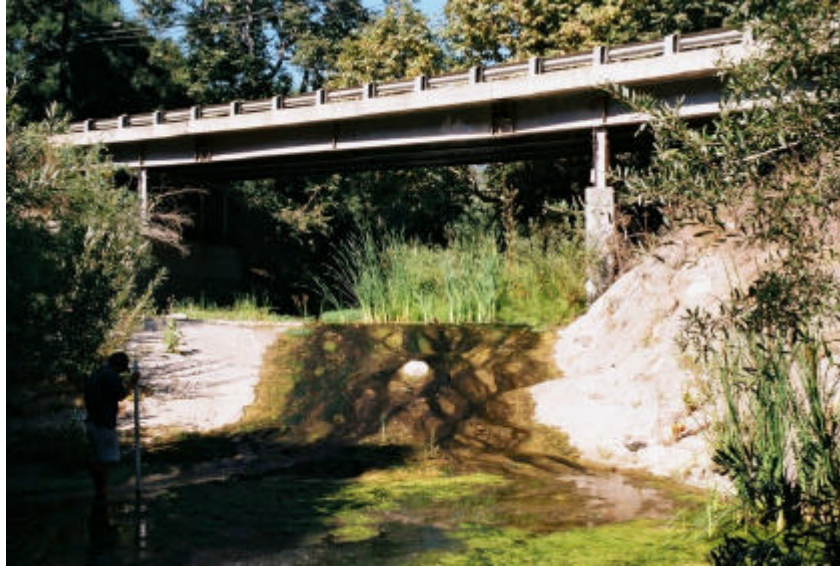
Description: Downstream of the San Marcos Road Bridge, a sloping concrete apron extended 29 feet with a slope of 17.8% to a relative flat reach of concrete that extended 14 feet to the downstream pool. The overall height of the structure, from the downstream edge of the concrete to the top of the apron, measured 5 feet 9 inches. The downstream pool measured 2 feet 8 inches deep downstream of the apron and submerged the flat concrete 5 inches near the downstream end. This structure was constructed to protect the bridge supports by reducing bank erosion and scour. According to Kuyper 1998, the Army Corps of Engineers built the current concrete apron in 1968. The Santa Barbara County Public Works-Roads Division repaired the structure in 1997 (Kuyper 1998, citing C. Elbert).

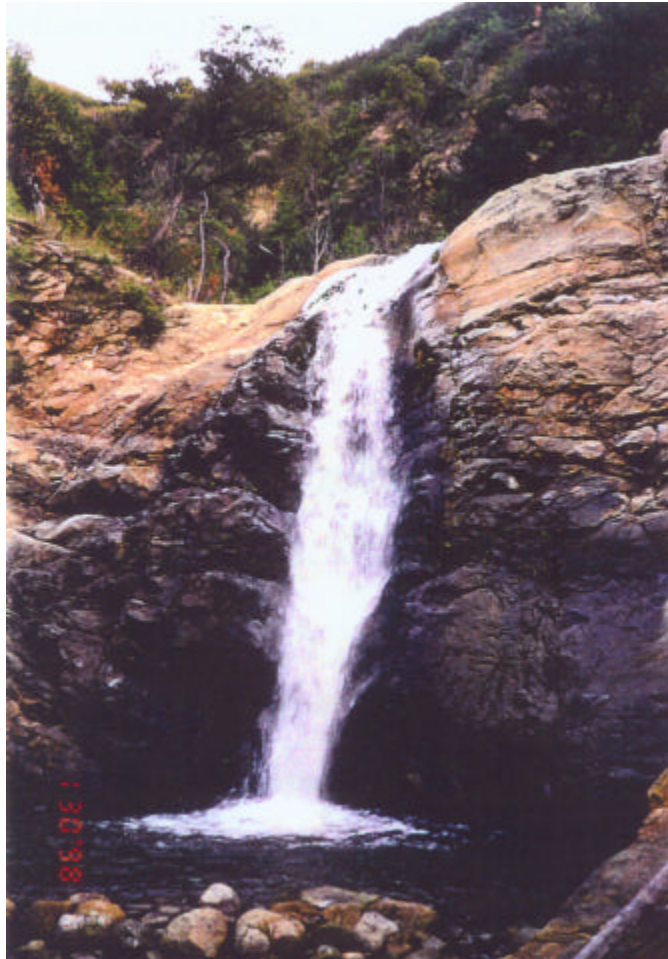
Description: The measurements and accompanying photograph are from Kuyper 1998. Access to this site was restricted. This bedrock waterfall measured 25 feet tall from the downstream pool to the top of the waterfall.

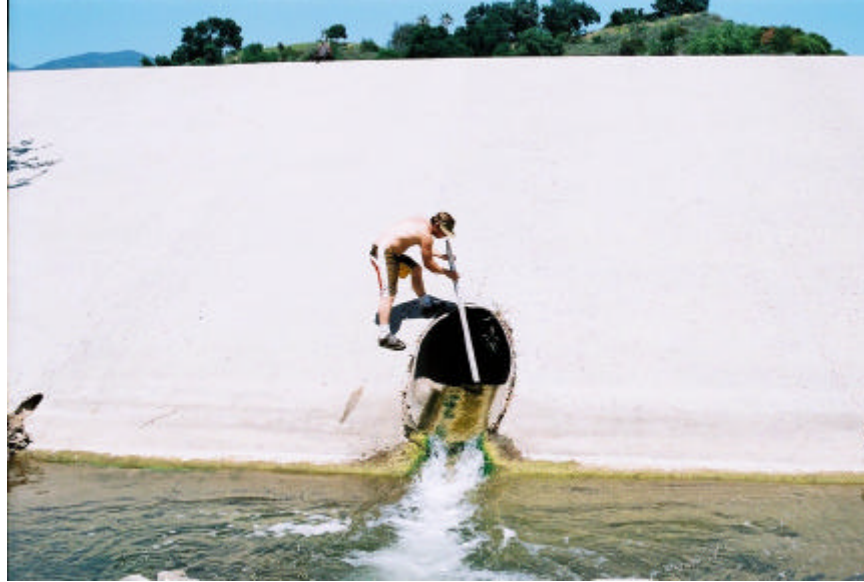
Description: This debris dam is composed of concrete and conveys low to moderate stream flows through the dam in a 3-foot diameter corrugated metal culvert that measures 77 feet 6 inches in length. The slope of the culvert was measured at 4.3%. The inside of the culvert has been lined with concrete. Water discharges from the culvert into a pool with a maximum depth of 2 feet 4 inches.

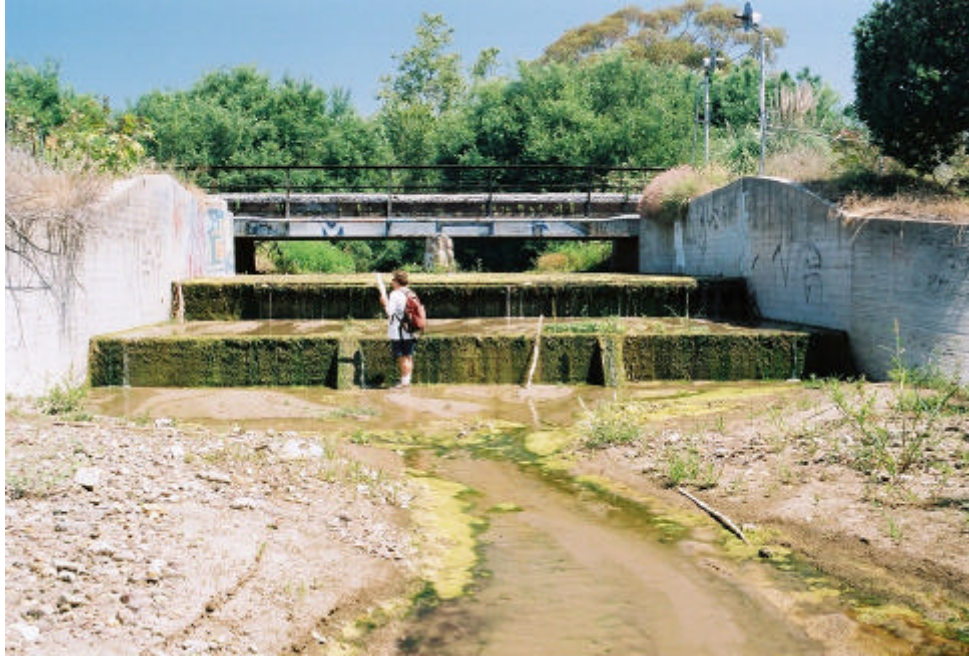
Description: A concrete-lined bottom with a slope less than 1% extends 70 feet from the upstream end of the UPRR crossing to the top of a two-step grade control structure drop downstream of the railroad crossing. The upstream step drops 2 feet 5 inches onto a fine silt bottom with no pool. This fine silt bottom extends 16 feet downstream to the next 1-foot thick grade control that drops 2 feet 3 inches to the substrate downstream with no developed pool. The grade control steps measured 35 feet 6 inches long between vertical wall revetments downstream of the UPRR crossing. The silt-laden bottom between the grade control steps may have concrete underneath at some depth, but none could be detected 6 inches below the silt. Low flows are spread out across the structure and very shallow.

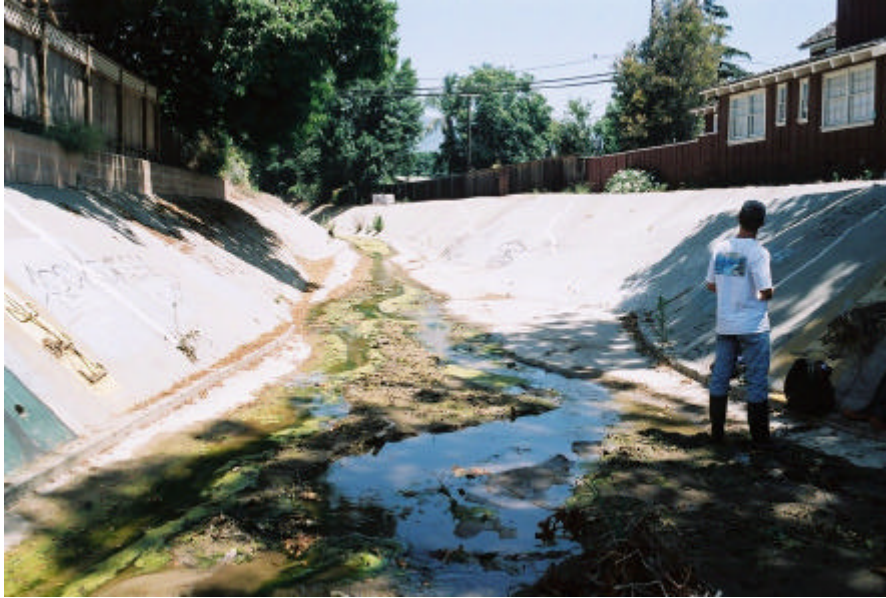
Description: This trapezoidal concrete channel connects to the downstream Highway 101 double box culvert (BR_AO_SJ_SP_2) and extends 0.29 mile upstream. The measured slope of the channel increased from 1.2% near the bottom to 1.8% at the upstream end. The channel measured 10 feet 6 inches wide on the bottom with sidewalls angled at approximately 45 degrees and 7-8 feet tall. The channel makes several gradual turns along its length. Residential homes and property are immediately adjacent to this channel.

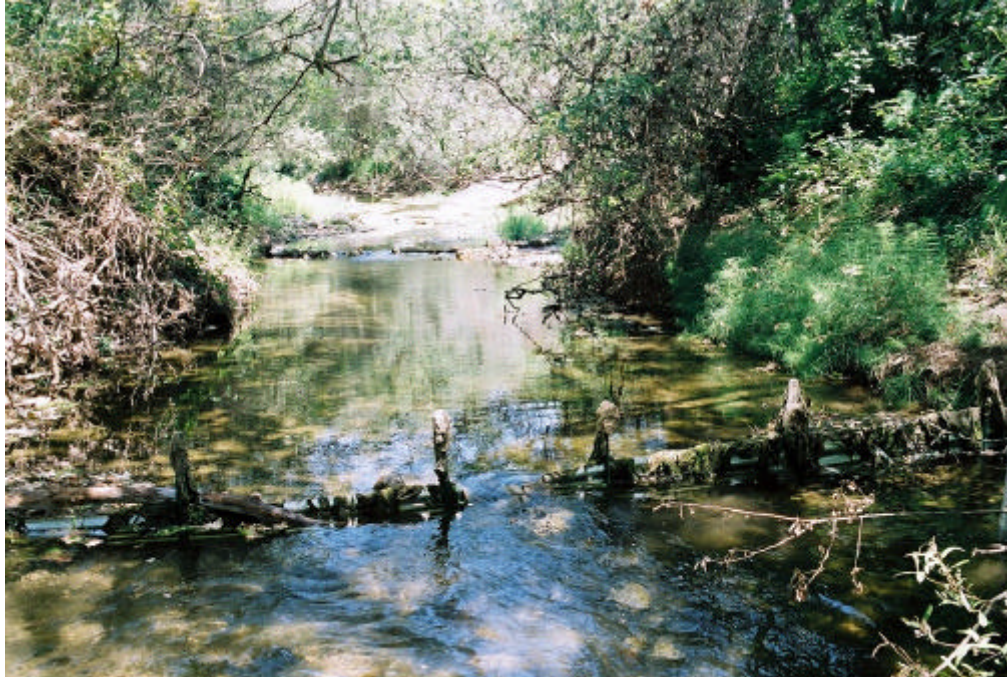
Description: This strange, temporary dam structure consisted of metal stakes pounded into the streambed with sheets of corrugated metal attached to back up or focus stream flows. A small space between the sheets at center allowed water to flow through. Water may be pumped out of the pool formed upstream although no signs of water extraction were observed. One 9-inch rainbow trout was observed 15 feet upstream of this structure holding in the center of the stream. This robust individual appeared to be in good condition, with a rosy lateral coloration and was actively feeding.

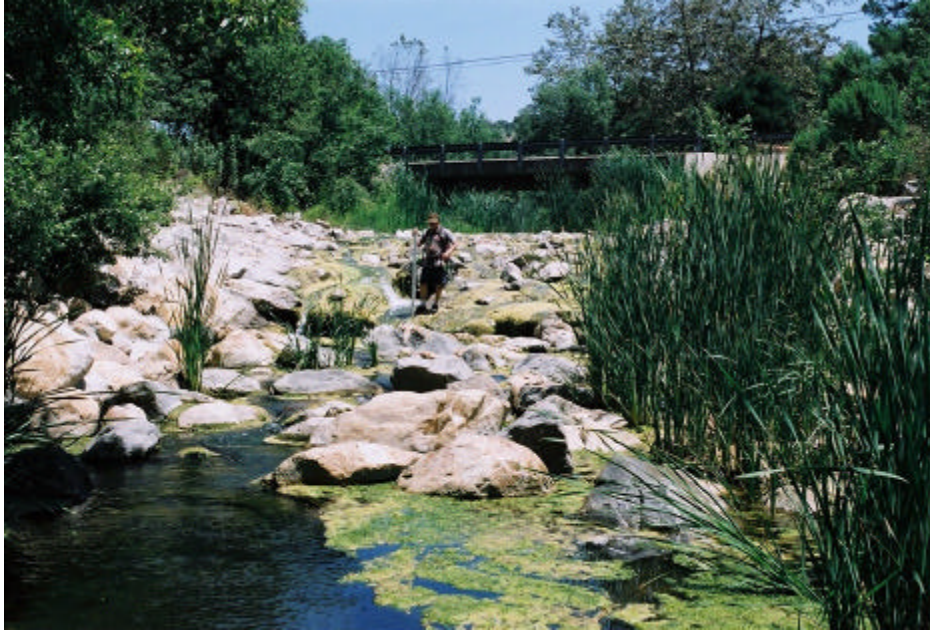
Description: Downstream from the bridge crossing a concrete and boulder riprap apron extends 52 feet at a slope measured at 13.3 %. This apron may also function as a grade control structure. Large boulders are placed downstream of the structure, apparently to limit scour. An old corrugated plastic culvert found at the center of the apron near the bottom no longer functions.

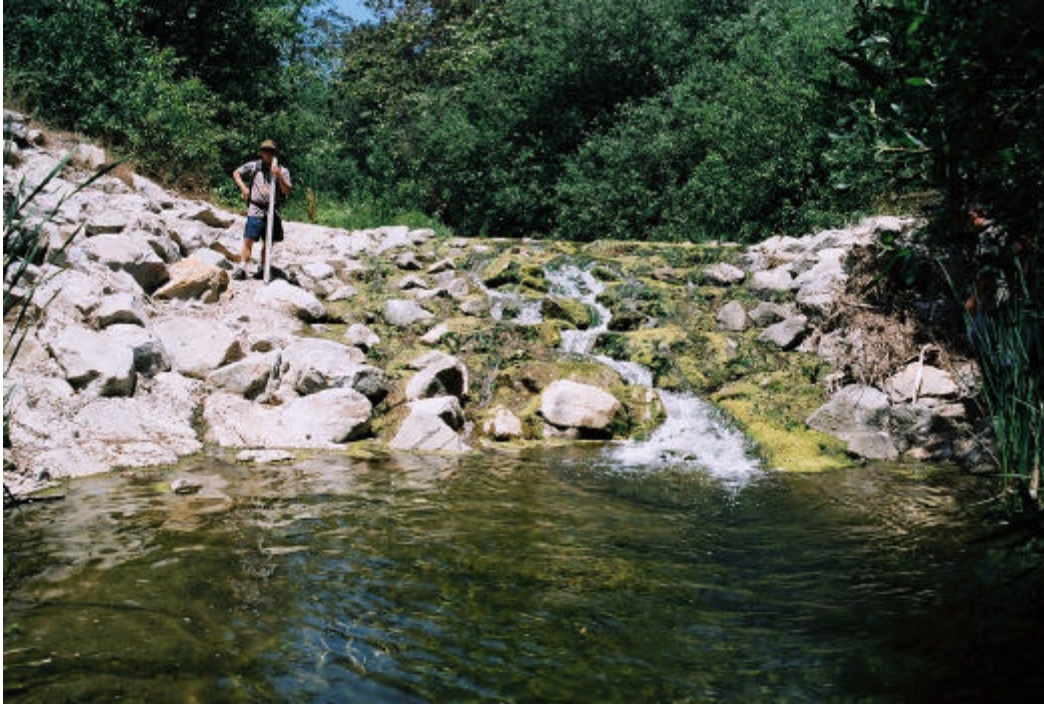
#22- This structure measured 34 feet from the top to the downstream pool surface with a slope of 20.8%. The overall height of the structure measured 7 feet 1 inch from the downstream pool surface to the top. The maximum pool depth downstream measured 3 feet 6 inches.

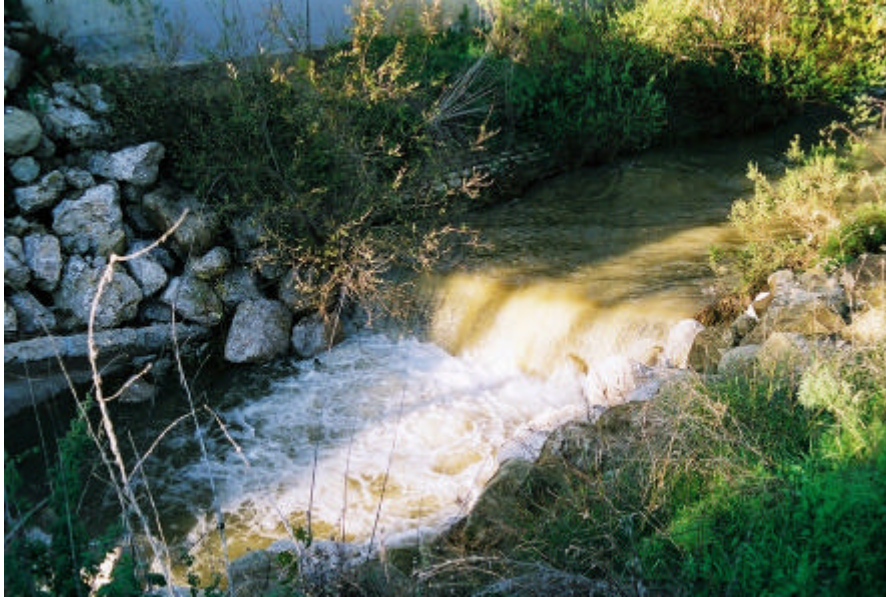
Description: This grade control structure was only observed from the public road access under Highway 101 due to access restrictions within the stream channel. A concrete-lined bottom extends under much of the Highway 101 Bridges and ends with a significant drop onto natural substrate or developed pool. Various bank revetments made of boulders, concrete filled sacks, and concrete slabs have been constructed adjacent to the grade control structure. The stream is very confined in this reach with access roads immediately adjacent to the grade control structure on both banks.

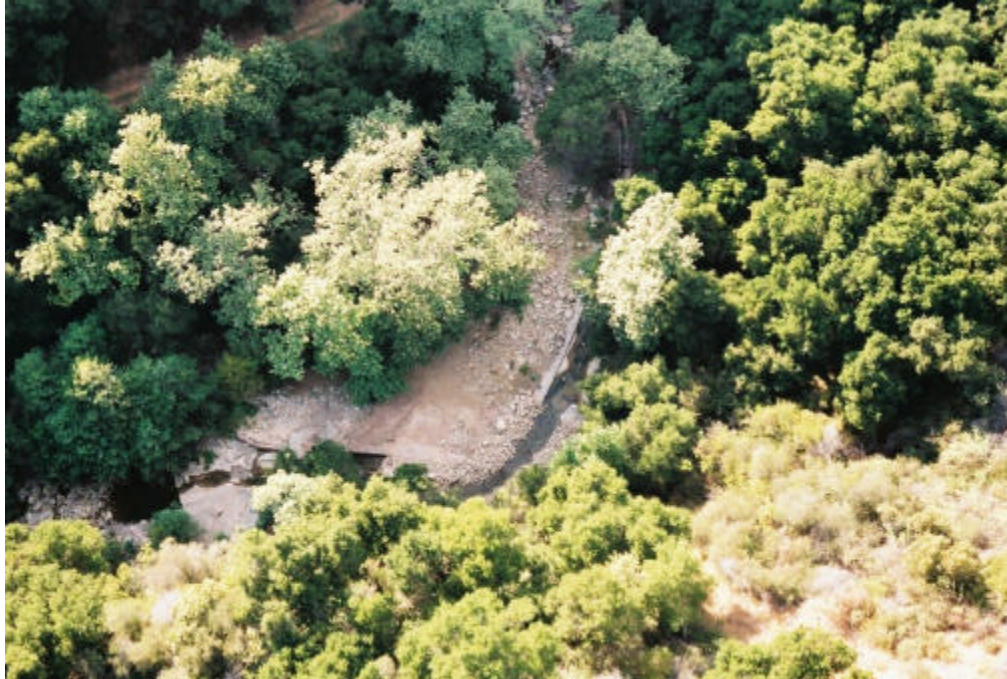
Description: Due to access restrictions, information about this structure was obtained from the air. The riparian canopy obstructed visual observation of much of this structure making it difficult to determine exactly what type of construction and operation is occurring. Two off-stream reservoirs occur downstream of the concrete channel on the west side of the creek and apparently store surface flows diverted from the stream at the channel. One weir reportedly does divert water into these collection reservoirs and is the main source of water extraction for the Dos Pueblos Ranch (pers. comm. H. Schulte 2001-08-04). From the air it appears that the concrete channel extends approximately 300 feet in length. The channel was being worked on with tractors. The channel appeared to contain all the surface flow. At the downstream end of the channel it appears that cobble and boulder levees/weirs have been made to confine stream flows into several pools downstream. Several significant drops occur downstream of the concrete channel that appear to have some concrete and boulder construction associated with them.

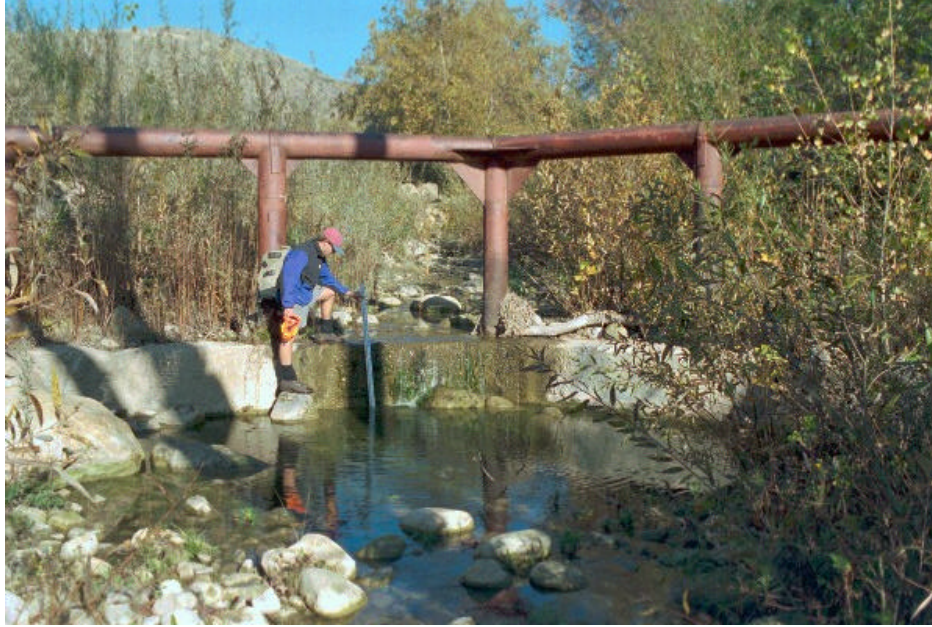
Description: This “trash rack” is designed to catch large, downstream migrating debris that may clog the Highway 101 culvert downstream. The structure has an upstream-facing V-shape with a concrete curb base and large metal pipes forming a grate. The 2-foot thick concrete curb spans the entire channel measuring 28 feet to the river-right side and 33 feet to the river-left side form the center of the V. During low flows, the height from the downstream pool to the downstream lip of the curb measured 2 feet 2 inches. The maximum depth of the downstream pool measured 2 feet 10 inches. The metal pipes have a 12-inch diameter and are spaced 7 feet 2 inches apart. The horizontal pipe across the top measured 6 feet 1 inch tall. Sediment is filled to the top of the upstream side of the curb.

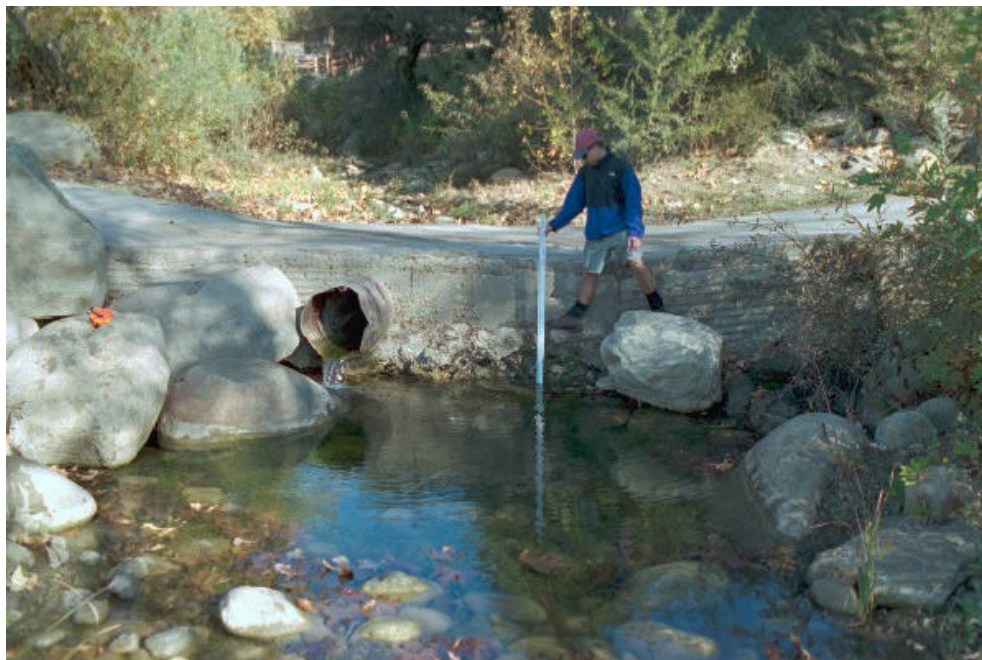
Description: This concrete crossing has a broad U-shape that extends 86 feet across the stream channel. A relatively flat section measuring 16 feet long occurs at the center and a 2-foot diameter corrugated metal pipe conveys low stream flows underneath. The width of the crossing is 10 feet and has a downstream slope of less than 1%. The culvert measured 12 feet 2 inches long and the downstream lip measured 11 inches above the pool surface downstream. The upstream end of the culvert was 85% filled with sediment. The height of the crossing from the downstream lip to the downstream pool surface measured 3 feet 5 inches.

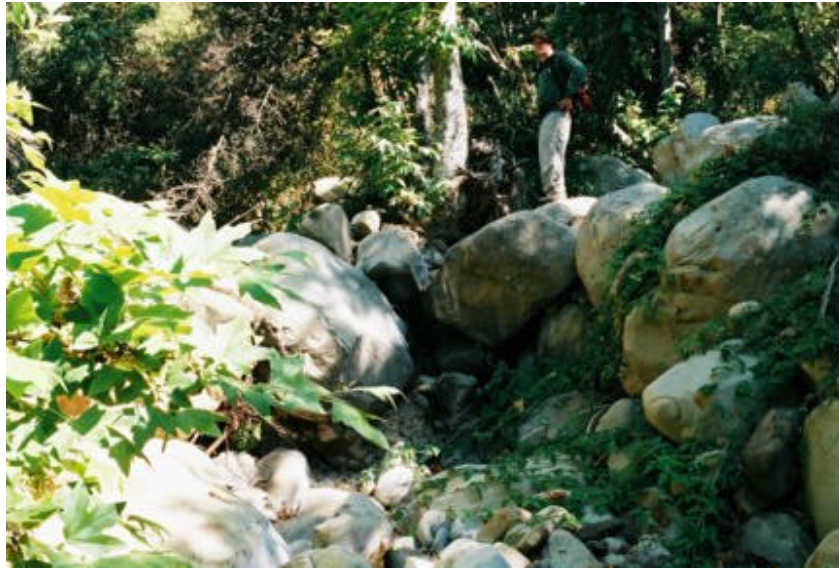
Description: This boulder cascade measured 7 feet 5 inches in height. A steep boulder gradient with a 15% slope extended from this cascade 50 feet upstream.

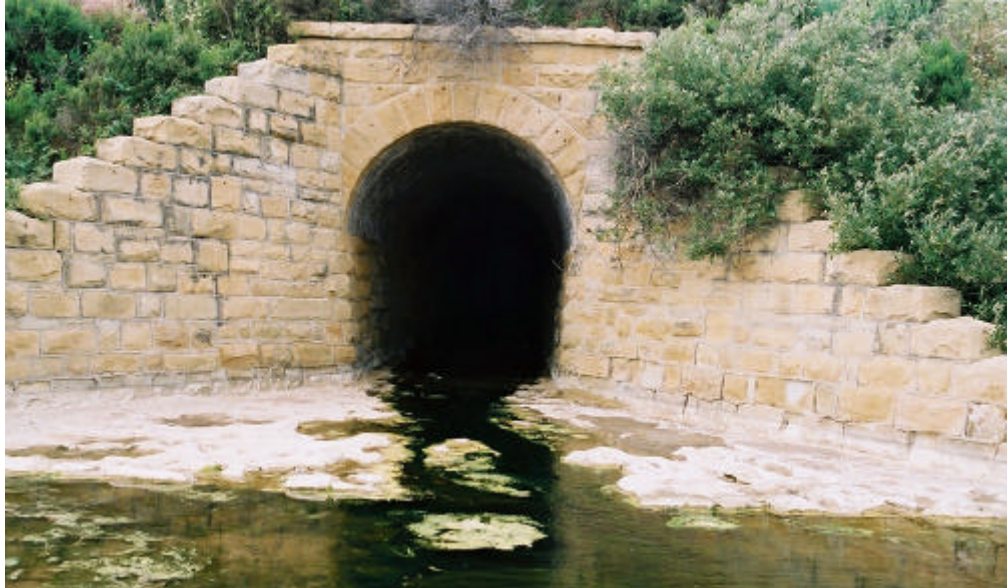
Description: Access to survey Corral Creek was not obtained. Surveys were conducted from the beach and Highway 101 to obtain general information about this culvert. The culvert appears to exceed 400 feet in length. No jump height occurred at the outlet of the UPRR arch culvert, which measured 14 feet tall by 10 feet 10 inches wide. A well-defined channel is worn into the bottom of the UPRR culvert that measured 2 feet deep and 8 inches wide. The measurements and configuration of the CALTRANS culvert were not determined, but are assumed to be similar to other CALTRANS Highway 101 culverts.

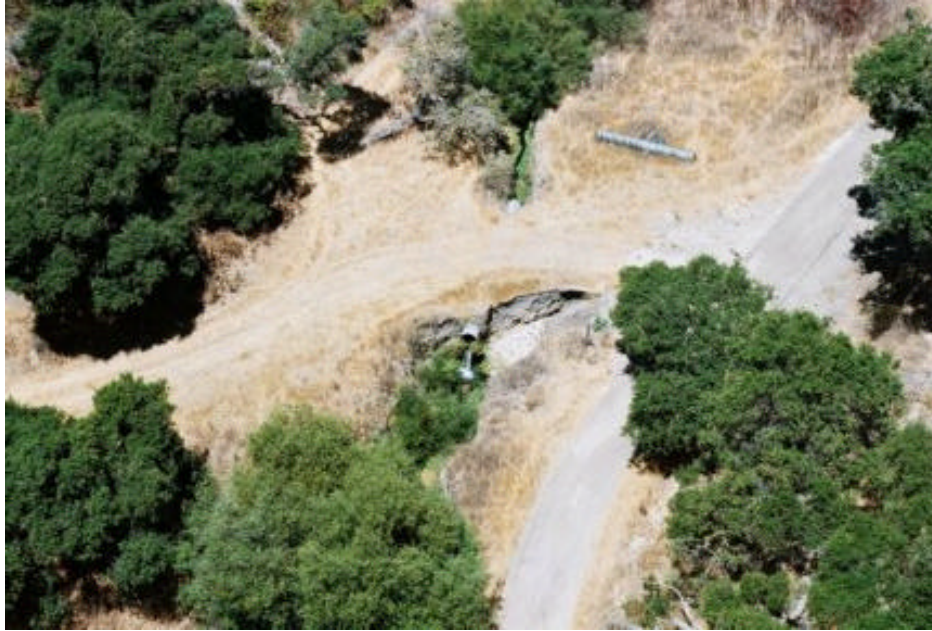
Description: Observations of this structure were limited from the air. A corrugated metal culvert passes through the dirt-fill crossing.
