City of Santa Barbara Existing Conditions Report- Fisheries

Draft Sections for Inclusion in Final Report

May 2005

4.8 City-Wide Watershed-Fisheries

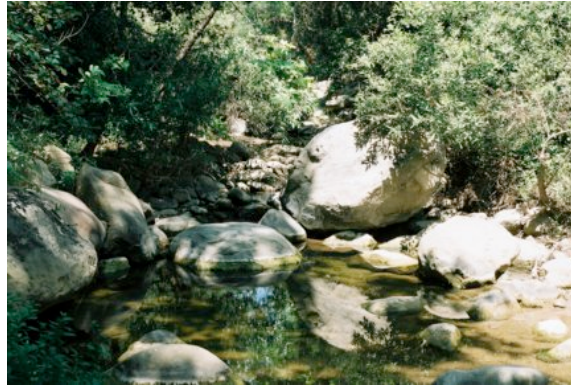
Upstream of the San Roque Debris Dam, salmonid habitat conditions improve with an increase in pools depth and frequency, instream cover, boulders, spawning gravel conditions, and cooler summer water temperatures. High quality salmonid habitat conditions continue to occur upstream into Rancho San Roque where clean spawning gravels occur in conjunction with plunge pool type rearing habitat. Upper San Roque Creek has adequate habitat conditions to support a self-sustainable population of rainbow trout and anadromous steelhead population if migratory access is provided at downstream barriers. Significant fish passage barriers occur at the Hitchcock Street culvert, the San Remo Drive culvert, several grade control structure upstream and downstream of the Ontare Road Bridge, and the County's San Roque Debris Dam.

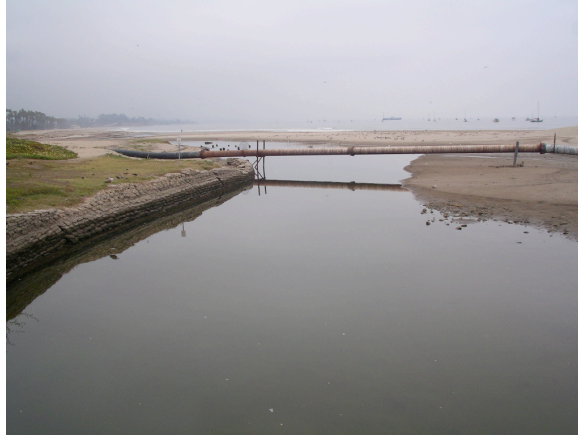
Mission Creek Lagoon

The Mission Creek lagoon is highly confined by urban development. The lagoon provides important habitat for a variety of previously mentioned fish species, including migratory steelhead. A recent ECORP Consulting study of the tidewater goby within the Mission Creek lagoon concluded that marginal habitat conditions seem to be the limiting factor in tidewater goby abundance (Johnson 2005). The lack of structural complexity and urban pollution inputs have decreased the aquatic habitat conditions for all fish species that currently and historically utilized this lagoon. The lagoon continues to provide an important acclimation zone for migrating adult and juvenile steelhead trout as they transition between fresh and saline environments.

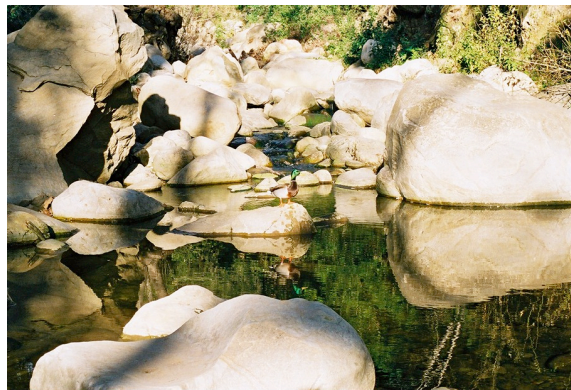
Mission Creek (Downstream of the Natural History Museum to Rattlesnake Creek)

Summer surface flows from upper Mission Creek and Rattlesnake Creek typically extend downstream past the Natural History Museum for several hundred yards before going subsurface. Rainbow trout occur throughout the summer from pools adjacent to the Museum upstream to the Rattlesnake Creek confluence. Salmonid spawning and rearing habitat conditions in this reach are fair to good with fairly clean, adequately sized substrate, adequate instream cover, mature riparian canopy conditions, and step-pool habitat. Significant fish migration barriers occur at a grade control structure adjacent to the Museum, the Mission Canyon Road Bridge, and the Highway 192 Bridge.

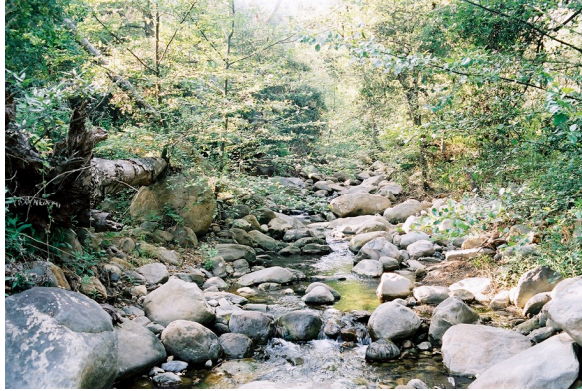
Moderate to high quality spawning and rearing habitat conditions continue through the Santa Barbara Botanical Gardens to the impassable Old Mission Dam. Low stream flows go subsurface for several hundred feet upstream of the Old Mission Dam where permeable substrate has been deposited behind the dam. The dry dam deposits impose a considerable gap in aquatic connectivity for much of the year. Habitat conditions are further degraded upstream of the County's impassable Mission Creek Debris Basin Dam where operations denude adjacent riparian vegetation, increase erosion, and enable invasive exotic species to spread.

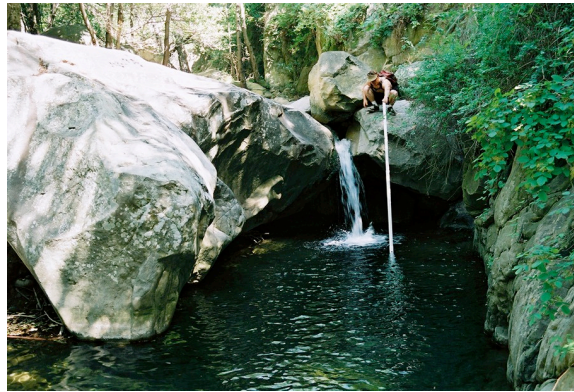
Upstream of the debris dam salmonid habitat conditions become excellent with an abundance of high quality spawning gravels associated with excellent pools up to 8 feet in depth and abundant instream and riparian cover. Future fish passage efforts at downstream migration barriers will allow steelhead to naturally recolonize upper Mission Creek to a 15-foot tall bedrock waterfall underneath the Tunnel Road Bridge crossing.

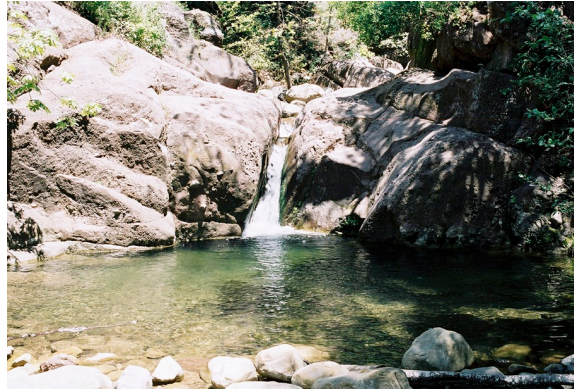
Rattlesnake Creek contains high quality habitat conditions from Mission Creek upstream to the Las Canoas Road Bridge. A reproducing *O. mykiss* population occurs throughout this reach where adequate spawning substrate conditions and pools are present in moderate to high abundance. Salmonid habitat conditions continue to improve upstream of Las Canoas Road, except at the County's impassable Debris Basin Dam where the stream channel is routinely filled with debris and then excavated. Habitat conditions are degraded upstream of the Debris Basin Dam where operations denude adjacent riparian vegetation, increase erosion, and enable invasive exotic species to spread. Immediately upstream of the debris basin, spawning and rearing habitat conditions become excellent with abundant instream and riparian cover, clean spawning substrate, undercut banks, and large boulder and bedrock pools up to 7 feet deep. A reproducing population of *O. mykiss* is present from Mission Creek upstream for over 2 miles to a series of bedrock waterfalls.

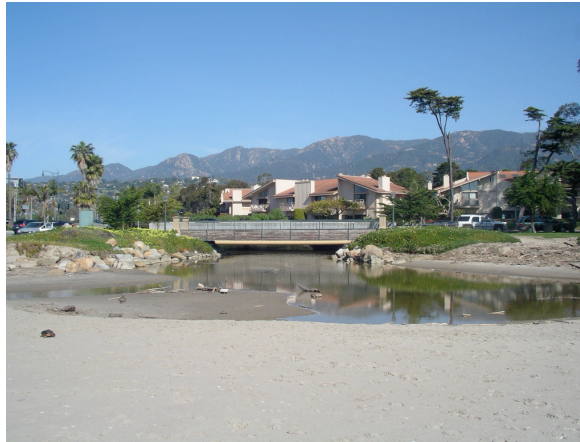
Sycamore Creek Lagoon

The lagoon at the mouth of Sycamore Creek is highly constricted by adjacent housing developments, roadways and road crossings. The streambed is mainly comprised of sand and silt. Stream flow was observed across the sandbar through a small channel 7 feet wide and between 2-7 inches in depth during February 2005 (pers. obsrv. Stoecker 2005). Out-migration of fish species would be possible during observed flows and limited upstream access from the ocean would be possible for smaller fish species or life stages. The lagoon was observed to extend upstream to a triple-box culvert road crossing to the Santa Barbara Zoo. The lagoon provides limited, but important habitat for estuarine fish species.

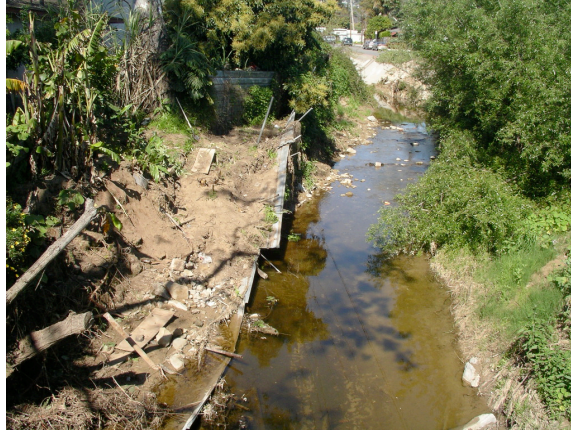
Lower Sycamore (Between the Santa Barbara Zoo Culvert and Alameda Padre Serra)

Lower Sycamore Creek is highly impacted by urban development, however the stream has not been confined to a concrete channel and retains a semi-natural streambed. Several road crossings of various configurations occur in this reach. Some of these crossings would present mild to moderate fish passage impediments to upstream migrating salmonids. Pipe and Wire revetment in various states of failure occur throughout much of this reach. Mature, native riparian vegetation mixed with a high abundance and diversity of exotic plant species occurs throughout this reach. Relatively poor to fair quality salmonid habitat conditions occur with a highly embedded silt and sand dominated substrate bottom, limited pool development, low to absent summer stream flows, and impacted water quality.

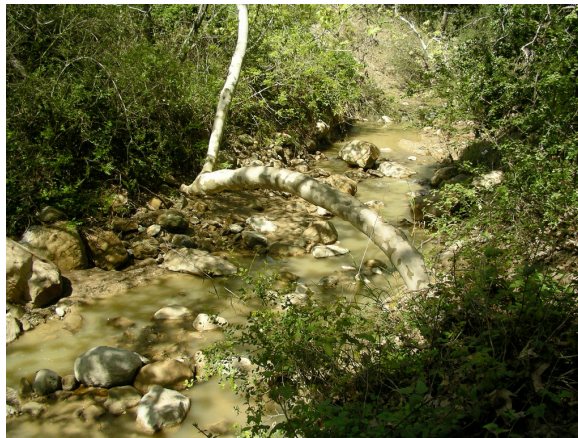
Middle Sycamore

Upstream of Alameda Padres Sera, the Sycamore Creek channel is confined as it cuts through the erosive foothills north of Santa Barbara. Dozens of private road crossings and driveways occur in this reach. Heavy winter rains frequently cause severe landslides on adjacent stream banks and hillsides. The stream substrate was observed to contain a high amount of fine sediment resulting in substrate embeddedness of 60% or more. Mature, native riparian trees including Sycamore, Live Oak, and Willow are present. Large boulders occur in this reach and create step pool and pocketwater habitat with pools up to 3 feet deep. A large boulder cascade occurs just downstream of the

Sycamore/Coyote Creek confluence. Step pool habitat occurs downstream of the cascade with a 3 foot deep pool and adequate salmonid rearing habitat. Spawning substrate conditions are limited due to the high amount of fine sediment deposition and embeddedness.

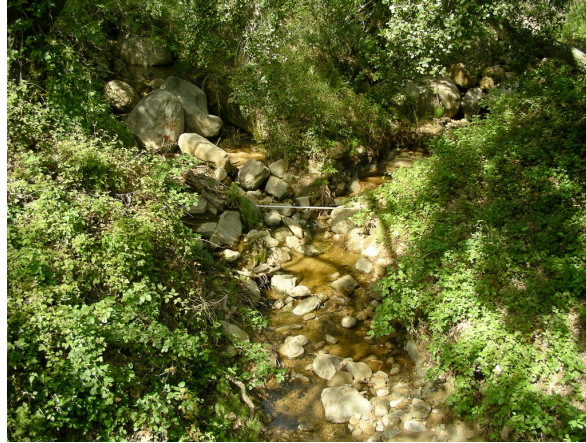
Upper Sycamore

Just upstream of the Sheffield Creek confluence a large boulder cascade occurs with multiple drops up to 3 feet in height. This cascade may limit upstream salmonid passage during all but high stream flows. Within Parma Park just upstream of the East Fork of Sycamore Creek, two boulder cascades drop approximately 4 feet each into small downstream pools less than 1-foot in depth. Each of these cascades would present a high severity barrier for all salmonid life stages during all stream flows. Upstream passage is unlikely, but may be possible for adult steelhead during ideal migration flows. Significant fish migration barriers occur at the Conejo Road culvert and the Stanwood Drive culvert.

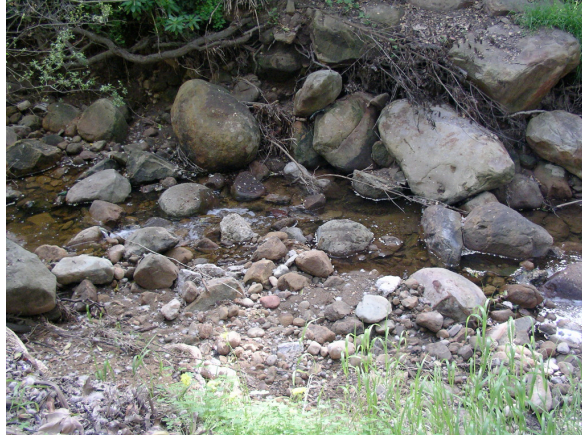
Chelham Creek contains fair habitat conditions for salmonid spawning and rearing upstream from Coyote Creek with a low abundance of moderately embedded spawning substrate and small pools up to 2 feet deep. Upstream of Coyote Road the creek channel is much smaller and low surface flows were present in March of an above average precipitation winter (pers. obsrv. Stoecker 2005). The persistence of summer flows in Chelham Creek is not well known, but may be a significant limiting factor to potential future salmonid presence. Significant fish migration barriers occur at a concrete grade apron just upstream of Coyote Creek, the Coyote Road culvert, both Highway 192 culverts, a private driveway crossing adjacent to Highway 192, and at the Chelham Way culverts.

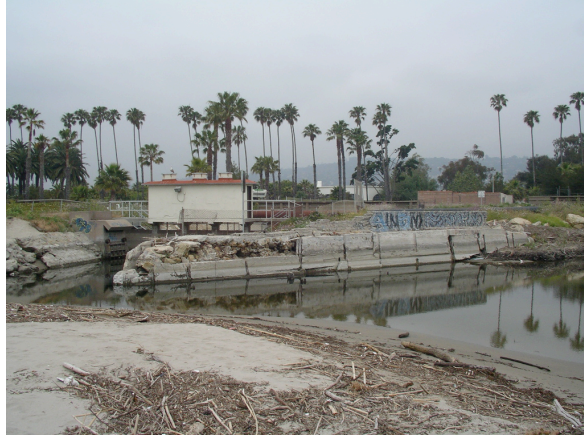
Lower Laguna Creek and Lagoon

Laguna Creek is typically a tributary to the Mission Creek lagoon, depending on sandbar formation, tidal elevation, and seasonal lagoon configuration. The Laguna Creek lagoon and upstream watershed are highly modified and constricted by a tidal dam, concrete channelization, water pumping facilities, drainage pipes, and an extensive underground urban drainage system. These modifications have reduced the size and ecological function of the lagoon and lower creek. Downstream of Cabrillo Boulevard, Laguna Creek is confined to an irregular trapezoidal channel constructed of both concrete and cobble. The channel extends downstream from Cabrillo Boulevard and drops in elevation to a large metal debris grate. An eastern channel breaks off the main channelized reach and conveys flows through the debris grate into a pump house water collection area. Downstream of the metal debris grate the western concrete channel extends downstream to a tidal gate dam, which prevents tidal flows from extending upstream. Creek flows that do not enter the pump house flow through this tidal gate dam and into the western arm of the lagoon. Creek flows that enter the pump house are pumped into an eastern concrete trapezoidal channel that conveys flows downstream across a boulder riprap apron and into the eastern arm of the lagoon. Two corrugated metal pipes also direct lower flows from the eastern concrete channel through the island separating the two channels and into the western lagoon arm just downstream of the tidal gate dam.

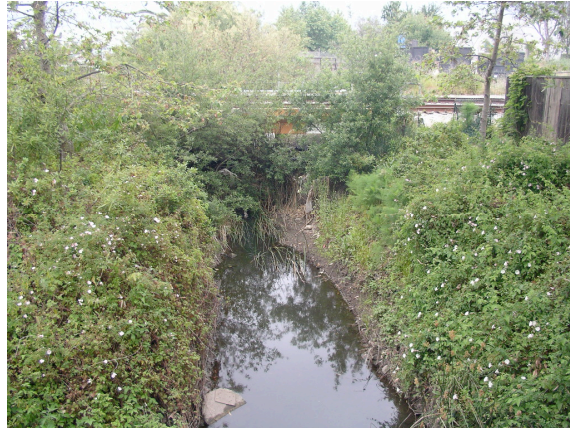
Laguna Creek has a natural substrate bottom upstream of Cabrillo Boulevard to Highway 101. The creek is impacted by adjacent development, but sustains exotic mosquito fish and therefore contains year-round flow during most summers and could support native fish species with adequate migratory access from the lagoon. Upstream of Highway 101, Laguna Creek is mainly comprised of a network of underground culverts and urban street drainages.

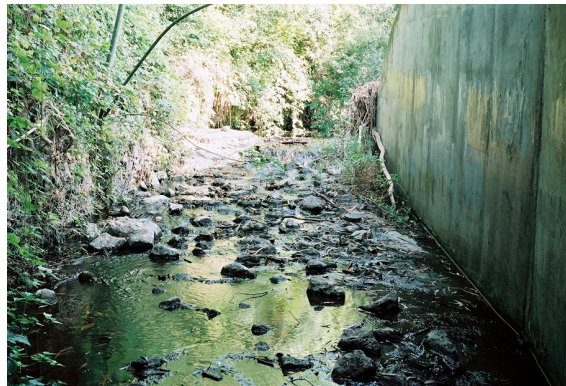
Calle de los Amigos Culvert

This concrete double-box culvert measures 76 feet in length with a slope of less than 1%. Each culvert box measures 12 feet tall by 12 feet wide. The outlet of the culvert is at streambed grade. An irregular inlet apron comprised of embedded boulders and cobbles extends upstream from the culvert 34 feet with a slope of 24% at the upper smooth concrete portion. This double box culvert is a high severity barrier to fish passage due to the steep slopes encountered on the inlet apron, lack of resting areas on the upper reach of the apron, and shallow water depth or excessive water velocities encountered inside the apron. The most effective fish passage project at this site would be to remove the entire structure and replace it with a wide-span bridge that does not impact the stream channel.

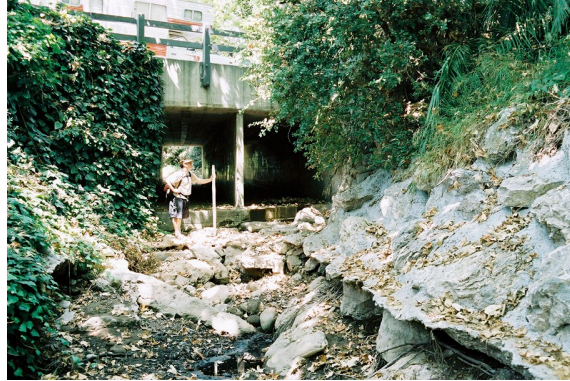
San Remo Drive Culvert

This double-box culvert measures 82 feet 6 inches long and each box measures 8 feet tall by 8 feet wide. The slope inside the smooth bottom culvert measures 2%. The outlet of the culvert drops 1-foot 7 inches to a boulder and concrete apron that extends between 8 and 15 feet downstream. The downstream apron does not allow pool development preventing salmonids from jumping into the culvert during migration flows. In addition, the culvert would limit upstream steelhead passage due to shallow water depth during lower flows and excessive water velocities during higher flows. An assessment of this structure should be conducted to determine the feasibility of replacing it with a wide-span bridge. A bridge would provide increased flow conveyance, the most effective fish passage, and restored stream habitat.

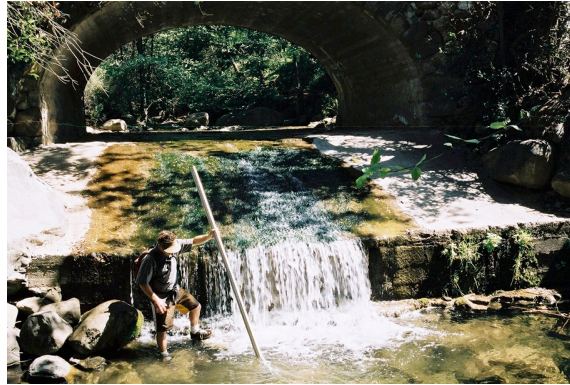
Las Canoas Bridge

A stone block bottom extends 37 feet 3 inches under this stone arch bridge with a slope of approximately 2%. At the upstream end of the bridge the bottom width between the bridge supports measured 27 feet 10 inches wide and the height of the arch bridge from the center of the bottom measured 11 feet 6 inches. Downstream of this relatively flat section under the bridge, a concrete apron measuring 14 feet 8 inches in length drops with a slope of 26.4%. The downstream end of the apron drops vertically 2 feet 9 inches to the pool downstream. This bridge is owned by the City of Santa Barbara. The apron appears to have been built to prevent scour from undermining the bridge. Scour is now undermined the apron and adjacent banks downstream. The river-left bank is experiencing considerable erosion caused by this structure, which is compromising the integrity of Las Canoas Road. Excessive water velocities and/or shallow water depth on the steep apron prevent all upstream salmonid migration at this site. A detailed study of

fish passage alternatives is needed and should consider removing the entire structure and replacing it with a wider span bridge that does not impact the stream channel, impeded fish migration, limit vehicular traffic like the current one-lane bridge, or further promote scour and bank erosion. This action would have the greatest results for fish passage and likely other traffic related objectives.

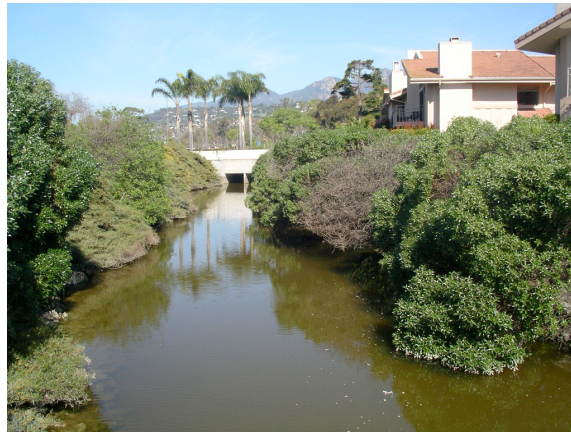
Lagoon Constriction

The lagoon has been considerably reduced in size due to the construction of road crossings, adjacent roads, and housing development. In addition, non-native vegetation and various bank revetment materials dominate the lagoon banks. There does not appear to be much room to expand the lagoon size due to the adjacent developments. A study should be conducted to determine effective lagoon restoration ideas.

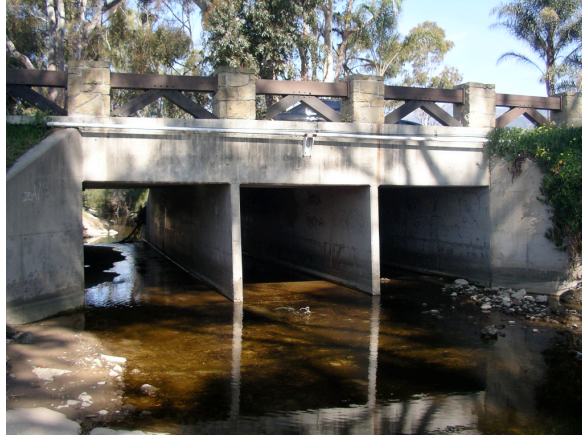
Santa Barbara Zoo Triple-Box Culvert

This road crossing contains three box culverts, each measuring 6 feet 8 inches wide by 8 feet tall. The culvert extends approximately 60 feet in length with a slope of less than 2%. Low surface flows are spread out through each box of the culvert. This crossing appears to limit the upstream extend of the lagoon and also limits upstream fish migration during lower flows due to the shallow water depth spread across the culvert boxes. Installation of curbs to focus low flows into the middle culvert to increase water depth along with increasing the water depth and roughness of the middle culvert should be further evaluated.

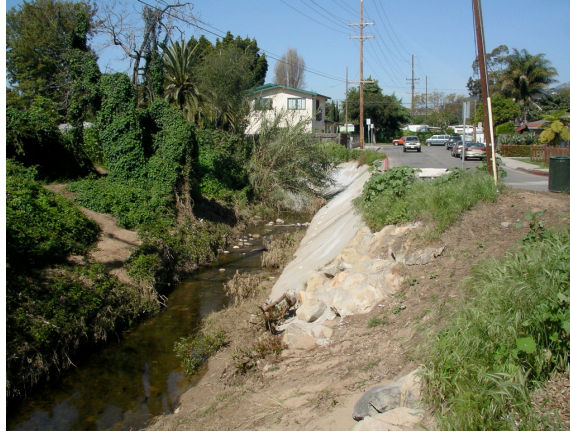
Soledad St. Revetment

Concrete bank revetment extends along the river-left side of the creek adjacent to Soledad Street and upstream toward Indio Muerto Street. There is no riparian vegetation along the creek bank adjacent to Soledad Street. The concrete revetment combines with instream concrete and boulder grade control structures in the stream channel and other bank protection measures upstream. The grade control structure likely limits fish passage during lower flows, but not significantly. This stream reach has been highly modified and degraded. An adjacent vacant lot on the west side of the creek may provide a unique opportunity to realign the creek toward the vacant lot, remove some of the concrete within the stream channel, establish a native riparian zone, connect an existing trail from Soledad to Punta Gorda Street, provide a public open space/park, and enhance flood conveyance and stream habitat conditions.

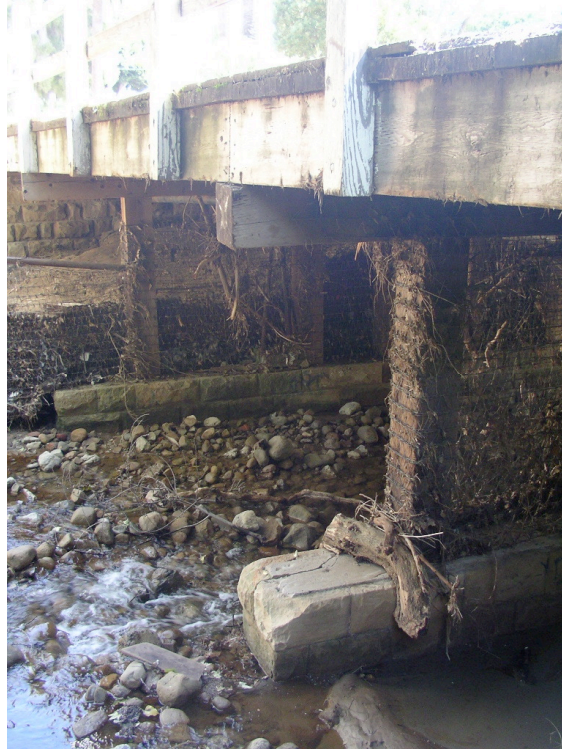
Carpinteria Street Bridge

This older bridge contains wood supports on concrete footings that occur within the stream channel. The footings and supports are significant debris blockage features that increase the likelihood of failure and/or adjacent flooding. Removal of this bridge and adjacent pipe and wire revetment and installation of a wide-span bridge would enhance stream habitat, sediment transport, and reduce flooding potential.

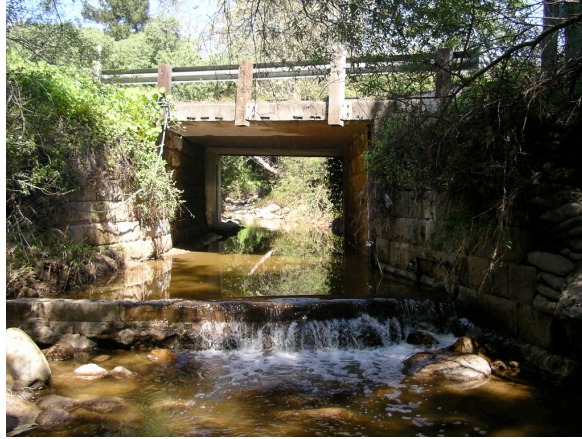
Alameda Padre Serra Bridge

A small concrete grade control curb occurs downstream of this bridge. This 14 to 20 inch thick curb produces a 3-foot 9-inch drop to the downstream substrate. A 2-foot deep pool occurs downstream and would provide sufficient depth to allow limited upstream salmonid fish passage during moderate to high stream flows. During low flows, the structure would limit upstream passage for juvenile salmonids. Cutting a small notch in the curb measuring approximately 3 feet wide by 8 inches deep would enhance low-flow fish passage at the site by focusing lower flows and reducing the jump height.

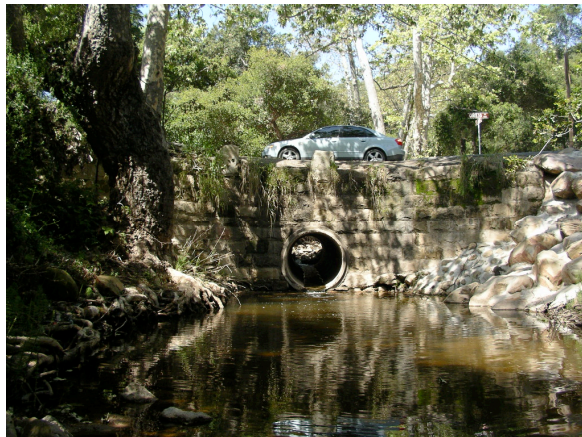
Conejo Road Culvert

The culvert diameter measures 4 feet 7 inches and extends approximately 40 feet in length. The slope is approximately 4%. Flows dropped 3 inches into a downstream pool with a maximum depth of 5 feet. This undersized culvert overtopped during the past winter and upstream debris was recently removed. Deposited sediment at the inlet has produced a 2-foot drop into the culvert. Depending on inlet configuration, this culvert would likely be impassable to all salmonid life stages during all flow conditions due to the excessive slope of the smooth culvert and velocities encountered during high flows and the presence of the inlet sediment deposit. Replacement of this undersized, unsafe crossing with a wide-span bridge would provide the most effective fish passage and traffic safety and should be studied further.

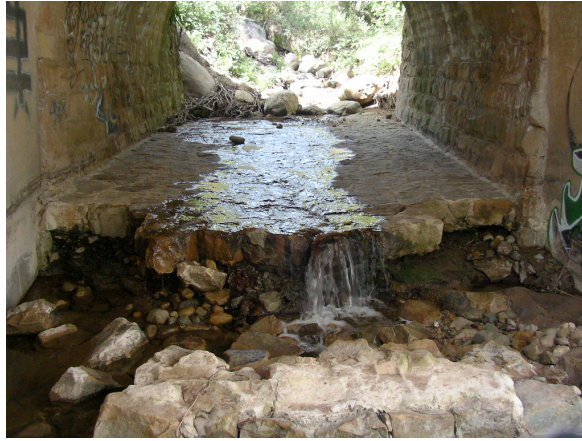
Stanwood Drive/Highway192 Culvert

The original stone arch bridge dated at 1919 has a rough stone and concrete bottom and newer concrete extension downstream. The rough stone bottom extends approximately 34 feet with a slope of 3 to 4%. Flows drop 2 vertical feet onto the downstream substrate. Some of the surface flow remains on natural substrate and a portion flows onto a downstream concrete curb and drops 9 inches into a small downstream pool measuring 2 feet 6 inches in depth. During moderate to high stream flows, adults steelhead would be able to migrate upstream of this structure with a moderate degree of difficulty. Reducing the jump onto the stone bottom and creating rest pools and a low flow channel across the stone bottom would improve lower flow salmonid migration. Removal of all or some of the stone bottom and protection of the bridge supports should also be investigated. Prior to any project at this crossing, further examination of the entire downstream creek channel to Conejo Road should be conducted to ensure that additional natural or anthropogenic fish barriers do not occur.

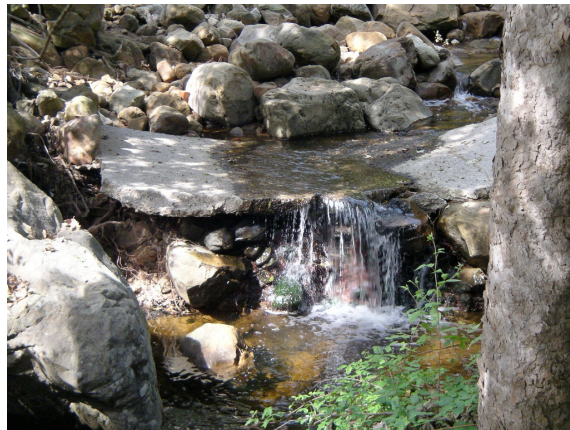
Chelham Creek Concrete Apron

A concrete apron occurs approximately 150 feet upstream of the Coyote Creek confluence. This apron drops surface flows approximately 4 feet to a downstream pool with a depth of 2 feet. This structure does not appear to have a current use and may be associated with the nearby concrete chute on Coyote Creek just upstream from Chelham Creek. This obsolete structure should be further assessed and if feasible removed to allow ecological connectivity and improve potential future fish passage.

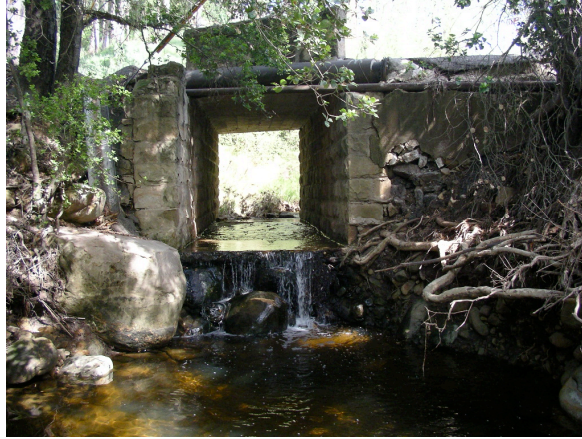
Chelham Creek Culvert at Coyote Road

The confluence of Westmont and Chelham Creeks occurs at this culvert inlet. This 34-foot long concrete box culvert measured 8 feet tall and 8 feet wide. The slope of the culvert measured approximately 1.5%. Stream flows drop 3 feet 3 inches from the culvert outlet to the pool surface downstream. During lower flows, the excessive jump height and shallow water depth in the culvert would prevent any upstream fish passage. During moderate to high flows, adult steelhead would be able to jump into the culvert, but excessive water velocities would limit upstream passage. Ecological connectivity would be improved with removal of this culvert and installation of a bridge. Additional assessment is needed to analyze bridge replacement options.

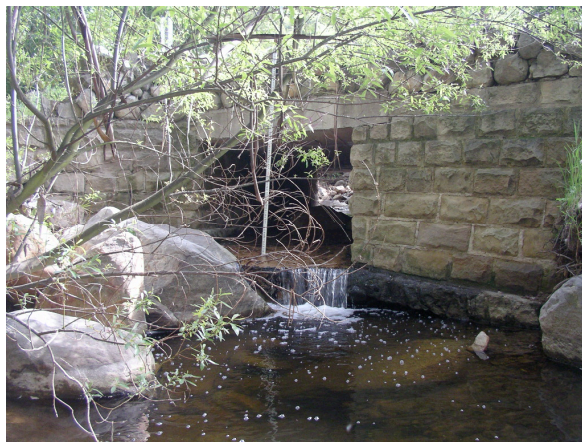
Chelham Creek Sycamore Canyon Road/Highway 192 Culvert

This concrete box culvert occurs approximately 75 feet upstream from the Westmont Creek confluence. The culvert measures 4 feet 5 inches tall and 6 feet 6 inches wide at the outlet. The inlet of the culvert measures 3 feet 9 inches wide. Flows drop 1-foot 4 inches to a small downstream pool measuring 3 feet in depth. The culvert appears to be undersized and signs of overtopping during the last winter rains were observed at the inlet. The culvert bottom was observed to be broken in several locations. Removal of this culvert and installation of a wide-span bridge should be studied and would provide ecological connectivity, future fish passage, improved flow capacity, and reduced flooding.

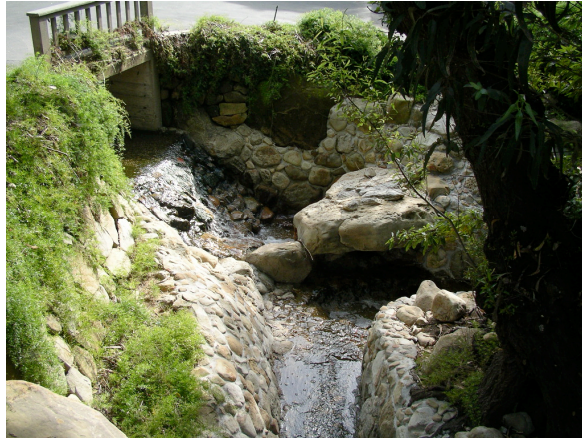
Chelham Creek Private Box Culvert

This concrete box culvert occurs on private property adjacent to Highway 192. A steep concrete apron occurs at the outlet of this culvert and drops flows 5 feet to the downstream substrate. This structure should be further assessed with landowner cooperation and removal and bridge installation considered.

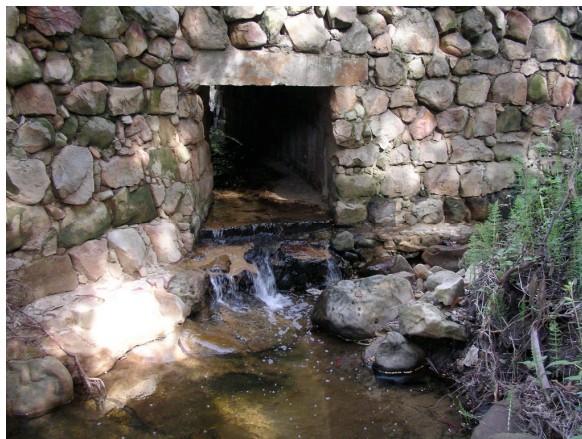
Chelham Creek Sycamore Canyon Road/Highway 192 Culvert #2

This concrete box culvert extends under the road in an arch shape. The outlet dimensions of the culvert measured 4 feet 2 inches tall by 4 feet wide. Flows were observed to drop 1 foot 6 inches to a downstream pool depth of 2 feet 6 inches. The culvert bottom consists of cobble and concrete. A 2-foot drop occurs at a boulder jam at the inlet of the culvert. Upstream fish passage would not be possible during low flows due to shallow water depth within the culvert and the inlet drop. During moderate flows limited upstream fish passage may be possible depending on the inlet conditions and sediment deposition. The culvert is likely undersized. A bridge or larger embedded culvert or arch culvert would provide improved ecological connectivity and flow capacity at this road crossing and should be assessed further.

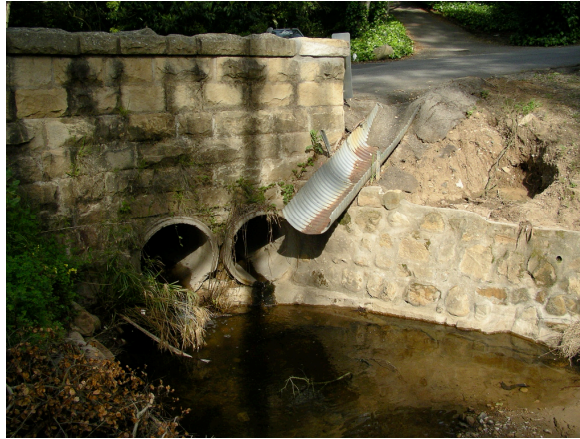
Chelham Way Culverts

Two circular concrete culverts with 3-foot diameters convey low to moderate flows under Chelham Way. Upstream debris removal and signs of overtopping during last winter flows were observed at the culvert inlets. Sediment deposits at the inlet produced drops between 1 to 2 feet into the culvert. The moderately steep slope within the culverts and smooth surface, combined with inlet sediment deposits, would prevent upstream fish passage during all flows. This undersized culvert crossing should be further assessed and replaced with a wide-span bridge to provide ecological connectivity and eliminate road flooding and erosion.

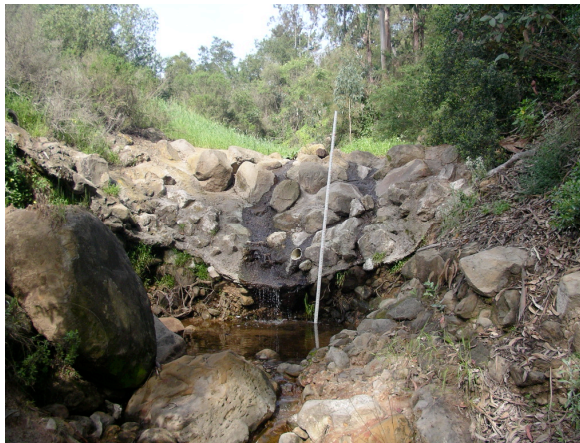
Westmont Creek Dam

This 10-foot tall boulder and concrete dam occurs approximately 100 feet upstream of the Chelham Creek confluence. The dam is completely filled in with sediment and conveys all flows over the dam and downstream face. The usefulness of this dam should be determined and dam removal feasibility assessed.
