Santa Clara River Steelhead Trout: Assessment and Recovery Opportunities

December 2005

The Santa Clara River Trustee Council and The Nature Conservancy

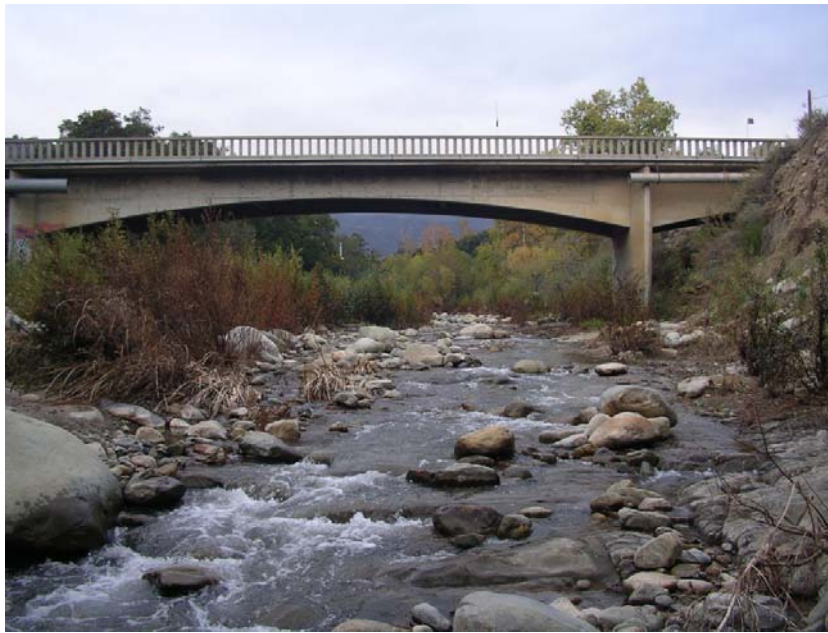
Santa Paula Creek at Steckel Park Bridge

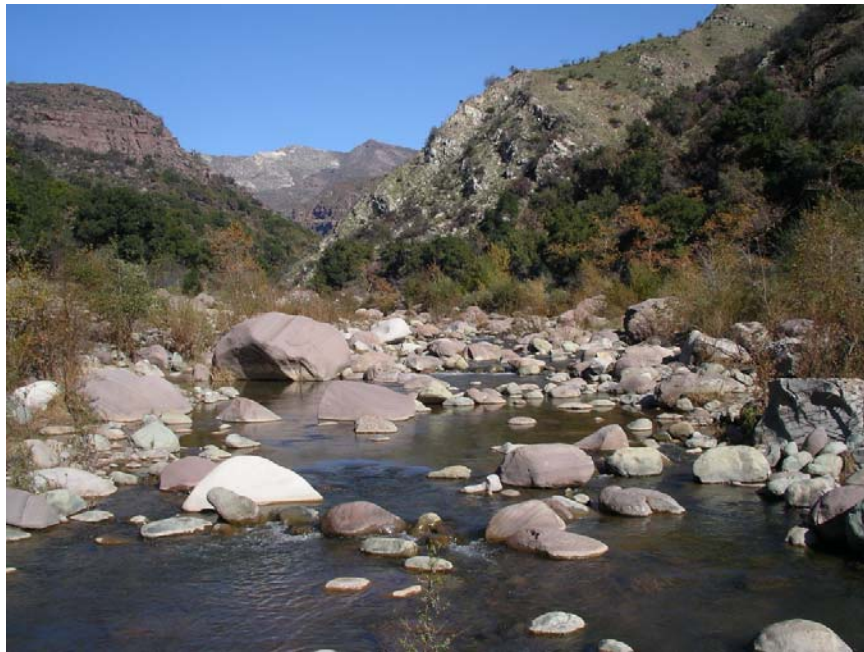
Sespe Creek upstream of Devil's Gate

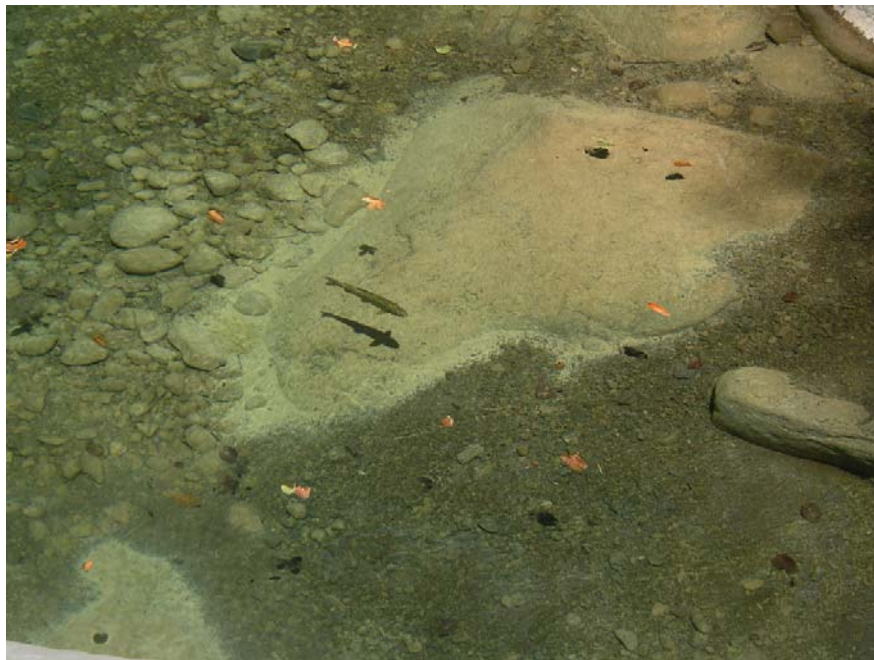
West Fork Sespe O. mykiss

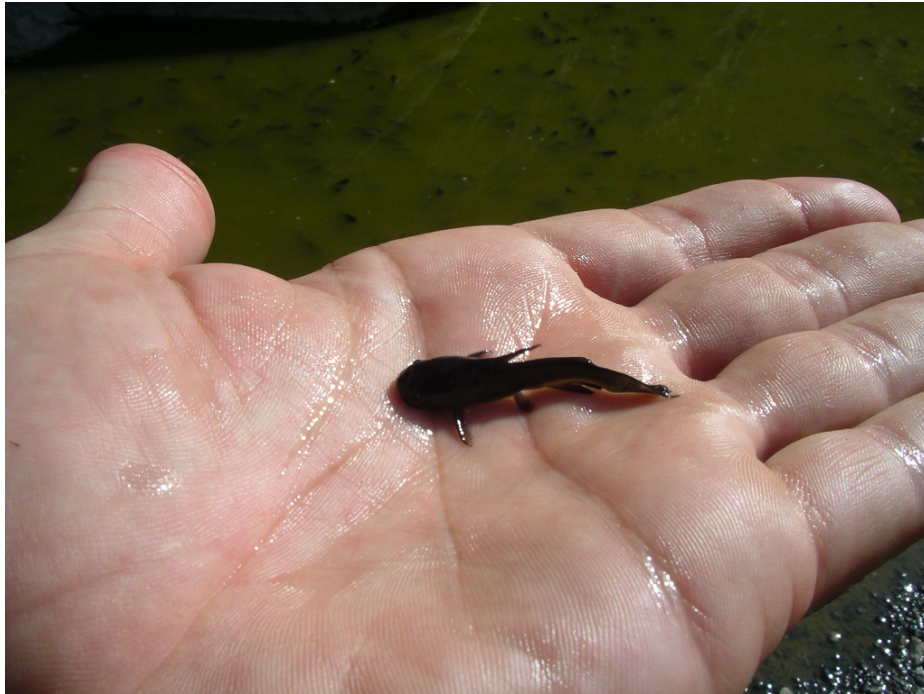
Bullhead catfish and green sunfish occur in Sespe Creek. The highest occurrence of exotic fish occurred from just upstream of the confluence of Coldwater Creek to near the confluence with Bear Creek. No exotic fish were observed in any Sespe Creek tributaries, but the source of these fish may be from reservoirs within the Howard Creek/Rose Valley tributary where exotic fish have been planted in the past. The average temperature for reaches in which

exotic fish occurred was 67.14°F versus 56.32°F for reaches that did not have exotic fish. Of the 107 surveyed reaches that had exotics, bullhead catfish occurred in 78 reaches, and green sunfish occurred in 46.

Juvenile Black Bullhead from Sespe Creek

At least two introduced fish species, the black bullhead and green sunfish, were observed while surveying Sespe Creek. These exotic species compete with, and prey upon, salmonids and other native fish species and a plan to eradicate them and prevent further planting of any non-native fish, including hatchery rainbow trout, should be formulated.

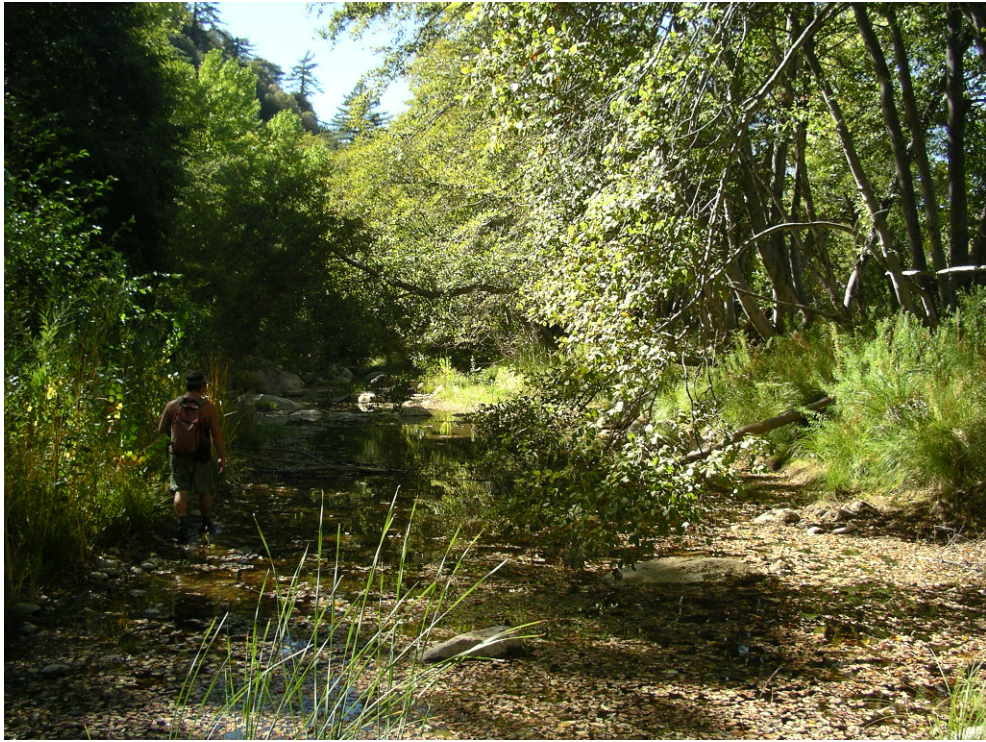
Perennial habitat on Sespe Creek downstream of Howard Creek

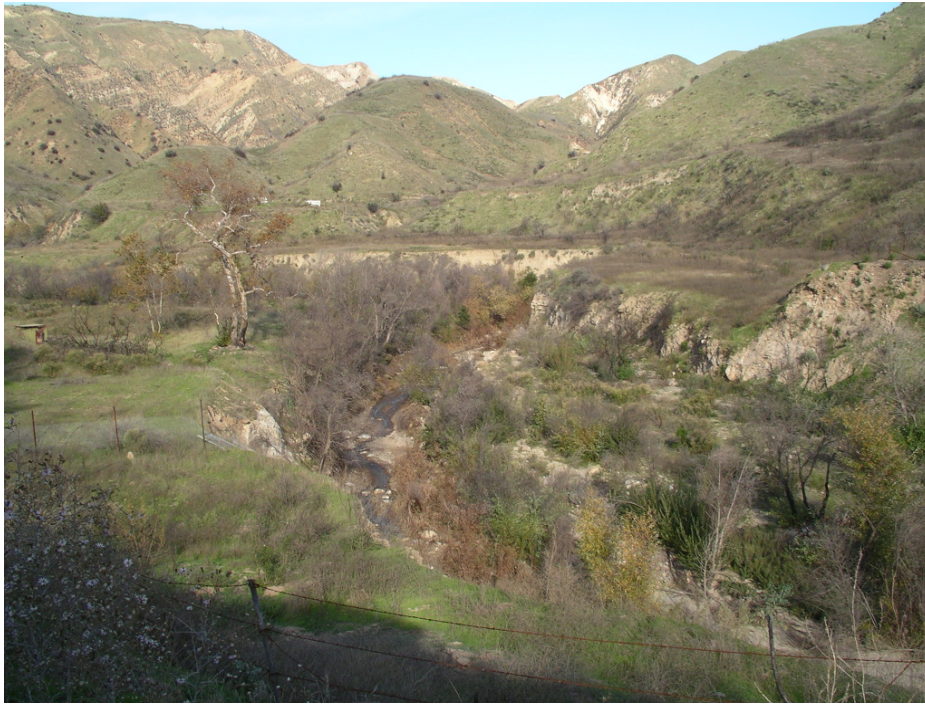
Hopper Creek upstream of nursery operations

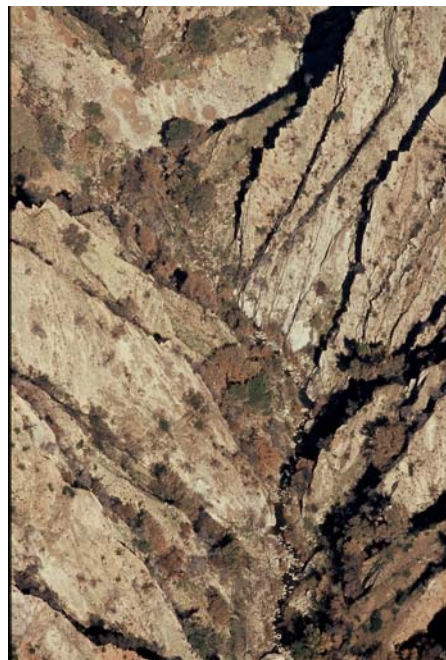
Perennial habitat downstream of impassable waterfall on Hopper Creek, post-fire

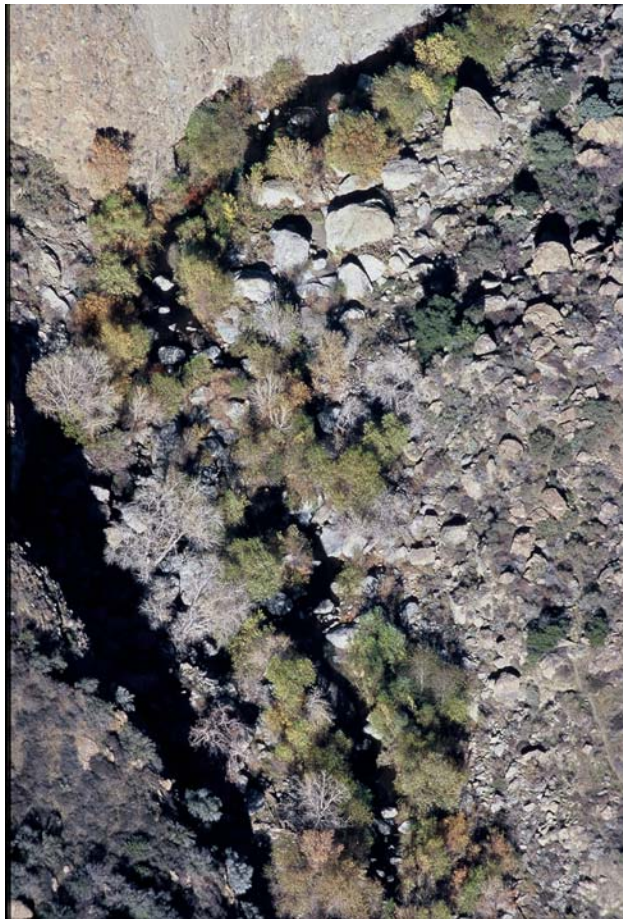
Piru Creek upstream of Agua Blanca Creek

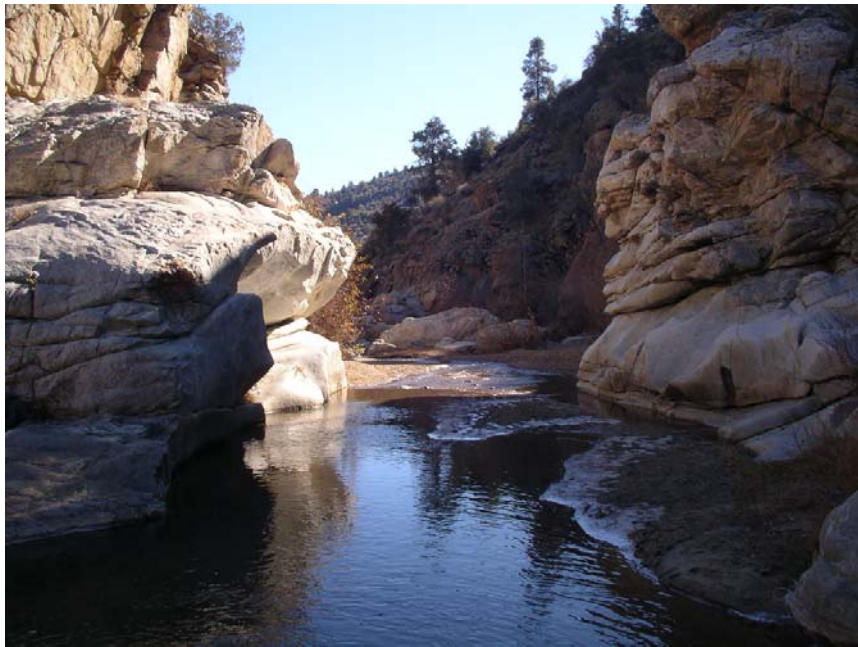
Piru Creek downstream of Gold Hill

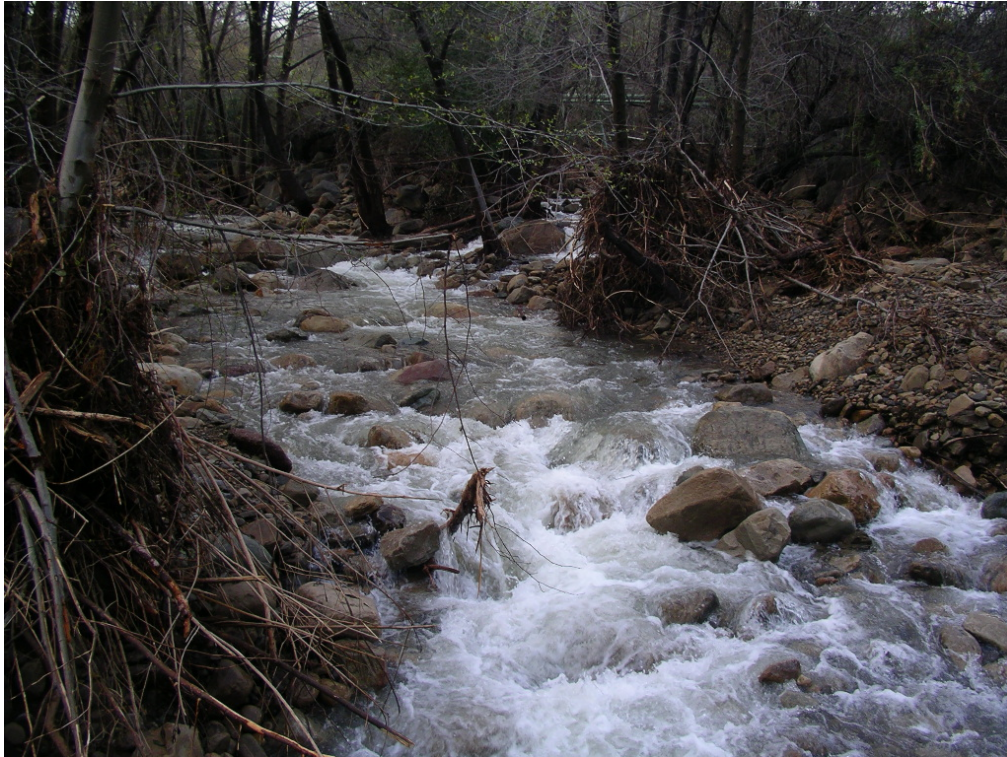
Sisar Creek at Bear Creek (right) confluence

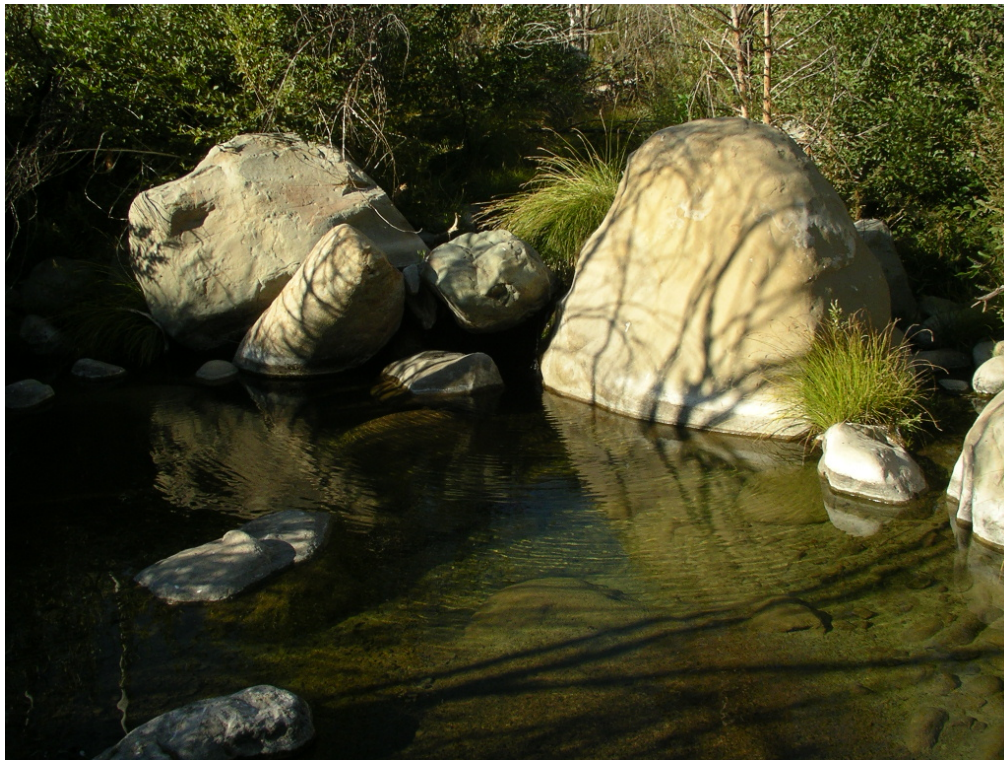
Pool habitat on Piedras Blancas Creek downstream of the East Fork

Piedras Blancas Creek by itself has an overall habitat quality score of 7.35 out of a maximum of 10, almost two full points higher than that of the Sespe Creek drainage overall.

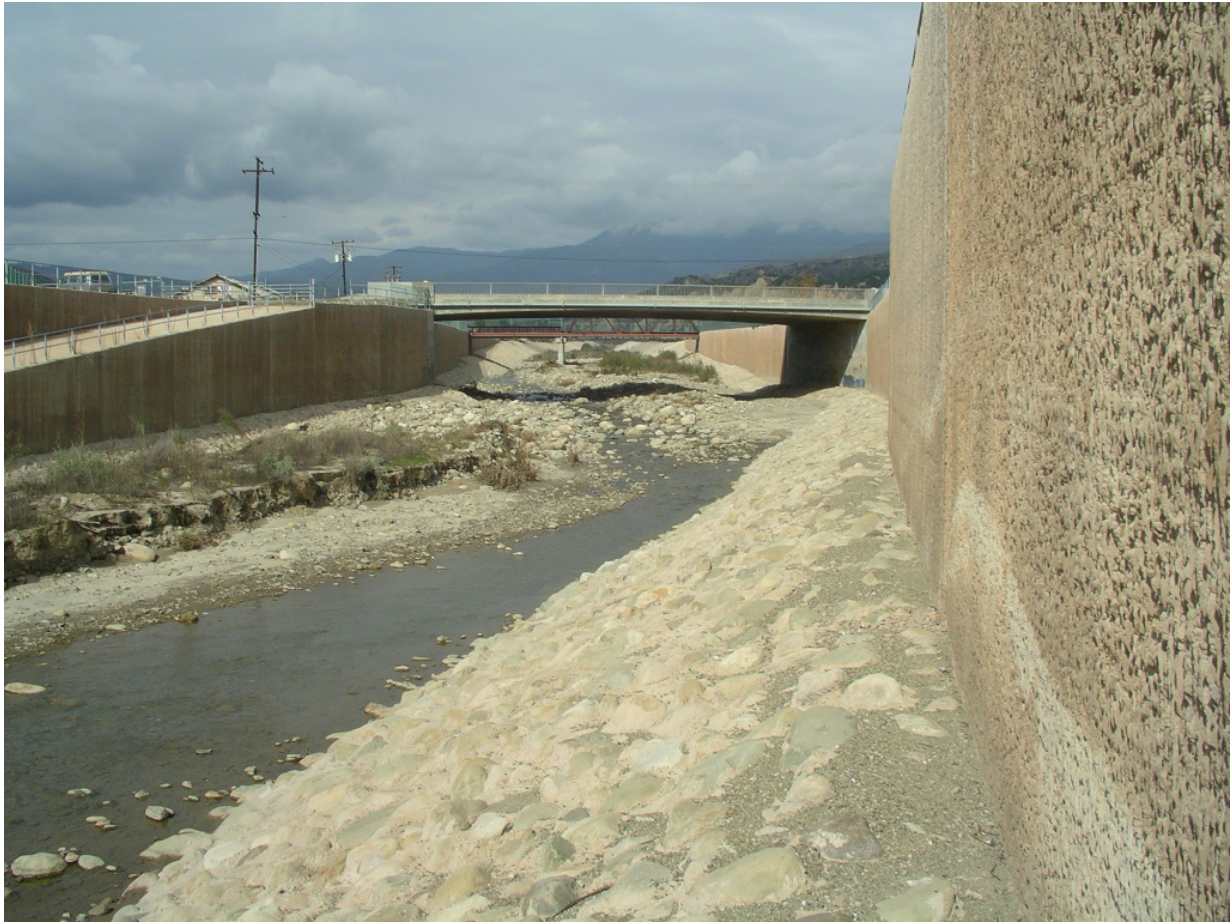
ACOE Channelization, Grade Control, and Fishway (SC_SP_1,2,3) - Santa Paula Creek

ACOE Channel adjacent to city of Santa Paula

Description: The Army Corps of Engineers built this extensive project in order to protect the City of Santa Paula from flooding. The channelized reach extends approximately 8625 feet from just upstream of the Santa Clara River to a concrete grade control structure downstream from a long fishway. The 215-foot long fishway rises 18 feet 6 inches with an overall slope of 8.6%. Following the 2005 flows the fishway and grade control were completely destroyed.

Recommended Action: A comprehensive alternatives analysis needs to be conducted and removal of the fishway and downstream grade control seriously considered. Reconstruction of similar fishway facilities will continue to have inherent failure risks, annual debris blockage, and require continual maintenance, or result in limiting or preventing upstream steelhead passage. Replacing the fishway with a roughened channel combined with channel-wide weirs tied into the existing trapezoidal concrete walls may provide the most effective steelhead passage and structural integrity with minimal maintenance. Such a design would need to extend downstream into the channelized reach to reduce the slope of the roughened channel and create a milder transition between the 18-foot 6-inch elevation difference between the current fishway inlet and outlet. The downstream channel appears to have sufficient capacity to allow for such an alternative.

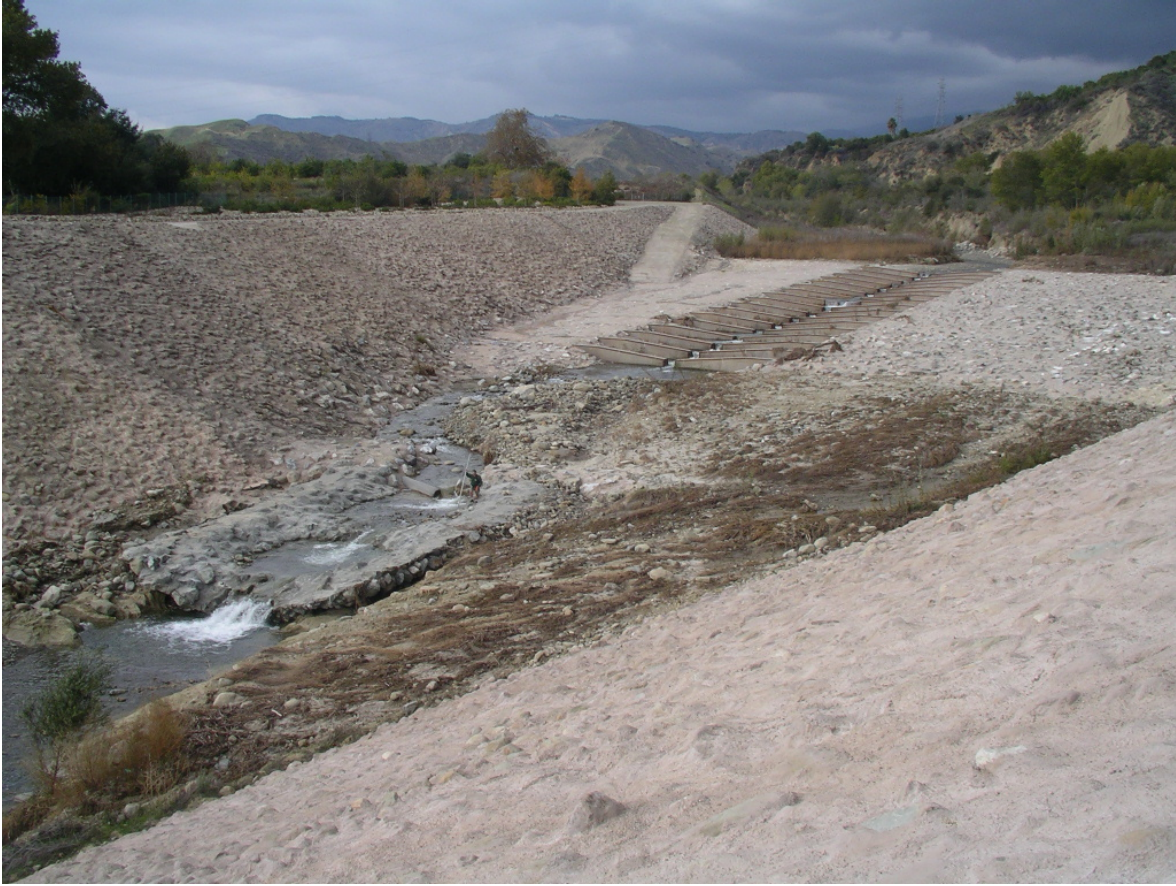
Grade control and fishway before 2005 failure

Diagnosis: The concrete channel is periodically dredged of sediments; this eliminates natural channel complexity and thus also creates unfavorable conditions for fish passage (pers. comm. Mark Capelli). Prior to the 2005 flows that destroyed the fishway and downstream grade control, this facility failed to meet DFG and NOAA fish passage criteria at all flows for strongest swimming species presumed present. The downstream grade control structure had an excessive outlet drop of 3 feet 4 inches and excessive concrete apron slope of 26%. Even the elaborate fishway failed to meet DFG and NOAA fish passage criteria at all flows due to inherent debris blockages that completely blocked the weir notches and produced drops exceeding 2 feet on 5 of the 17 weirs. In addition, many of the weirs were filled with substrate and some had large boulders located in the ideal steelhead jump location and landing zones.

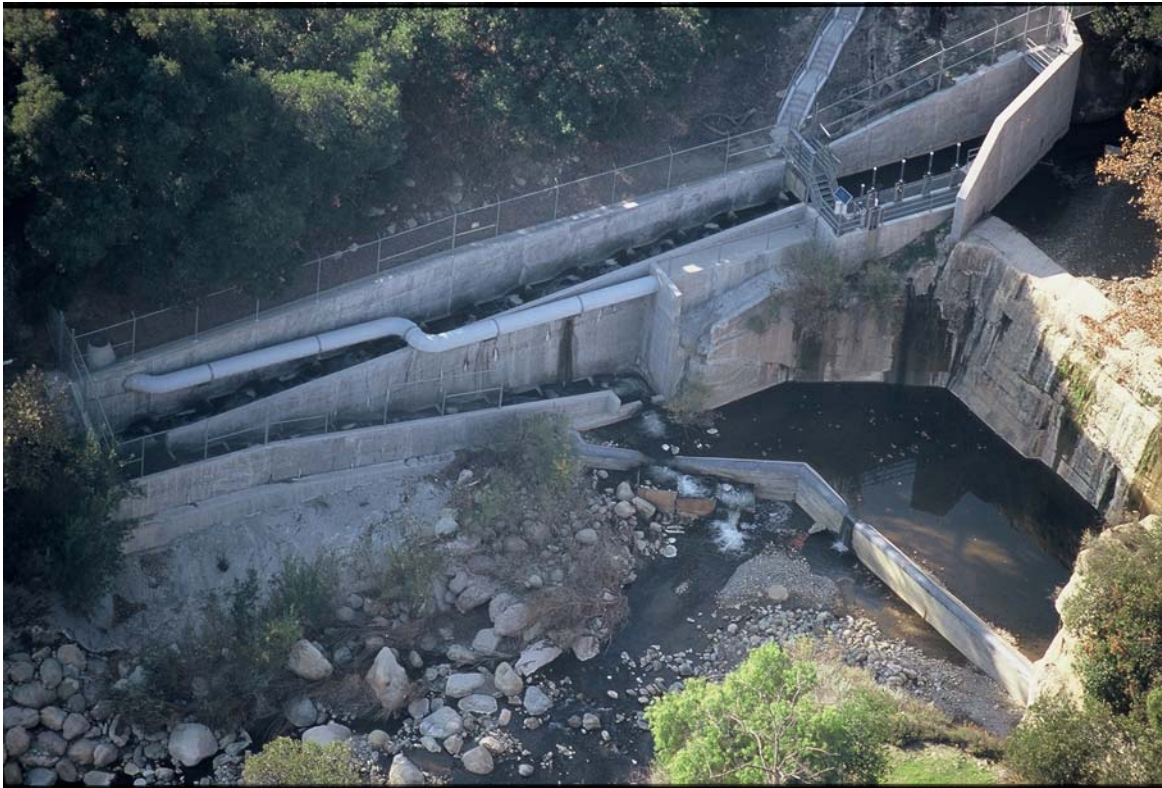
Harvey Diversion Dam (SC_SP_4) – Santa Paula Creek

Dam and ladder before 2005 damage

Description: Permission to conduct a ground survey at Harvey Dam was not obtained and limited observations were made from Highway 150 before and after the record stream flows during January 2005. The concrete dam was built in 1923 and is owned and operated by Canyon Irrigation District. The dam occurs immediately upstream of Mud Creek. Though our initial observation of Harvey Dam was conducted in the fall of 2004, conditions at the dam and fishway were dramatically altered during the high stream flows of early 2005. We observed the dam again in the spring of 2005 and it is that observation that is presented here. Harvey Dam experienced major damage and substrate mobilization with the 2005 winter flows. The dam was side-cut by flows on the river-left side and flows were observed cutting between the concrete dam and adjacent bedrock. Much of the dam's concrete sill was destroyed exposing the re-bar underneath. The force of the high flows dropped the substrate elevation below the dam, downstream of the weir, by more than 5 feet, leaving a drop of greater than 7 feet. The fishway was also extensively damaged, completely filled in with substrate, and rendered ineffective following the high flows. The Fishway's outlet jump boxes were filled with substrate and the metal was so damaged they are likely destroyed. The outlet drop of the most-downstream jump box was observed to be over 4 feet in height following the elevation drop of downstream substrate. The inlet to the fishway at the upstream end of Harvey Dam was also completely buried by substrate.

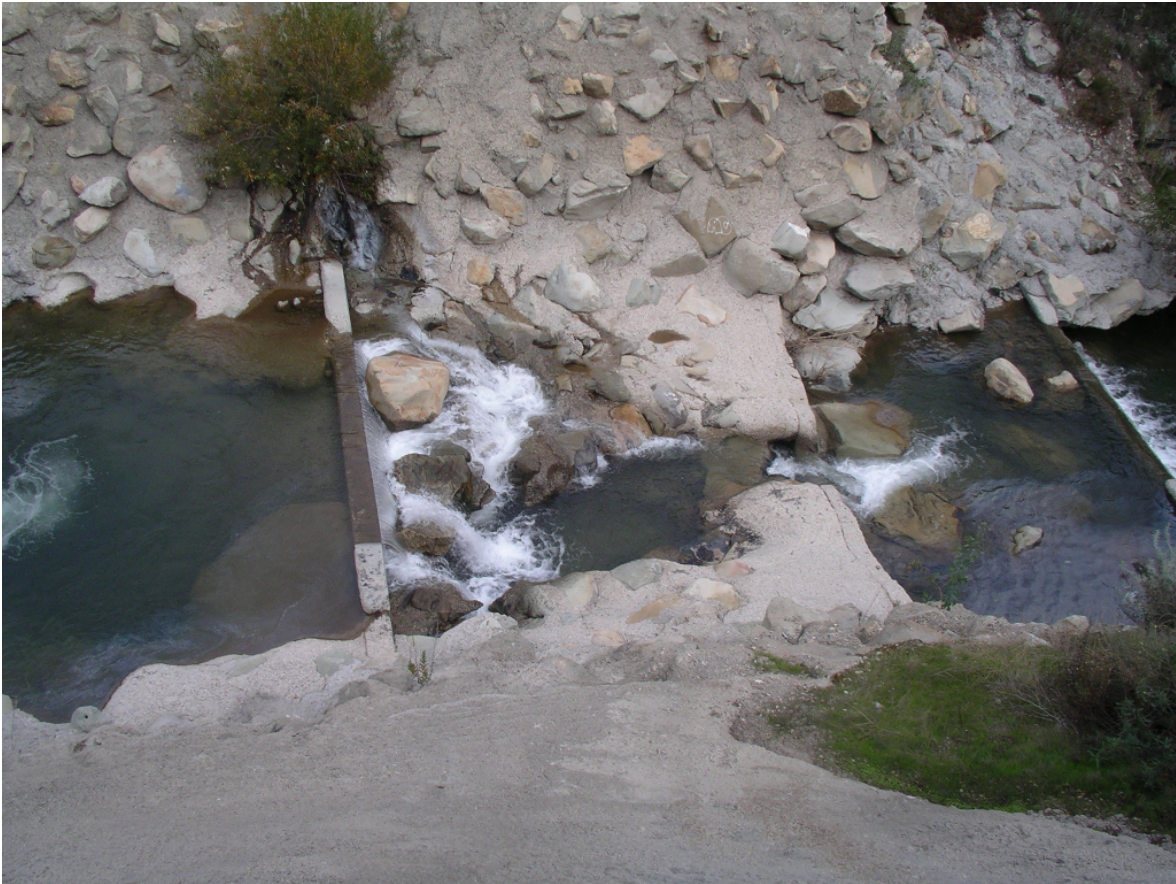
CALTRANS Highway 150 Bridge (SC_SP_5) – Santa Paula Creek

Downstream grade controls before 2005 flood

Description: Prior to the record rainfall and stream flows on Santa Paula Creek during January 2005, seven grade control structures occurred in association with the Highway 150 Bridge. These concrete curbs and associated concrete bank revetment stretched for over 400 feet from the upstream side of the Highway 150 Bridge downstream. During November 2004 surveys several of the curb drops exceeded 3 feet and the most severe drop measured 6 feet 4 inches in height. Large boulder cascades also occurred on the downstream side of several curbs and interfered with ideal steelhead jump locations. The fifth curb upstream also contained a steeply sloped apron extending 8 feet and with a slope exceeding 26%. High stream flows in January 2005 devastated much of Santa Paula Creek and dramatically changed the configuration of these Highway 150 grade control structures. The two most downstream curbs and bank revetments were completely destroyed and washed downstream.

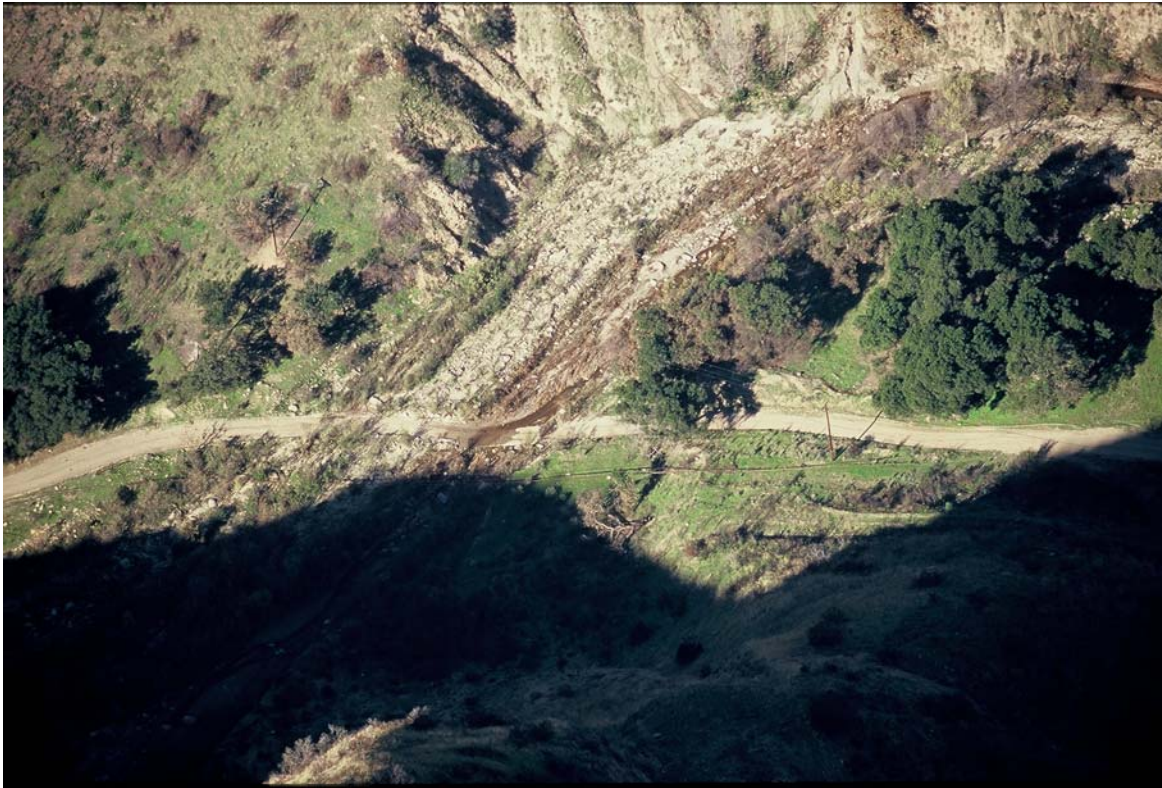
Hopper Creek barrier #2

Description: Permission to survey upper Hopper Creek was obtained, but access through locked gates on private land was never provided and observations were limited from the air and adjacent road up to the locked gate. A total of 14 private road crossings were observed on Hopper Creek upstream of Highway 126 while conducting the aerial survey. Three of the crossings appear to be constructed of concrete, while the remaining 11 appear to be in-stream fords on natural substrate that may not impede fish passage. The 3 concrete crossings were observed to have considerable outlet drops associate with them up to 4 or more feet in height. The crossings appear to service oil facilities in the canyon.

Diagnosis: Ground surveys are needed to determine the impacts of these crossings on fish passage, but aerial observations indicate that the three concrete crossings represent partial or complete barriers to upstream fish migration and limit or prevent upstream fish passage to excellent habitat located upstream. SC_HR_2 appears to have a 2-foot outlet drop while SC_HR_3 and SC_HR_4 appear to have outlet drops exceeding 4 feet in height.

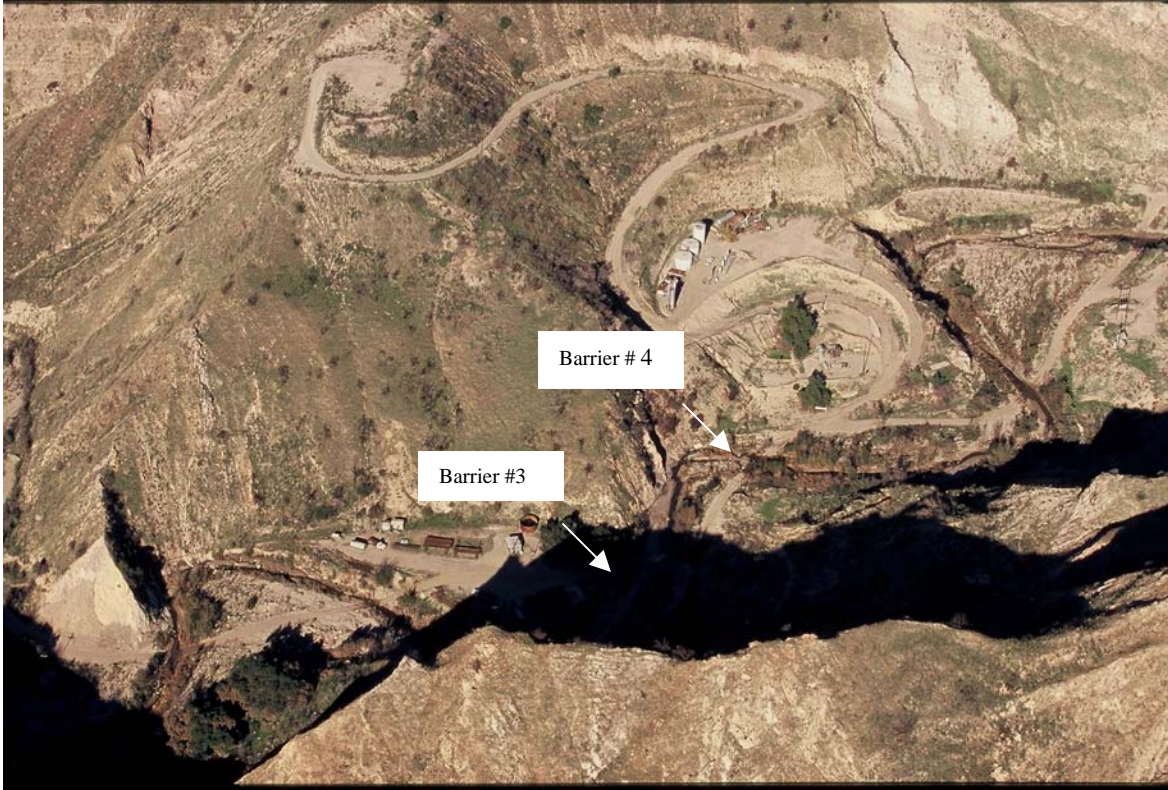
Hopper Creek Barriers #3 and #4 and other at-grade oil facility road crossings

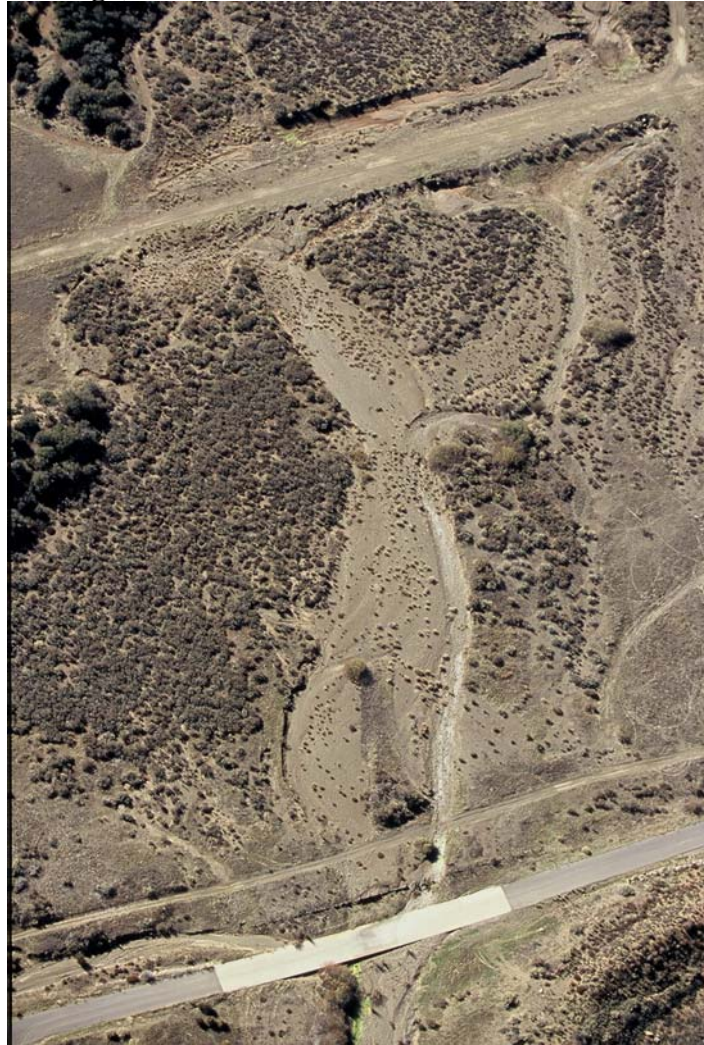
Rose Valley Road Crossing (SC_SE_HD_3) – Howard Creek

Rose Valley Road (bottom) and Airstrip (top)

Description: This concrete low-flow crossing spans 198 feet across a braided and unconfined reach of Howard Creek at the edge of a large meadow and private ranch (Rancho Grande). The crossing is 22 feet wide with a slope of 1.5 %. The outlet sill drops flows 1-foot 4 inches to the downstream substrate.

Recommended Action: See survey recommendation for the downstream culvert (SC_SE_HD_2). These culverts should be further assessed in coordination with unsurveyed upstream barriers and habitat on Rancho Grande that will influence potential alternatives at this site.

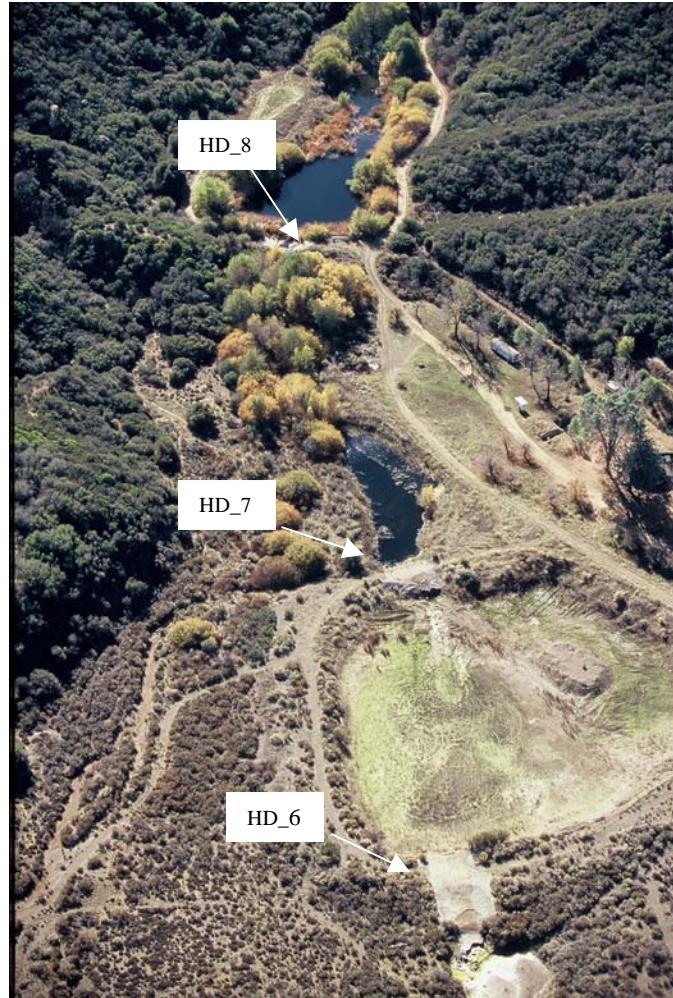
Four Dams on Rancho Grande (SC_SE_HD_5,6,7,8) – Howard Creek

Upper Three Dams and Reservoirs #6-#8 (lower dam not visible)

Description: Access to survey these four dams was not obtained and limited observations were made from the air. All dams appear to be earth filled dams with concrete spillways. The dams occur in sequence with the reservoir elevation at the next upstream dam. The concrete spillways also appear to be used for vehicle access across the dam crest.

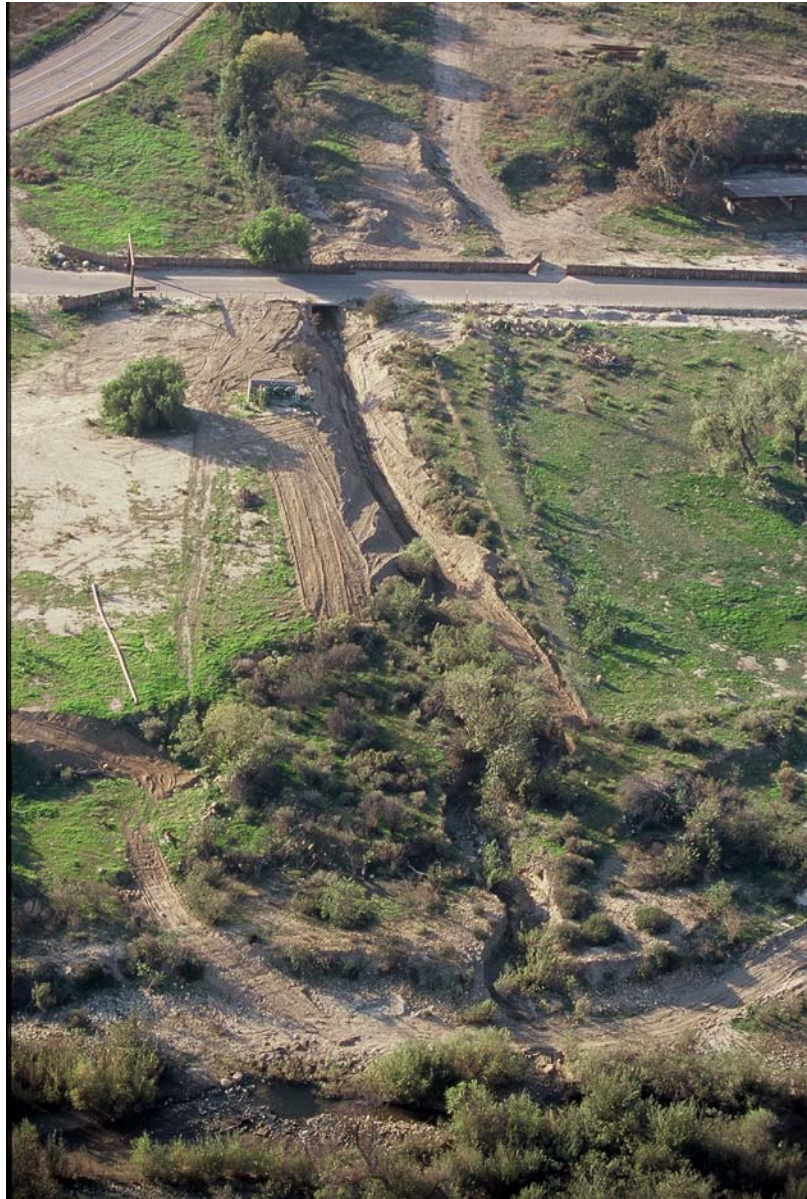
Private Box Culvert (SC_PU_LE_1) on Lime Creek

Description: Permission to survey these lower Piru Creek tributary crossings was not obtained and observations were limited from Piru Canyon Road and the air. The downstream-most box culvert on Lime Creek occurs downstream of Piru Canyon Road. Concrete box culverts occur on Modelo and Blanchard Creek under Piru Canyon Road and Lime Creek has a circular culvert. The remains of an old structure that appears to be a failed culvert crossing occur upstream of Piru Canyon Road on Lime Creek.

Recommended Action: Contact the landowners and request permission to survey the crossings and upstream habitat. Discuss the desirability of the crossings and potential grant opportunities to improve the crossings for vehicle access and fish passage. If the crossings are limiting fish passage and restoration projects are warranted, the preferred NOAA Fish Passage guideline alternatives are removal of the crossing and road realignment to avoid crossing the stream, installation of a bridge, or streambed simulation strategy (NOAA 2001).

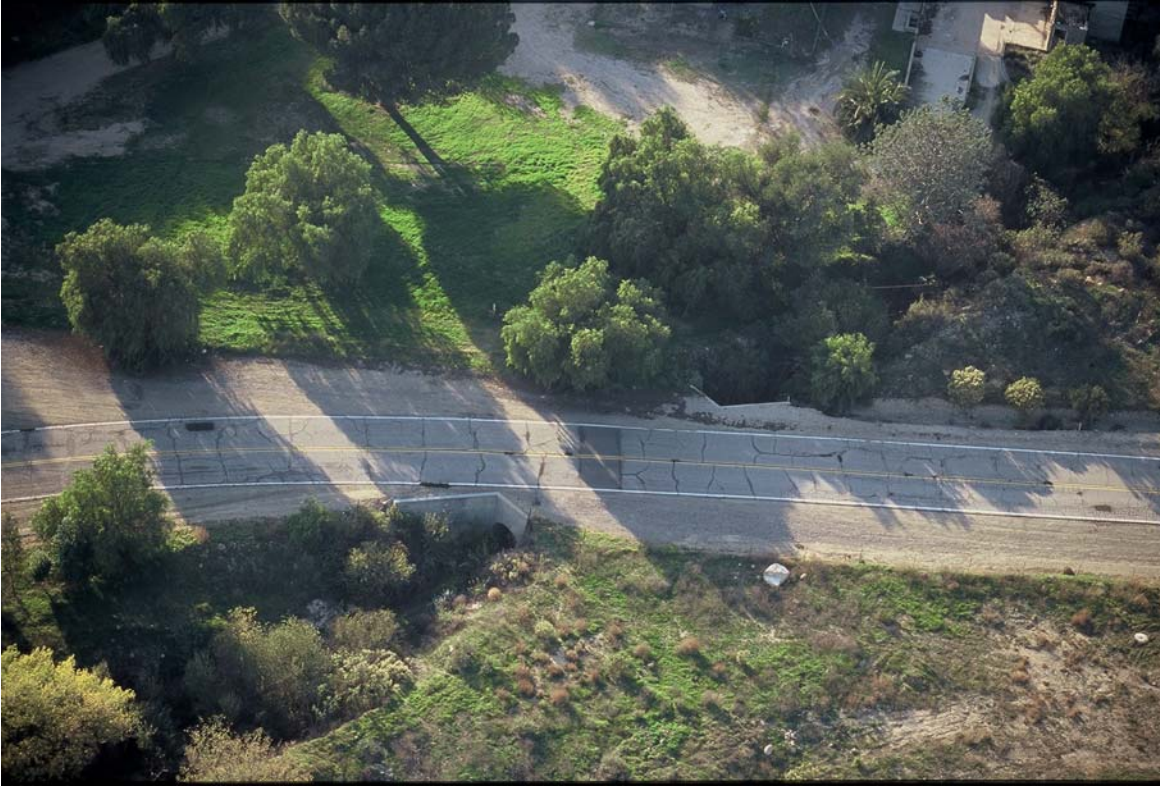
Piru Canyon Road Culvert (SC_PU_LE_2) on Lime Creek

Diagnosis: Additional assessment is needed to determine the impacts of these crossing on fish passage and ground surveying of upstream habitat conditions and summer flows is needed to determine if fish passage projects are warranted. Each culvert likely limits fish passage to some degree during various flow conditions.

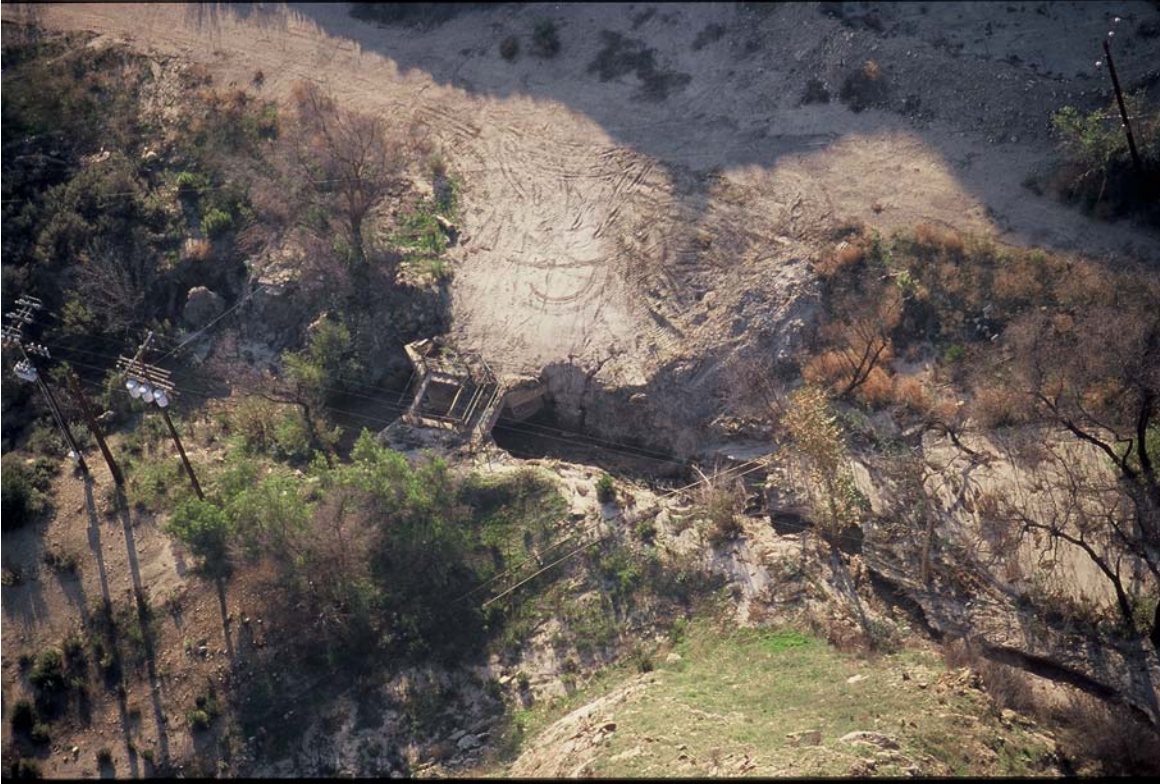
Old structure (SC_PU_LE_3) on Lime Creek

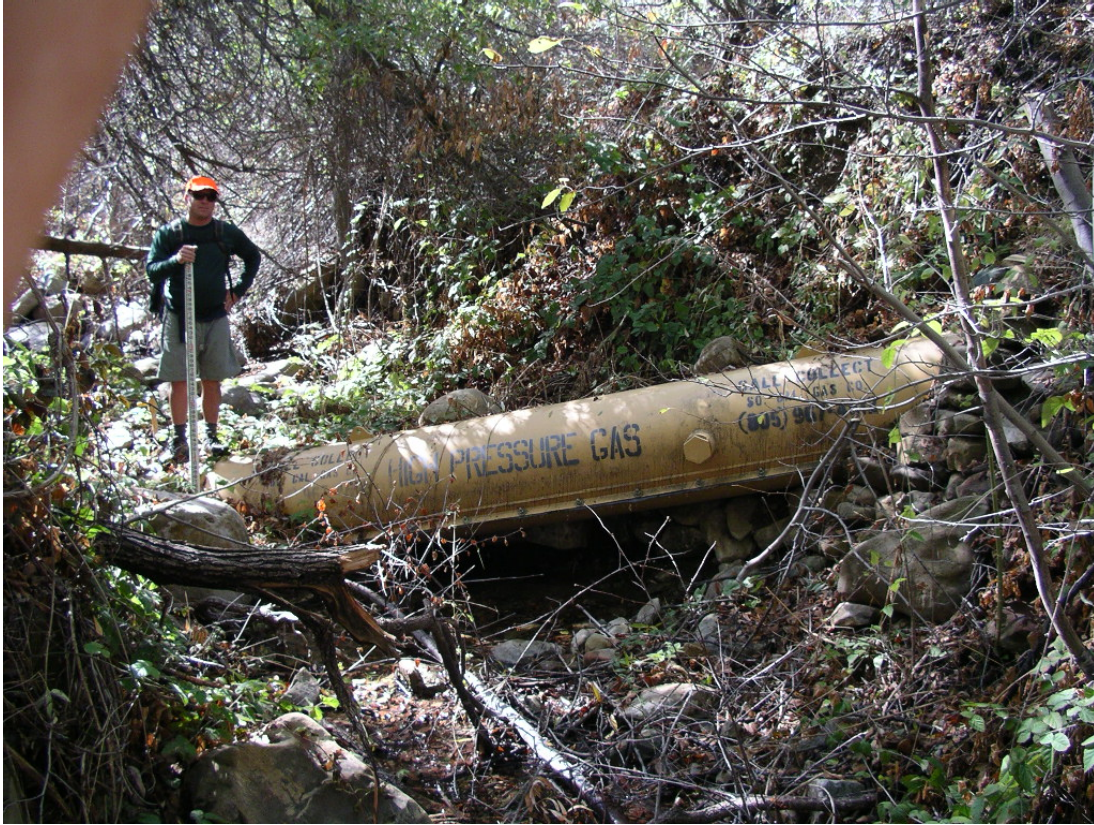
So. Cal. Gas Pipeline Crossing (SC_SE_CY_1) - Cherry Creek

Description: This high-pressure gas line is highly exposed in the stream channel and presents a partial barrier to trout migrating into Cherry Creek from Sespe Creek. The 2-foot diameter pipeline has natural substrate occurring on top of it on the far river-left side of the channel and produced a 12-inch drop to the downstream pool that measured 12 inches in depth. Spray painted on the side is “High Pressure Gas” and “So. Cal. Gas Co. (805) 967-4612”

Diagnosis: The short jump height required to clear this pipeline would likely not limit upstream fish migration during moderate and high flows, but imposes a moderate degree of difficulty during lower flows and especially for small salmonids that occur upstream in Cherry Creek.

Recommended Action: So. Cal. Gas Co. should remove this pipeline and reroute it aerially in a “gooseneck” design to allow unimpeded fish passage and eliminate damage from the stream channel. A small population of *O. mykiss* were observed in Cherry Creek upstream of this pipeline this partial barrier and potential pollution hazard should be rerouted out of the active stream channel.

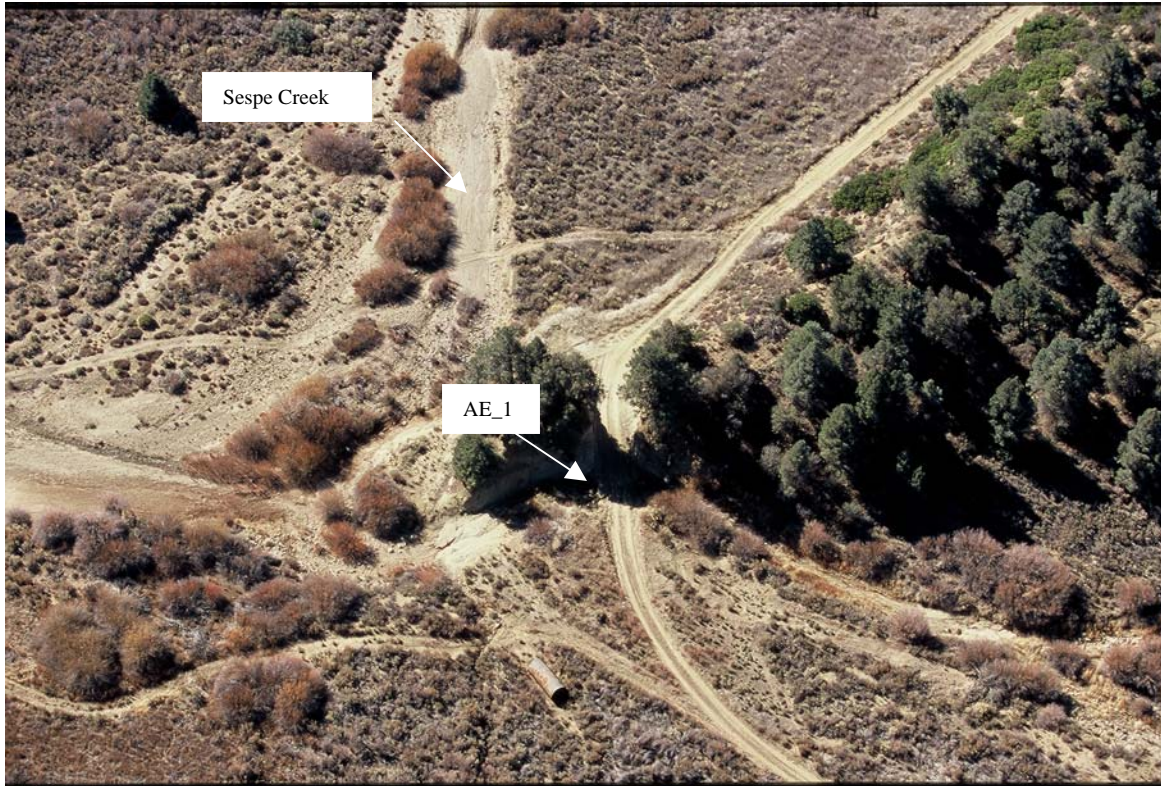
Private Crossings (SC_SE_AE_1,2) - Adobe Creek

Private culvert crossing on Adobe Creek just upstream of Sespe Creek

Description: Permission to survey these crossings was not obtained and observations were limited from the air. The most downstream crossing appears to be a culvert pipe and dirt road crossing that occurs immediately upstream from the Sespe Creek confluence. The upstream crossing occurs upstream of the Highway 33 Bridge and observations could not determine the configuration of the crossing due to excessive vegetation cover.

Recommended Action: Contact the landowners and request permission to survey the crossings and discuss the desirability crossings and potential grant opportunities to improve the crossings for vehicle access and provide fish passage. If the crossings are limiting fish passage and habitat conditions warrant restoration projects, the preferred NOAA Fish Passage guideline alternatives are removal of the crossing and road realignment to avoid crossing the stream, installation of a bridge, or streambed simulation strategy (NOAA 2001).
