Santa Clara River Steelhead Trout: Assessment and Recovery Opportunities

December 2005

The Santa Clara River Trustee Council and The Nature Conservancy

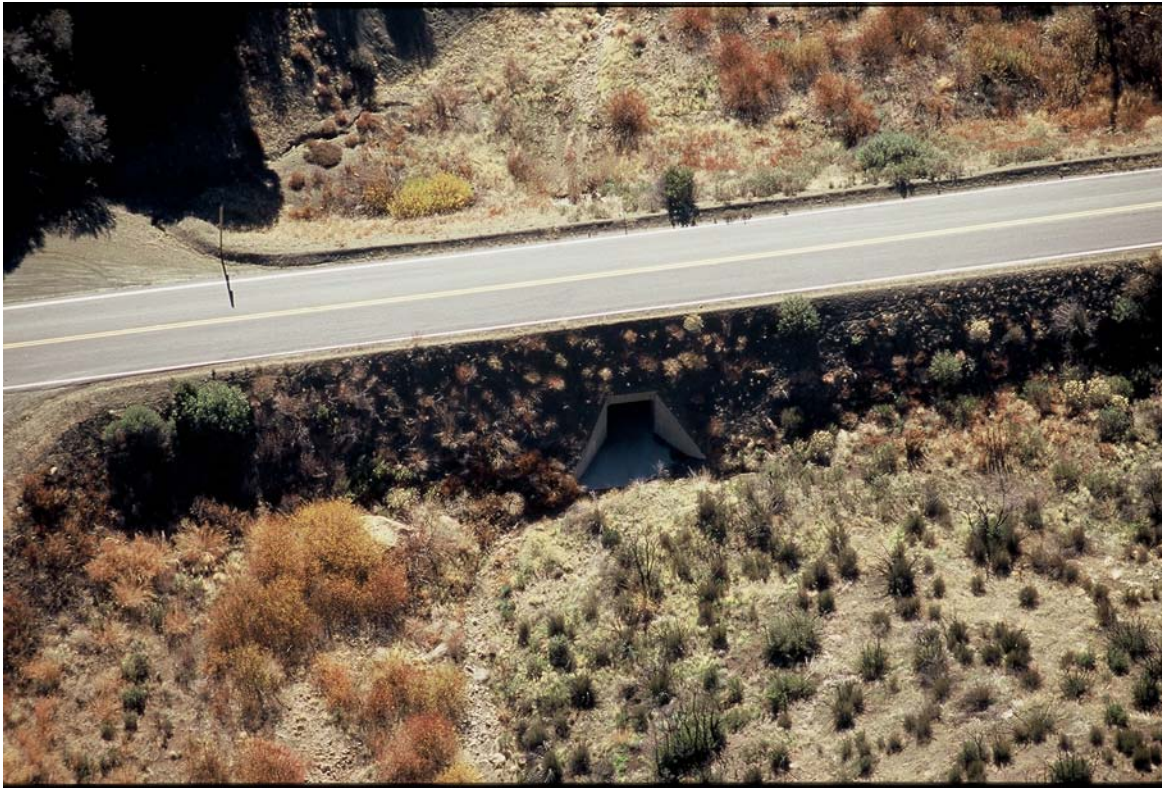
Burro Creek Highway 33 Box Culvert

Description: Two Highway 33 concrete box culverts occur on Burro Creek and the adjacent (unnamed) Burro Creek #2. The Burro Creek #2 box culvert measured 56 feet long and 6 feet wide by 8 feet tall. The steep slope of the culvert measured 11.8% with a total rise of 6 feet 7 inches from the inlet to the outlet at substrate level. The culvert bottom is damaged with exposed metal re-bar and worn concrete. No access was obtained to survey the Burro Creek culvert, but observations from the road reveal a similarly steep slope and approximately 2-foot outlet drop.

Diagnosis: Due to the steep slope of these culverts, the structures fail to meet DFG and NOAA passage criteria at all flows for strongest swimming species presumed present. During low flow conditions encountered in late November only 214 feet of habitat with surface was observed upstream of the Burro Creek #2 culvert and below an impassable 19-foot tall waterfall. However, much of the habitat observed was step-pool habitat with pools over 2 feet deep and one large plunge pool over 6 feet deep. This limited habitat may be able to support a small number of trout and provide one large over-summering pool. In accessible private lands occur upstream of Burro Creek #1 and habitat conditions were not surveyed upstream from the ground.

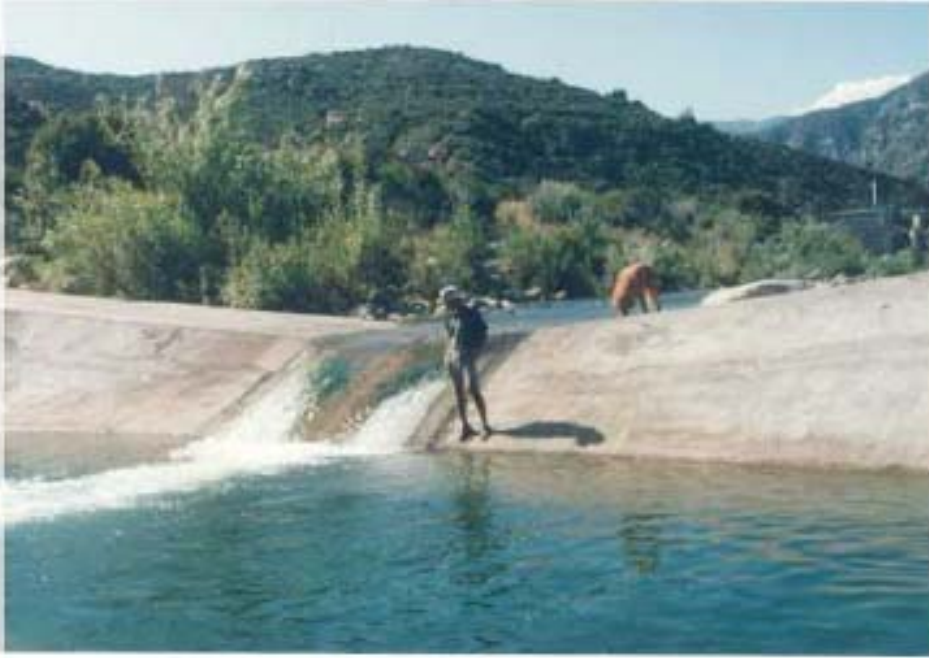
Photo # 13 Ventura River

An artificial barrier is present at a road crossing 150 meters downstream of the diversion dam (photo 13). Here, the stream flows over a concrete road and drops down a 1.5-2 meter slide into a large pool. This barrier may be passable during periods of high flows.
