# **Steelhead Migration Barrier Assessment and Recovery Opportunities for the Sisquoc River, California**

Prepared by:  
Matt Stoecker and Jim Stoecker  
Consulting Biologists  
P.O. Box 240  
Santa Barbara, Ca. 93102  
and  
Community Environmental Council  
930 Miramonte Drive  
Santa Barbara, Ca. 93109

**January 23, 2003**

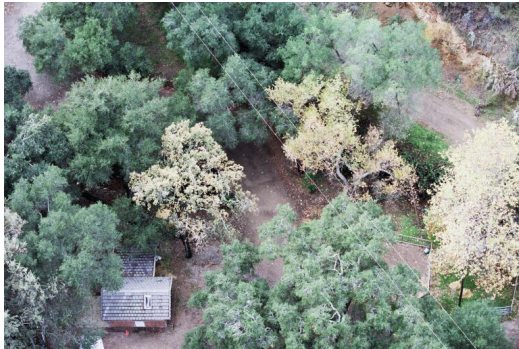
SC\_TT\_17

**Description:** Access to ground survey these structures was not obtained. Observations of these dirt crossings were made from the air and are limited in detail. Both crossings were obstructed from view by riparian vegetation, but are assumed to be culvert crossings with earthen fill, as no flow was observed passing over the top of the dirt roads. These crossings occur approximately one hundred feet apart from each other. The outlet configuration and downstream pool could not be seen through the thick riparian vegetation.
