Steel head Assessment and Recovery Opportunities in Southern Santa Barbara County, California

**BY
Matt W. Stoecker
and
Conception Coast Project**

June 2002

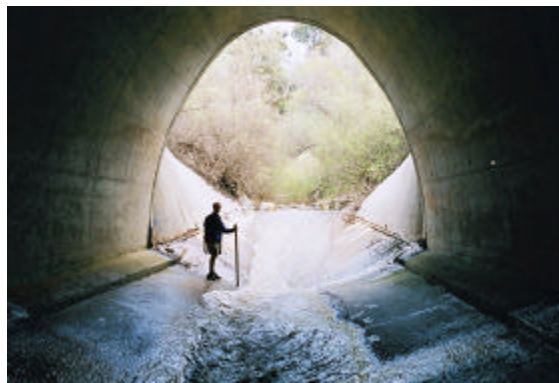
*Figure 1.3.1
Rincon Creek Highway 101 Culvert*

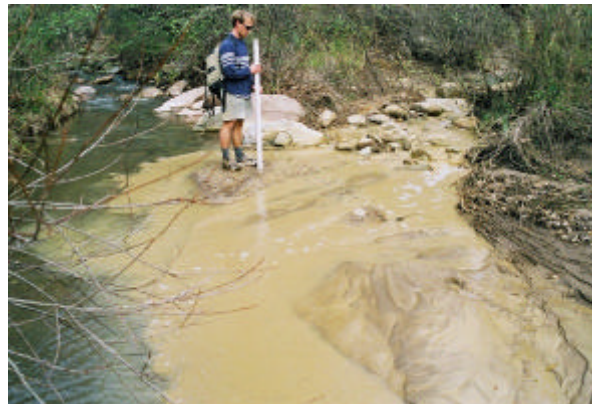
Figure 1.3.2
Excessive sediment from Casitas Creek entering Rincon Creek

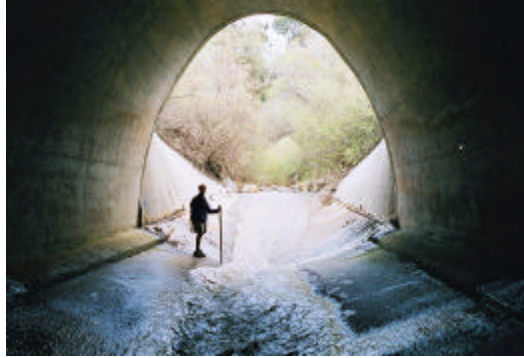
Location: Highway 101 Crossing

Description: This concrete arch culvert has a shallow U-shaped bottom and mild slope for over 800 feet to the base of a steep inlet apron. Three small 8-12 inch tall concrete drops occur along the length of the culvert. The inlet apron measures 41 feet in length with a vertical height of 6 feet 5 inches from the downstream culvert bottom to the upstream apron lip. The slope of the inlet apron measured greater than 15%. A detailed analysis of this culvert, along with fish passage analysis and alternatives, is discussed in a report titled, Preliminary Plan Formulation Report for the Rincon Creek Aquatic Ecosystem Restoration Project Santa Barbara/Ventura County, California prepared by MEC Analytical Systems, Inc. for the U.S. Army Corps of Engineers, Los Angeles District 2002.

Diagnosis: During migration flows, steelhead can easily swim into the outlet of the culvert, which is at streambed level or slightly submerged, depending on stream flow and lagoon influence from downstream. The mild slope of the culvert and three, small concrete drops would allow moderately difficult upstream passage of adult steelhead for over 800 feet through the culvert to the base of the inlet apron. The steep slope of this inlet apron, length, and smooth concrete characteristics produce excessive water velocities during all migration flows, in addition to shallow conditions during lower stream flows, that preclude all upstream steelhead passage. The culvert is currently not sized to carry a 100-year flow event (pers. comm. Capelli).

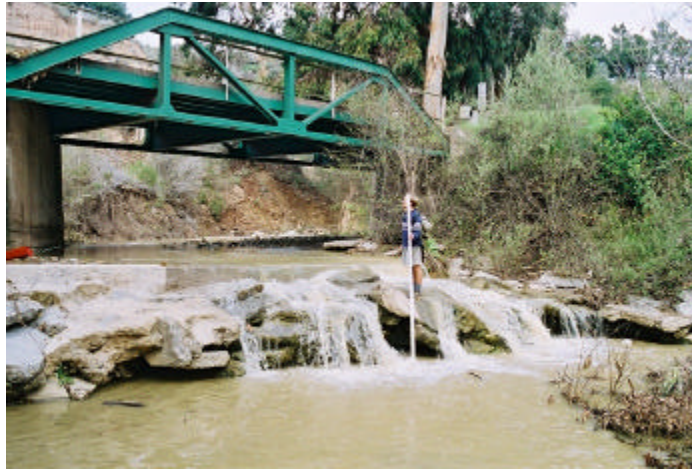
Location: #1 Highway 150 Bridge

Description: Downstream from this Highway 150 bridge, a concrete curb of varying thickness spans 42 feet across the entire stream channel. Sediment has accumulated behind this curb to within one foot of the top. Water is mainly concentrated over the middle and river-left portion of the curb at lower flows. A riprap apron composed of concrete slabs extends 7 to 9 feet downstream from between 6 inches to 2 feet below the lip of the curb. The apron has a moderate downward slope. Flows drop vertically from the downstream end of the apron 2 to 3 feet into the pool downstream. The maximum depth of the downstream pool measured 2 feet 2 inches. The overall height of the structure from pool surface to the lip of the concrete curb measured 5 feet.

Condition: This structure is in fair condition with several feet of undercutting on the downstream side of the apron. The alignment of the bridge and Highway 150 seem to be contributing to significant bank erosion upstream of the bridge.

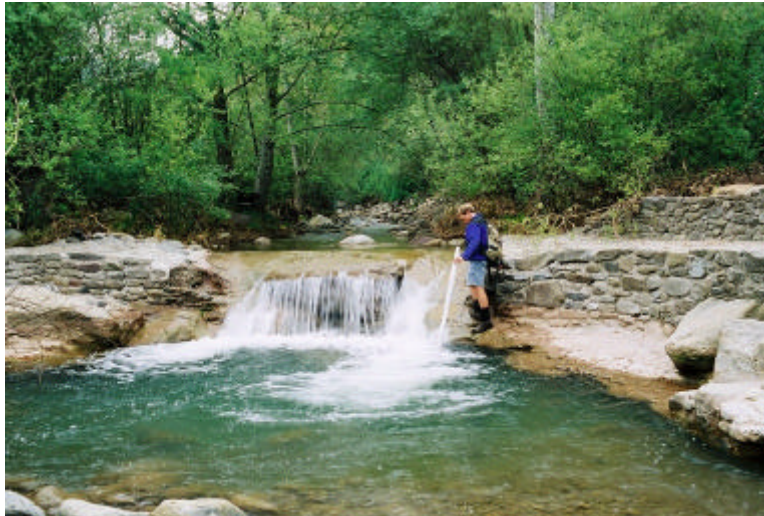
Location: Approximately 500 feet upstream from #3 Highway 150 Bridge

Description: This dam was built with large boulders, stones, and concrete by the previous landowner to make a recreational pool upstream, but quickly filled in with sediment (pers. comm. current landowner). The dam has a shallow U-shape in the center that concentrates flows over, and around, a large boulder ledge that extends out from the dam with a moderate downward slope. The horizontal length from the upstream lip of the dam to the downstream lip of the large boulder ledge measured 8 feet. Water also flows on either side of the boulder ledge down steep concrete chutes. The maximum jump depth of the pool downstream measured 5 feet 10 inches and the jump height from the pool surface to the top of the dam measured 3 feet 6 inches.

Condition: Downstream scour has caused significant undermining of the dam and adjacent revetment that is compromising the integrity of the structure. This dam is in poor condition.

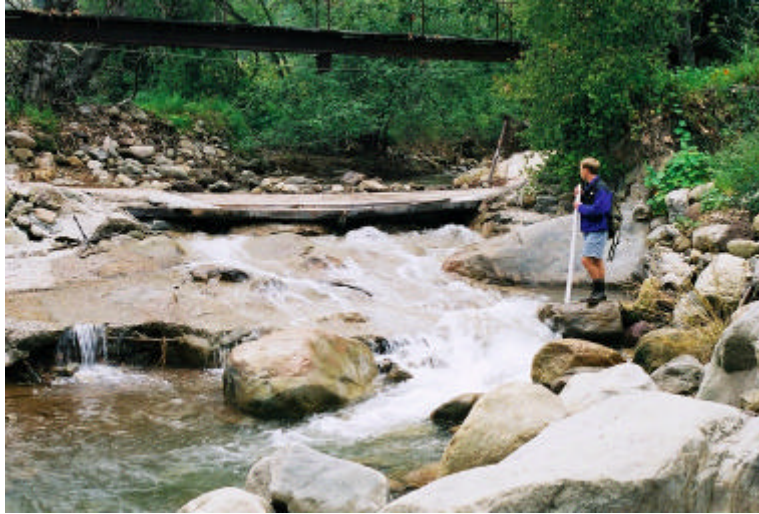
Location: #1 Crossing upstream from #3 Highway 150 Bridge

Description: This 12-foot wide concrete and steel road crossing spans the creek with water flowing underneath in three one-foot diameter culvert pipes. All culverts are blocked with cobbles at the upstream end, but still convey the flows encountered. Water is also flowing under the structure outside of these culverts. The downstream lip of the road crossing drops 1 foot 7 inches vertically to the irregular, concrete and boulder riprap apron that extends 20 feet downstream at a moderate to high slope. Flows are concentrated down the river-left side of the apron, which transitions into the small pool downstream. On the river-right side, the apron drops one-foot onto substrate.

Condition: The structure appears to be in poor condition with significant undermining of the crossing adjacent to the clogged culverts and minor undercutting downstream of the apron and on both adjacent banks.

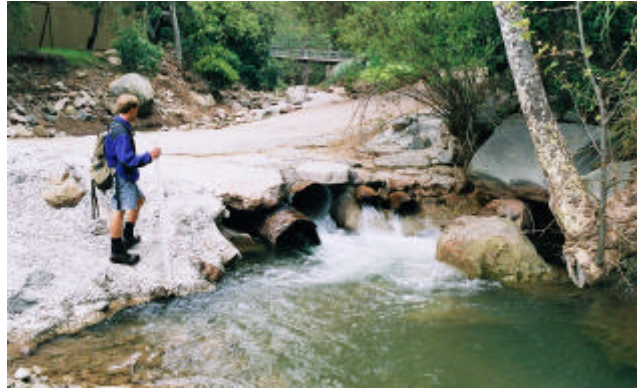
Location: #3 Crossing upstream from #3 Highway 150 Bridge (#1 Stanley Park Road crossing)

Description: This concrete riprap crossing spans the creek at a width of 25 to 30 feet from the upstream surface edge to the downstream surface edge. This crossing has been repaired and added onto several times and contains four visible metal culverts of varying size and condition. The two smooth metal culverts on the river-left side measured one-foot in diameter and were conveying water under the crossing. At the center of the crossing two corrugated metal culverts with 2-foot diameters sit side-by-side. The river-right culvert was not conveying any water while the other culvert was. All culverts, except the 2-foot diameter culvert conveying water, were completely blocked with sediment on the upstream side of the crossing. The 2-foot diameter culvert conveying water measured approximately 25-30 feet in length with a moderate slope. The jump height into this culvert measured 10 inches and the jump depth measured 2 feet 2 inches.

Condition: The culverts are in fair to poor condition and the structure has moderate undercutting adjacent to the culverts and downstream bank edges.

Diagnosis: The one culvert that was visible from the upstream end of the crossing was running at 90% capacity during the flows encountered (~6 c.f.s). The moderate slope of this culvert produces a highly difficult passage scenario under ideal conditions and during most migration flows this culvert is likely conveying excessive water velocities or is clogged with sediment and flows are passing over the crossing. The culvert inlet appeared to be cleared recently to convey water and was surrounded by deposited substrate with a steep slope of cobbles upstream of the culvert. Passage over the top of the crossing at high flows would be extremely difficult due to the high water velocities over the smooth concrete road, lack of resting areas, and moderately difficult jump onto the crossing.

Recommended Action: Work with the owner to assess the feasibility of removing this crossing and replacing it with a bridge that does not impact the streambed or impede fish passage. Because of the low stream banks adjacent to the existing crossing it may be ideal to place a new bridge approximately 150 feet upstream near an existing pedestrian bridge where the stream banks are higher and more ideally suited for a bridge. A bridge would reduce the safety and access concerns for upstream resident that are occasionally trapped during high stream flows (pers. comm. local landowners).

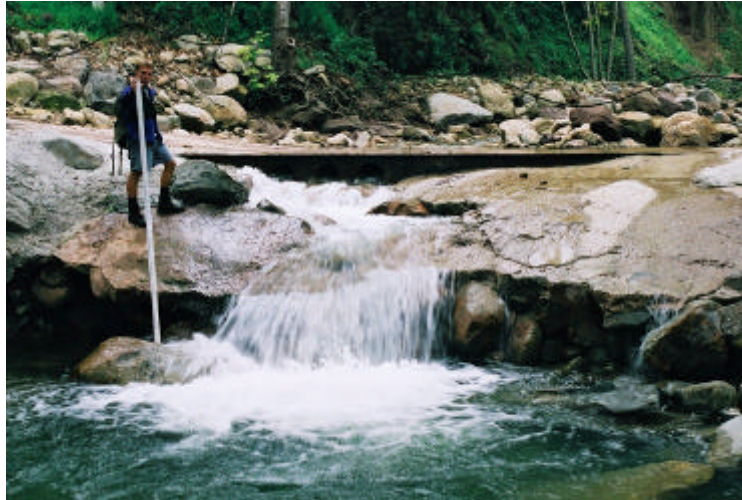
Location: #6 Crossing upstream from #3 Highway 150 Bridge

Description: This 12-foot wide concrete and steel beam road crossing contains three one-foot diameter smooth metal culverts. All three culverts conveyed water at 50% capacity during the survey. A small amount of water flowed over the surface of the crossing. Downstream of the crossing's surface, an irregular and damaged concrete and boulder riprap apron slopes downstream over 12 horizontal feet and terminates 2-3 feet above the downstream pool. The overall height of the structure from the downstream pool surface to the surface of the crossing measured 7 feet 10 inches.

Condition: Scour on the downstream side of the structure has undercut the structure 4 feet on the river-right side. The adjacent stream banks have been eroded significantly.

Diagnosis: The downstream pool provides a sufficient jump depth of 5 feet to allow a moderately difficult vertical jump (4 feet 5 inches) and horizontal jump (6 feet) to a small resting pool broken through the concrete apron. This resting pool measured 4 feet by 2 feet with a depth of 16 inches. From this resting pool, steelhead would attempt to migrate through the culverts at low and moderate flows. Passage through the culverts is not possible due to the constricted size and smooth characteristic of these pipes, presence of obstructive concrete and boulders at the culvert outlets, moderate slope, and deposited sediment at the upstream inlet. With higher stream flows it may be possible, although extremely difficult, for steelhead to jump and swim onto the crossing and migrate upstream. During all stream flows, this structure would likely be impassable to upstream steelhead migration or, at best, presents an extremely high degree of difficulty.

Recommended Action: Work with owner to assess the feasibility of removing this structure and replacing it with a bridge or natural streambed alternative such as a large bottomless arch culvert.

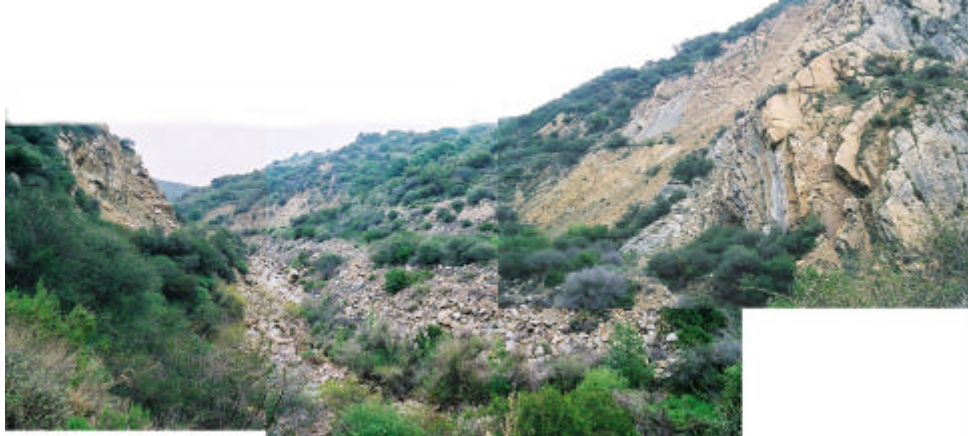
BR_RN_13: Rock Quarry Looking Upstream

Description: This barrier description includes a significant reach of Rincon Creek that has been extremely modified from a past rock quarry operation. This section of stream has been dramatically confined and partially buried with large boulder debris that was blasted from the adjacent canyon walls. Debris tailing mounds below the blasting sites (especially on the river-left side of the stream) have created excessive stream gradients associated with boulder cascades, waterfalls, and bedrock chutes. Specific features of this modified stream reach are discussed below as they relate to potential upstream steelhead passage.

Condition: This is an extremely altered stream reach with major channel realignment and riparian degradation.

- 1) Steep Boulder Gradient- Large boulder debris from the quarry has created a 77-foot long section of steep boulder cascades near the lower end of the quarry with a measured slope of 18%. This section is impassable to all salmonids during all flow conditions.

Recommended Action: According to Mr. Sjovold, the quarry was a major petroleum related operation that extracted rock to build the Richfield Island, southeast of Rincon Point. It is believed that a conditional use permit was obtained from both Santa Barbara and Ventura Counties and a lease was obtained from the Los Padres National Forest to extract rock from the quarry. Under this conditional use permit, Sjovold recalls that the quarry operator was required to restore the creek after the quarry operation ended and this never happened. Sjovold believed that Atkinson Construction filed the mining claim and was under contract to Richfield (now ARCO-Atlantic Richfield Company) to build the Richfield Island. Recommendations for this section of Rincon Creek include:

- 1) Locating the original permits, leases, and information regarding the quarry operation as well as the construction of roads to access the quarry, which may include downstream barrier crossings.
- 2) Determining the owner/operator of the quarry at the time of construction and current owner of the quarry's products (i.e. Richfield Island) and others.
- 3) Work with appropriate owners and stakeholders to address restoring this section of Rincon Creek and potentially mitigate the damage that has occurred due to the quarry and potential road crossings.
- 4) Assess the feasibility of providing unimpeded steelhead migration through this stream reach to the upper watershed.

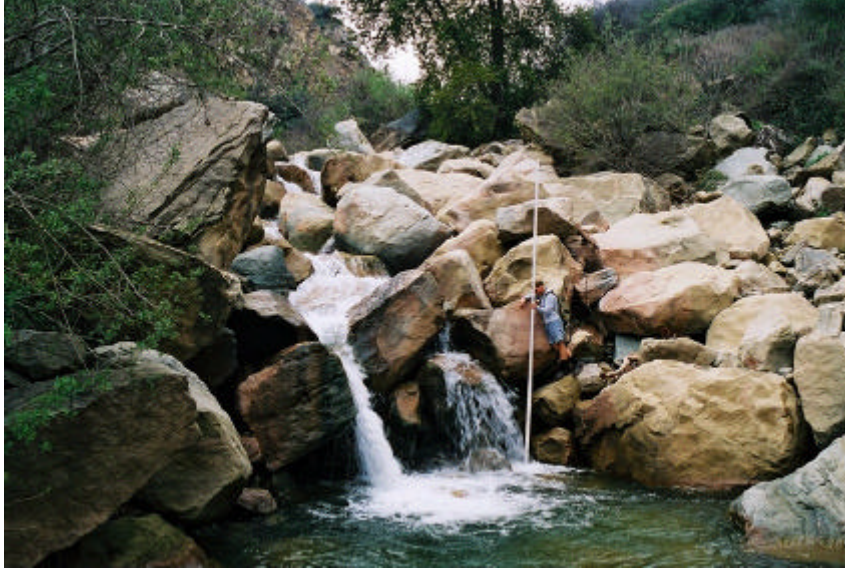
BR_RN_13: Boulder Waterfall/Cascade

- 2) Boulder Waterfall/Cascade- Upstream of the steep boulder gradient a large boulder jam has produced a long section of boulder cascades and a waterfall that measure 29 feet in total height. This section is impassable to all salmonids at all flows.

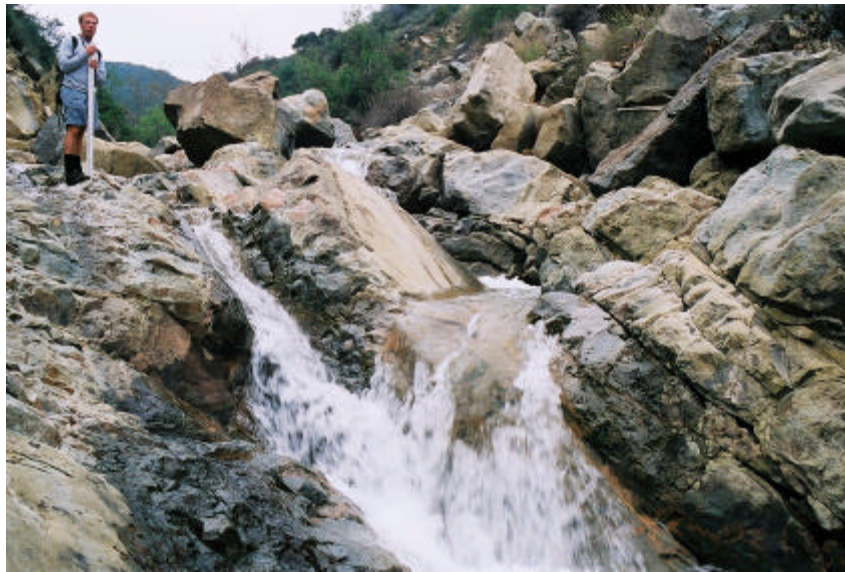
BR_RN_13: Bedrock Chute

- 3) Bedrock Chute- A steep bedrock chute exists upstream of the boulder waterfall/cascade that has a total height of 15 feet and slope in excess of 30%. This feature does not appear to be part of the original streambed and is likely a result of the debris-tailing mound on the river-left side of the stream confining the stream against this bedrock on the river-right side.

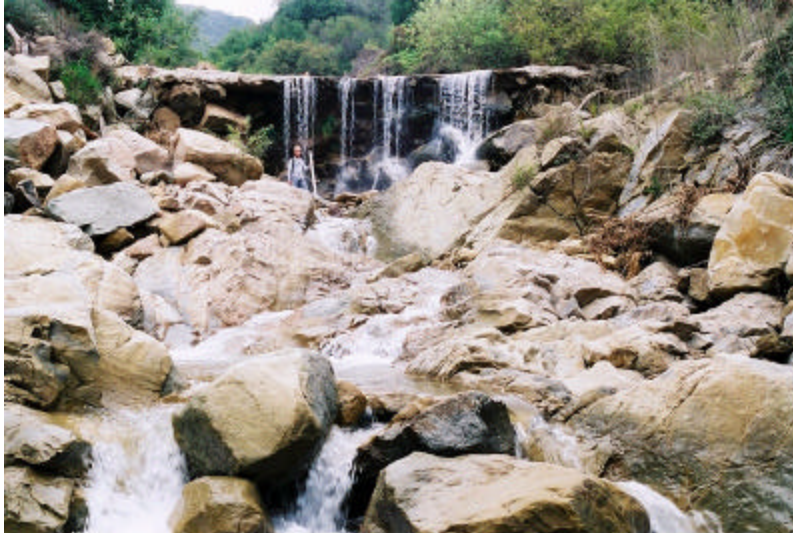
BR_RN_13: Failed Road Crossing

- 4) Failed Road Crossing- Near the upstream end of the quarry operation, downstream from the Rincon Creek Trail crossing, a failed road crossing spans most of the stream channel and has a height of 15 feet. The far river-right side of the crossing has blown out and no longer connects to that stream bank. This structure appears to be eroding rapidly but currently would be impassable for upstream steelhead migration.

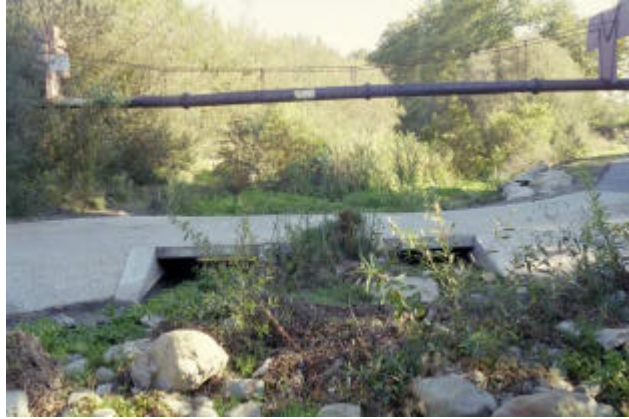
Location: 50 feet upstream from Highway 101 Bridge

Description: This pedestrian crossing has three small concrete box culverts at the center of the structure that convey low stream flows under the crossing. Each of the three adjacent box culverts measured 60 inches wide with a height of 20 inches. The bottom of each the culvert was partially embedded with streambed substrate and the middle culvert was completely clogged with debris and aquatic vegetation. The relatively flat slope within the culverts is consistent with that of the streambed. The top of the crossing is smooth concrete and relatively flat.

Condition/Sizing: This structure is in fair condition with minor damage to the concrete from bedload sediment abrasion during high stream flows. The crossing is designed to carry low stream flows through the culverts and higher stream flow over the top. The culverts are highly susceptible to clogging.

Recommended Action: The City of Carpinteria and Carpinteria Creek Committee are currently discussing fish passage improvements at this pedestrian crossing. Because this structure is the lowest significant impediment to upstream steelhead migration in the watershed, discussions of removing the crossing are encouraged to eliminate blockage hazards and delays to upstream migration. A pedestrian bridge or existing alternative crossing site that does not impact the streambed is recommended.

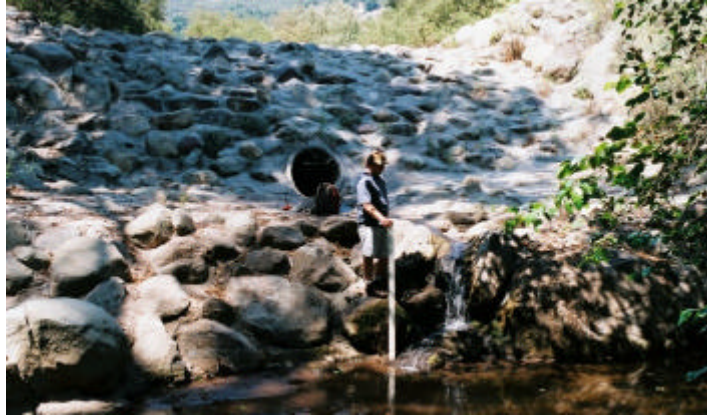
Location: Approximate Elevation 340 feet

Description: This debris dam is composed of boulder and concrete riprap and is of similar construction to the Gobernador Creek debris dam (BR_CA_GR_6). A small pool downstream of riprap apron had a jump depth measuring 1 foot 6 inches. A jump height onto the riprap apron measured 4 feet 6 inches. The apron extends 35 feet from the downstream lip upstream to the outlet of the culvert with an overall slope of 4.8%. This apron has several slope changes and an irregular boulder embedded surface. The length and slope of the culvert could not be accurately determined because the culvert inlet was clogged with sediment and debris. It is assumed that the length is similar to the Gobernador Creek culvert, which measured 97 feet.

Condition: This obsolete debris basin has not been maintained for several years and accumulated sediment and debris behind the dam has clogged the culvert at the inlet and filled most of the basin. Surface flows are still able to permeate through the upstream debris and pass through the culvert. Currently, the SBCFCD has no access road to the debris basin and dam and reportedly drove heavy equipment up the stream channel to access the dam in the recent past (pers. comm. Pinkham, Vedder). Moderate undercutting is occurring on the downstream river-right side of the dam.

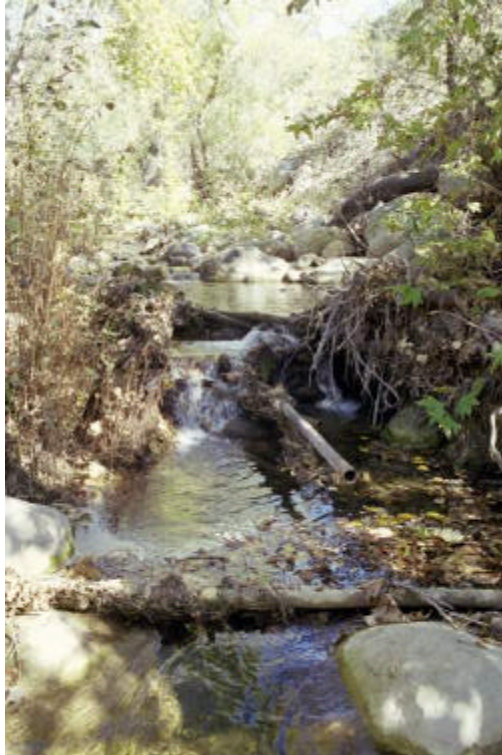
Location: Approximate elevation 260 feet

Description: Several abandoned metal pipes have become wedged and entangled to produce a drop of 3 feet over to small step.

Diagnosis: During low flows, upstream migrating salmonids need to execute an easy 2-foot jump into a small resting pool produced by the metal pipes and then jump 1-foot over the top of the last pipe. Upstream migration past this site has a minimal to low degree of difficulty.

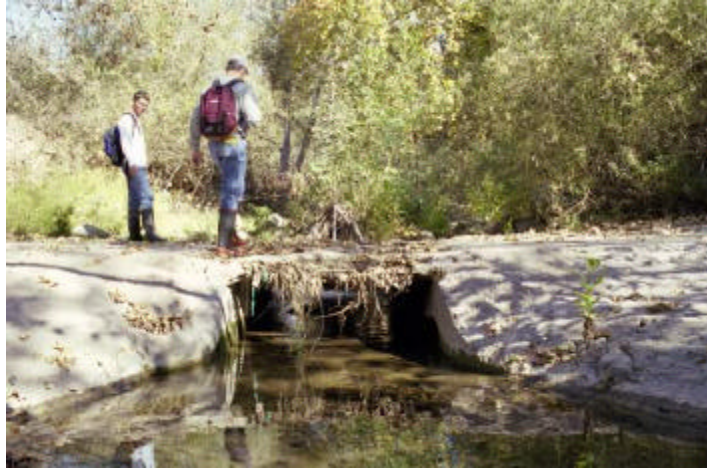
Location: Approximate elevation 290 feet

Description: This concrete crossing spans the stream channel in a gradual U-shape from bank top to bank top. A concrete box culvert measuring 60 inches wide and 26 inches tall at the downstream end extends 136 inches under the center of the crossing. A debris grate composed of 2-inch diameter metal bars surrounds the inlet of the culvert where flows drop 23 inches from the upstream substrate down into the culvert bottom. The pool below the crossing extends into the culvert and created a depth of 8 inches throughout.

Condition: The concrete structure and debris grate are in fair conditions with moderate damage from bedload sediment passing over and through the crossing at high flows.

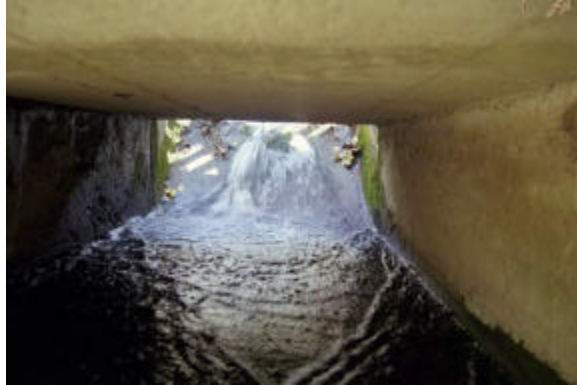
Location: Approximate elevation 300 feet

Description: This concrete stream crossing is very similar to the next downstream crossing (BR_CA_GR_3) and was likely built around the same time and possibly by the same individual(s). The crossing spans the entire stream channel in a gradual U-shape from bank top to bank top. A concrete box culvert measuring 60 inches wide and 28 inches tall at the downstream end extends 146 inches under the center of the crossing. A debris grate composed of 3-inch diameter metal bars covers the inlet with a flat, parallel configuration and 6-inch spacing between the bars. Flows pass through the grate and down a steep slope at the inlet of the culvert and drop 40 inches to the culvert bottom. Unlike the crossing downstream, the culvert bottom extends downstream of the culvert 34 inches and forms a small ledge. At low flows, water drops 3 inches off this ledge into a pool downstream with a maximum depth of 3 feet.

Condition/Sizing: This structure is in extremely poor conditions due to major undercutting of the road on both downstream sides (up to 7 feet deep) and scour on adjacent downstream banks. The integrity of this crossing is compromised due to scour influenced by the crossing.

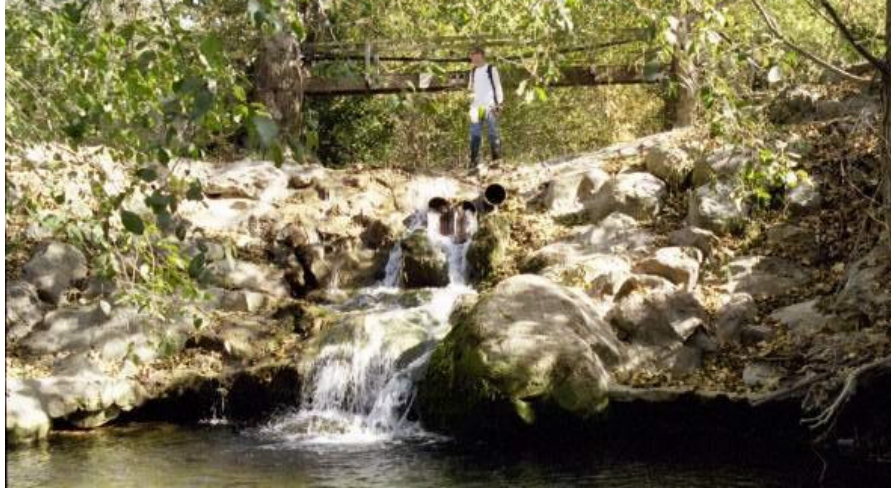
Location: Approximate elevation 345 feet

Description: This private crossing is composed of boulder and concrete riprap and spans the stream channel in a shallow U-shape. The overall height of the structure, from the crossing's surface to the bottom of the downstream pool, measures 15 feet. The maximum pool depth measured 5 feet giving the structure a height of 10 feet tall from the pool surface. During low flows, water is conveyed under the crossing in three irregularly placed metal pipes with equal diameters of 10 inches. Water flowing out of the culverts cascades 7 feet down a steep riprap section onto a moderately sloped step measuring 70 inches in length and then falls almost vertically 3 feet 6 inches into the downstream pool. The overall horizontal distance from the pool to the downstream lip of the crossing measured 15 feet. Sediment is backed up to the top of the upstream side of the structure.

Condition/Sizing: The crossing is in poor condition with moderate concrete wear, significant undercutting of the structure, and erosion of adjacent downstream banks.

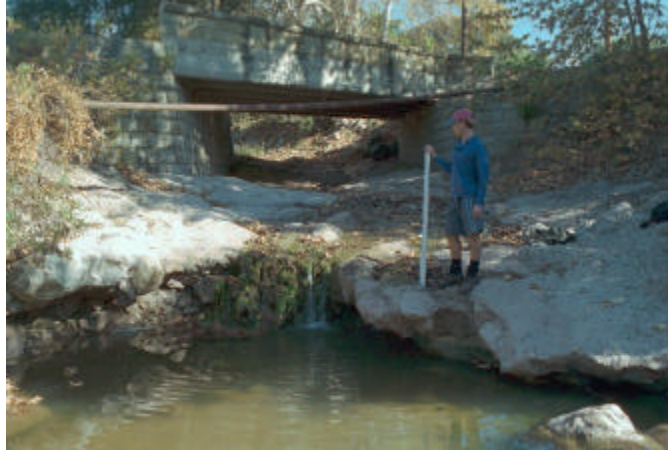
Location: Highway 192 Crossing

Description: The bridge is constructed of cut stone and concrete. The concrete-lined bottom extends 71 feet in length from the upstream side of the bridge to a small pool downstream. The upper 21 feet of the concrete-lined bottom drops 2 feet 11 inches at a slope measuring 13.9% to a small pool under the bridge where the concrete has been completely eroded through. This damaged concrete pool measured 9 feet long, 3 feet wide, and 1 foot 9 inches deep. The lower 50 feet of concrete bottom has a mild slope measuring 4.5% to the downstream lip of the concrete where stream flows dropped 2 feet vertically into a pool with a jump depth of 1 foot 2 inches.

Condition: The concrete-lined bottom is in poor condition with several areas completely eroded through to streambed and extensive cracking throughout. Concrete at the upstream and downstream end is undermined with exposed metal re-bar at the inlet.

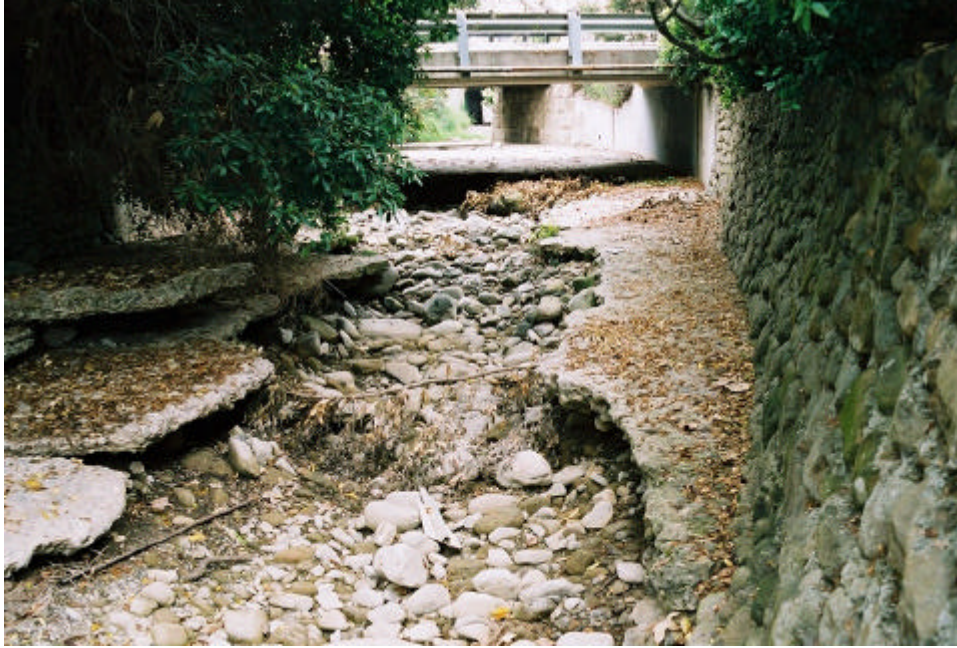
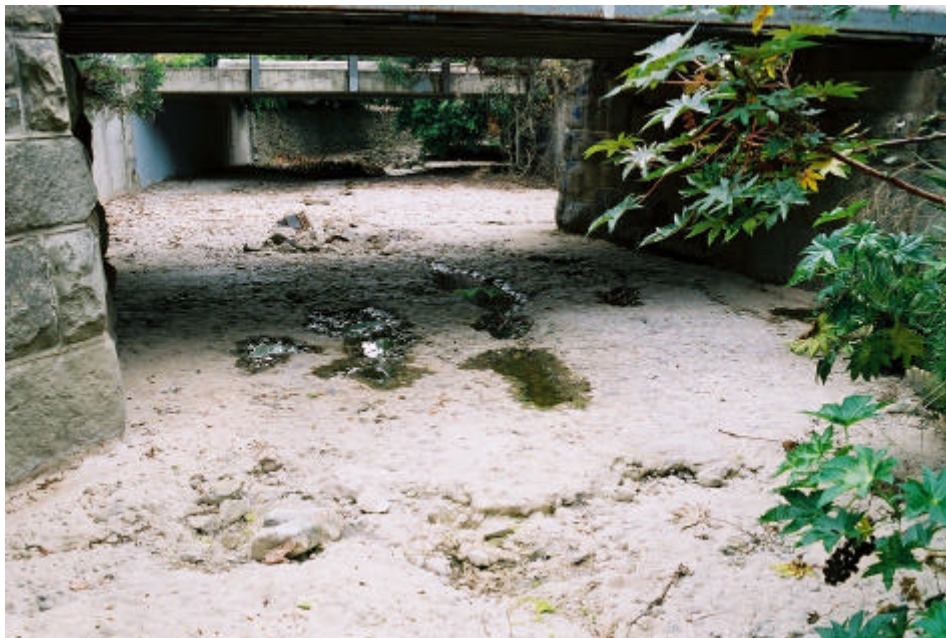
Location: UPRR and Santa Barbara County road crossing

Description: A rough concrete-lined channel extends from 10 feet upstream of the UPRR crossing 72 feet downstream to the start of major concrete channel failure underneath the S.B. County road crossing. The concrete channel drops 2 feet 11 inches into the failed section onto the streambed bottom. From this point, the remnants of the concrete channel and an 8-foot wide slot of natural streambed extend downstream 93 feet until the entire concrete bottom has disappeared.

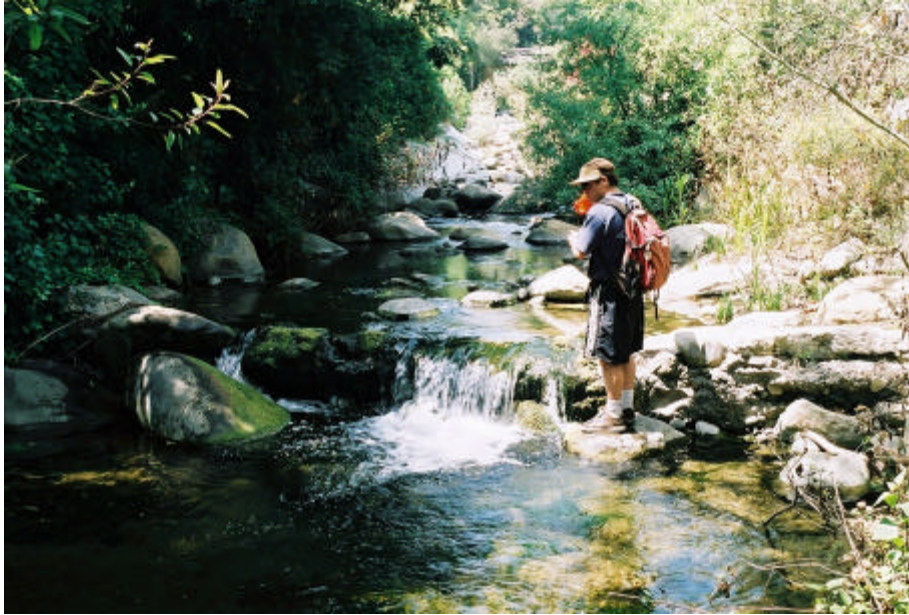
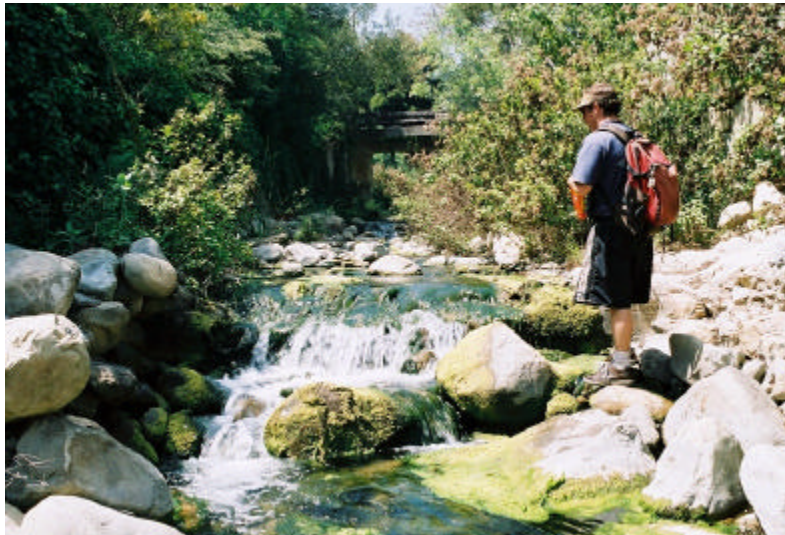
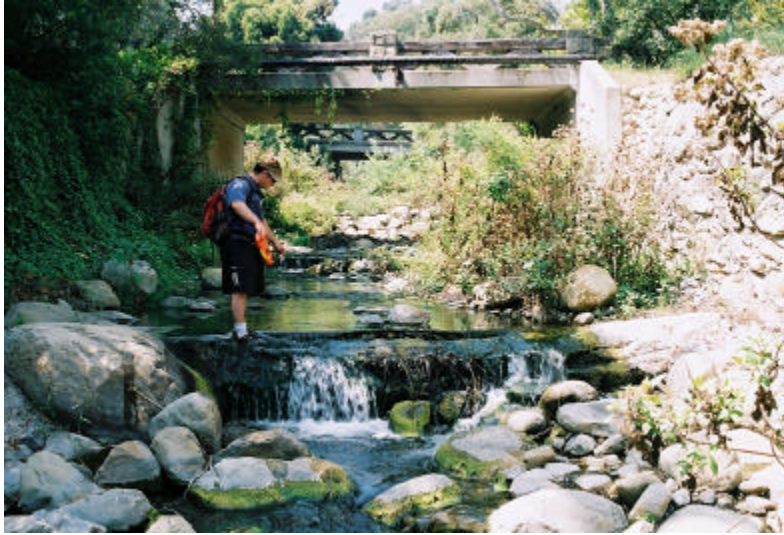
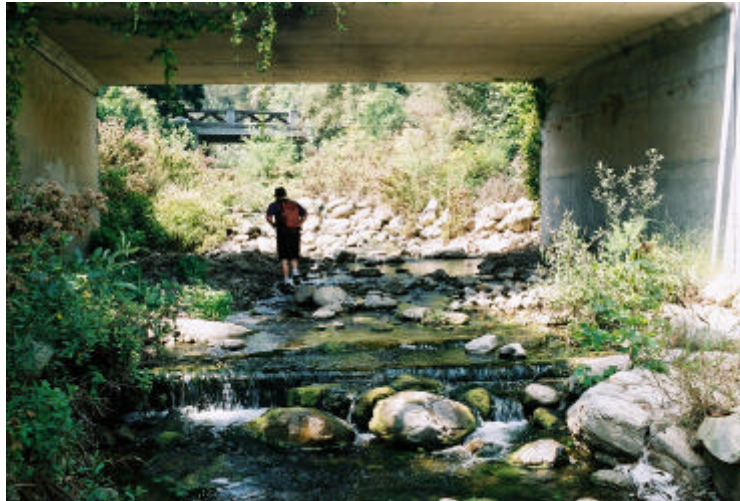
Description and Diagnosis: These four grade control structures occur downstream of the Highway 192 Bridge over several hundred feet.

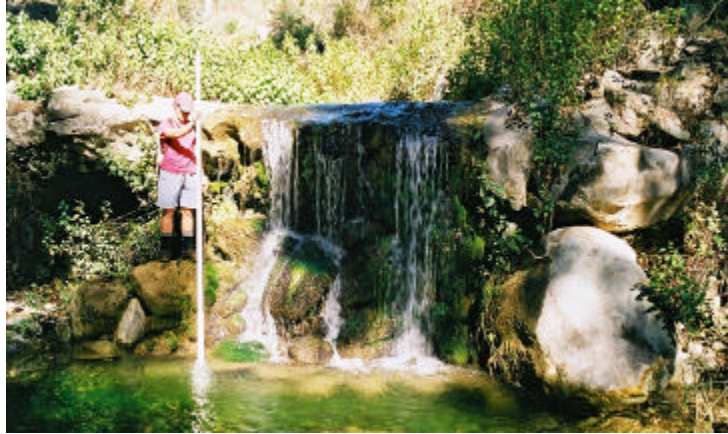
Location: Approximately 100 feet downstream from Santa Barbara County Flood Control District Debris Basin Dam

Description: A pipeline crosses the stream with a concrete and boulder grade control structure covering the top that spans 33 feet across the channel and averages 8 feet wide. Extensive downstream scour has occurred and has severely undercut the structure. A small amount of stream flow is currently passing under the concrete. The scour has produced a 9-foot vertical drop from the top of the grade control to the surface of the downstream pool. This pool measured approximately 17 feet in diameter and had a maximum depth of 3 feet 11 inches. Two *O. mykiss* (5"-7") were observed rising to terrestrial insects off the surface of this pool.

Condition/Sizing: This structure is in extremely poor condition due to major undermining from scour and is at risk of failing.

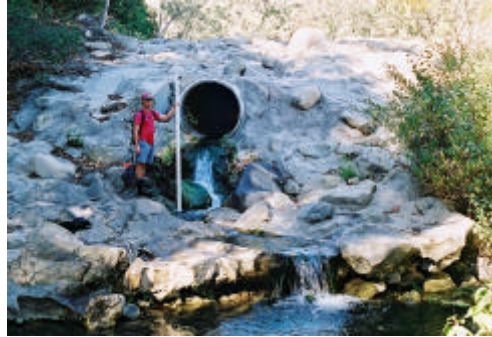
Location: Approximate Elevation 490 Feet

Description: This debris dam is composed of boulder and concrete riprap and conveys low to moderate stream flows through the dam in a 4-foot diameter smooth concrete culvert that measures 64 feet 6 inches in length. The slope of the culvert measured 4.8%. Water discharged from the culvert and dropped 5 feet onto an apron composed of boulder and concrete riprap that extends downstream 14 feet 3 inches over a mild slope among embedded boulders and two shallow pools (8 and 10 inches deep). On the downstream side of this apron, water dropped vertically 20 inches off the structure into a pool with a maximum depth of 15 inches.

Condition: This dam is regularly maintained and cleared of debris by the SBCFCD and is in fair condition with minor concrete damage and wear inside the culvert associated with bedload sediment scour during high stream flows. Low and moderate flows pass through the culvert and storm flows pass over the top of the structure when the debris basin has been filled and culvert is blocked.

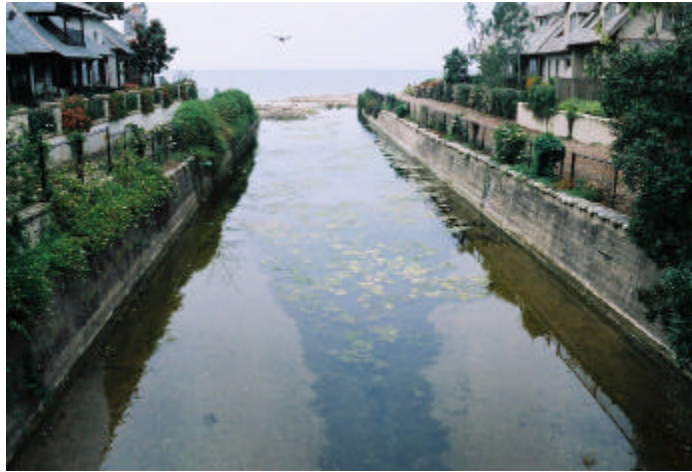
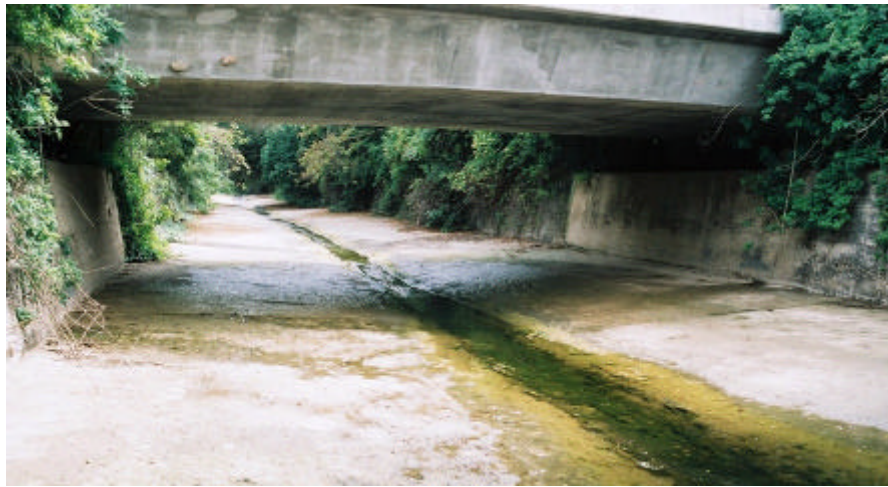
Location: Extends from mouth upstream to UPRR Crossing

Description: This concrete channel extends from the beach sand at the mouth of Montecito Creek upstream over 800 feet to approximately 25 feet downstream of the UPRR crossing. The measured length of this channel was 810 feet, but it is likely longer as beach sand covered part of the downstream end and streambed substrate covered the upstream end. What remains of the Montecito Creek lagoon is entirely within this channel and the “lagoon” water was backed up the channel 332 feet from the outflow on the beach. The exposed portion of the channel measured 478 feet in length from the upstream end of the lagoon water to the top of the channel. The walls of the channel are slightly less than vertical and measured 6 feet 5 inches tall upstream from the pedestrian bridge near the downstream end. At this same location the channel has a shallow V-shape bottom measuring 33 feet 9 inches across at the base of the concrete walls. Low stream flows are concentrated in a small, 2-foot wide U-shaped low-flow channel that runs most of the channel length at center. The low-flow channel becomes less confined in the upstream-most 200 feet and eventually disappears at the upper end of the channel with spread out shallow flows. The

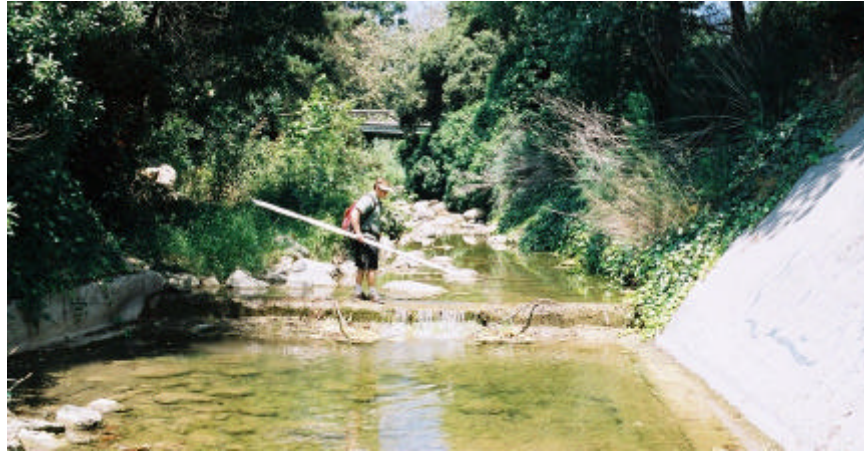
MO_2- This small, concrete curb is keyed into sloping concrete walls at the upstream end of the Highway 101 crossing bank revetments. This curb measured 21 feet across the channel with a thickness of 1 foot 6 inches. The jump height of the curb measured 1 foot 3 inches from the surface of the downstream pool, which had a jump depth of 2 feet 5 inches. Damaged re-bar on top of the curb was facing downstream. Low flows were concentrated at center. Upstream steelhead passage at this site is easily obtained with a minimal degree of difficulty.

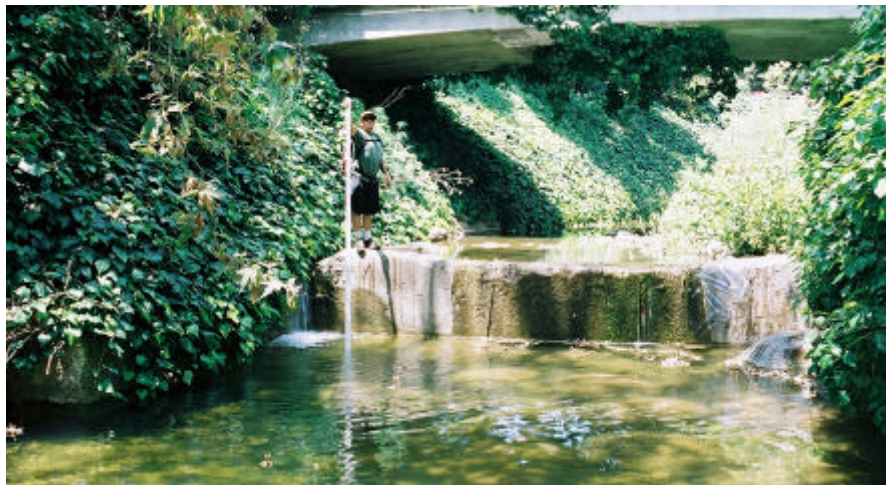
MO_3- This concrete curb measured 23 feet across the channel with a thickness of 2 feet. The height of the curb measured 3 feet 5 inches from the surface of the downstream pool, which had a jump depth of 1 foot 4 inches. Lower flows are currently directed against the far river-right side of the curb where an eroded notch exists 2 feet 8 inches above the downstream pool surface. Severe undercutting of the downstream river-right bank revetment is occurring. During migration

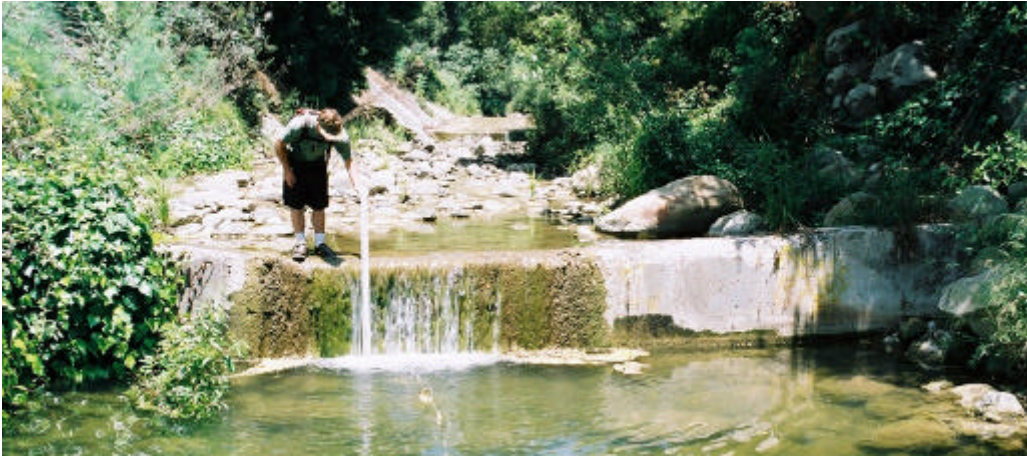
MO_4- This concrete curb measured 30 feet across the channel with a thickness of 2 feet. The height of the curb measured 2 feet 9 inches from the surface of the downstream pool, which had a jump depth of 4 feet 4 inches. During migration flows steelhead could make a moderately difficult jump over this curb. Concentrated low flows against the river-right revetment may impede upstream passage during lower flows.

MO_4- A notch of similar dimensions as recommended for MO_3 would provide a similar benefit.

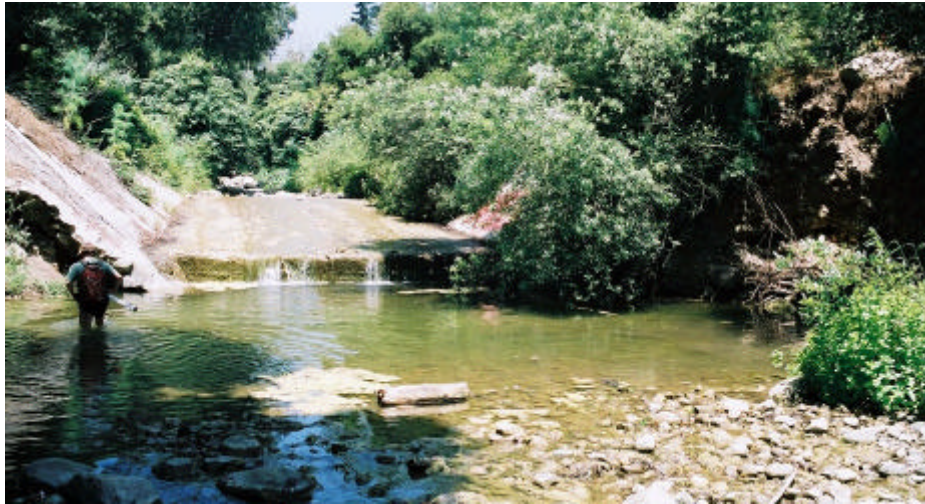
BR_MO_5 Before Modification

Description: This grade control structure measured 25 feet between sloping concrete wall revetments on adjacent stream banks. The flat concrete bottom measured 50 feet in length from the inlet to the downstream lip. The slope measured 6.66% with a rise of 3 feet 4 inches over 50 feet. The SBCFCD added wooden baffles to this structure early in 2002 after the first survey was conducted on 6/6/01. Significant erosion prevention measures were also constructed on both downstream banks where massive erosion had previously occurred. Large boulders were also placed immediately downstream of the structure, apparently to prevent downstream scour. Ten downstream facing V-shaped baffles were installed on the concrete bottom. The baffles have been spaced 5 feet apart and consist of two 11-foot 6 inch long pieces of 3.5 by 3.5 inch wood that is

Condition: The recently completed project appears to have improved bank erosion problems and reduced downstream structural undercutting. The concrete structure itself is in fair condition with minimal wear. Natural substrate is backed up to the top of the upstream side of the grade control.

Diagnosis: During the initial survey of this structure in 2001 the steep slope and length of the concrete surface was impassable to upstream migrating steelhead due to excessive water velocities and/or shallow depth. The wood baffles appear to have made upstream migration possible under ideal flow conditions by providing a series of resting pools upstream of the V-shaped baffles. Upstream migration from the downstream pool into the first baffle pool will have a low degree of difficulty during migration flows with adequate downstream jump depth. Migration over the lower baffles appears to have a low to moderate degree of difficulty with the baffle pools backing up to the bases of the next baffle. The upper baffles occur on a steep slope and have up to 12 inches of exposed concrete downstream of the next baffle that does not have water backed up over it. These reaches have minimal jump depth and present a moderate to high degree of difficulty during migration flows. The baffles should reduce velocities enough to enable steelhead to migrate upstream during higher flows with a high degree of difficulty overall.

Recommended Action: While this baffle and weir project has improved upstream fish passage conditions; the wood baffles will be highly susceptible to failure during storm flow events when large substrate moves across the structure. The effectiveness and maintenance of these baffles should be monitored to determine if adequate upstream passage conditions occur at the beginning of each migration season and following significant stream flows. An elaborate fishway design for this structure was developed by SBCFCD in 2000, but was never implemented (pers. comm. Treiberg). The baffles and boulder weir should be monitored during migration flows to determine their effectiveness of providing adequate upstream passage conditions. This structure will likely continue to present a significant impediment to upstream migrating steelhead during certain flow conditions and following baffle failure during high stream flow events. A project that provides unimpeded upstream passage during a wide range of flows and is not dependant on continual human maintenance should be assessed for this site. Removal of the structure and bank stabilization techniques should be considered. A natural stream bottom would provide the most effective and dependable upstream passage situation. Removal of the structure would dramatically affect the surrounding stream banks and additional studies are needed to determine the feasibility of this action and potential bank reinforcement techniques.

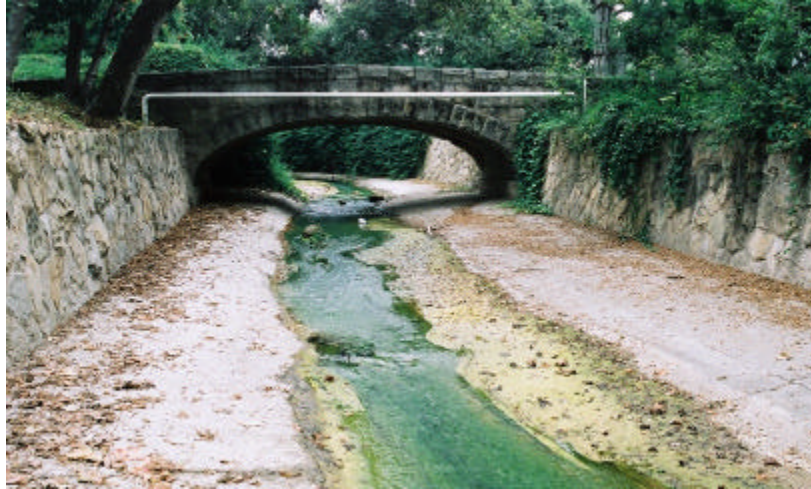
Location: Extends upstream from new Montecito Debris Basin Dam (BR_MO_13)

Description: This survey was conducted on 6/8/01 during construction of the Montecito Debris Basin Dam. The length of the concrete channel may change with the completion of the new Debris Dam. The survey of the channel began near the downstream end, where a temporary dam and water intake were set up to convey flows around the project area. This concrete channel extends upstream from this water intake 669 feet. The profile of the channel as well as the slope varies slightly throughout its length. Under the downstream private road crossing for the Casa Dorina retirement community, the channel is 25 feet wide at the base of the channel walls. The walls of the channel are slightly less than vertical and averaged 6 feet tall. At this same location the channel has a shallow, U-shaped low-flow channel at center that measured 2 feet 3 inches wide and 5 inches deep. The low-flow channel becomes less confined at the upstream end of the channel and eventually disappears with unconfined and shallow flows near the inlet. The slope of the channel was measured to be 3.1% at the downstream crossing. The upstream-most 75 feet of the channel had a slope measuring 3.5%.

Condition: Several locations exist along the channel where the concrete has been completely eroded through and the natural substrate is exposed. These damaged areas are discussed here working upstream from the downstream intake and temporary dam:

- 1) 40 feet upstream from the intake- this hole through the concrete bottom measured 8 feet long by 4 feet wide and had significant undercutting of the concrete.
- 2) 75 feet upstream from the downstream Casa Dorina crossing- the channel is highly damaged with exposed re-bar bent or broken and facing downstream every 20 inches.
- 3) 297 feet upstream from the intake- a large, damaged hole measuring 22 feet long, 4 feet wide, and 3 feet deep has major undercutting 4 to 5 feet under the concrete channel. Exposed re-bar surrounds the hole. One unidentified 3-inch fish spooked under the channel in this pool.
- 4) 390 feet upstream from the intake- another large damaged hole similar in size to the previous one exists here.
- 5) 500 feet upstream from the intake- Damaged and exposed re-bar is present.

Recommended Action: Any fish passage project at this channel will be complex and require significant coordination among stakeholders and detailed studies to assess alternatives for fish passage while maintaining adequate flood protection. A fish passage feasibility study to determine alternatives and associated impacts should be conducted. Within this study, the option to naturalize this channel reach and reinforce adjacent stream banks should be evaluated. Natural substrate conditions will provide the most effective upstream steelhead migration and overall aquatic benefit. Until a fish passage improvement project has begun, the holes in the channel should not be eliminated as they may offer the only chance for steelhead to migrate upstream of this channel. All exposed re-bar should be quickly eliminated and cut ends made dull.
