Steel head Assessment and Recovery Opportunities in Southern Santa Barbara County, California

**BY
Matt W. Stoecker
and
Conception Coast Project**

June 2002

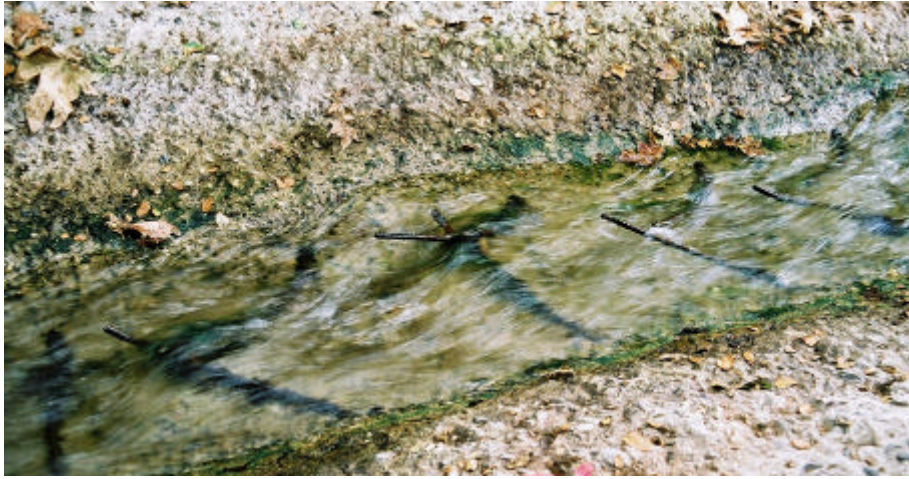
- 6) 596 feet upstream from the intake- A large, damaged hole measuring 8 feet long, 3 feet 6 inches wide, and 13 inches deep has major undercutting taking place under the concrete channel. Exposed re-bar surrounds the hole.

Diagnosis: Due to the length of the channel, sustained moderately-high slope, accelerated stream velocities during migration flows, and unconfined sheeting flows near the inlet, this structure presents an extremely high degree of difficulty to upstream steelhead passage and is likely impassable during most/all flows. The damaged holes in the concrete may provide resting spots to migrating steelhead and should not be eliminated until a project to improve overall passage has begun. The large amount of sharp downstream facing metal re-bar present a gauntlet of hazards to upstream migrating steelhead and would likely inflict serious injury, puncture eyes, and possibly cause mortality.

Recommended Action: Any fish passage project at this channel will be complex and require significant coordination among stakeholders and detailed studies to assess alternatives for fish passage while maintaining adequate flood protection. A fish passage feasibility study to determine alternatives and associated impacts should be conducted. Within this study, the option to naturalize this channel reach and reinforce adjacent stream banks should be evaluated. Natural substrate conditions will provide the most effective upstream steelhead migration and overall aquatic benefit. Until a fish passage improvement project has begun, the holes in the channel should not be eliminated as they may offer the only chance for steelhead to migrate upstream of this channel. All exposed re-bar should be quickly eliminated and cut ends made dull.

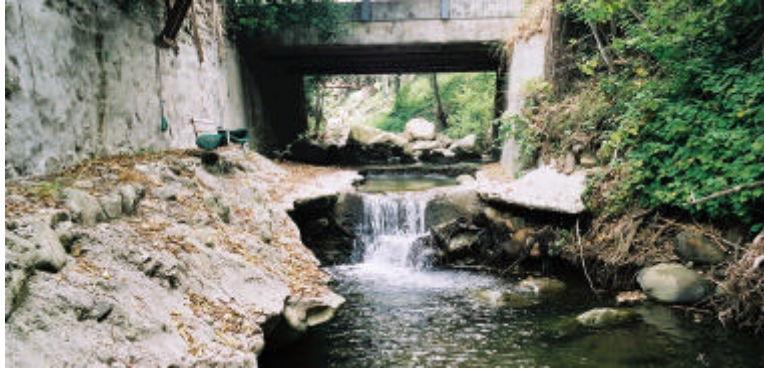
Location: Highway 192 Crossing

Description: The stream is confined between the vertical concrete bridge supports that measured 18 feet 7 inches apart. Concrete bank revetment with associated with adjacent homes extends downstream on the river-right side, and is keyed into the bridge. A grade control structure just downstream from the bridge measured 4 feet 1 inch in height from the surface of the downstream pool, which had a jump depth measured at 2 feet 6 inches. The grade control is actually 2 feet tall, but major downstream scour has dropped the substrate elevation and exposed the footing material the grade control sits on. Stream flows conveyed over this 1 to 2-foot thick grade control drop onto downstream boulders exposed from scour. A second 8-foot long concrete grade control extending 18 feet across the channel between the bridge supports occurs 20 feet upstream from the above mentioned grade control structure.

Condition: The grade control structures under the bridge are in poor condition with significant wear and undercutting. The bridge supports and downstream bank revetment are also extremely undercut and damaged. The structural integrity of the downstream bank revetments appears to be severely weakened.

Diagnosis: The presence of boulders below the grade control drop, limited pool depth, and jump height produce moderate to highly difficult passage conditions for adult steelhead during migration flows. Passage during lower flows may not be achievable for these same reasons.

Recommended Action: It is likely that the revetment downstream of the bridge will need to be significantly improved in the near future. This revetment is currently dependant on the presence of the bridge and any significant modifications to the bridge crossing will need to be coordinated with adjacent landowners. The extensive damage and poor condition of the grade controls and adjacent revetment present a complex situation that should be further evaluated to assess alternatives for improving fish passage and providing bank protection. Alternatives should assess options that maintain natural streambed conditions and reduce the confinement of the creek channel. One option to consider is the removal of the bridge deck and river-left support and associated grade control structures, slight channel realignment toward the river-left side, installation of a wider-span bridge, and reinforcement of the existing bank revetment and bridge support on the river-right side.

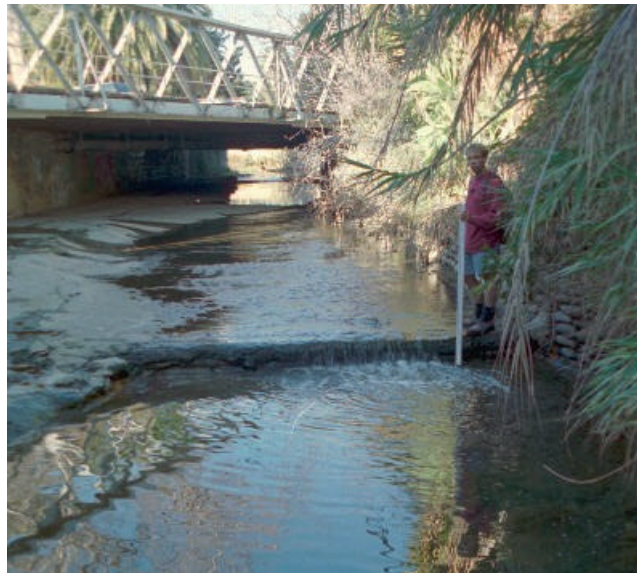
MN_1- The total length of this SBCFCD channel measured 0.17 mile, using GPS. The relatively flat channel gradient and presence of eroded holes and vegetation growing along the river-left side, allows upstream steelhead passage with a moderate to high degree of difficulty during moderate stream flows. Upstream passage is not possible during low flows, when shallow water depth occurs throughout the channel length. During extremely high stream flows, excessive water velocities likely prevent upstream passage.

Condition: The lowest channel (MN_1) is in poor condition with significant wear and damage through the concrete bottom in several places. The CALTRANS channels (MN_2 and MN_5) are in fair condition with moderate concrete wear on the channel bottom and minimal cracking.

Recommended Action: Due to the structural and political complexity of providing flood control and landowner safety, stream restoration and steelhead passage in lower Mission Creek needs to be addressed in a much larger planning process that seems to be moving forward in Santa Barbara. In order to make the most informed decision about the future of lower Mission Creek, a watershed-focused stakeholder planning process should be initiated that assesses long-term alternatives from the ocean to at least the Santa Barbara Natural History Museum. An entire watershed-wide plan would be ideal to formulate, but may not be essential to addressing critical components of accomplishing stream restoration, adequate flood control, landowner safety, steelhead passage, and other components for lower Mission Creek.

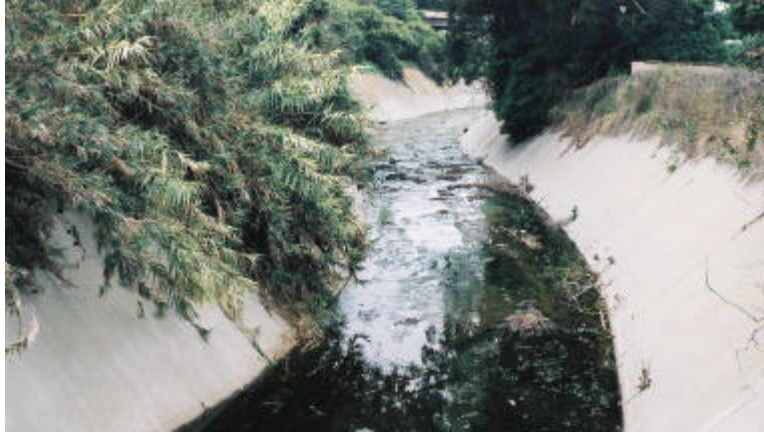
MN_2- This CALTRANS channel measured 0.74 mile, using GPS. The trapezoidal concrete channel measured 25 feet 9 inches wide along the bottom. The angle of the sloping concrete walls is approximately 45 degrees. The slope of the downstream 200 feet of the channel measured less than 1% (0.83). Near the Anapamu pedestrian bridge crossing, Highway 101 actually crosses over a portion of the concrete channel that enters a large box culvert. During low flows, upstream steelhead migration is not possible due to the unconfined, shallow water depth throughout the channel. When adequate water depth occurs in the channel, accelerated stream velocities are sustained throughout the long channel with no velocity breaks. Upstream steelhead passage is prevented due to exhaustion attempting to migrate the long channel.

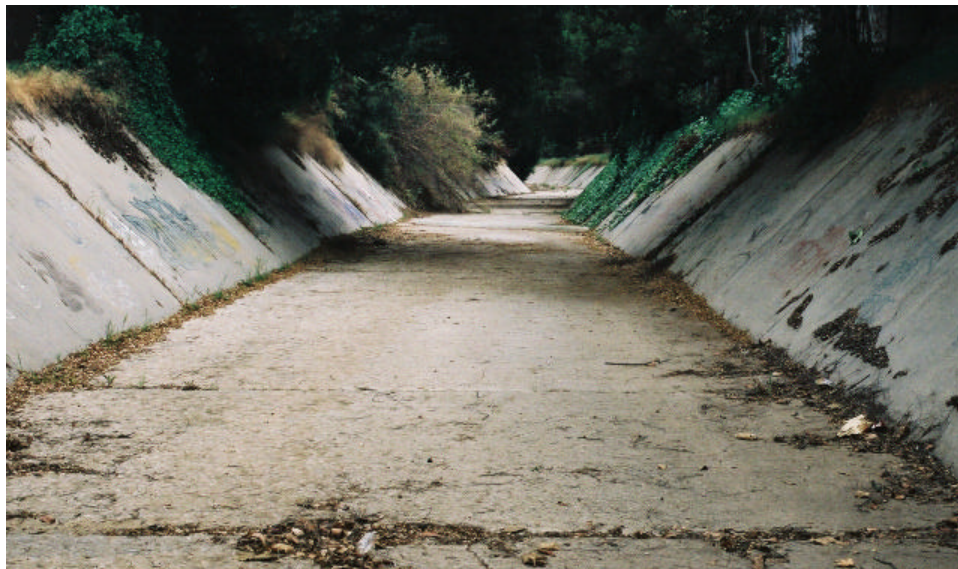
MN_5- This CALTRANS channel measured 0.27 mile, using GPS. The channel is almost identical in configuration to the downstream channel (MN_2). During low flows, a short 2-foot vertical drop occurred at the downstream end of the channel to the surface of the downstream pool, which measured 2 feet 7 inches deep. Sufficient water depth exists to allow a jump onto the concrete channel with a low degree of difficulty. Once on the channel, steelhead will encounter similar limitation as described above for MN_2. While this channel is shorter than the downstream channel, the slope increased and was measured at 1.2% at the upstream end.

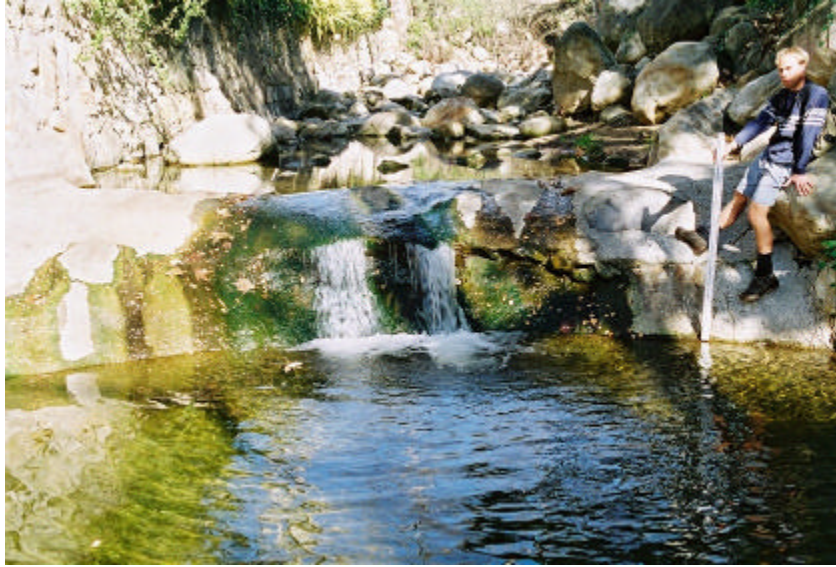
Location: Adjacent to Santa Barbara Museum of Natural History

Description: This concrete and boulder grade control structure is keyed into a stone revetment wall on the river-right stream bank and measured 24 feet across the channel. The downstream pool depth measured 2 feet 2 inches and is limited by a concrete-lined pool bottom. The jump height from the pool surface to the top of the structure measured 3 feet 2 inches. The top of the structure slants downstream over 6 feet and then drops to the downstream pool.

Condition: The structure appears to be in fair condition with moderate concrete wear.

Recommended Action: Upstream passage conditions could be improved, especially for juvenile salmonids and future adult steelhead migration during lower flows, by cutting a relatively level notch approximately 3 feet wide and 8 inches deep slightly off-center toward the river-left side where the maximum pool depth downstream is located. This action would reduce the jump height, length and steepness of the top of the structure, and concentrate flows toward the deepest part of the downstream pool for an increased jump depth.

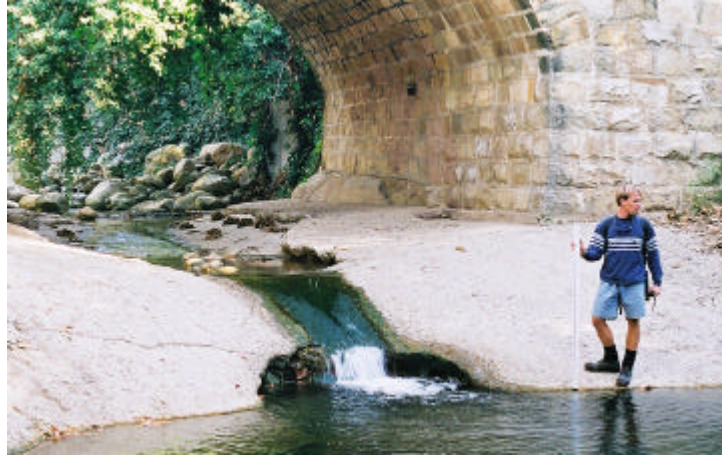
Location: Downstream-most (#1) Mission Canyon Road Bridge

Description: This stone arch bridge has been reinforced with a concrete bottom and sloping apron that are significantly damaged. The concrete bottom measured 58 feet in length from the upstream end of the concrete bottom to the downstream end of the apron. The apron ends 10 inches above the downstream pool. The smooth concrete apron measured 6 feet 11 inches in length with a slope of 31%. The jump height from the downstream pool surface to the top of the apron measured 2 feet 9 inches. Five feet downstream from the apron the jump depth measured 3 feet 4 inches. The maximum depth of the pool measured 8 feet 6 inches. A small 7-inch deep pool in broken concrete exists at the upstream end of the sloping apron and extends upstream 16 feet. The upper 35 feet of concrete-lined bottom has a slope of less than 2%.

Condition: The concrete bottom is in poor condition with significant damage throughout its length.

Recommended Action: It is likely that a significant amount of maintenance is scheduled to occur at this crossing in the near future. Improved fish passage should be incorporated into future maintenance projects and the desirability of maintaining the concrete-lined bottom should be assessed with streambed naturalization and bridge reinforcement options considered. If removing the concrete-lined bottom is not feasible, then a notch 10 inches deep and 2 feet wide at the upstream end of the apron should be cut where flows are concentrated. Immediately upstream of this notch, the shallow concrete pool should be dug out to a depth of approximately 24 inches to provide an adequate resting/landing spot for upstream migration salmonids of all life stages. This action would significantly improve passage for juveniles and eventual adult steelhead passage during lower stream flows.

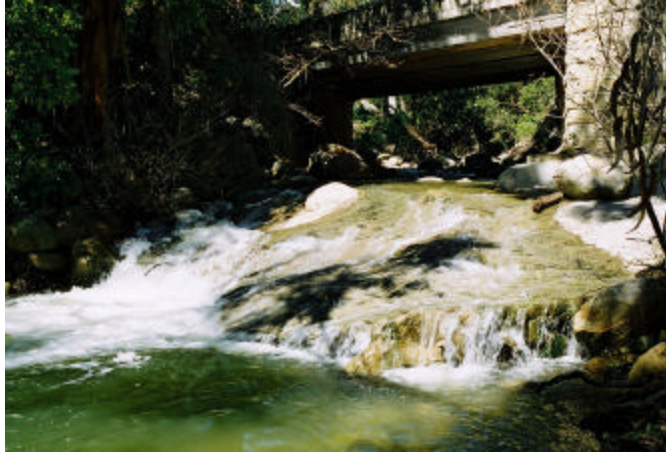
Location: Downstream from Highway 192 Bridge

Description: Natural streambed conditions exist under the Highway 192 Bridge. Immediately downstream of the bridge a long concrete and boulder riprap apron extends 34 feet downstream with a slope measured at 11%. The total height of the apron, from the downstream pool surface to the top of the apron measured 5 feet 3 inches. Flows dropped vertically 9 inches off the apron into the downstream pool, which had a jump depth of 4 feet 5 inches. Exposed, damaged re-bar at the downstream end of the apron presents a significant hazard to upstream migrating salmonids.

Condition: The apron is in poor condition with significant wear and undercutting on the downstream side. The apron is also causing major scour and bank erosion that appears to be influencing the substantial loss of property on both downstream banks and undermining the road fill.

Recommended Action: CALTRANS should assess the feasibility of eliminating this apron and either stabilize the bridge supports and adjacent stream banks or replace this bridge with a bridge that does not influence the streambed. Adjacent stream bank stabilization should use a bio-technical approach. This situation is similar to the Arroyo Paredon Highway 192 Bridge replacement project CALTRANS is currently planning. Attempts to battle the continual expansion of downstream scour by extending the apron are not recommended. Effective passage at this site is essential to providing upstream access to both tributaries of upper Mission and Rattlesnake Creeks.

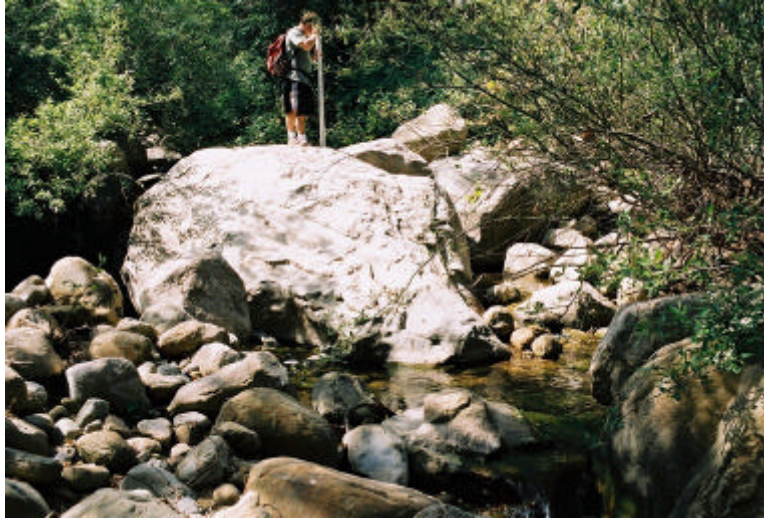
Location: 25 feet upstream from Rattlesnake Creek confluence

Description: This boulder cascade occurs just upstream from Rattlesnake Creek and appears to be a backup of boulders behind a very large boulder approximately 8 feet in diameter. The low flows encountered dropped 4 feet 1 inch from the river-left side of the large boulder to a small pool with a maximum depth of 2 feet 4 inches.

Condition: The large boulder holding this cascade together appears to be fairly stable but smaller boulder are likely seasonally mobile.

Diagnosis: Rainbow trout have consistently been observed in contemporary times throughout the Rattlesnake Creek tributary and the main stem of Mission Creek downstream of Rattlesnake Creek. This cascade feature appears to be preventing colonization of upper Mission Creek as no rainbow trout were observed upstream during extensive surveys, including snorkeling over two dozens high quality pools upstream of this cascade to the Tunnel Road Crossing (BR_MN_21). The only rainbow trout observation in Mission Creek upstream of Rattlesnake Creek occurred in the small pool downstream of this structure. While smaller salmonids appear to be unable to migrate upstream of this structure due to jump height limitations, adult steelhead would be able to migrate upstream of this structure with a high degree of difficulty during moderate to high stream flows. With adequate upstream access at barriers mentioned downstream, adult steelhead will be able to recolonize upper Mission Creek, which will add considerably to the size of the overall salmonid population in the Mission Creek watershed and likely increase steelhead production.

Recommended Action: No recommended action for this natural feature. Address downstream barriers and steelhead will migrate upstream of this feature and recolonize upper Mission Creek. Natural sea-run recolonization of this upper section of Mission is recommended to encourage the anadromous tendencies of the re-established salmonid population as opposed to reseeding this reach with rainbow trout from Rattlesnake Creek, which may currently have more residential tendencies.

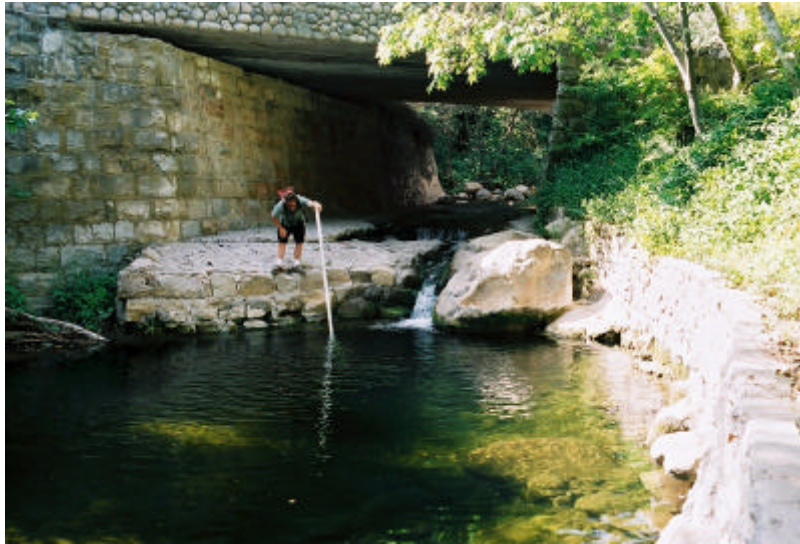
Location: Upstream-most (#2) Mission Canyon Road Bridge

Description: This bridge has a concrete and cut-stone bottom that measured 66 feet 6 inches from the downstream to upstream end with an overall slope measuring 5%. The lower end of the concrete bottom is extremely damaged with a large, irregular-shaped hole completely through the concrete and a confined chute eroded down the last 12 feet to a 15-inch vertical drop into the downstream pool, which had a jump depth of 7 feet. Several holes through the concrete exist under the bridge along the channel bottom. At the upstream end of the bridge, the concrete bottom measured 16 feet 7 inches between the stone walls and 11 feet tall to the underside of the bridge.

Condition: The concrete bottom is in poor condition with significant wear and damage through the concrete bottom. The downstream end of the structure and adjacent bank revetments are significantly undercut and damaged.

Diagnosis: During migration flows the downstream pool has sufficient depth to allow a moderately difficult jump upstream onto the concrete channel or into the eroded chute. Migration up the chute and the jump onto the channel presents a high degree of difficulty due to the limited jump depth from the damaged pool, high turbulence during migration flows, and confined high velocities in the chute. Accelerated velocities will also be encountered along the channel upstream.

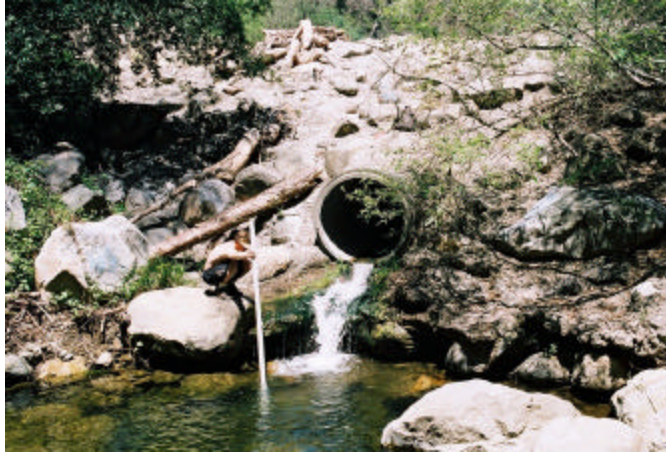
Location: Upstream from the Santa Barbara Botanic Garden, approximately 5.91 miles from the ocean.

Description: This concrete and boulder debris dam conveys flows through a smooth concrete culvert with a measured length of 68 feet 8 inches and slope of 6.1%. Downstream of the culvert outlet, stream flows dropped 7 inches onto a small concrete apron that extends 3 feet downstream with a moderate slope that ends abruptly 2 feet 9 inches above the surface of the downstream pool, which has a jump depth of 3 feet 1 inch.

Condition: The culvert appears to be in good condition with minimal wear. The dam appears to be in fair condition with 1-2 feet of undercutting on the downstream side of the dam.

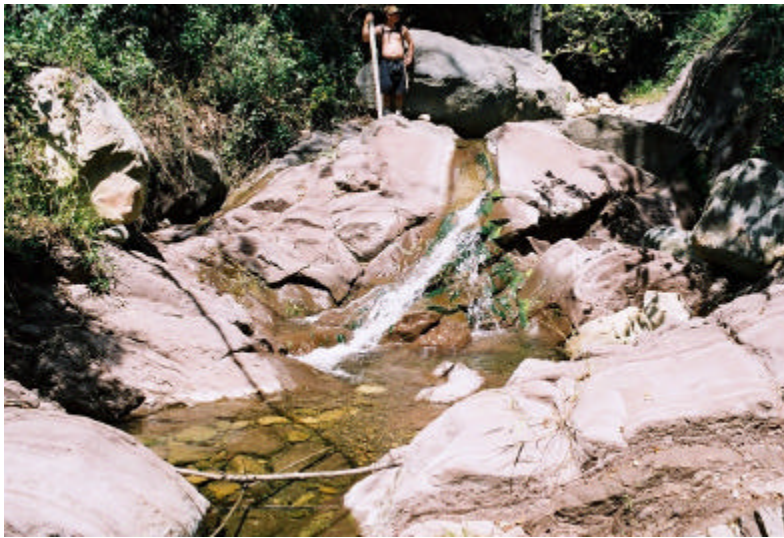
#15- This bedrock chute measured 6 feet 6 inches tall from the downstream pool to the top of the main chute at the center. The slope of the chute was approximately 45%. Two potential high flow routes exist on the far river-right and river-left side of the chute. At the tail-out of the downstream pool, exposed bedrock with a narrow outlet would allow the shallow downstream pool to back fill approximately 3 feet during high stream flows. This situation would create a pool depth of approximately 4 feet 6 inches and a jump to the top of the chute approximately 3 feet 6 inches high. These high flow conditions may allow a jump upstream with a high degree of difficulty.

Recommended Action: No recommended action for these natural and seasonally changing features.

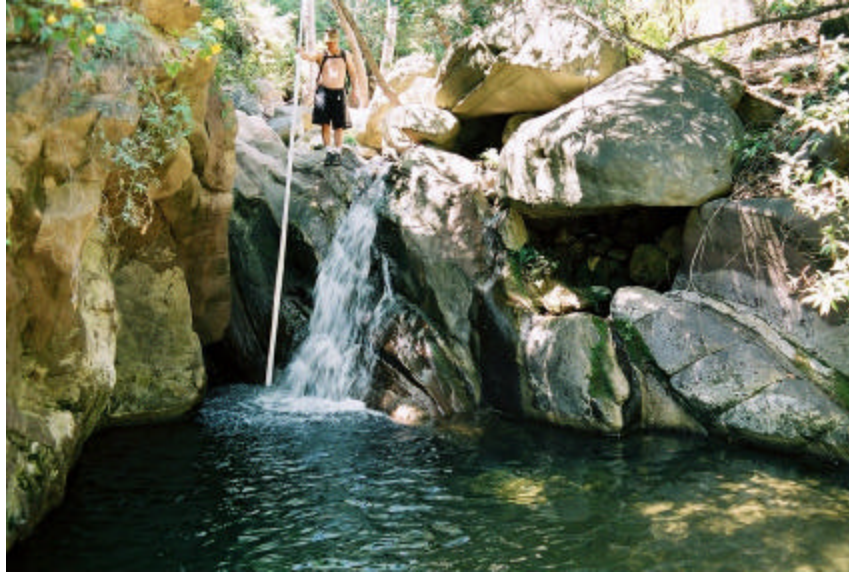
#17- This bedrock waterfall measured 8 feet 7 inches tall from the downstream pool surface to the top of the waterfall. The downstream pool depth measured 6 feet. During high stream flows the downstream pool may backfill approximately 2 feet producing a pool depth of 8 feet and a jump height of 6 feet 7 inches. A jump during this high flow situation may provide an extremely difficult upstream jump over the waterfall, but during these flows the downstream pool will be extremely turbulent.

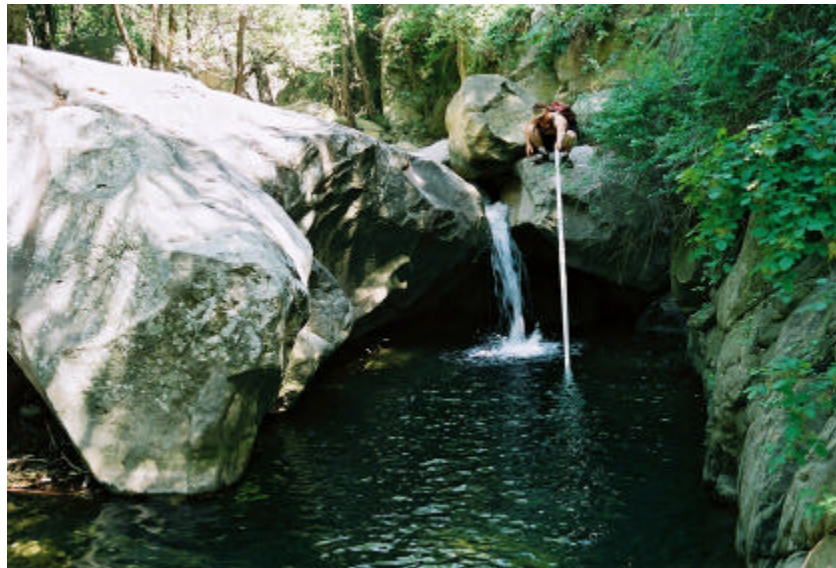
#18- This bedrock and boulder waterfall measured 7 feet in height from the surface of the downstream pool, which had a jump depth of 8 feet 5 inches. While the downstream pool has sufficient depth to allow a difficult jump to the top of the waterfall during migration flows, a large boulder at the top of the waterfall may block attempts to land upstream. This boulder may blow out in the next significant flow event reducing the severity and extremely difficult upstream passage may be possible even with it in place.

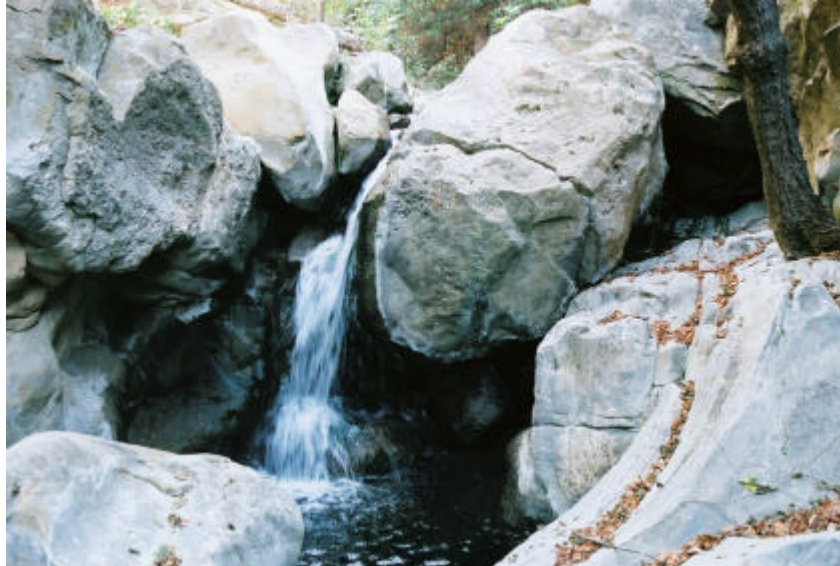
#19- This bedrock and boulder waterfall measured 10 feet 2 inches in height from the surface of the downstream pool, which had a maximum depth of 4 feet 3 inches. Large boulders downstream of the waterfall limit the extent and depth of the pool, which will be inundated with turbulent falling water during high stream flows essential for an attempt at jumping this tall waterfall. Passage at this waterfall is not possible in its current configuration, but the waterfall is composed of many boulders that may be seasonally mobile and extremely difficult passage may be obtained if the configuration changes favorably during future high flow events. Passage is highly dependant on the development of the downstream pool depth each year.

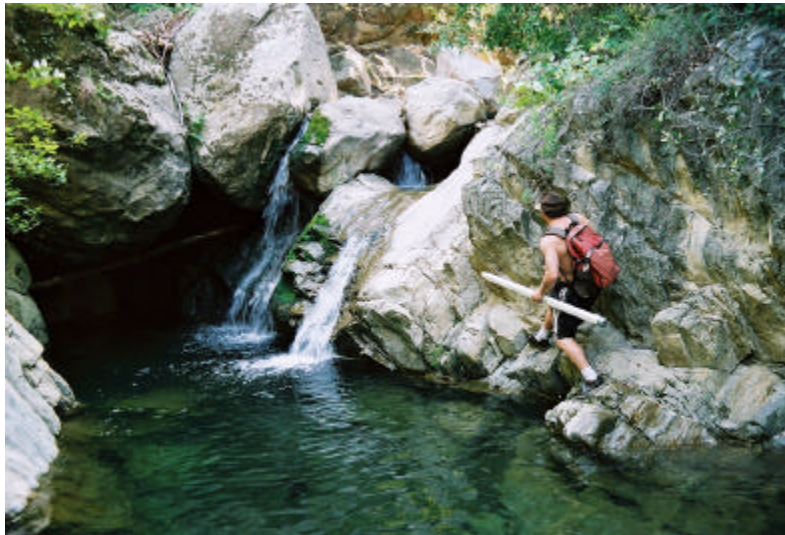
#20- This two-part bedrock and boulder waterfall measured 5 feet 5 inches tall from the downstream pool surface to a small resting pool 1 feet deep midway up the waterfall. From this small pool, a second jump of 3 feet occurs to the top of the feature. The total height of the waterfall measured 8 feet 5 inches from the downstream pool surface to the top. The downstream pool measured 4 feet 4 inches deep and would provide sufficient depth for a steelhead to jump to the small pool in the waterfall. From the small pool upstream passage is likely impossible due to the limited depth, excessive jump height, and overhanging boulder blocking the jump. During

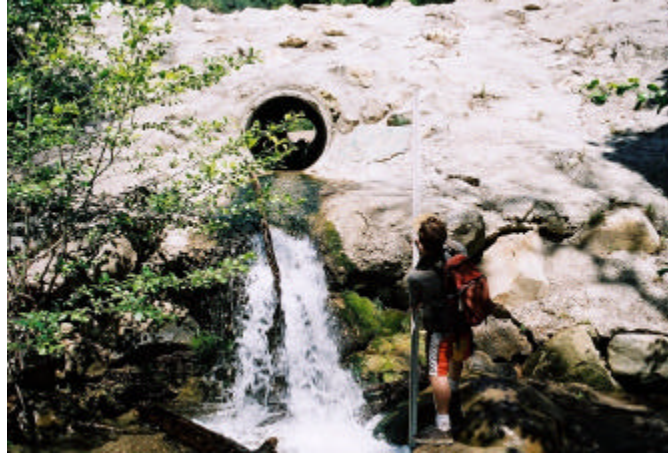
Location: 0.17 mile upstream from the Las Canoas Road Bridge

Description: This concrete and boulder debris dam conveys low flows through a smooth concrete culvert with a measured length of 65 feet and slope of 5.4%. Downstream of the culvert outlet, a smooth concrete apron with an overall slope measured at 11.4% extends downstream 13 feet 10 inches. The apron ends abruptly and stream flow falls vertically 5 feet 7 inches to the substrate below. There is no developed jump pool downstream and flows fall directly onto woody debris and gravel with a water depth of 3 inches.

Condition: The dam appears to be in fair condition with significant downstream scour and only moderate concrete damage.

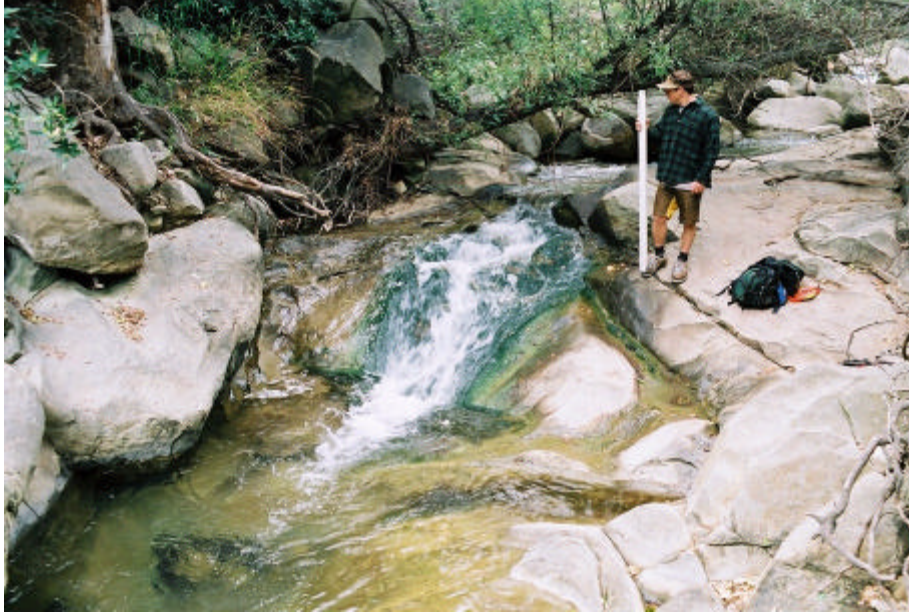
#10- This bedrock chute occurs 200 feet upstream of the old Rattlesnake Mission Dam and had a measured length of 9 feet between upstream and downstream pools with a slope of approximately 30%. The downstream pool measured 2 feet 2 inches deep. A highly difficult swim up this short bedrock chute is possible during moderate stream flows due to the presence of several velocity breaks.

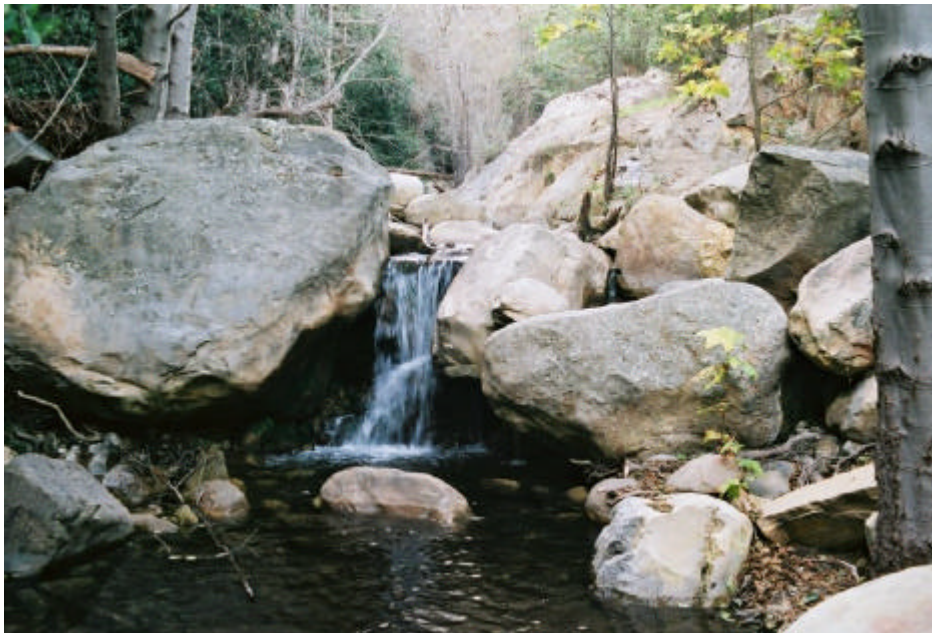
#11- This boulder cascade measured 6 feet 8 inches from the top of the drop to the surface of the downstream pool, which had a jump depth of 1 feet 7 inches. Upstream migration during moderate to high stream flows would have a high degree of difficulty, but would be possible if the downstream pool depth increased approximately 2 feet, adding to the jump depth and lowering the jump height.

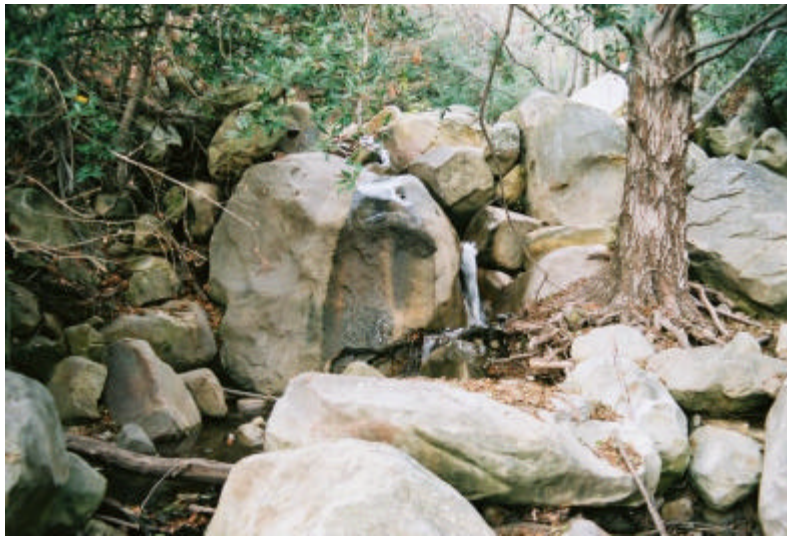
#13- This two-part boulder cascade measured 23 feet tall on the downstream section to a 60-foot long, moderately-sloped reach that proceeded upstream to the base of the second steep reach measuring 20 feet tall. A massive boulder that produces a 10-foot drop onto boulders holds the downstream 23-foot cascade together. This reach is currently impassable due to the excessive heights of both sections and lack of sufficient downstream jump depths. Some boulders within this reach are seasonally mobile and the cascade likely changes configuration often, potentially allowing limited passage in the future.

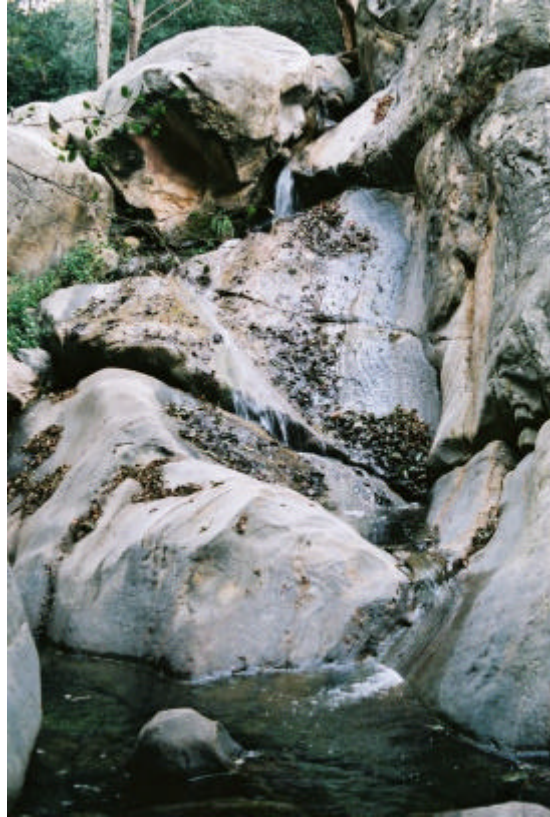
#14- This bedrock chute measured a total of 25 feet tall and consists of a massive bedrock wall on the river-left side and large boulders at the top and down the river-right side. No significant jump pools exist and all slopes encountered exceed 40%. This excessively tall chute is completely impassable and is very stabile. Downstream natural features may limit steelhead passage up to this site during most or all years, but this site is an absolutely impassable location that will not dramatically change in severity anytime soon.

Recommended Action: No recommended actions for these natural features.

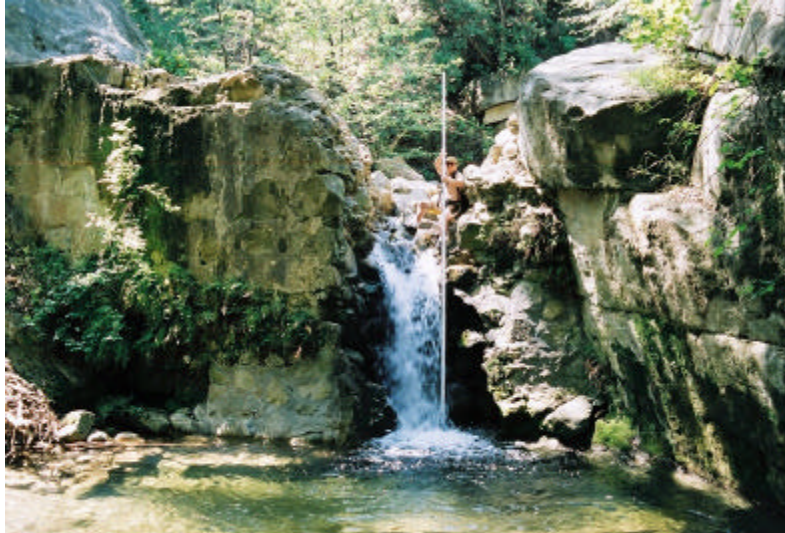
Location: 0.40 mile upstream from Las Canoas Road Bridge

Description: Chumash natives that were enslaved by Franciscan Padres built the “Rattlesnake Dam” in 1808 to supply water to the Mission water system. Water was diverted from this site down an aqueduct to the Mission. The dam is composed of cut stones, cobbles, and likely lime mortar. The dam no longer functions and is naturally being washed away. The dam measured 35 feet across the channel and is keyed into bedrock walls on both sides. The total height of the dam from the downstream substrate to the top of the dam measured 21 feet 10 inches. A major portion of the dam has blown out and stream flows now fall 11 feet 6 inches from the damaged notch to the surface of the downstream pool, which measured 4 feet 10 inches deep.

Condition: The dam is in extremely poor condition with massive structural failure and significant undercutting on the downstream side. Sediment is backed up to the top of the failed notch.

Diagnosis: The excessive height of the dam would likely prevent upstream migration during most/all flows unless the downstream pool fills approximately 3-4 feet during high stream flows. Passage at such flows would be extremely difficult due to turbulent water conditions in the downstream pool and very high water velocities confined through the failed notch in the dam.

Recommended Action: Continue to allow the dam to naturally erode. The dam will likely blow out on its own, but if recovery efforts downstream allow steelhead to migrate upstream to this site and passage is still significantly impeded, the rest of the dam should be broken apart.

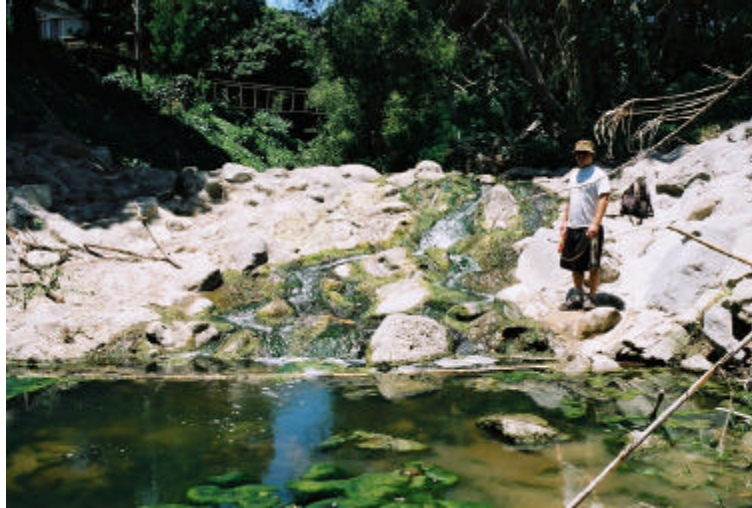
Location: 0.33 mile upstream from Cliff Drive Bridge

Description: This concrete and boulder grade control structure measured 6 feet 2 inches tall from the top of the structure to the surface of the downstream pool, which measured 2 feet 3 inches depth. The downstream side of the structure can be broken up into two distinct slopes. The milder downstream slope rises 2 feet 2 inches over 10 feet with a slope of 21.7%. The upper-most slope rises 4 feet over 12 feet with a slope of 30%.

Condition: The structure appears to be in fair conditions with moderate wear and adjacent bank erosion. The grade control is completely filled with sediment on the upstream side.

Recommended Action: Due to the impassability of this structure near the downstream end of the Arroyo Burro watershed, an effective fish passage project must be implemented at this site to begin steelhead recovery in this system. With an estimated 91.1% of the watershed (Main stem Arroyo Burro and San Roque Creek) found upstream of this structure, and limited downstream spawning habitat, steelhead production in the Arroyo Burro watershed is likely not possible without providing additional access. The most effective, self-sustainable solution for allowing steelhead passage at this site is to remove the structure and reinforce adjacent stream banks. Additional assessment of this structure and potential implications of removal need to be conducted with the safety of adjacent homes considered. Several homes adjacent to the stream channel upstream would likely be impacted by removal and would require sufficient bank protection measures. Bioengineering techniques to stabilize stream banks following removal should be assessed.

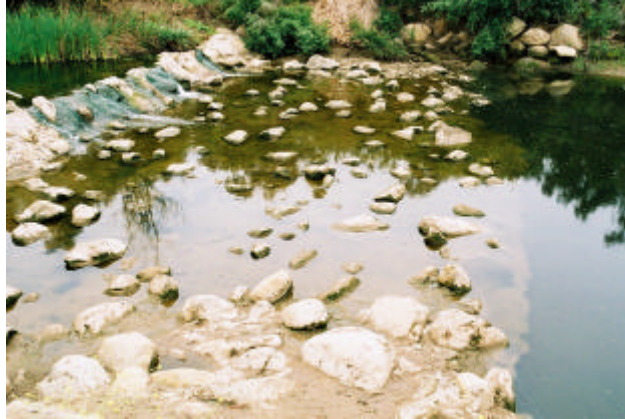
Location: Upstream end of Goleta Slough tidal influence

Description: This grade control structure spans 84 feet across the stream channel at the upstream end of the Goleta Slough, separating the tidal water downstream from the fresh water of Atascadero Creek upstream. Ward Drive dead-ends approximately 100 feet downstream from this site. Apparently, The Gas Co. has a pipeline running under this structure for protection and the SBCFCD maintains the structure (pers. comm. Treiberg). The structure is constructed of rough concrete and boulder riprap and consists of a 2-foot 11 inch tall berm at the upstream end that drops at an approximately 45-degree angle, at center, to a relatively flat apron downstream. Shallow stream flows were spread out across the concrete berm at center and toward the river-left side. The apron measured between 34 and 29 feet in length downstream from the berm to the Goleta Slough water. Slough water was backed up onto the apron with depths of 7 inches to 2 feet measured along the irregular, boulder-embedded apron. Approximately 90% of the apron was submerged by slough water. Downstream of the apron a submerged vertical drop of 2 feet 11 inches occurred to the downstream substrate.

Condition: The structure is in poor condition with several holes through the apron, cracked concrete, and significant undercutting of the apron from downstream scour.

Diagnosis: The severity of this structure to upstream steelhead migration appears to be dependant on the tidally influenced Goleta Slough and the extent to which the apron is submerged or potentially elevated above the downstream pool. The structure limits upstream steelhead passage during low flows due to the limited jump depth on the apron downstream of the berm and the steep angle of the berm and shallow flows encountered. Smaller native fish species found within the Goleta Slough are likely blocked from migration upstream during most or all flows. With moderate and high stream flows there would be sufficient water depth across the apron, velocity breaks provided by the embedded boulders, and reduced jump height over the berm to allow upstream steelhead migration with, at greatest, a high degree of difficulty. Kuyper 1998 observed this structure completely submerged after a major precipitation event sometime in 1997 or 1998. A likely route over the berm during moderate flows occurs on the far river-right side where the slope is more gradual to the top of the berm. Tidal action that increases the depth of water over

While steelhead migration is likely impaired during lower flows, the impacts of this structure are more severe to the migration and distribution of other native species found in the Goleta Slough. Conversely, this structure may impede upstream migration of exotic species present in the slough. The impact of any migration impediment at the downstream end of a stream is always significant due to the limited window of opportunity steelhead have in these flashy creeks to quickly get upstream to spawn. In this case, steelhead bound for Maria Ygnacio, San Antonio, or upper Atascadero Creek must deal with several difficult upstream barriers whose severity is highly dependant on stream flows. Delayed passage at his site may leave steelhead stranded at upstream barriers that are only passable during short periods of higher stream flow.

Recommended Action: The impact of this structure on the overall tidal dynamics and ecological health of the Goleta Slough should be assessed. The functionality and desirability of this structure should be determined with the owner and the SBCFCD along with larger Goleta Slough Management studies currently being discussed by several local groups. Elimination of the structure and rerouting the pipeline over, or further under, the creek would provide the most effective upstream fish passage and may expand the size of the Goleta Slough and have other potential benefits. Upstream sediment trapped behind the structure needs to be evaluated in conjunction with alternatives assessed. A short-term action that would improve passage immediately can be achieved by, cutting a notch approximately 5 feet wide and 10 inches deep at the center of the berm. This action would concentrate low flows across the berm, increase water depth, and reduce the height of the berm.

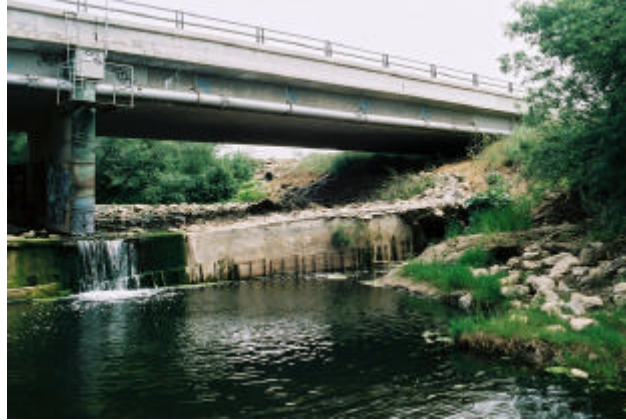
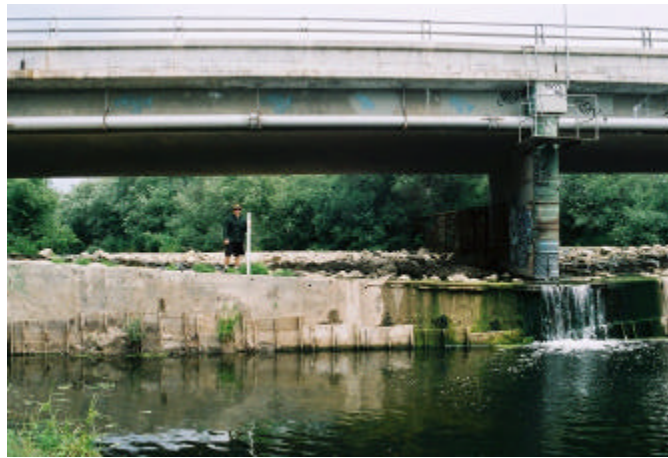
Location: Under the Paterson Avenue Bridge across the Maria Ygnacio and Atascadero Creek confluence

Description: This bridge and grade control structure occurs exactly where Maria Ygnacio Creek and Atascadero Creek flow together to form lower Atascadero Creek. This is the only structure in this report that has two different Barrier ID's due to its presence on two different stream reaches. A concrete bridge support divides the two creeks during lower flows, which then flow together downstream and drop off a concrete curb to the pool downstream. The 1-foot thick concrete curb measured 116 feet across the stream channel in a shallow V-shape that concentrates flows at center downstream of the bridge support. Flows dropped 4 feet 6 inches vertically to the surface of the downstream pool, which had a jump depth measured at 7 feet 8 inches. A small landing pool 4 feet in diameter and 16 inches deep occurs immediately upstream of the curb. Upstream of the concrete curb, a boulder and concrete riprap apron extends approximately 79 feet up the likely

Condition: The structure is in fair condition overall, but is causing severe undercutting and bank erosion on the downstream river-left side. High flow marks, and a date of 1-10-95 painted next to them, occurs 9 feet high on the bridge support and 4 feet from the bottom of the bridge.

Diagnosis: Migrating across the rough, boulder-embedded apron has a low degree of difficulty due to the presence of velocity breaks and moderate slope. The downstream pool provided adequate depth to allow a moderately difficult jump upstream of the apron. Salmonid habitat conditions in the Maria Ygnacio sub-watershed are far better than in upper Atascadero Creek and the location of this structure complicates upstream navigation to the correct upstream tributary, especially during high stream flows when a fish may jump the curb from the river-left side of the downstream pool and be forced to migrate up Atascadero Creek. The passage severity of this structure is highly dependent on the formation of the downstream pool and tailwater control, which likely experiences major seasonal change and is subject to blowing out during higher flows. The reduction of the downstream pool depth would increase the jump height and reduce the jump depth leading to a higher severity and potentially an impassable structure. The severity of this structure likely changes from season to season. The overall upstream steelhead passage difficulty of the structure was rated as “high” due to the physical configuration and the likelihood of disorientation caused by the location at the confluence.

Recommended Action: The complicated hydraulic conditions encountered at this site and the importance of all components of the structure to the integrity of the bridge requires additional analysis to determine potential fish passage improvement recommendations. Cutting a notch at center of the curb may compromise the integrity of the bridge support with uncertain benefits. The most effective option for improving upstream steelhead passage would be to eliminate the apron and drop under the bridge. It appears that one possibility may be to remove the concrete apron and curb under this wide bridge, reinforce the adjacent stream banks, and rebuild a central bridge support that penetrates deep into a natural substrate bottom. This action would also likely result in a greater flow capacity under the bridge.

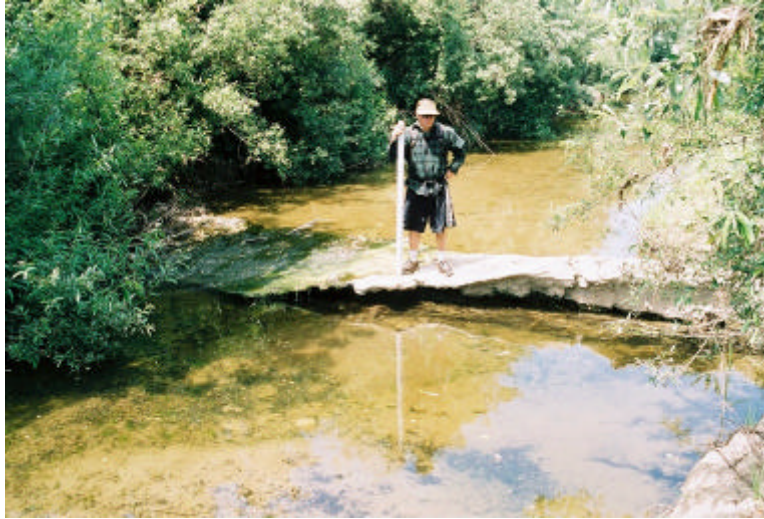
Location: 0.16 mile upstream from the Atascadero Creek confluence

Description: This concrete grade control may be associated with underground utilities (pers. comm. Treiberg). During low stream flows encountered, the height of the structure measured 12 inches above the surface of the downstream pool, which had a depth measured at 1 foot 7 inches. A smooth, moderately sloping section of concrete conveys low flows for 6 feet across the structure.

Condition: The grade control is in extremely poor condition with severe undercutting and concrete damage.

Recommended Action: Identify the owner of the structure and determine its functionality and desirability. If feasible, remove or break up the concrete to improve low flow migration and prevent potential changes in the configuration and severity of the structure caused by scour and erosion.

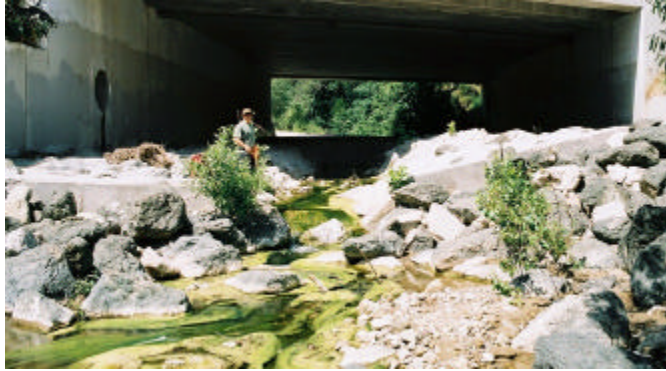
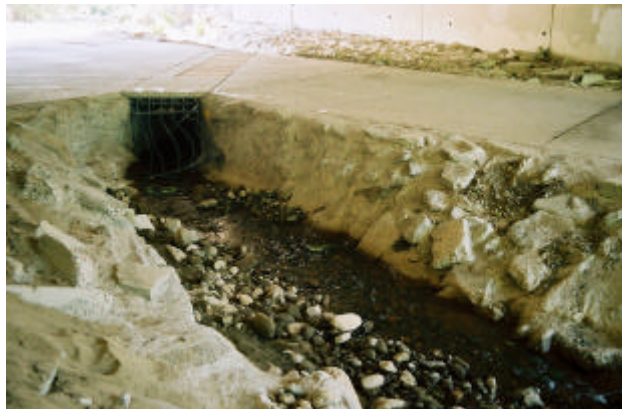
Location: Hollister Avenue Bridge and Pedestrian Path Crossing

Description: The Hollister Avenue Bridge was constructed in 1963 by the SBCPWRD and the Army Corps of Engineers riprapped the channel below the bridge in 1968 (Kuyper 1998, citing C. Elbert). A concrete pedestrian path crosses the creek underneath the bridge through a small box culvert. The stream flows are confined to a small concrete and boulder riprap channel that winds under the bridge in an S-shape. At the downstream end, the 3-foot deep U-shaped channel measured 4 feet 6 inches wide at the bottom and 10 feet 6 inches wide at the top. Large boulders have been placed at the downstream end of the structure, apparently to prevent downstream scour. The lowest 10 feet of the channel is fairly smooth concrete with a stepper slope. The channel extends a total of 147 feet from the downstream end to the upstream end. The downstream end of the pedestrian path box culvert occurs 70 feet upstream from the downstream end of the channel. The smooth-bottom concrete box culvert measured 31 feet long, 4 feet wide, and 3 feet 6 inches tall with a slope of 4.3%. A damaged metal grate occurs on the upstream end of the culvert.

Condition: The structure appears to be in fair condition overall with moderate concrete wear and cracking and a highly damaged metal grate.

Diagnosis: Entry into the channel from downstream is achievable with a moderate degree of difficulty during migration flows when water depth is adequate. Passage through the box culvert

imposes a high degree of difficulty due to the moderately sloped smooth concrete bottom, accelerated stream velocities, absence of resting spots, shallow water depth during low flows, and likely seasonal debris blockage at the culvert inlet and metal grate. Signs of clearing debris from the metal grate are present. During moderate flows and unblocked conditions, upstream passage can occur with a high degree of difficulty. This structure is impassable during low flows and may be impassable for extended periods of time with debris blockage at the culvert.

Recommended Action: Improved steelhead passage at this site is necessary to ensure consistent access upstream from year to year. The feasibility of providing natural substrate conditions under the bridge should be assessed to provide the most effective, unimpeded upstream steelhead passage. This action could consist of removing all of the riprap bottom and significantly reinforcing the adjacent bridge wall supports or leaving some of the riprap adjacent to the bridge walls in place and reestablishing a majority of the natural streambed under the bridge. The pedestrian path could hug one of the bridge support walls under the full length of the bridge and either cross the creek upstream or downstream over an elevated bridge out of the stream channel and storm flows. At a minimum, the box culvert should be removed and converted to a rough riprap channel similar to the adjacent upstream and downstream configuration and a small bridge or arch culvert installed over this channel. Removal of the grate and potential blockage point would accompany this action. The box culvert is the major impediment and potential blockage point throughout this structure. The moderately steep, smooth 10-foot section of concrete at the downstream end of the channel should be roughened to reduce the water velocities encountered.
