Steel head Assessment and Recovery Opportunities in Southern Santa Barbara County, California

**BY
Matt W. Stoecker
and
Conception Coast Project**

June 2002

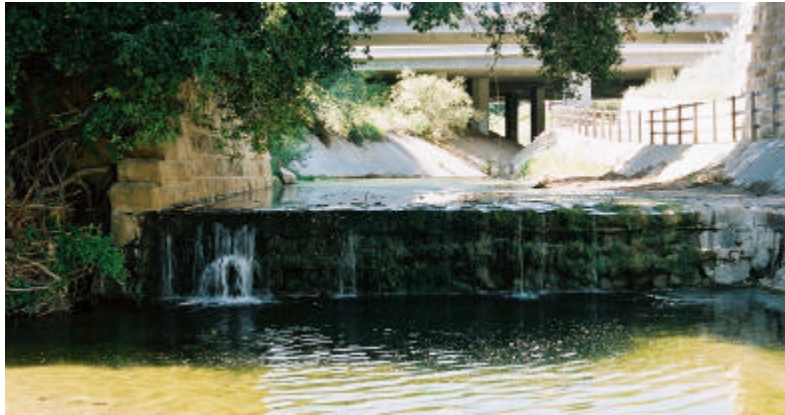
Location: Under the UPRR Crossing and Highway 101 Bridges

Description: Under the UPRR crossing, 104 feet of stone-lined bottom and adjacent vertical stone walls line the creek channel. A bike path occurs on the far river-left side of the channel confining the stone-lined bottom to a width of 33 feet 4 inches across. Significant scour on the downstream end of the UPRR channel has produced a drop measured at 7 feet from the lip of the channel to the substrate of the downstream pool. The pool depth ranged widely over several observations throughout 2000-2001 and is seasonally variable with modifications to the downstream substrate configuration and fluctuations in stream flow. During a survey on 5/22/2001 with a stream flow of approximately 0.5 c.f.s., the jump depth of the downstream pool measured 4 feet and a jump height was measured at 4 feet 6 inches.

The stone-lined UPRR channel reach is relatively flat and connects with the upstream sloping concrete walls that line the banks of Maria Ygnacio Creek and extend underneath and upstream of the Highway 101 Bridge Crossings. Upstream of the UPRR stone-lined channel, the stream bottom becomes natural between the sloping concrete walls and consists of fine silts, sand, and cobbles. The concrete walls extend under the Highway 101 Bridges to provide protection to the concrete bridge supports along the banks and bike path. The concrete walls extend upstream of Highway 101 and into the lower reaches of San Antonio Creek and Maria Ygnacio Creek upstream from the confluence. Small pools and an irregular stream bottom were present in this reach. The same type of sloping concrete wall extends downstream of the UPRR channel drop on the river-left side adjacent to the bike path.

Condition: The UPRR stone-lined bottom is in poor condition with moderate wear occurring throughout the channel and significant downstream scour and extensive adjacent bank erosion. The concrete walls of the bike path downstream of the UPRR channel are significantly undercut in several places and are at risk of failure.

during lower flows, add to the difficulty of migrating past this 104 feet of channelization. Overall, this structure is passable for adult steelhead with a high degree of difficulty during ideal flow conditions with adequate downstream pool formation and depth. The window of opportunity for adult steelhead to migrate upstream of this location is significantly reduced due to the presence of this structure and may be blocked for extended periods of time, or seasonally depending on jump pool depth and stream flows. High stream flows in Maria Ygnacio Creek were observed to carry high amounts of suspended sediment and navigation over this structure may be limited during these flows. Upstream steelhead migration past the CALTRANS concrete wall section upstream of the UPRR channel presents no significant challenge with the natural substrate conditions and velocity breaks associated with the irregular bottom. A 27-inch long steelhead was rescued from the drying pool downstream of the UPRR channel on 6/16/2000 by C. Fusaro (California Trout), N. Lohmus (CDFG), and M. Cardenas (CDFG) and transferred downstream to the Goleta Slough. It is unknown whether or not this adult steelhead made it upstream of the UPRR channel earlier in the season or was prevented from upstream migration due to low flow condition.

Recommended Action: Upstream migration conditions for steelhead should be improved at this site to allow adult steelhead easy access to upstream habitat in Maria Ygnacio and San Antonio Creeks. Efforts to improve upstream passage at this site have been initiated by Craig Fusaro (California Trout) and David Pritchett (FishTap) with advice from Jon Mann (NMFS). Fusaro designed the diagram below of the proposed project. The proposed action would cut a low-flow channel across the UPRR channel with resting pools and install downstream boulder weirs. This action would likely provide improved passage by increasing the water depth across the channel within the low-flow channel, providing resting spots along the channel, assisting in adequate downstream pool formation, and slightly reducing the jump height. The downstream weirs may be susceptible to damage or failure over the long-term and the effectiveness of such a project would likely not be known until after it was completed and monitored for several seasons. A grant proposal for this project with additional information can be obtained from David Pritchett. In addition to the proposed project discussed above a long-term goal of providing unimpeded access at this site should be coordinated with UPRR and CALTRANS. A feasibility study should determine the possibility of removing the entire UPRR structure, replacing it with a wide-span bridge that does not impact the stream channel (such as the Montecito Creek UPRR crossing), reinforcing upstream concrete walls and CALTRANS bridge supports, and reestablishing a natural stream bottom through this reach.

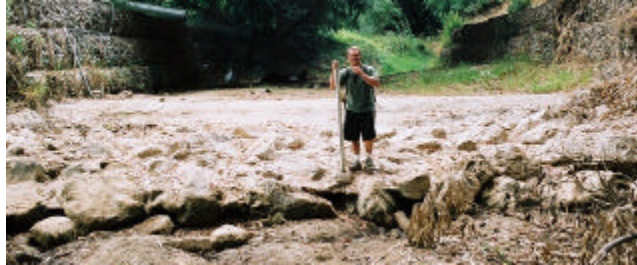
Location: 40 feet downstream from the University Drive Bridge

Description: This concrete and boulder grade control structure spans 50 feet across the stream channel and measured 18 feet 6 inches from the downstream lip of the riprap apron to the top of a concrete curb on the upstream end. No stream flow was present while surveying this structure. The riprap apron extends from the base of the concrete curb to the downstream substrate with an overall slope measured at 2 %. The concrete curb has a steep slope of approximately 45 degrees to the downstream apron and measured 2 feet in height above the apron, at center. On the far sides of the structure, the apron transitions gradually to within 12 inches of the top of the concrete curb. Upstream of the structure, fine silt and sand was backed up to the top of the concrete curb. The grade control is likely intended to provide protection to the upstream bridge and bank protection.

Condition: The structure is in fair condition with moderate wear and downstream scour.

Recommended Action: It appears that upstream bridge protection measures are designed around the presence of the grade control structure and backed up sediment upstream. The grade control may also serve to provide improved flow measurement consistency for the USGS gaging station just upstream. The bridge appears to be built wide enough to allow a continuous natural stream bottom through this reach with moderate reinforcement of the bank protection measures and removal of the grade control. This option would provide unimpeded access for steelhead, but needs to be further studied to determine the technical feasibility and is not immediately critical. When major modifications are to occur at this site this option should be considered. In the short-term, cutting a notch approximately 4 feet wide and 6 inches depth at the center of the concrete curb would improve upstream passage during moderate and low flow condition by increasing water depth across the structure and reducing the jump height of the concrete curb.

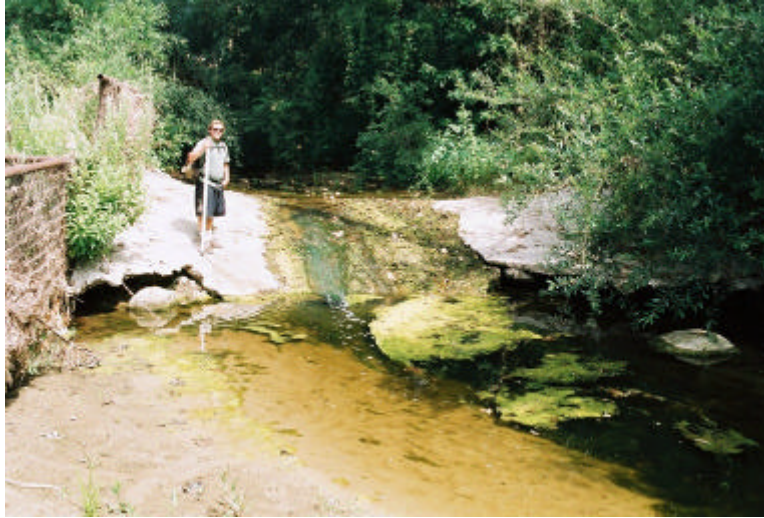
Location: 0.17 mile downstream from the Cathedral Oaks Road Crossing

Description: This sloping concrete grade control structure measured 14 feet in length from the upstream end to the surface of the downstream pool, which had a jump depth of 2 feet 1 inch. The vertical height of the structure from the downstream pool surface to the top of the structure measured 3 feet 1 inch. The overall slope of the structure measures 22%.

Condition: The structure is in fair condition with significant downstream scour and undermining of the concrete and adjacent pipe and wire revetment.

Diagnosis: During migration flows the downstream pool depth will increase, reducing the height of the structure and length of the sloping concrete face. Adult steelhead should be able to migrate upstream with a moderate degree of difficulty during ideal flow conditions, either by jumping over the entire structure or bursting directly up the sloping face when velocities are not too great and the distance has been considerably reduced. During lower flows the structure is impassable due to shallow water depth over the steep concrete slope. Five *O. mykiss* ranging from 2.5 to 4 inches in total length were observed in the downstream pool on 6/2/2001.

Recommended Action: A Goleta Sanitary District pipeline crosses overhead near this structure with concrete support structures on the creek banks. The grade control is likely intended to protect this pipe crossing. The feasibility of removing this grade control structure and reinforcing the existing pipe supports or setting them back further out of the stream channel should be assessed. Elimination of the grade control and alternative pipe crossing bank protection would provide the most effective steelhead passage alternative at this site and is recommended for effective and reliable fish passage at this site.

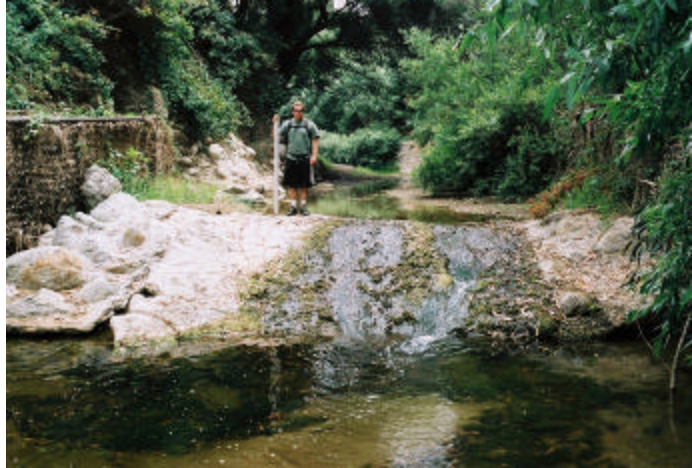
Location: 0.14 mile downstream from the Cathedral Oaks Road Crossing

Description: This sloping concrete grade control structure is similar to the downstream one (BR_AO_MY_6) and measured 13 feet in length from the upstream end to the surface of the downstream pool, which had a jump depth of 2 feet 6 inch. The vertical height of the structure, from the downstream pool surface to the top of the structure, measured 3 feet 1 inch. The overall slope of the structure measured 23.7%.

Condition: The structure is in poor condition with significant downstream scour, undermining of the concrete, and adjacent pipe and wire revetment damage on the downstream river-right side.

Diagnosis: During migration flows the downstream pool depth will increase, reducing the height of the structure and length of the sloping concrete face. Steelhead should be able to migrate upstream with a moderate degree of difficulty during ideal flow conditions, either by jumping over the structure or bursting directly up the sloping face when length has been reduced and velocities are not to great. During lower flows the structure is impassable due to shallow water depth over the steep concrete slope. A corrugated metal pipe was discharging polluted water with a high amount of suds into the creek just downstream of this grade control structure. The structure may have been constructed to provide protection to this pipe. Two *O. mykiss* measuring 3-4 inches in total length were observed in the downstream pool on 6/2/2001.

Recommended Action: The feasibility of removing this grade control structure and reinforcing the adjacent banks, that currently have pipe and wire revetment, should be assessed. Elimination of the grade control would provide the most effective and reliable upstream steelhead passage alternative at this site. Polluted discharging from the metal pipe should be prevented.

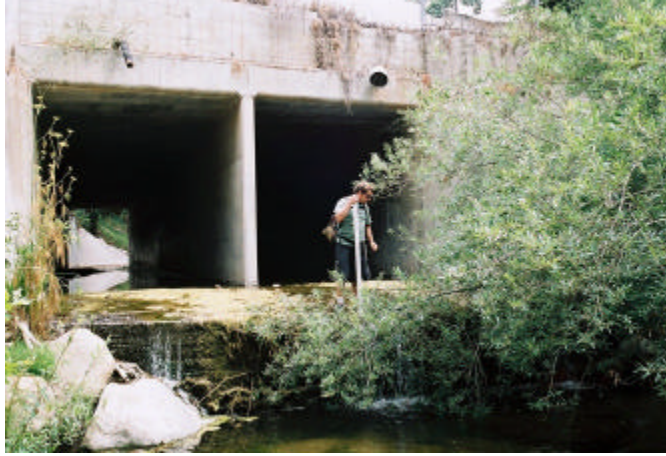
Location: Cathedral Oaks Road Crossing

Description: Each box culvert measured 12 feet tall by 12 feet wide with a 12-inch thick central divider. Downstream of the culvert outlets, a 25-foot wide smooth concrete apron extends 20 feet and drops vertically 2 feet 4 inches to the surface of the downstream pool. The downstream pool had a measured jump depth of 3 feet 6 inches. Upstream of the apron, the culvert runs straight under the road for 122 feet with a mild slope measured at 0.5%. At the culvert inlet, curved wing walls and a concrete bottom become confined as they extend upstream 45 feet to the natural substrate upstream. The inlet to the structure is confined to only 3 feet 9 inches wide at the base of the sloping wingwalls. The overall length of the concrete bottom from the downstream lip of the apron to the natural substrate upstream measured 187 feet. This bridge was constructed in 1961 pursuant to a contract administered by the County of Santa Barbara (Kuyper 1998 citing Elbert). Due to the alternating patchwork of ownership and maintenance between CALTRANS and Santa Barbara County along Cathedral Oaks Road/Highway 192 there may be overlap in ownership, maintenance, and/or easements for this structure (pers. comm. Marrs).

Condition: The concrete appears to be in good condition with minimal damage. The confined inlet design seems counter intuitive in the confined construction has apparently resulted in significant erosion due to the encroachment into the channel. Boulders have been placed around the inlet to prevent additional bank erosion and undercutting.

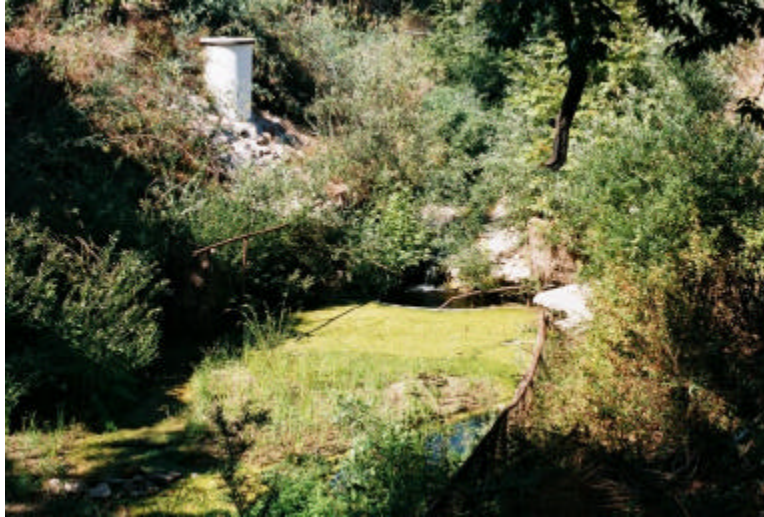
Location: 0.07 mile downstream from Old San Marcos Road Bridge

Description: The specific measurements and the accompanying photograph are from Kuyper 1998. This U-shaped section of concrete channel was constructed to protect a COMB pipeline that crosses the creek underneath (pers. comm. Treiberg). The structure measured 55 feet long from the upstream to downstream end with a downstream drop of 1 foot 6 inches to the surface of the downstream pool. The downstream pool measured 7 feet deep downstream of the concrete channel. Low stream flows are concentrated down the center of the channel. Pipe and wire revetment occurs along the sides of the channel and directly downstream.

Condition: The concrete appears to be in poor condition with significant wear and downstream undercutting cause by scour.

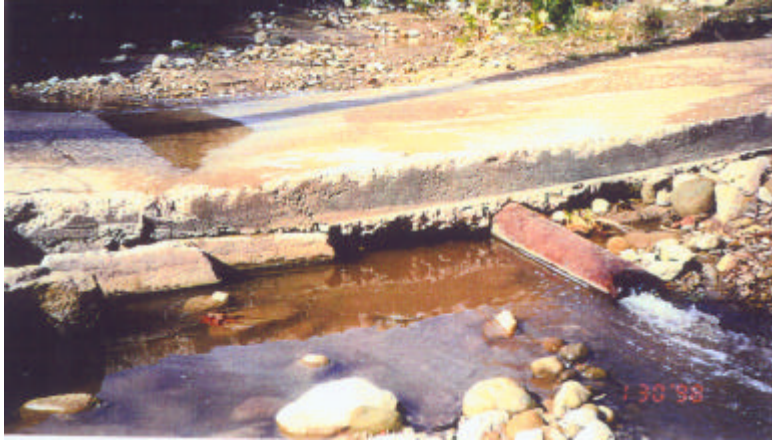
Location: 0.25 mile upstream from Old San Marcos Road Bridge

Description: The measurements and accompanying photograph are from Kuyper 1998. Stoecker provides additional evaluation and recommended action. This concrete crossing was poured directly on the streambed substrate with a 6-inch diameter metal pipe running underneath. The surface of the crossing measured 12 feet from the downstream to upstream end with a mild slope. A drop of approximately 1 foot 6 inches occurred on the downstream side to a shallow pool.

Condition: The crossing is in poor condition with significant concrete damage and moderate undercutting on the downstream side.

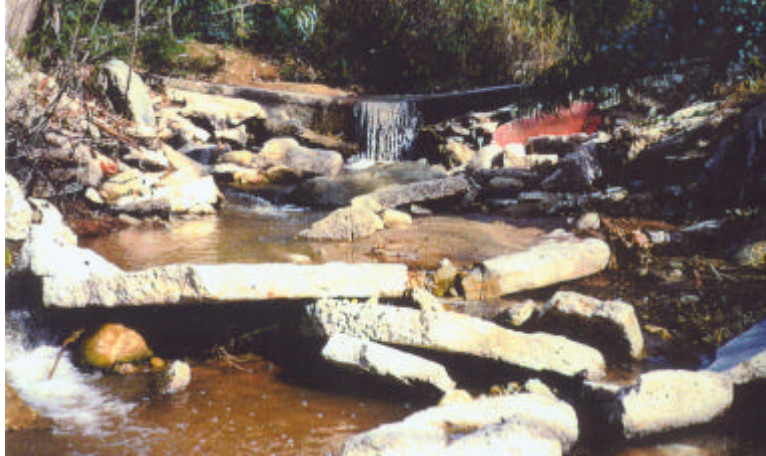
Location: 0.62 mile upstream from Old San Marcos Road Bridge

Description: The measurements and accompanying photograph are from Kuyper 1998. Stoecker provides additional evaluation and recommended action. Access to this site was restricted. This U-shaped concrete crossing measured 15 feet from the downstream to upstream end. Kuyper noted the exposed height of the crossing was 5 feet. Concrete slabs exist on the downstream side of the crossing, presumably to prevent downstream scour or from past road failure. Low stream flows are concentrate within the shallow U-shaped surface of the crossing. No jump depth or pool information was provided.

Diagnosis: The shallow water depth across the concrete crossing, and likely excessive jump height, would prevent upstream passage during low flows. Depending on downstream pool formation and depth, upstream steelhead passage can likely be obtained during moderate to high stream flows with a high degree of difficulty. Excessive stream velocities may impair passage across the smooth concrete crossing during higher flows. The window of opportunity for upstream migration may be very limited due to these factors, especially during exceptionally dry years and low stream flow.

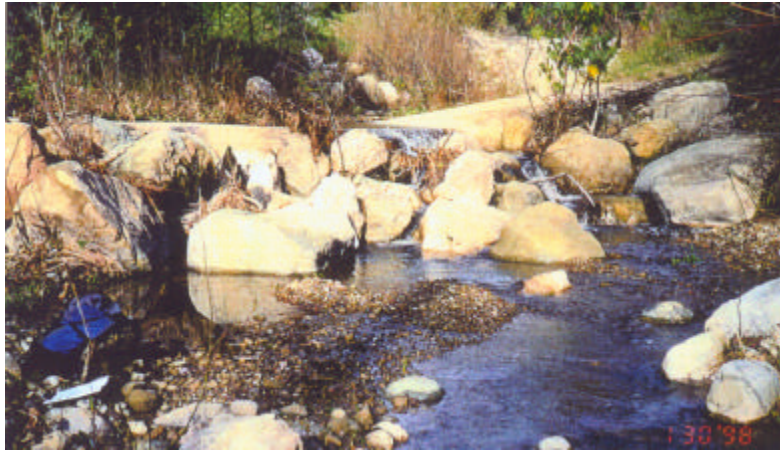
Location: 1.04 miles upstream from Old San Marcos Road Bridge

Description: The measurements and accompanying photograph are from Kuyper 1998. Stoecker provides additional evaluation and recommended action. This U-shaped concrete crossing occurs just downstream from the SBCFCD Debris Dam and measured 15 feet from the downstream to upstream end. Kuyper noted the exposed height of the crossing was 6 feet. Boulders have been placed on the downstream side of the crossing, presumably to prevent downstream scour. Low stream flows are concentrate within the shallow U-shaped surface of the crossing and onto the cascade of boulders on the downstream side. No significant jump depth occurred downstream from the boulders.

Diagnosis: The shallow water depth across the concrete crossing and limited jump depths occurring along the boulder cascade would block upstream steelhead passage during low flows. During moderate to high migration flows, the boulder cascade may have sufficient water depth and jumping/resting areas to allow upstream steelhead passage onto the concrete crossing with a high degree of difficulty. Excessive stream velocities may impair passage across the smooth concrete crossing during high flows and have a high degree of difficulty during moderate flows. The window of opportunity for upstream migration may be very limited due to these factors, especially during exceptionally dry years and low stream flow. The overall, the structure has a high degree of difficulty for upstream adult steelhead passage during ideal moderate to high stream flows.

Recommended Action: Work with owner to determine the structural and access requirements for this stream access. It appears that the crossing mainly serves the purpose of allowing the SBCFCD access to conduct maintenance activities at their Debris Dam and grade control upstream. If this access does not serve any residential purpose and is only used for the Debris Dam, steelhead passage improvements should be planned in conjunction with the Debris Dam (BR_AO_MY_17). If the crossing is desirable for other reasons, the feasibility of both removing the structure and having an in-stream crossing on substrate or installing wide-span bridge that does not impact the stream channel should be assessed. Complete removal of the structure will provide the most effective long-term solution at this site.

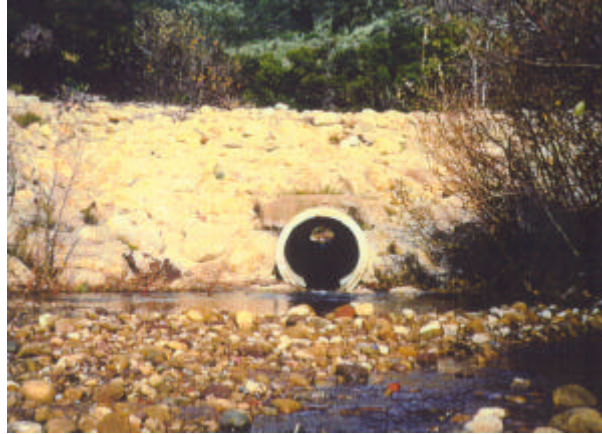
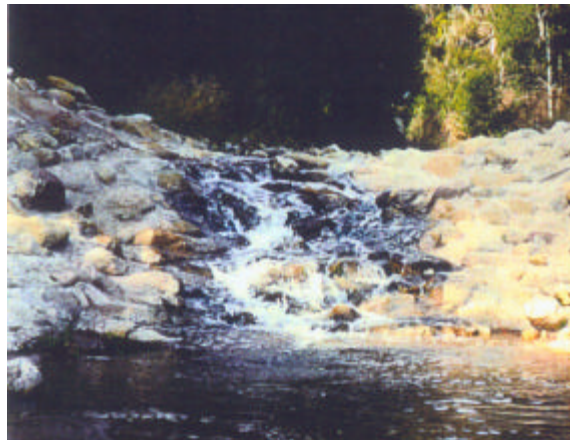
Description: Access to survey this reach of stream was not obtained. The following measurements and accompanying photograph are from Kuyper 1998. Stoecker conducted additional assessment. This debris dam is composed of boulder and concrete riprap and conveys low to moderate stream flows through the dam in a 54-inch diameter smooth concrete culvert. Water discharges from the culvert onto a pool with 6 feet deep. Kuyper notes that the United States Department of Agriculture's Soil Conservation Service (SCS) and the SBCFCD, in response to the Painted Cave Fire, built the dam and grade control in 1990. The grade control structure occurs approximately 500 feet upstream of the debris dam. The structure measured 15 feet tall and is composed of grouted riprap. The purpose of the structure is to function as an inlet to the debris basin. The downstream face of the structure has an angle of approximately 45 degrees for a length of 38 feet.

Condition: This dam is regularly maintained and cleared of debris by the SBCFCD (pers. comm. Treiberg). Low and moderate flows pass through the culvert when it is conveying water and storm flows pass over the top of the structure when the debris basin has been filled and the culvert is blocked.

Recommended Action: Due to the high quality salmonid habitat upstream of these structures, and the presence of salmonids downstream, fish passage should be provided at these sites. See section 7.9 for additional discussion and recommended action for this SBCFCD Debris Dam.

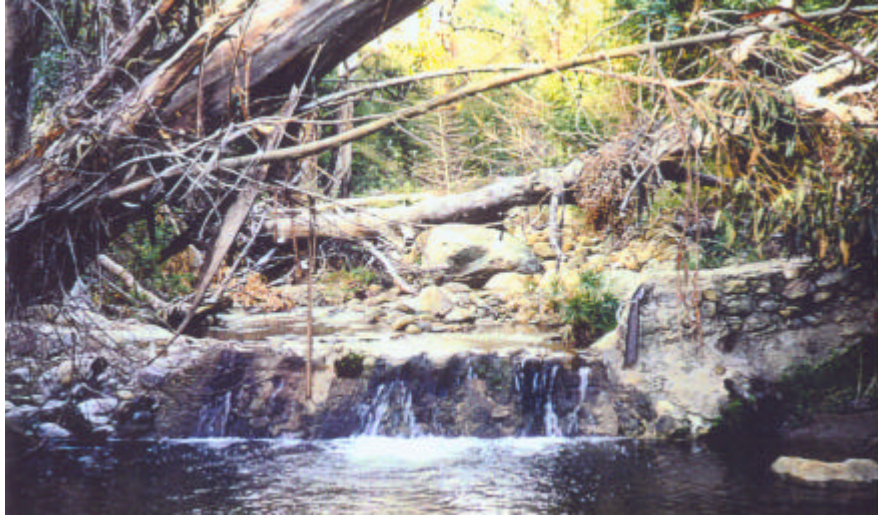
Location: 0.21 mile upstream from Santa Barbara County Flood Control District Debris Basin Dam (BR_AO_MY_17) Approximate elevation 300 feet

Description: The measurements and accompanying photograph are from Kuyper 1998. Access to this site was restricted. This eroded dam is composed of concrete and natural streambed stone. Where flows spill over the dam, Kuyper measured the height of the dam face at 3 feet, from the top to the surface of the downstream pool that had a depth of 6 feet. The dam measured 5 feet thick across the top.

Condition: The dam is highly eroded and appears to have been blown out in the past as an additional 2 feet of dam height exists on the river-left side. The dam is filled with a small amount of sediment on the upstream side. No apparent water diversion operations appear to be functioning at this structure, which appears to be obsolete.

Diagnosis: Sufficient jump depth occurs in the downstream pool to allow upstream steelhead passage with a low to moderate degree of difficulty during most flow conditions. The passage severity of this structure is dependant on the configuration of the downstream pool.

Recommended Action: Upstream passage for juvenile salmonids, and adults during low flows or with reduced downstream pool height, can be improved by removing this structure or cutting a notch 4 feet wide by 6 inches deep at center to concentrate low flows, improve attraction flows, and reduce the jump height.

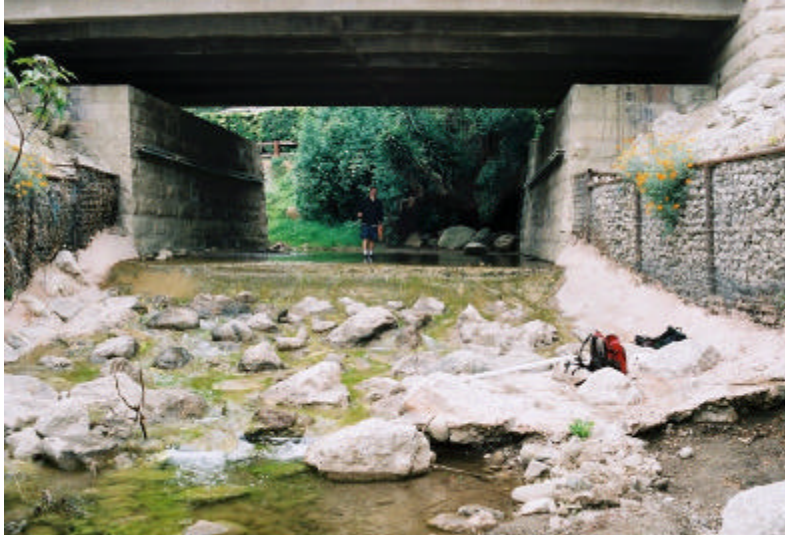
Location: San Marcos Road Bridge Crossing

Description: Downstream of the San Marcos Road Bridge, a sloping concrete and boulder riprap apron extends 23 feet 3 inches with an overall slope of 17.6% to the downstream pool. The overall height of the structure from the downstream edge of the apron to the top of the apron measured 4 feet 1 inch. At the upstream end of the boulder embedded apron, a 1-foot 8-inch tall concrete curb with a 55.3% slope and 8-inch vertical lip occurs. Above the concrete curb, a relatively flat and smooth concrete channel extends under the bridge 45 feet to the upstream end. The downstream pool measured 11 inches deep below the apron. The concrete-lined bottom and apron were constructed to protect the bridge supports that occur in the stream channel, by reducing bank erosion and scour.

Condition: The concrete appears to be in good condition with minimal damage and minimal downstream undercutting of the apron. Significant bank erosion occurs downstream despite pipe and wire bank revetment efforts.

Diagnosis: The presence of large embedded boulders in the downstream apron reduces stream flow velocities across the apron and increases water depth between the boulders to provide adequate passage conditions during moderate to high stream flows to the base of the concrete curb. The concrete curb and small vertical lip impose a significant impediment due to the accelerated stream velocities falling from the upstream concrete channel, lack of velocity breaks, and minimal downstream water depth on the apron for obtaining adequate acceleration for jumping the curb. Upstream passage during higher migration flows along the river-right side of the apron, where the concrete curb has no vertical lip, may be obtained with a moderate to high degree of difficulty. The concrete-lined bottom under the bridge would have accelerated stream velocities during migration flows that would add to the difficulty of migrating upstream of the entire structure. Overall, upstream adult steelhead passage may be possible with a high degree of difficulty and during a limited window of ideal migration flow.

Recommended Action: Work with the SBCPWRD to assess alternatives for improving upstream steelhead passage at this site. For the most effective long-term steelhead passage improvement, the feasibility of removing the entire crossing and replacing it with a wider span bridge that does not impact the stream channel should be assessed. In the short-term, a migration channel should be cut across the concrete bottom under the bridge with associated resting pools/velocity breaks to concentrate lower flows and reduce velocities across the concrete during high stream flows. This channel would also reduce the height of the concrete curb at the upstream end of the apron allowing easier access from the apron into the migration channel.

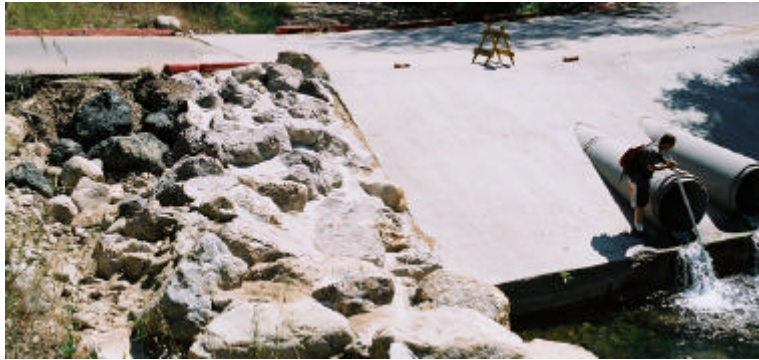
Location: San Antonio County Park

Description: This newer-looking concrete crossing extends 45 feet across the stream channel and has two 3-foot diameter concrete culverts conveying stream flows through the structure. The concrete culverts measured 65 feet 6 inches in length with slopes of 3.4%. Outflow from the culverts dropped 2 feet to the surface of the downstream pool, which had a jump depth of 2 feet 4 inches.

Condition: The concrete crossing itself appeared to be in good condition with minimal wear or cracking. Significant downstream scour has undercut the structure up to 3 feet. High stream flows that are conveyed over the top of the crossing have caused major bank erosion on the opposite side of the river-right riprap bank revetment.

Diagnosis: During higher migration flows, the conveyance capacity of the two culverts is quickly surpassed, and/or blocked with debris. These high stream flows are conveyed across the surface of the crossing and down the steep downstream. When the culverts are blocked with debris, upstream steelhead migration is not possible due to the excessive water velocities across the steep downstream face of the road crossing. With lower flow conditions and unobstructed culverts, shallow water depth in the culverts prevents upstream passage. When adequate water depth occurs in the smooth culverts, stream velocities are likely to great to allow upstream migration due to the moderately steep culvert slope and smooth concrete surface. The structure is likely impassable during all flow condition.

Recommended Action: This structure should be removed and replaced with a bridge to provide the most effective upstream steelhead passage, reduce bank erosion, eliminate sediment clearing of the culvert, prevent further downstream scour, improve aquatic connectivity for other native species, provide road access during high stream flows, eliminate crossing hazards during high stream flows, and to improve the aesthetic value of the adjacent public parks. This recently built public road crossing is directly blocking steelhead access to the protected upstream habitat in San Antonio County Park. This structure may have been built within steelhead habitat after the species was listed as endangered. Alternative access to the parking lot on the east side of the creek may be obtained from Highway 192, instead of the Tuckers Grove Park access currently being used, and eliminate the need to install a bridge across the creek at this site.

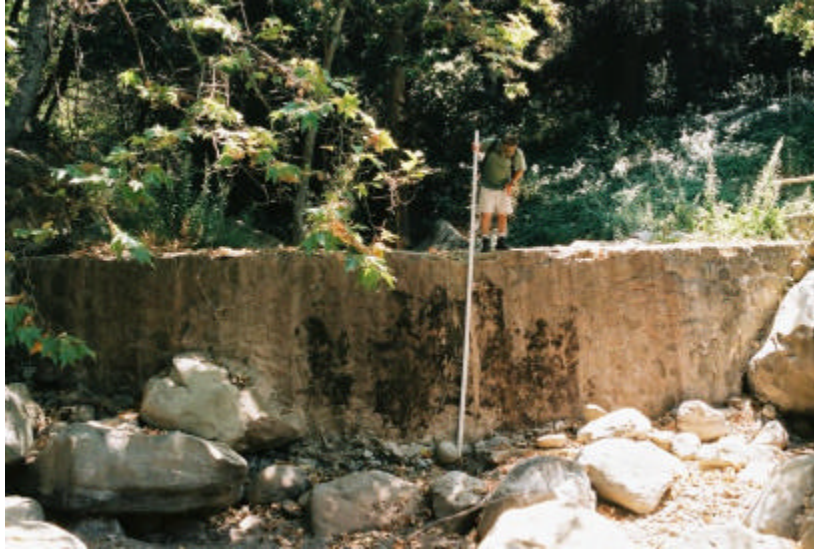
Location: Approximately 1.25 miles upstream from Highway 154 Bridge

Description: This stone and concrete dam measured 8 feet tall from the downstream substrate to the top of the dam and is keyed into boulders on the banks and within the streambed. Downstream bank erosion has seriously undermined a concrete patio on the river-left bank next to a small house. Sediment is filled to the top of the dam, which apparently does not serve a purpose anymore (pers. comm. Landowner). Surface stream flows were absent during the survey.

Condition: The dam is in poor condition with significant adjacent bank erosion.

Recommended Action: The landowner indicated that this dam is no longer used and the possibility of removing the dam may be desirable for the landowner due to the major bank erosion near the small house caused by downstream scour. Work with the landowner to remove this small dam. Removing this dam would likely be relatively easy and the native stones that make up the dam could likely be broken up and left on sight.

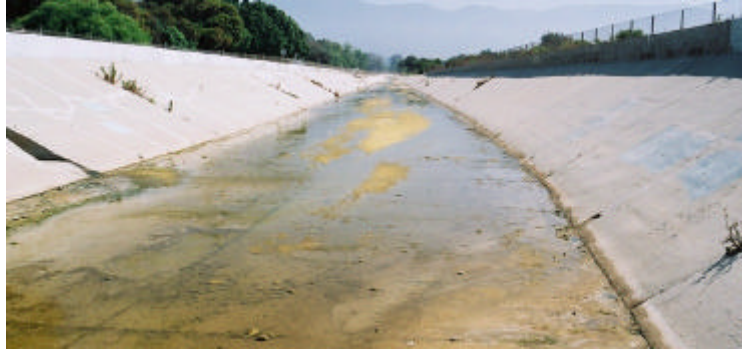
Location: From the Goleta Slough upstream approximately 0.78 mile to the upstream side of the Hollister Avenue Bridge

Description: This entire reach of San Jose Creek was created by realigning the stream from its former channel to the west into this trapezoidal concrete channel, which was built by the Army Corps or Engineers (pers. comm. Treiberg). Portions of the original natural stream channel continue to exist to the west, but the upstream end of this channel has been covered around Hollister Avenue and confined by development. The total length of the concrete lined channel measured 0.78 mile, using GPS. Stream flows are unconfined and spread out over the bottom of the lower channel and then become more confined in the middle and upper reaches as the slope increases. The lowest reach of the channel is relatively flat, but the slope gradually increasing to 1-2% at the upstream end. Under the Hollister Avenue Bridge the concrete channel measured 20 feet wide on the bottom and 9 feet tall to the bridge bottom. The channelized reach is currently maintained by the SBCFCD (pers. comm. Treiberg).

Condition: The channel is in poor to fair condition with significant concrete wear and several holes completely eroded through the bottom. A total of five significant holes through the concrete were observed. The channel walls are cracked in many places with vegetation growing through the concrete in several locations.

Diagnosis: The downstream end of the channel transitions into natural silt substrate and no jump exist for steelhead attempting to migrate into the channel. Prior to 1984, Beguhl noted that he observed adult steelhead ascend the concrete channel to within a couple hundred feet of the upstream end, but they could never successfully negotiate the upper reach (pers. comm. Beguhl). Sjovold also observed adult steelhead trying unsuccessfully to swim upstream in the concrete channel (See the Salmonid Documentation Table in Section 6.0 for more information about these sightings). The steepest slope in the channel occurs along the upper reach, where excessive water velocities and/or shallow water depth prevent upstream steelhead migration. The excessive length of the channel, with no significant resting areas, accelerated stream velocities, and/or shallow water conditions, prevents upstream steelhead migration.

creating a new stream channel is described below and may offer a solution that meets most stakeholder objectives and is not currently being considered. A coordinated effort with watershed stakeholders should assess the feasibility of abandoning the existing concrete channel and realigning the creek from near the upstream end of the channel at Hollister Avenue under Highway 217 to the open agricultural land to the east. Should the landowner(s) be interested in selling a portion of this agricultural land, a buffered riparian and stream corridor approximately 200-300 feet wide could be established through this area and into lower Atascadero Creek, near the grade control structure (BR_AO_1) at the Goleta Slough. Lower Atascadero Creek is not confined by adjacent development and appears to have a channel large enough to convey the increased flows. Historically, the streams draining into Goleta Slough jumped their banks and shifted in such a manner reconnecting to other adjacent streams near the slough. This action would have many potential benefits, including those described below.

- 1) Revival of a naturalized lower San Jose Creek and native riparian corridor (0.78 miles of which are currently lost with the existing concrete channel).
- 2) Development of public trails and bike paths along this creek parkway that are consistent with Santa Barbara County objectives of developing a park in this area and providing public linkages from Goleta to the ocean and the existing bike path along Atascadero Creek.
- 3) Increased flood control with an adequately sized, unconfined, natural stream channel, using biotechnical bank stabilization techniques, and a native riparian buffer zone.
- 4) Unimpeded migration of aquatic species, including steelhead.
- 5) Improved water quality into the slough and ocean would be accomplished by providing riparian shade and restoring the biofiltration functions of a natural stream channel.

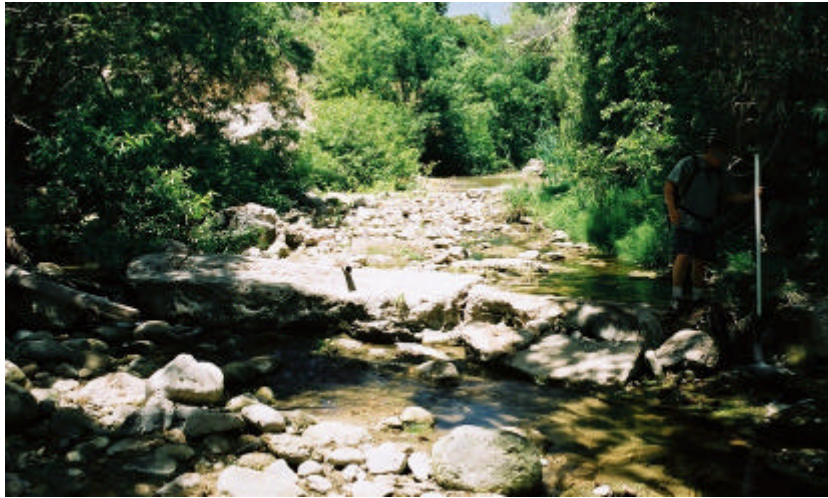
#2= This grade control structure is highly damaged and broken into at least three separate pieces. The height from the downstream pool to the top of the concrete structure measured 12 inches. The maximum pool depth downstream at the jump location measured 1 foot 2 inches.

Diagnosis: All of these grade control structures will have minimal jump heights, or be completely submerged, during migration flows and impose a minimal to low degree of difficulty for upstream passage of salmonids. Juvenile salmonids can migrate upstream of these structures during moderate flow conditions.

Recommended Action: Improvements for fish passage at these sites would provide a minimal to low benefit to steelhead, but downstream scour might alter their configuration and severity in the future. While #3 serves a function as a gaging station, both #2 and #6 are in extremely poor condition, do not appear to be essential or maintained, and could be broken up and/or removed to eliminate the possibility of the structures increasing in severity in the future. Continue to monitor these structures if left in place.

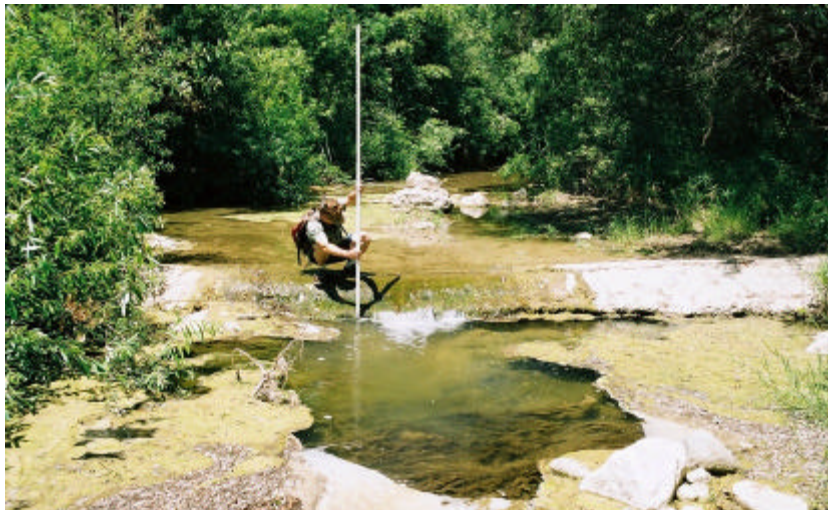
#3= This grade control/gaging weir measured 37 feet across the channel and 12 inches in height from the surface of the downstream pool, which had a jump depth measured at 2 feet 9 inches. This structure is maintained by SBCFCD (pers. comm. Treiberg).

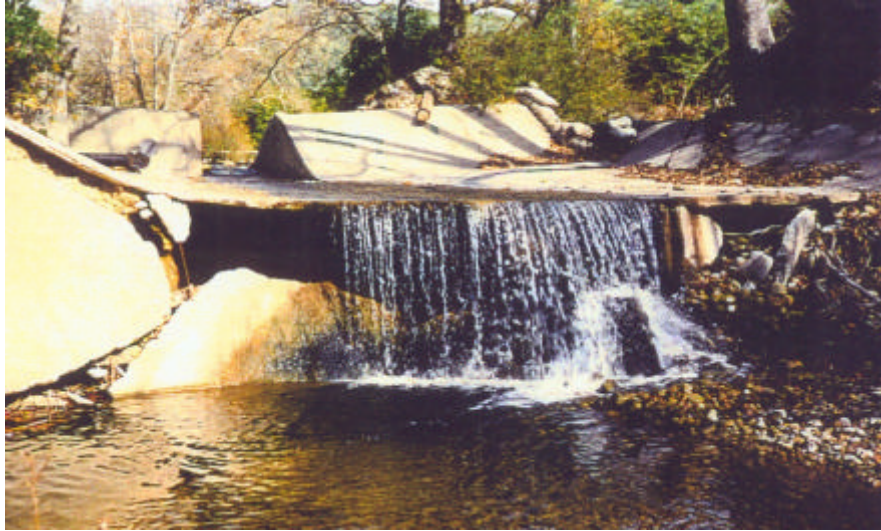
Location: Approximate elevation 145 feet

Description: Access to survey this structure was not obtained. The following survey measurements and accompanying photograph of the dam are from Kuyper 1998. Kuyper reported that: The overall height of this structure measured approximately 11 feet from the downstream pool surface to the top of the dam. A concrete spillway measuring approximately 65 feet in length extends downstream from the 4-foot tall dam and flows drops nearly 7 vertical feet off the end into a pool with a maximum depth of 5 feet. Low stream flows along the structure were less than 2 inches deep and moderately accelerated. Photo observations suggest that this is a flashboard dam with a narrow slot in the dam designed to accept flashboard insert, which would allow the storage of water upstream (pers. observ. Stoecker).

Condition: This structure is reportedly no longer used for the purpose of providing a water supply for surrounding agricultural applications or any other apparent function (Kuyper, 1998). Photo observations indicate that this structure is in extremely poor condition with major downstream undercutting and concrete spillway failure.

Diagnosis: Kuyper noted that this structure would “definitely” impede steelhead migration during low stream flows due to insufficient water depths and its height above the downstream channel bottom. High discharge conditions may yield sufficient stream depth along this structure, but stream flows may reach excessive velocities as they are forced out of the small weir and travel along the spillway. An upstream migration severity of extremely high to impassable was applied to this structure.

Recommended Action: Work with the owner to assess the feasibility of removing this structure due to its reported obsolete status, extremely high severity or impassability, deteriorating condition, and presence of up to 2.25 miles of high-quality salmonid habitat upstream.

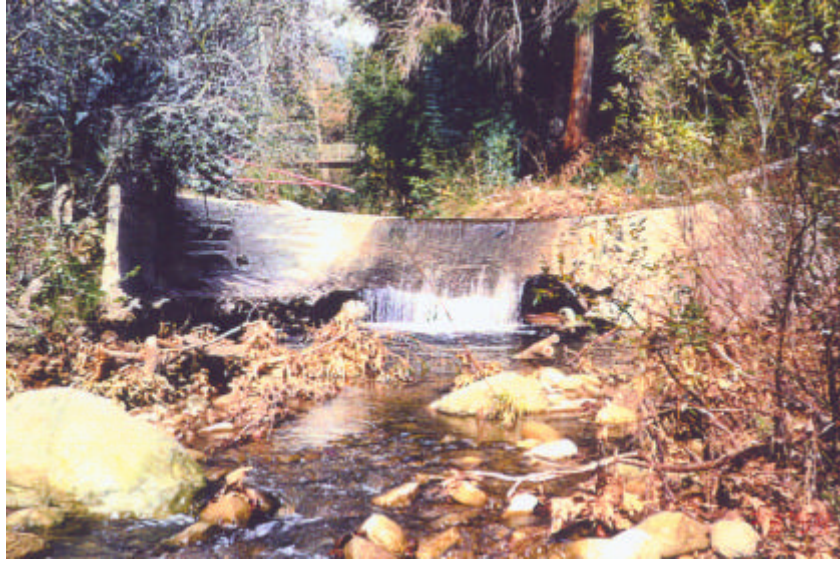
Location: Approximate elevation 175 feet

Description: Access to survey this structure was not obtained. The following survey measurements and accompanying photograph of the stream crossing are from Kuyper 1998. Kuyper reported that the overall height of this 25-foot wide concrete stream crossing measured approximately 8 feet from the downstream pool surface to the top of the crossing. The downstream pool depth measured 5 feet. All stream flow is conveyed over the top of the crossing and then falls steeply down a concrete apron and vertically off the apron 2 feet above the downstream pool.

Condition: Photo observations indicate that this structure is experiencing major downstream undercutting and adjacent bank erosion.

Diagnosis: During migration flows the high water velocities associated with the steep apron and excessive jump height likely present impassable conditions for all upstream steelhead migration, but extremely difficult passage may be possible depending on how much the downstream pool backfills during very high stream flow conditions.

Recommended Action: Work with the owner to assess the feasibility of removing this structure and replacing it with a bridge or other streambed simulation strategy that allows unimpeded fish passage and improved landowner access and safety at this crossing. Additional assessment of the sediment accumulation upstream of the crossing and impacts of removing the structure are needed.

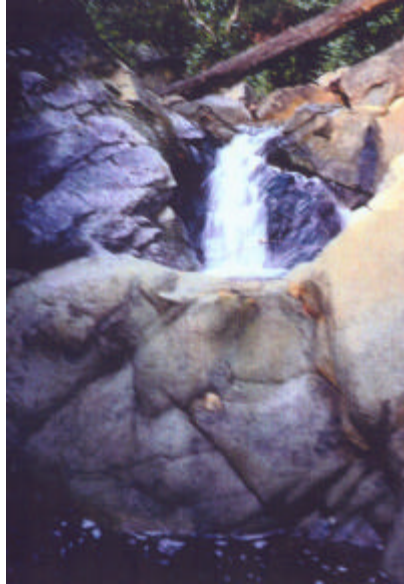
#7= This two-part bedrock cascade measured 16 feet in height over two separate 8-foot tall sections.

Diagnosis: Kuyper noted that both #7 and #8 have the potential to prevent upstream steelhead migration. The steep slopes and height associated with these two features may produce excessive velocities and/or jump heights for upstream steelhead migration during most or all stream flows. Both #7 and #8 were given severities of extremely difficult or impassable. The excessive height of the bedrock waterfall (#9) is impassable to steelhead during all flow conditions.

Recommended Action: No recommended actions for these natural features.

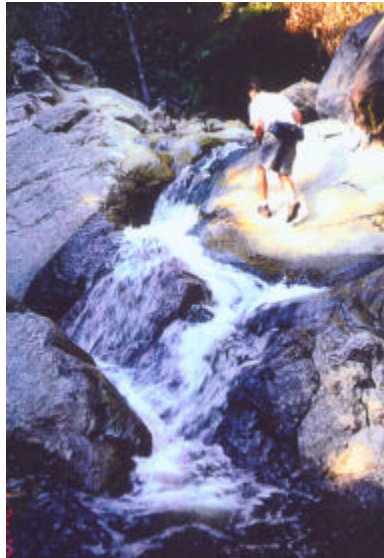
#8= This bedrock chute measured 20 feet in height.

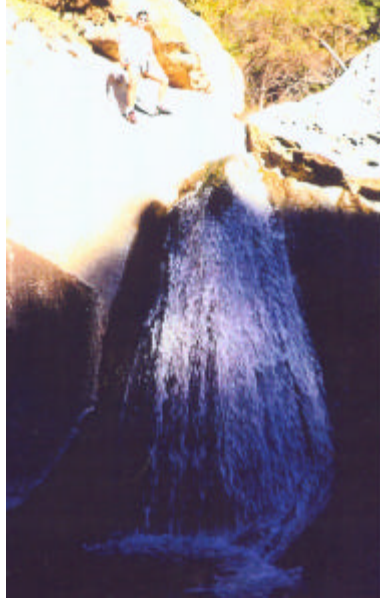
#9= This bedrock waterfall measured 30 feet in height.

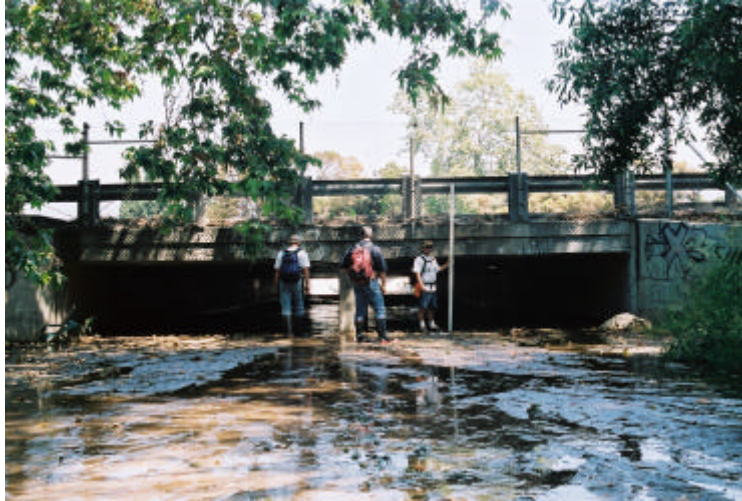
Location: Highway 101 Crossing

Description: According to the engraved date on the crossing, this 195-foot long double box culvert was built in 1945. Each culvert measured 16 feet wide and 4 feet tall. The bottom of the relatively flat culverts was covered with 5 inches of fine sediment.

Condition: The culverts appeared to be in good condition, but may be undersized with the short culvert height.

Recommended Action: Any fish passage improvement action at this site should be completed in coordination with the long upstream flood control channel that is impassable. See recommended action for BR_AO_SJ_SP_3.

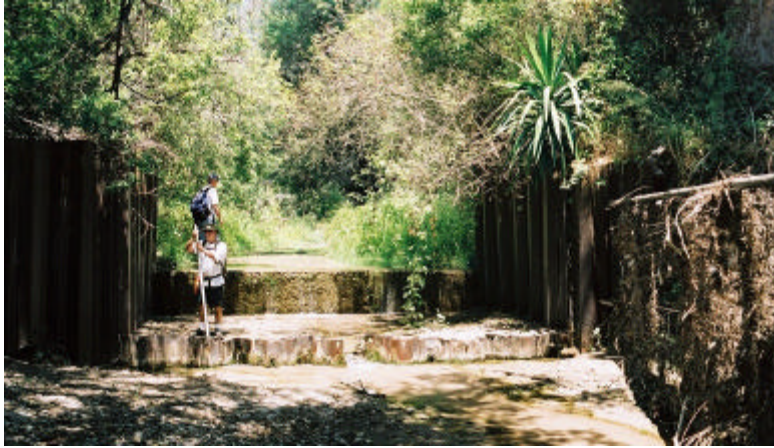
#4= This unique concrete curb grade control has adjacent corrugated metal walls and a small metal grade control downstream with a space at center. The height of the concrete curb above the downstream substrate measured 2 feet 11 inches. The curb measured 19 feet across and 2 feet thick. The small space in the downstream metal grade control would allow upstream passage to the base of the concrete curb. No pool depth was present at the base of the curb during low flows, but during migration flows adequate depth would allow an upstream jump with a moderate to high degree of difficulty.

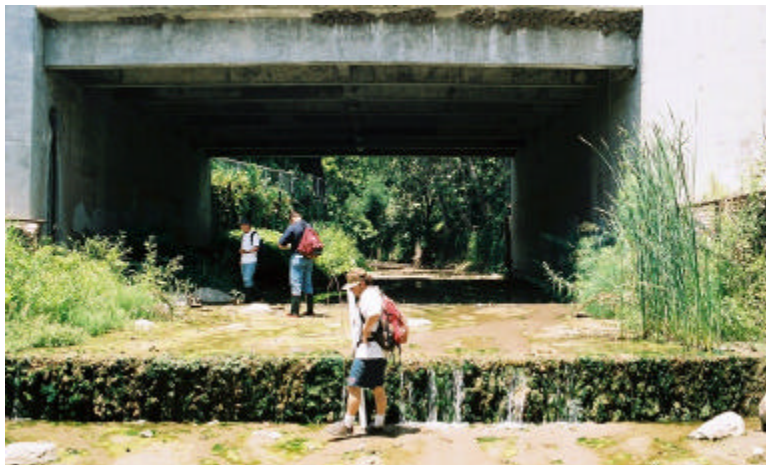
#5= This 1-foot thick concrete curb measured 2 feet 3 inches in height from the downstream substrate. No pool downstream was present and flows were spread out across the curb. Sediment was filled to the top of the upstream side of the structure. The low height of this structure would present a low to moderate degree of difficulty for an upstream jump during migration flows.

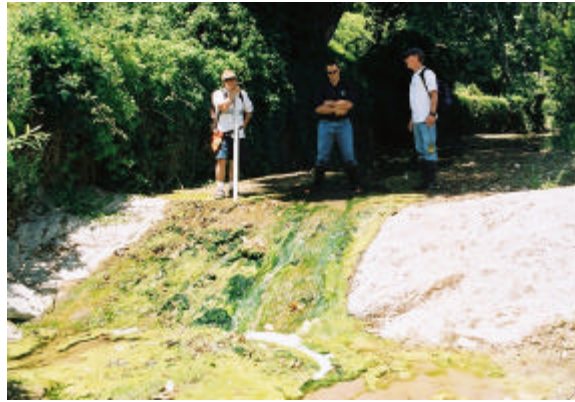
#6= This concrete and boulder riprap grade control structure measured 2 feet 9 inches tall from the downstream substrate and slanted 8 feet upstream at a slope of 34%. No downstream pool was present. During migration flows upstream passage of adult steelhead at this site would have a moderate to high degree of difficulty due to the accelerated velocities over the steeply sloped structure.

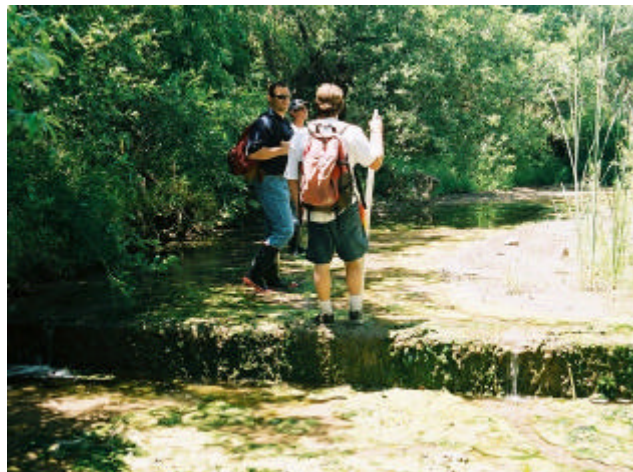
#7= This 1-foot thick curb measured 1 feet 3 inches tall from the surface of the downstream pool, which measured 13 inches deep. Upstream passage at this short structure has a minimal degree of difficulty during migration flows.

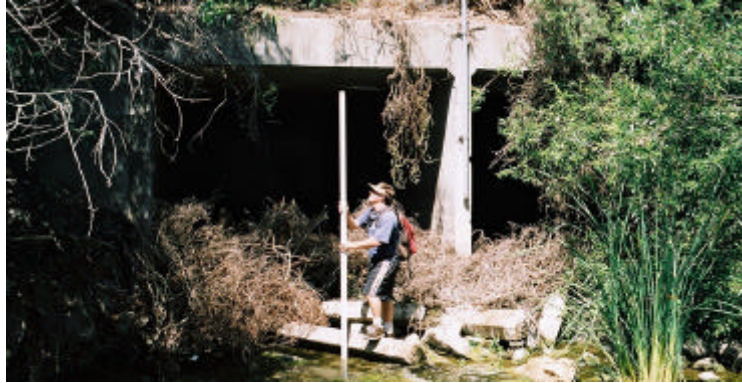
Location: Approximately 50 feet downstream from UPRR Crossing

Description: The owner and purpose of this structure could not be determined, but it may have been built by UPRR for protection and/or maintenance access to the railroad upstream or by the property owner on the river-right side of the creek (pers. comm. Treiberg). This gradually turning double box culvert measured 105 feet in length along the center support in the culvert. Each box culvert measured 12 feet wide by 8 feet tall. Downstream of the culvert, flows drop 2 feet 3 inches onto concrete slabs and into the small pool below, which had a maximum depth of 2 feet 5 inches. The bottom of the culvert is smooth concrete with a mild slope. At the upstream end of both culverts, a steep, concrete apron rises 2 feet 3 inches over a distance of 8 feet with a slope of 28% to a pool upstream.

Condition: The structure appears to be in fair condition with minimal wear and moderate downstream scour and bank erosion.

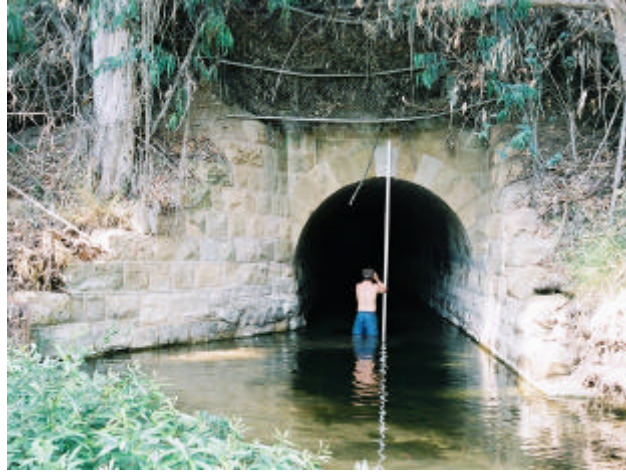
Location: UPRR, Highway 101, S.B. County road crossings

Description: This extremely long culvert was not completely surveyed due to high amounts of automotive exhaust fumes encountered inside the culvert during two survey attempts. The outlet and inlet conditions are described here. The outlet of the culvert is the UPRR railroad section, which is composed of cut stone blocks. The height of the flat bottom arch culvert measured 10 feet 6 inches at center and 9 feet 6 inches wide at the bottom. Water was backed up into the culvert at a depth of 1 foot 10 inches. The inlet of the culvert is part of the CALTRANS section, which is composed of smooth concrete and has a shallow U-shaped bottom and arch top measuring 13 feet 6 inches in height and 14 feet wide. A concrete apron extends upstream 75 feet from the culvert inlet at a slope measured at 3.8% to a metal debris grate. The slope inside the culvert appeared to be slightly less than the apron. Based on observations of this crossing from outside, the total length of the culvert is estimated to exceed 500 feet in length.

Condition: The culvert appeared to be in fair condition with minimal wear and no significant damage observed. The condition inside the culvert was not determined.
