Steel head Assessment and Recovery Opportunities in Southern Santa Barbara County, California

**BY
Matt W. Stoecker
and
Conception Coast Project**

June 2002

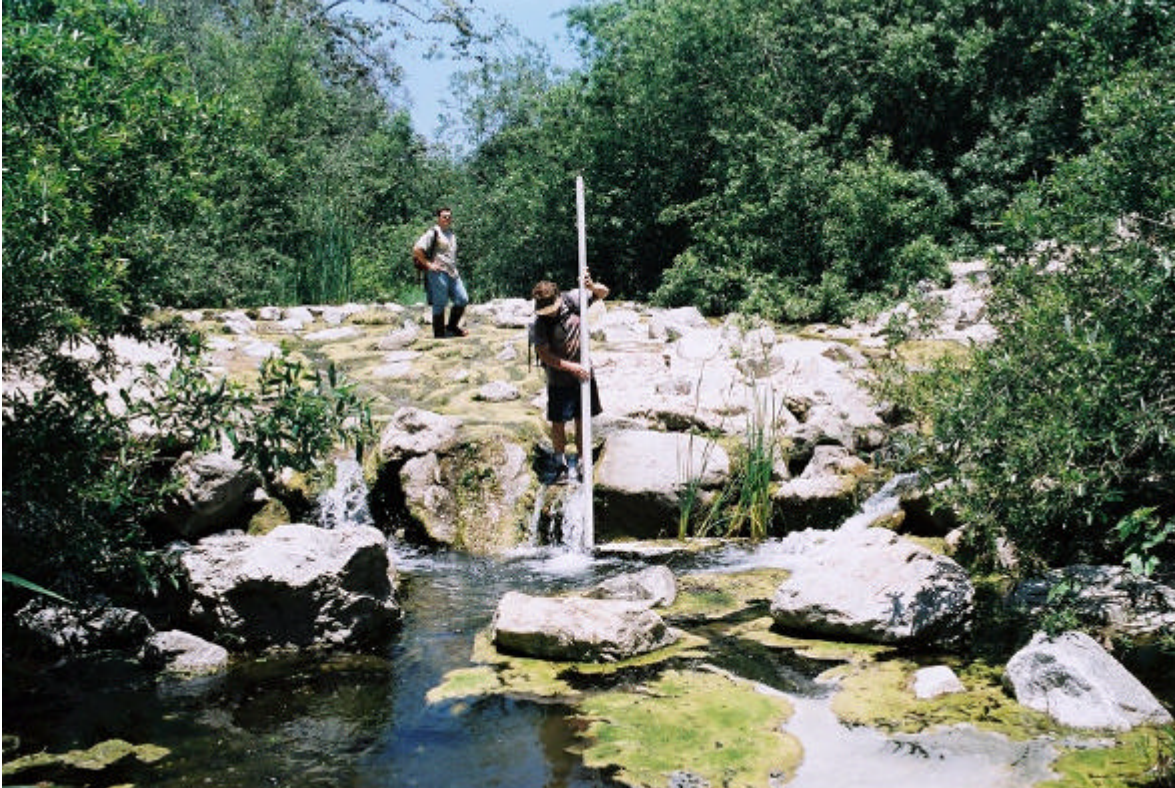
#21- This structure measured 45 feet from the top to the downstream pool surface with a slope of 10.9%. The overall height of the structure measured 6 feet 9 inches from the downstream pool surface to the top. The maximum pool depth measured 3 feet.

Condition: Both structures appear to be in fair conditions with moderate wear and adjacent bank erosion.

Diagnosis: During migration flows, adult steelhead would be able to swim or jump onto both of these structures. Once on the structures, salmonids would encounter high water velocities and minimal areas to rest or gain momentum to jump. The presence of large embedded boulders on the apron would provide some velocity breaks and extremely difficult upstream passage may be possible for adult steelhead when flow conditions are ideal. Both structures are major impediments to upstream passage and would severely limit or block upstream movement of steelhead during migration flows.

Recommended Action: Due to the high severity of these structures and their location relatively low in the watershed, an effective fish passage project needs to be implemented at these sites. While the most effective, self-sustainable solution for passing steelhead at this site would be to remove the structures and reinforce adjacent stream banks, this option may not be feasibly depending on the effectiveness of these structures for flood control. Work with the SBCFCD to assess the effectiveness and desirability of these structures for flood control within the system and alternatives for fish passage at these sites. If the structures must remain in place, providing adequate step pools up the structures is recommended.

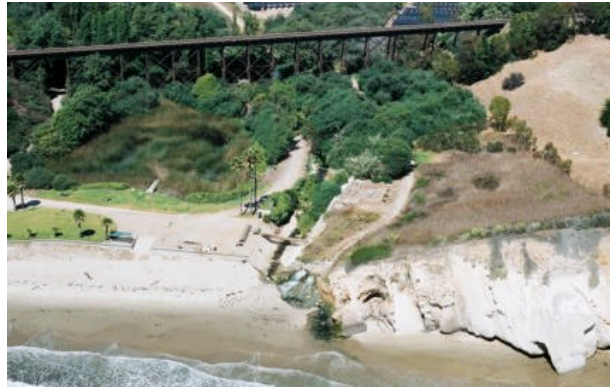
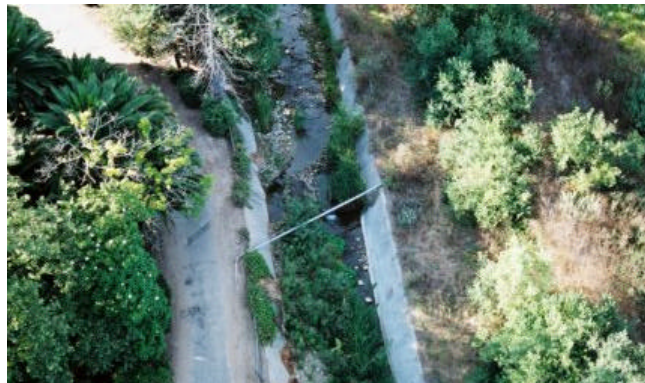
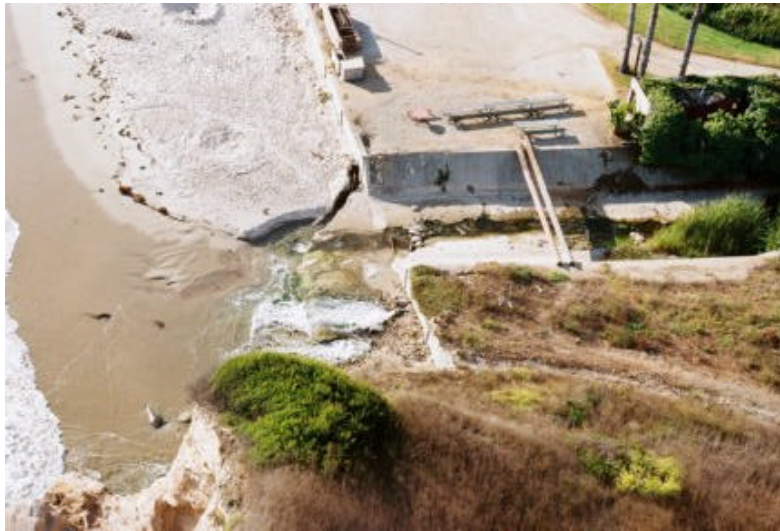
Description: Access to ground survey this structure was not obtained and information about this structure was limited to aerial surveying and personal communication with knowledgeable individuals. This trapezoidal concrete channel extends from the mouth of Dos Pueblos Creek upstream approximately 0.2 mile, to near the first upstream road crossing. At the downstream end of the channel a concrete apron approximately 15 feet long extends out over the sand beach where flows drop approximately 2 feet into a small, sand-bottom pool that is influenced by the waves and tides. The channel appears to have a bottom width of approximately 20 feet and slanted walls rising approximately 7 feet. The channel confines stream flows under one road crossing, the UPRR trestle, and past what remains of the former lagoon, which continues to exist on the west side of the channel, but is now disconnected from the creek and sea. Page reported that chemicals are sprayed into the isolated lagoon at the mouth of Dos Pueblos Creek for mosquito abatement. The history of this structure could not be determined and the may have been built by UPRR and/or the Dos Pueblos Ranch. Dos Pueblos Ranch owns the surrounding land.

Condition/Sizing: The channel appears to be in poor condition with significant damage along, and completely through, the channel at several locations. During biological monitoring surveys for Level 3 Communications in 2001, Carl Page reported that the road adjacent to the highly damaged concrete channel is being severely undermined (pers. comm. Page). Vegetation is also present growing within and through the channel.

Diagnosis: Locating and jumping into this channel from the ocean presents at least a moderate to high degree of difficulty to sea-run steelhead. The narrow length of beach and tidal action downstream of the channel prevents an adequate sand bar from forming and maintaining a significant lagoon. Depending on the configuration of the sand downstream, upstream migrating adult steelhead may not have adequate pool depth to jump onto the channel during most, or all, flows. Virtually no acclimation zone between fresh and salt water exists for potential upstream and downstream migrating salmonids.

In addition to the physical difficulties encountered by steelhead trying to jump into the channel, at least two metal pipes discharge water onto the concrete apron adjacent to the channel outlet. During two aerial surveys, the amount of discharged water exceeded the amount of stream flow exiting the channel. This water is apparently coming from the aquaculture operation approximately 0.15 mile upstream on the east side of the creek (pers. comm. Page). The discharged water may significantly deter or completely eliminate upstream passage of steelhead onto the channel depending on the chemical and temperature characteristics of this water, which may be intolerable to steelhead. The different water chemistry being discharged may also prevent steelhead from even attempting to enter Dos Pueblos from the ocean due to the altered water chemistry characteristics flowing into the ocean, which steelhead hone in on to locate their natal stream or other suitable creek during their spawning run.

If upstream migration into the channel is achieved, steelhead passage to the top of the channel appears to be relatively easy during migration flows due to the mild slope and many velocity breaks provided along the channel's damaged, substrate-lined, and vegetated bottom. Several areas of the upper channel were not observed from the air due to the thick riparian conditions near the upstream end. Page noted that steelhead migration along the channel is achievable, but expressed concern about steelhead entry into the channel from the ocean and potentially negative effects

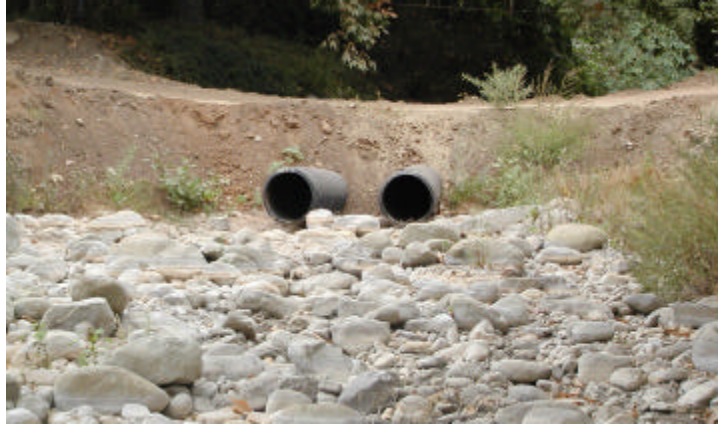
Description: Observations of this structure were limited to the air due to access restrictions. Carl Page, a biological monitor working on the Level 3 Communications project on Dos Pueblos Creek, provided the accompanying photograph. This dirt-fill road crossing has two smooth plastic culverts approximately 2 feet in diameter and 25 feet in length. The culverts sit just above the streambed level on the downstream side.

Condition: This crossing appears to have been recently constructed or modified. Dirt-fill crossings with undersized culverts are highly susceptible to blowing out during moderate to high stream flows.

Diagnosis: Due to the relatively small diameter of the culverts, length, and smooth interior configuration, migration flows through the culvert would be confined and accelerated with no velocity breaks for upstream migrating salmonid. Depending on the condition of the culvert, slope, and configuration on the upstream end of the culvert, this crossing presents a significant impediment or complete barrier to upstream steelhead migration.

Recommended Action: Work with the landowner to replace this structure with a bridge, large embedded culvert, or bottomless arch culvert that will not impeded steelhead passage and will provide effective and safe vehicle passage. Providing steelhead access upstream of this structure is critical because the creek often dries up downstream of this site and the most productive spawning and rearing habitat in the watershed occurs upstream.

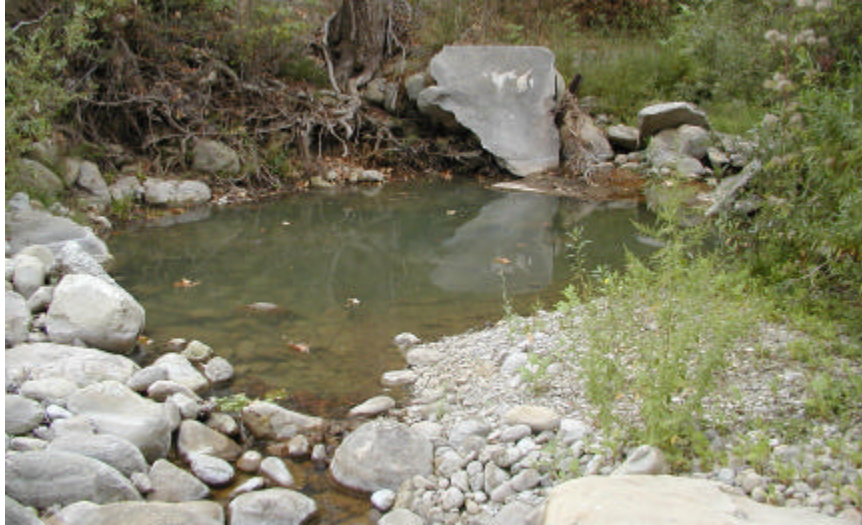
Description: Information about this structure and the accompanying picture was obtained from Carl Page, a biological monitor working at Dos Pueblos Creek for Level 3 Communications. Remains of this old concrete weir still exist on the stream banks and some concrete slabs are present in the channel. The weir no longer functions and does not span the width of the channel. A natural bottom extends between the old weir abutments.

Condition: This weir is almost completely washed away.

Recommended Action: The remaining concrete and metal should be removed to eliminate potential blockage at this site, or further downstream, and improve the ease of upstream migration.

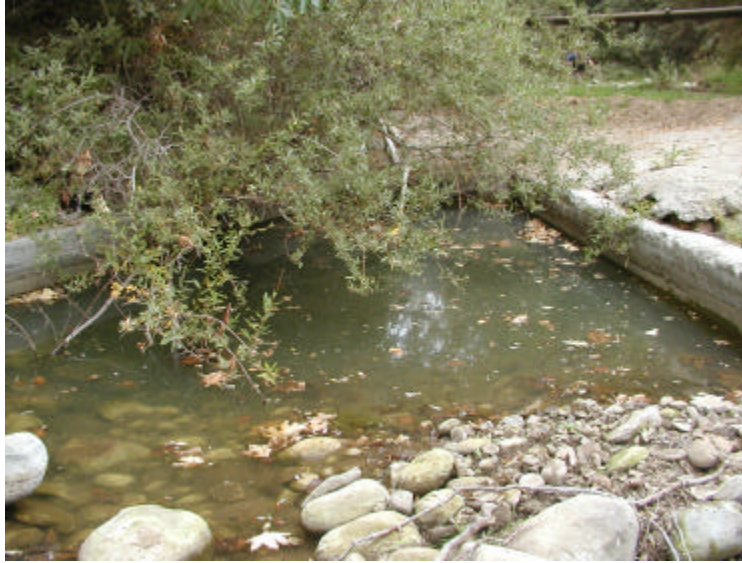
Description: Information about this structure and the accompanying picture were obtained from Carl Page, a biological monitor working at Dos Pueblos Creek for Level 3 Communications. This grade control structure consists of an upstream V-shaped concrete curb and apron that extends upstream. The curb is approximately 1-foot thick and extends 1-2 feet in height above the downstream pool during subsurface flows. The upstream apron has a moderately steep slope.

Condition: The structure appears to be in poor condition with moderate cracking and damage occurring on the curb and apron.

Recommended Action: Assess the desirability of this structure with the landowner and determine if it is necessary. If the grade control is not needed, it should be removed to allow unimpeded upstream passage for salmonids.

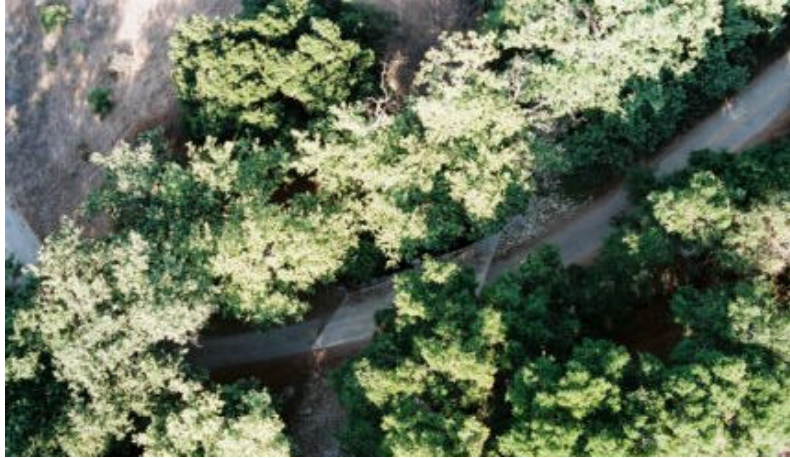
Description: Access to survey Gato Creek was not obtained. Information was obtained from *Gato Creek Faunal Survey* (Hunt 1995), personal communication with Hunt (2001), and aerial photography. Hunt observed this road crossing in 1995 and reported that downstream of the paved crossing had experienced a high amount of scour and the road surface was elevated at least 8 feet above the downstream substrate. Stream flows were conveyed across the top of the crossing with sediment backed up to the top of the upstream side of the road, which completely blocked a culvert passing under the road (pers. comm. Hunt 2001).

Condition: The crossing appears to be in extremely poor condition with major erosion and undercutting from scour.

Recommended Action: Work with the Las Varas Ranch to assess the feasibility of replacing this crossing with a bridge that does not impact the stream channel, provides unimpeded upstream steelhead access, and improved vehicular access during higher stream flows.

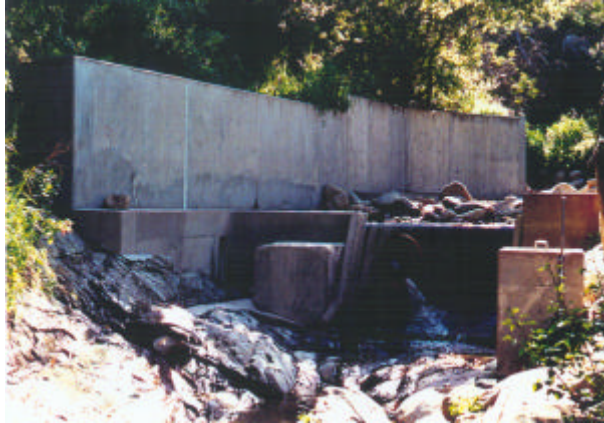
Description: Access to survey Gato Creek was not obtained. Information about this dam was obtained from the *Gato Creek Faunal Survey* (Hunt 1995), personal communication with Hunt (2001), and photo-observations were made from pictures provided in Hunt 1995 (attached). See the Santa Barbara County *Gato Creek Water Diversion. Final Environmental Impact Report. 83-EIR-19; 82-MP-4* and Hunt 1995 for more detailed information regarding the diversion dam operations and associated off-stream reservoir. The downstream face of the dam appears to be between 4-5 feet in height above the downstream bedrock, where no observable pool exists. It appears that this dam occurs on Los Padres National Forest land.

Diagnosis: Upstream steelhead migration does not appear to be possible due to the lack of an observable downstream pool to provide acceleration needed for the jump over the concrete dam. During high stream flows, adequate downstream depth may develop that could allow limited upstream steelhead passage. Additional surveying of the structure is needed to assess fish passage in more detail.

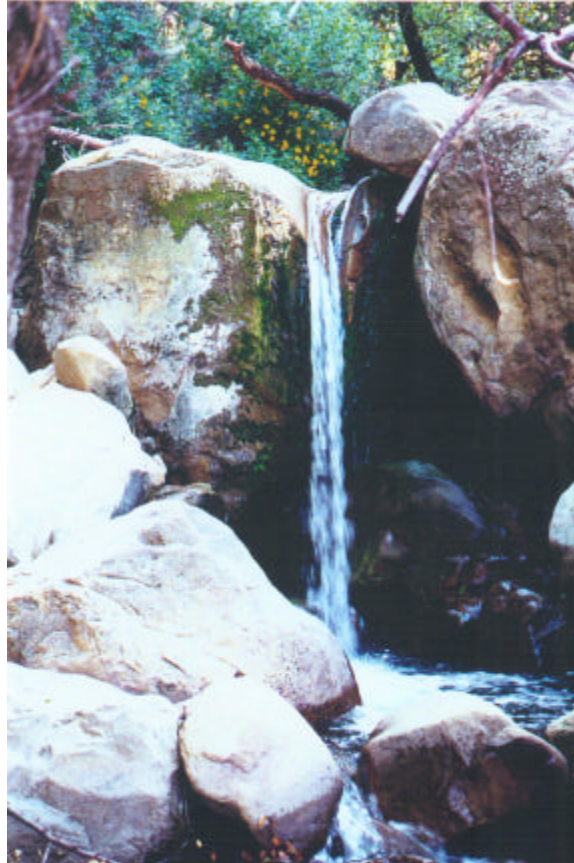
Description: Access to survey Gato Creek was not obtained. Information about this waterfall was obtained from the *Gato Creek Faunal Survey* (Hunt 1995), personal communication with Hunt (2001), and photo-observations were made from a picture provided in Hunt 1995 (attached). The waterfall is said to occur approximately 500 feet upstream of the diversion dam (Hunt 1995). The bedrock waterfall appears to be between 7-9 feet tall with a small pool downstream.

Diagnosis: The limited size of the downstream pool and excessive height of the waterfall, suggest that upstream steelhead migration would likely not be possible and that this feature may signify the natural upstream limit to steelhead migration in the watershed.

Recommended Action: No recommended action for this natural feature.

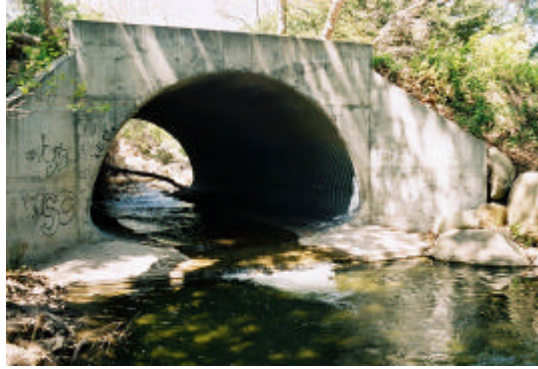
Description: This 41-foot long corrugated metal culvert has a shallow U-shaped bottom and half circle top that is encased in concrete. A concrete apron with a minimal slope extends 4 feet 10 inches from the downstream end of the culvert to a pool downstream, which is only 3 inches below the concrete lip during low flows. An apron of the same length occurs between concrete wing walls on the upstream end of the structure and is at streambed level. The culvert had a measured height of 9 feet 10 inches at center and a maximum width of 16 feet 6 inches. The metal corrugations within the culvert measured 2 inches in depth. The downstream pool measured 11 inches deep just downstream from the apron.

Condition: The bottom of the culvert is extremely rust-damaged with several holes through the culvert and exposed substrate below. Large woody debris was stuck sideways at the inlet of the culvert presenting a moderate risk of future blockage.

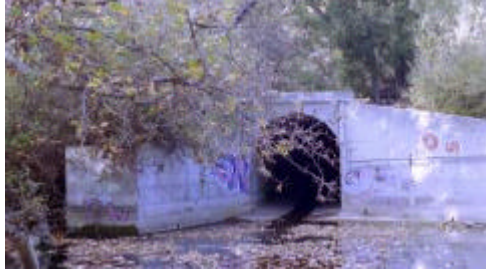
Description: This concrete culvert measured approximately 450 feet in total length with several changes in slope. A concrete apron measuring 25 feet long extends from the downstream end of the culvert between two wing walls and into a pool downstream, which had a maximum depth of 4 feet. The downstream pool backwatered the entire apron to the downstream end of the culvert. At the downstream end of the culvert, the height measured 11 feet 9 inches at center and the width measured 10 feet near the bottom. The bottom of the culvert has a shallow U-shape that measures 8 inches deep from center to the sidewalls of the culvert. The original culvert has been added onto and now consists of two separate reaches that connect 240 feet upstream from the outlet of the culvert. The downstream 240-foot reach of culvert has a slope of approximately 2%. The upstream 210-foot reach has a steep transition at the downstream end and a measured slope of 6.5 % over the upstream-most 95 feet.

Condition: The upstream 210-foot reach of culvert is extremely damaged with several large holes completely through the bottom, major undercutting, flows reemerging into the culvert through cracks, and exposed metal reinforcement bars. These damaged holes have produced large pools with several feet of depth. In its current state this structure has a high risk of failure.

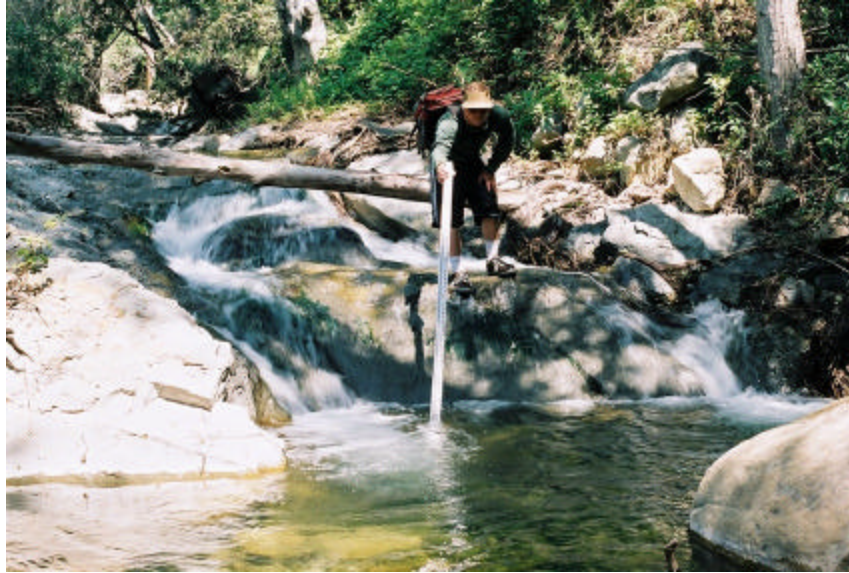
#5- This series of bedrock chutes measured 19 feet long and 5 feet 6 inches tall from the surface of the downstream pool to the top of the chute. A small, 1-foot deep pool exists half way up the chute. The downstream pool measured 4 feet 2 inches deep.

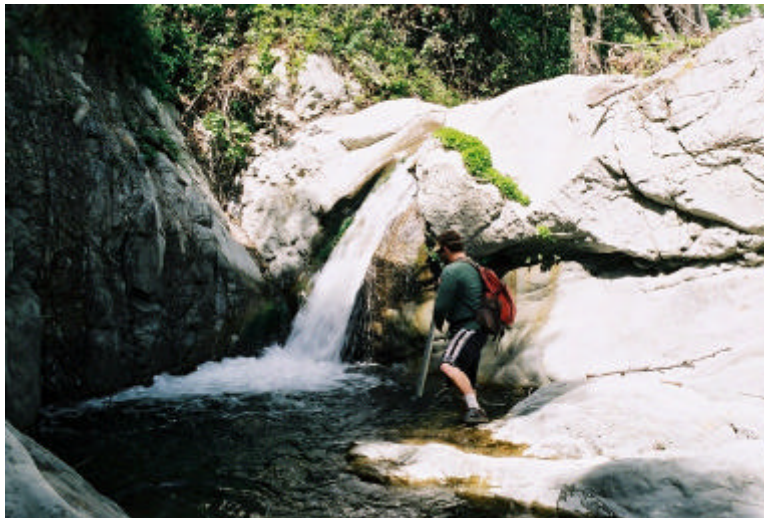
#6- This bedrock waterfall measured 8 feet tall from the downstream pool surface to the top of the waterfall. The maximum pool depth downstream measured 6 feet 1 inch. The upper 6 feet of

the waterfall conveys water down a very steep bedrock chute that drops vertically 2 feet above the downstream pool.

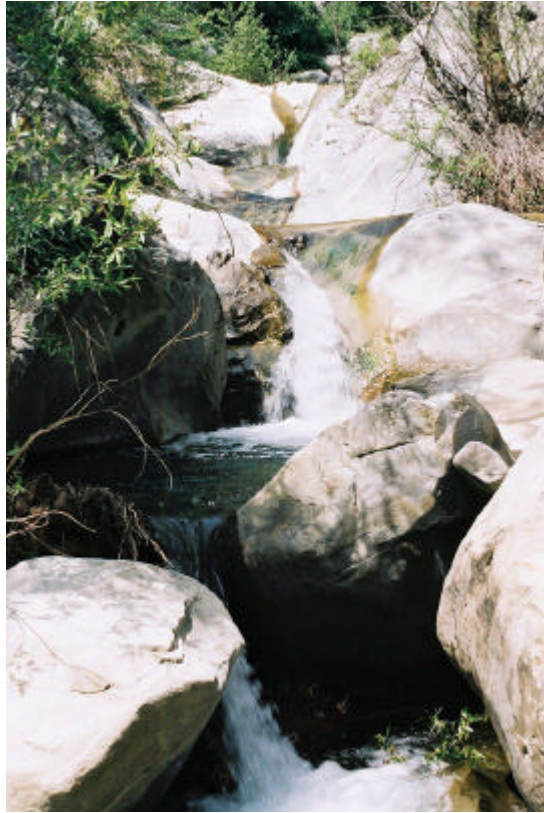
#7- This series of four bedrock chutes measures over 25 feet in height with the upstream-most chute measuring over 12 feet in height. No significant pool exists immediately downstream of the upper chute.

Condition: All bedrock features appear very stable.

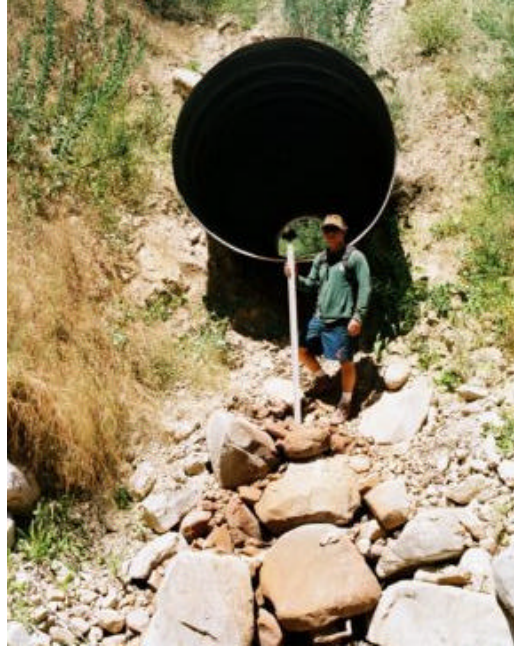
Description: This dirt-fill crossing contains a 6-foot diameter corrugated metal culvert that measured 61 feet 2 inches in length. The middle of the culvert was moderately squashed with a diameter of 5 feet 3 inches at the center. The height from the downstream lip of the culvert to the streambed downstream measured 8 feet 7 inches.

Condition: The culvert is in fair shape with minimal damage from rust, but significant compaction in the center. Significant undercutting of the structure downstream and associated bank erosion is occurring. Four washed-out culverts are scattered downstream from this site that apparently failed at this crossing in the past.

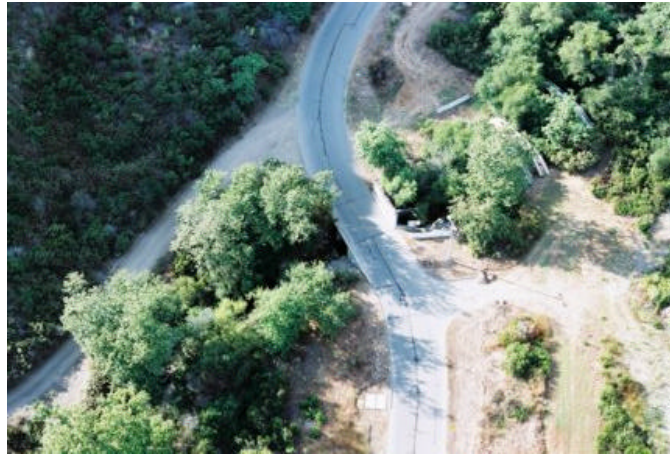
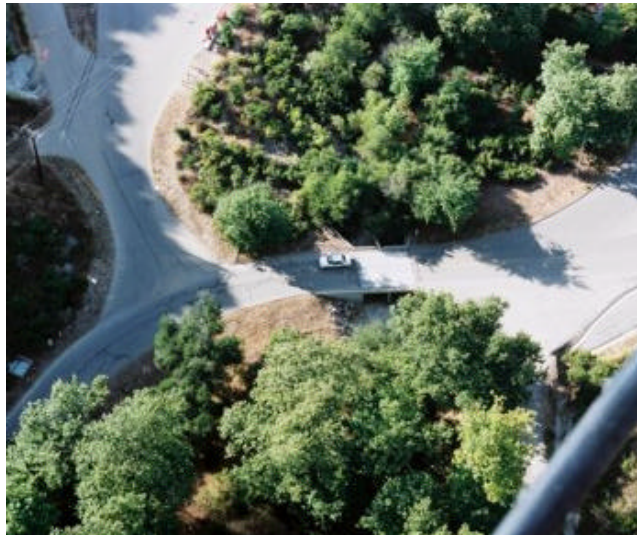
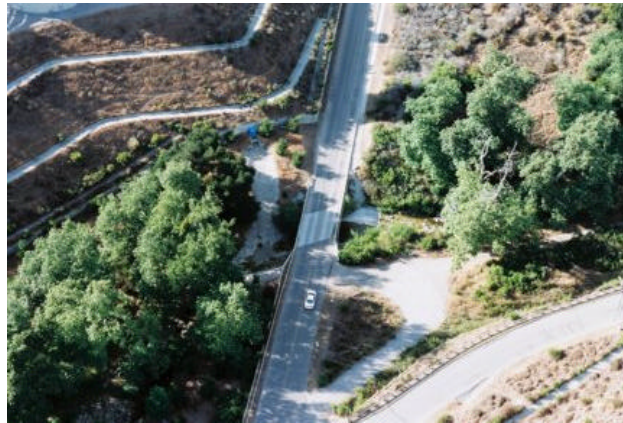
#2,3,5,7- These crossings are similar in construction and were likely built around the same time with the development of the Las Flores Plant road system. The observed two-lane road crossings convey stream flows through concrete double-box culverts. Wing-walls extend from the upstream and downstream sides of the culverts and some appear to have concrete bottoms and sloping inlet and/or outlet aprons associated with them.

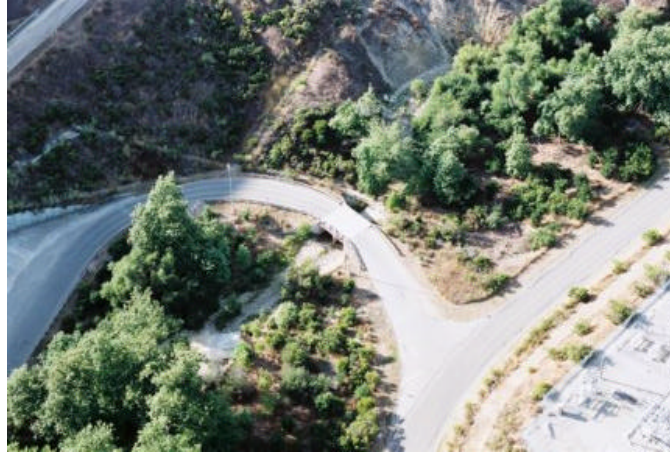
BR_CL_4,5

#4- This structure is located approximately 100 feet downstream from #5. The concrete structure appears to be an obsolete concrete road crossing that is no longer used due to the double-box culvert crossings just upstream and downstream. This old crossing has a metal culvert extending from the downstream side that appears to be filled with sediment on the upstream side. An estimated vertical drop of 3 to 4 feet occurs on the downstream side. The concrete is significantly undercut on the downstream side and the culvert appears to be highly rusted.

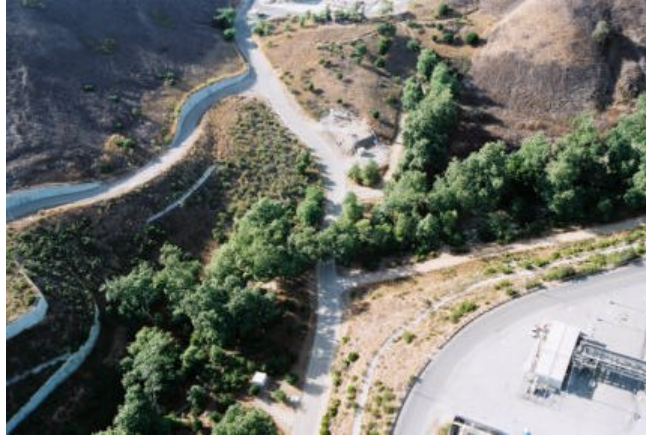
BR_CL_6

#6- This road crossing occurs just downstream from the confluence of Las Flores Creek and was covered from view by riparian vegetation adjacent to the crossing. The configuration of the crossing could not be determined.

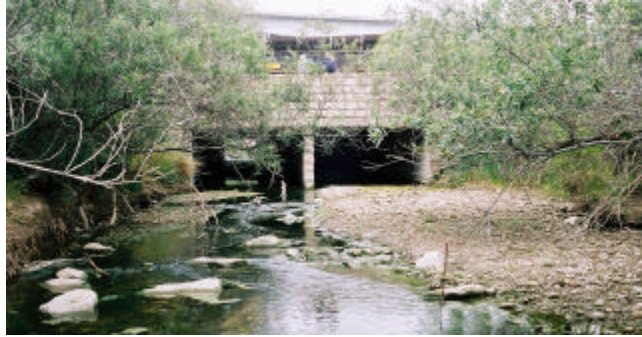
Location: State Park crossing at upstream end of lagoon

Condition/Sizing: The culverts are in good condition with minimal damage inside. Woody debris and sediments had collected on the upstream side of the central concrete support at the inlet.

Diagnosis: Steelhead have easy access into the culverts during most flow conditions due to the absence of any jump and mild slope. The long length of the culvert and smooth concrete bottom make upstream migration during low flows difficult or impassable due to the spread out and shallow water depth. During moderate flows, when adequate water depth exists and velocities are tolerable, passage through the culverts would be moderately difficult. During high stream flows, the combination of excessive water velocities confined through the culvert and lack of resting areas would present a high degree of difficulty for upstream migration. The structure is passable, but limits upstream migration to periods with adequate flow.

Recommended Action: In addition to limiting upstream migration, this structure has buried a significant amount of lower Refugio Creek in a biologically important area for salmonids, where fresh water flows into what remains of the confined lagoon downstream. This is an important mixing zone for the native species living in the lagoon as well as for adult and juvenile steelhead acclimating between saline and fresh water. With any future projects at this site, CALTRANS should consider removing this structure or modifying it so that a natural streambed exists under the crossing for unimpeded upstream passage and a restored streambed. Options to evaluate should include:

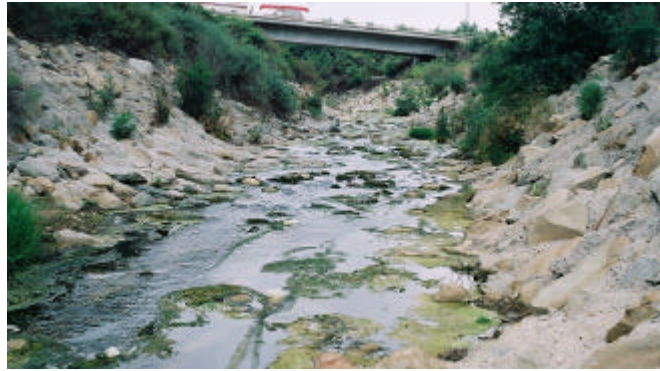
Location: Under Highway 101 Bridges

Condition/Sizing: Several significant holes in the concrete channel have produced pools up to 2 feet 7 inches deep. Areas where flows resurface through the concrete indicate that the channel is undercut and damaged in several locations.

Diagnosis: The embedded boulders, rough channel bottom, mild slope, and sufficient resting areas in the channel allow steelhead upstream passage with a low to moderate degree of difficulty during migration flows. This reach of stream and associated riparian vegetation has been significantly degraded and modified with the construction of this channel.

Recommended Action: Due to the presence of these bridges over Highway 101, Refugio Creek has great potential for steelhead recovery without the complexity associated with providing passage at an impassable Highway 101 culvert, such as those present on other Gaviota Coast streams. While upstream passage is possible along this reach of Refugio Creek, aquatic and riparian habitat conditions and improved fish migration can be achieved.

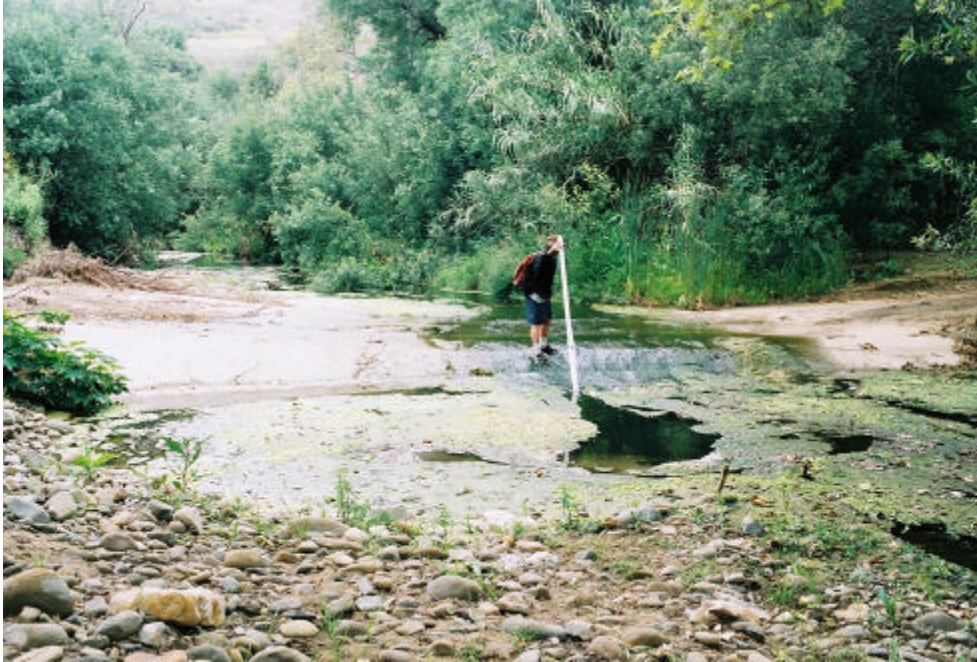
Location: 0.4 mile from mouth

Condition: The crossing appears to be in good condition with minimal concrete damage.

Recommended Action: Continue to monitor the condition of this crossing and work with landowner to improve fish passage with any future modifications.

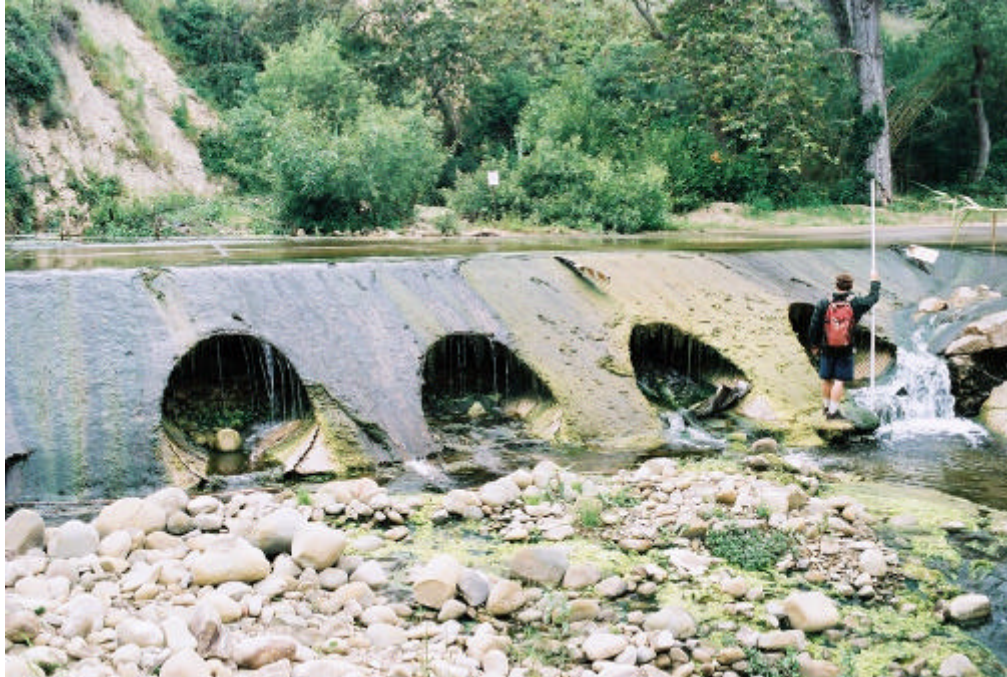
Location: #2 Refugio Road crossing

Condition/Sizing: The structure is in poor condition with significant culvert damage on the downstream side caused by heavy equipment clearing sediment deposits away from the structure. The downstream river-left side of the crossing is undercut with significant bank erosion. The upstream side of the crossing and all four culverts were filled with sediment for most/all of the 2000-2001 migration season, with stream flows passing over the crossing top. This structure is not sized for a significant stream flow event and remains a safety hazard to vehicle access on Refugio Creek.

Diagnosis: This structure acts similar to a small debris dam during heavy rainfall years and effectively traps sediment behind the crossing and blocks all four culverts. As was observed in 2001, this crossing may remain filled with sediment for extended periods of time and remain impassable to all salmonids. With sediment cleared from the upstream side and culverts, steelhead can pass through the culverts with a moderate degree of difficulty during low and moderate flows. The severity this structure imposes on upstream migrating steelhead is highly dependant on the accumulation of substrate and debris upstream, the extent of culvert blockage, and the timing and effectiveness of clearing activities.

Recommended Action: This crossing imposes a significant safety hazard for Refugio Canyon residents and liability to SBCPWRD and should be replaced for these reasons alone. In addition, this structure severely limits or blocks steelhead migration during years of high stream flow with the blockage of the culverts. During the 2000-2001 migration season, subsequent clearing of the culverts occurred after ideal migration flows had subsided. Due to the relatively unconfined nature of the stream channel and low bank tops at this site, replacement of this structure with a bridge may not be practical or safe. A study is needed to determine an effective solution for both vehicular and steelhead passage that will accommodate high stream flows. Unimpeded steelhead passage at this site is essential for steelhead recovery in Refugio Creek due to the presence of almost all adequate spawning and rearing habitat upstream from this site. A large, bottomless arch culvert may provide an effective solution. Moderate road realignment on the north side of crossing away from the stream channel may be necessary to facilitate an effective solution.

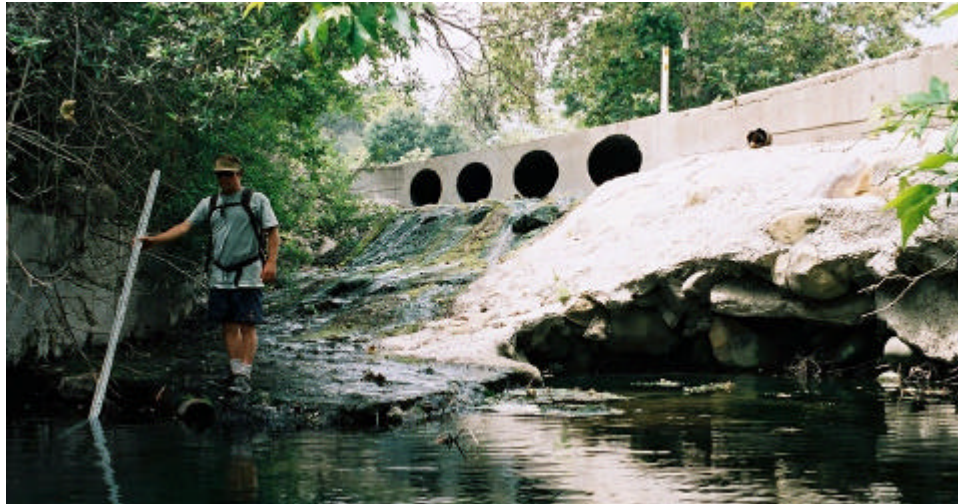
Location: #3 Refugio Road crossing

Condition/Sizing: The culverts appear to direct flows toward the river-right stream bank and have cause significant erosion, despite the presence of a small concrete wall intended to keep flows from eroding the bank. The concrete apron is extremely undercut and damaged. Significant bank erosion has also occurred on the river-left side downstream of the crossing. During high stream flows, this crossing is effective at trapping sediment, clogging the culverts, and forcing stream flows over the top of the road surface.

Diagnosis: The combined height, length, and steepness of the concrete apron produces excessive stream velocities and slope that prevent upstream migration during all flow conditions. Unimpeded steelhead passage at this site is essential for steelhead recovery in Refugio Creek due to the limited amount of adequate spawning and rearing habitat downstream from this site and the presence of perennial rearing habitat and high quality spawning substrate found upstream. Several Refugio Canyon residents observed two adult steelhead, approximately 24 inches in length, in the pool downstream of this crossing in 1969 (pers. comm. Alegria, Hancock, Brown).

Recommended Action: Apparently, at least one person has been swept off the crossing in their car and killed trying to cross this structure during high stream flows (pers. comm. Hancock). This crossing remains a significant safety hazard for Refugio Canyon residents and liability to SBCPWRD and should be replaced due to these reasons alone. The stream channel is narrow enough and stream banks high enough at this site to facilitate a bridge across the creek. Complete removal of this structure and replacement with a bridge and natural streambed that does not present a hazard to vehicle access or impede upstream steelhead migration is recommended.

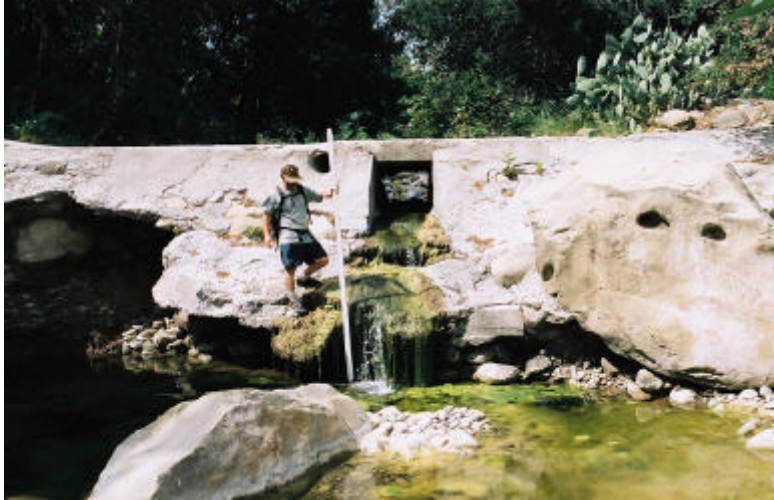
Location: Private crossing approximately 0.5 mile upstream from #3 Refugio Road Crossing

Condition/Sizing: Massive undercutting has occurred on the downstream side of the crossing and the overall structural condition is poor with significant concrete cracking and damage. The roof of the box culvert is also very damaged.

Recommended Action: Work with landowner to assess the feasibility of removing this crossing and replacing it with a bridge and natural streambed. The stream banks are narrow enough and may be high enough in this area to facilitate a bridge across the creek that can also pass peak stream flows. The bridge may need to be slightly elevated at this site to provide adequate sizing for the 100-year flow and stream banks would need to be reinforced for bank protection.

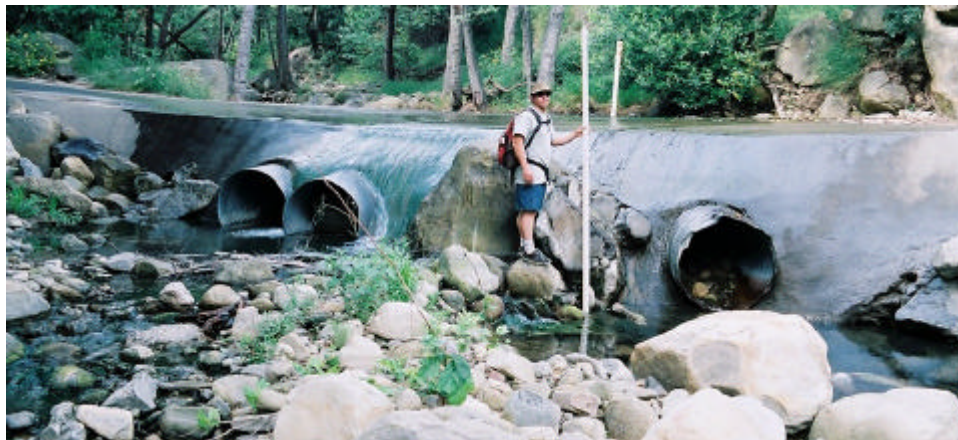
#8-The concrete section of this 21-foot wide road crossing measured 34 feet across the stream between the connecting asphalt road and the entire road measured 54 feet across the stream channel. The crossing consists of 3 corrugated metal culverts with 3-foot diameters. The overall height of the crossing from the downstream pool surface to the road surface on the downstream side measured 3 feet 10 inches. The jump height from the downstream pool surface to the bottom of the culverts measured 3 feet 10 inches. The jump depth in the downstream pool measured 3 feet 2 inches. A 10-foot long concrete chute on the river-left side of the crossing drops toward the downstream pool with a 19% slope that ends to 2 feet above the downstream pool. Deposited sediment was still backed up to the top of the upstream side of this crossing during survey work conducted on 6-1-2001 and for the 2000-2001 winter season. All three culverts were completely obstructed with substrate and flows were conveyed over the road surface.

Condition/Sizing: All the crossings are undersized to convey higher stream flows under the road crossing and highly susceptible to substrate and woody debris blockage as observed during the

2000-2001 winter. Downstream scour has significantly undermined these crossings and adjacent stream banks to varying degrees. The concrete and metal culverts are in fair shape with moderate concrete wear, minimal to moderate rusting in the culverts, and some culvert damage on the exposed upstream and downstream sides where clearing activities have occurred.

Diagnosis: During higher migration flows these structures function similarly to small debris dams and effectively trap sediment that blocks the small diameter culverts. As was observed in 2001, these crossings may remain filled with sediment for extended periods of time and remain impassable to all salmonids. Even with sediment cleared from behind the culverts, upstream steelhead passage would still be impossible or extremely difficult with the lower flow conditions encountered after such a clearing operation would likely occur following the upstream steelhead migration season when stream flows have subsided. Upstream migration over the top of the crossings during migration flows would be extremely difficult or impossible due to the substantial jump heights required to land on the crossing and accelerated velocities across the smooth concrete road surface. The migratory severity of these crossings is highly dependant on the accumulation of upstream sediment, configuration of the downstream substrate, pool formation, and inlet conditions, all of which are highly susceptible to seasonal change. With the culverts clear of substrate and adequate jump depth downstream for steelhead to access the culverts, steelhead would encounter high water velocities in the moderately sloping culverts and likely sloping substrate conditions immediately upstream of the culvert inlets. Following substrate clearing there are often excessively steep substrate conditions at the inlet where flows are accelerated and confined down the steep substrate, which forms a funnel-shaped drain into the culvert (pers. observation 2000-2001 Stoecker).

Recommended Action: Refugio Canyon residents acknowledged that these crossings often conveying stream flows over the top of the road surface and limit vehicle access during higher stream flows. The crossings impose a significant safety hazard for Refugio Canyon residents and a liability to SBCPWRD and should be replaced for those reasons alone. Complete removal of these structures and replacement with bridges or large bottomless arch culverts that do not present a hazard to vehicle access or impede upstream steelhead migration is recommended. It is likely that the most cost effective way to address the Santa Barbara County road crossings on Refugio Creek will be to determine structural requirements at each site and develop a road crossing improvement plan for all crossings in the canyon. Implementation of projects may need to be staggered in order to allow residential vehicle access. A temporary loaner bridge could be obtained to allow vehicle passage at these sites while a permanent bridge is installed. Continual maintenance, modification, and/or clearing of the crossings is discouraged due the ineffectiveness of fish passage, on-going safety hazard, and significant water degradation that occurs downstream of clearing efforts that dislodge massive amounts of substrate and dramatically increase the suspended sediment load in the stream. This elevated suspended sediment load during the lower stream flows encountered with clearing efforts may suffocate salmonids and other native aquatic species downstream. Additional studies are needed assess the impacts of removing these crossings, bank stabilization alternatives, and structural requirements for bridge installation.

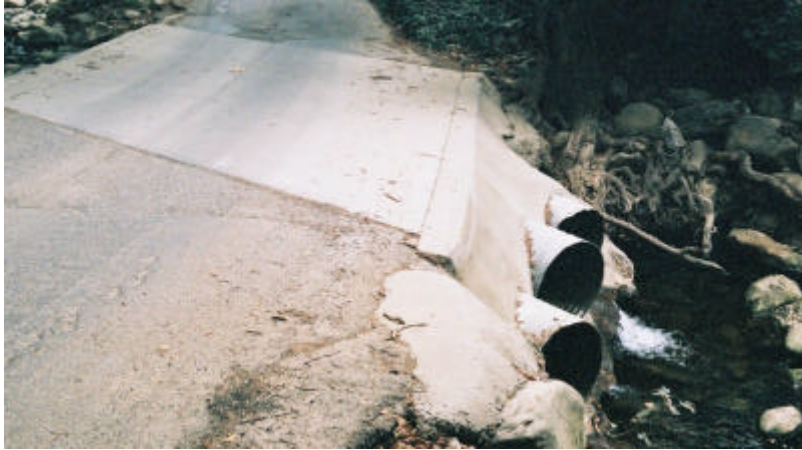
#9- The concrete section of this crossing measured 18 feet 6 inches wide and 65 feet across the stream between the connecting asphalt road. The crossing consists of 3 corrugated metal culverts with 3-foot diameters. The overall height of the crossing from the downstream pool surface to the road surface on the downstream side measured 4 feet 1 inch. The outlets of two culverts were at streambed level and the river-left culvert measured 6 inches above the substrate. The downstream pool backed up into the river-right culverts. Deposited sediment was backed up to the top of this crossing during survey work conducted on 6-1-2001 and for the 2000-2001 winter season. All three culverts were completely obstructed with substrate on the upstream side and most stream flow was conveyed over the road surface, which had a slope measured at 4.5%.

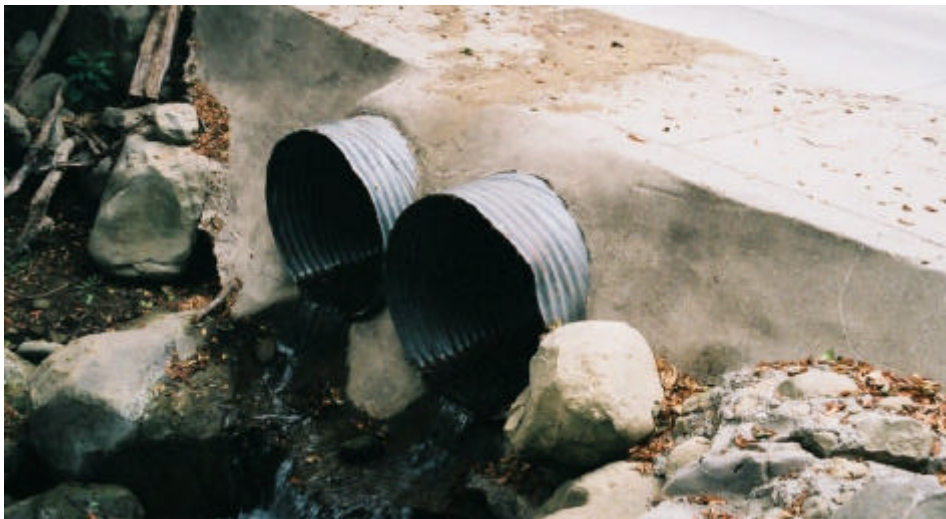
#10- This concrete section of this crossing measured 29 feet wide and 27 feet across the stream between the connecting asphalt road. The crossing consists of 3 corrugated metal culverts with 3-foot diameters. The overall height of the crossing from the downstream pool surface to the road surface on the downstream side measured 5 feet. The jump height from the downstream pool surface to the culvert outlets measured 16 inches. Deposited sediment was backed up to the top of this crossing during the 2000-2001 migration flow season and was cleared by 9-10-2001. The middle culvert measured 39 feet 6 inches long with a slope of 6.5%.

#11- This concrete section of this crossing measured 22 feet 6 inches wide and 29 feet across the stream between the connecting asphalt road. The crossing consists of 2 corrugated metal culverts with 4-foot diameters. The overall height of the crossing from the downstream pool surface to the road surface on the downstream side measured 7 feet. The jump height from the downstream pool surface to the culvert outlets measured 3 feet 4 inches. The culvert measured 29 feet 6 inches long with a slope of 2.5%. At the outlet of the culverts, stream flows dropped onto a slightly downstream sloping concrete apron 18-21 inches in length. Concrete and boulder riprap occur on the downstream banks. The culvert inlets were 50-75% blocked with substrate and large woody debris.

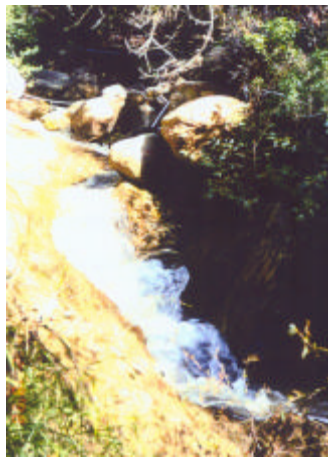
RE_13- Photo-observation of this bedrock chute indicates that this steep section has accelerated stream velocities and turbulent flows with minimal resting areas. Kuyper reported that this structure “halts steelhead migration”.

Recommended Action: No recommended actions for these natural features.

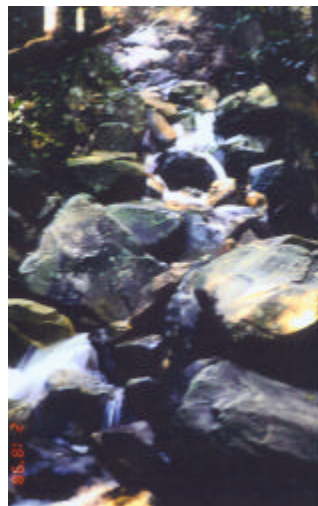
WF_2- Photo-observation of this long boulder cascade indicates that excessive and sustained stream gradient would prevent upstream steelhead passage, as reported by Kuyper.

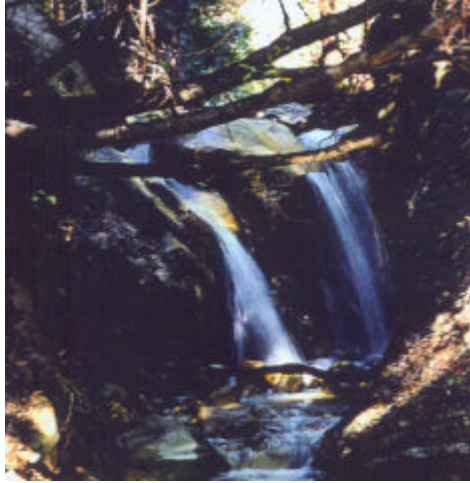
WNF_1- Photo-observation of this waterfall indicates that the excessive jump height and limited downstream pool formation would prevent further upstream steelhead migration, as reported by Kuyper.

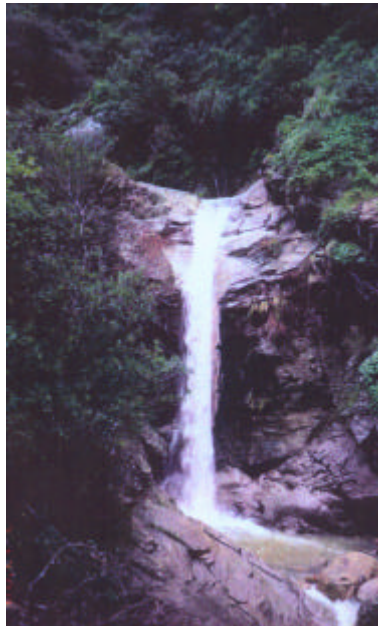
EF_1- Kuyper reported that this impassable bedrock waterfall has a height “in excess of 50 feet”.

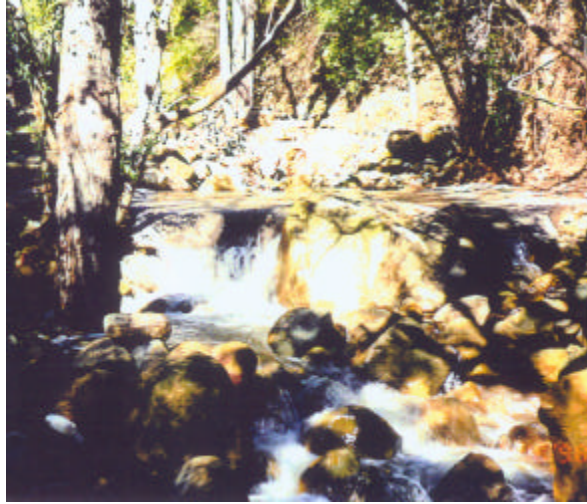
Location: Approximately 250 feet upstream from Refugio Creek.

Diagnosis: Kuyper noted that the “height of this structure, the lack of adequate streamflow along its length, and insufficient water depth downstream from the structure qualify this road crossing as a “definite” steelhead migration barrier”. Photo-observations indicates that during ideal migration flow extremely difficult upstream passage may be obtained with adequate downstream pool formation, but most flows would prevent upstream migration due to factors mentioned by Kuyper.

Recommended Action: Contact the landowner to discuss the feasibility of providing adequate steelhead passage conditions at this site when access to this portion of the watershed is provided with downstream barrier passage. Assess the possibility of replacing this structure with a bridge or large embedded culvert.
