Steel head Assessment and Recovery Opportunities in Southern Santa Barbara County, California

**BY
Matt W. Stoecker
and
Conception Coast Project**

June 2002

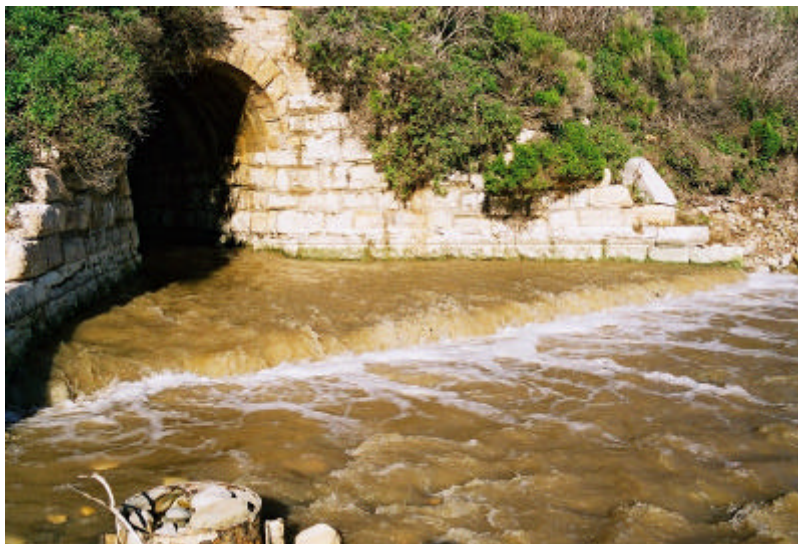
Location: UPRR and Highway 101 Culvert

Diagnosis: Assuming this culvert is similar to other long concrete CALTRANS culverts built over Highway 101, upstream steelhead migration is impossible due to the excessive culvert length, lack of resting areas within the culvert, shallow water conditions during low flows, and accelerated velocities encountered during high flows. A rainbow trout/steelhead was observed in the pool below this culvert in 2001 and historic documentation of adult steelhead exists for this watershed. See the Salmonid Documentation Table in section 6.0 for more information.

Recommended Action: See section 7.8 for additional discussion and recommended action for this CALTRANS Highway 101 culvert.

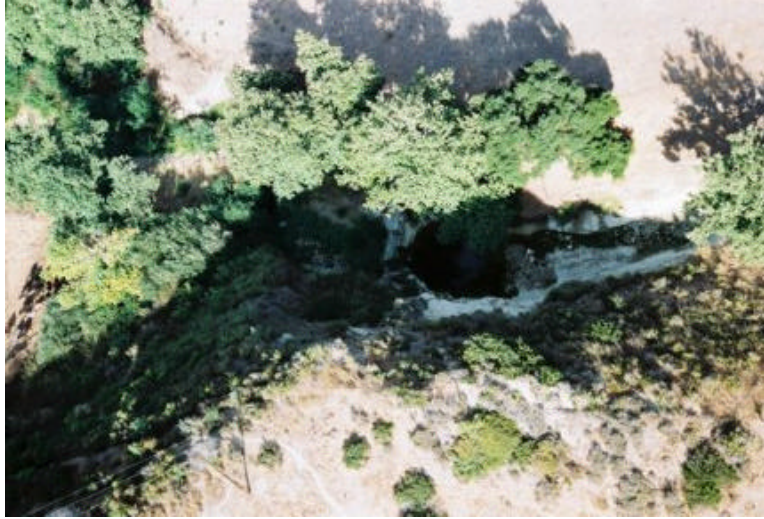
Location: 0.67 mile upstream from Highway 101 Culvert

Condition: The dam does not appear to be in operation and may have significant damage underneath.

Diagnosis: Limited observations from the air prevented accurate assessment of this dam and the severity of this structure could not be determined. A significant drop was observed from the base of the dam to the downstream pool and migration under the dam would likely be extremely difficult or impossible with confined flows passing under the dam.

Recommended Action: Work with owner to assess fish passage, the condition of the dam, desirability, and feasibility of removing the structure if it is not functioning any purpose. Depending on the condition of the dam, this structure may present a significant hazard to the UPRR/Highway 101 culvert and public safety if portions of it were to wash downstream during high stream flows and block the culvert inlet.

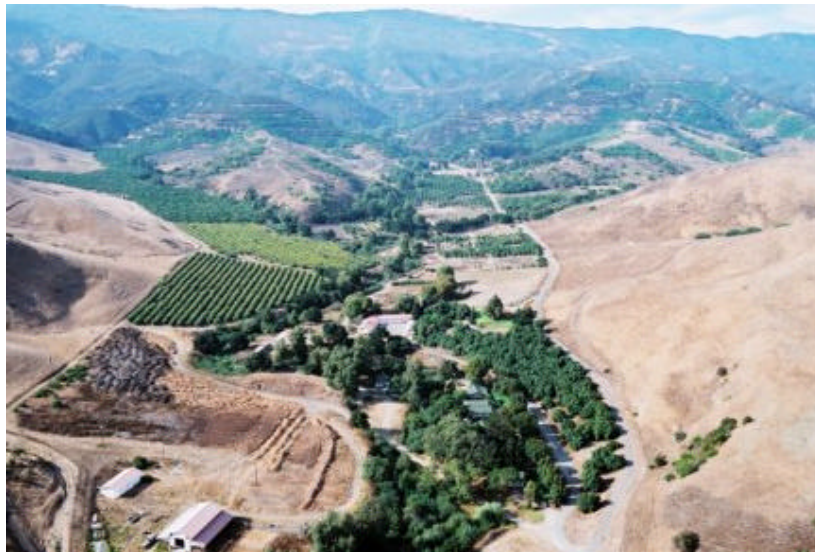
BR_TS_3

#3- This crossing occurs near several residences and a large barn. Only the dirt-fill road crossing was observed, but it is likely that a culvert passes stream flows underneath.

Recommended Action: An on-the-ground fish passage assessment of these crossings should be conducted and other possible in-stream structures identified. Work with the landowner to develop a plan that removes or modifies barriers to fish migration, minimizes the number of stream crossings, and consolidates the crossing points along the stream to bridges, bottomless arch culverts, embedded culverts, and/or natural streambed crossings that will not impede upstream salmonid migration.

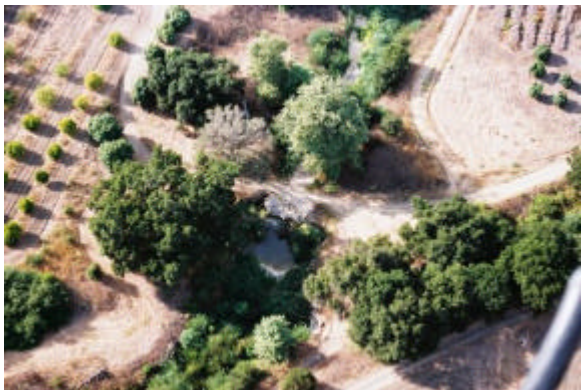
BR_TS_4

#4,5,6- These crossings were the only structures that could be observed well enough to determine the general construction and estimate their severity to potential salmonid migration. These three crossings are all fairly similar in construction and impact on salmonid migration. All three concrete crossings appear to be trapping large amounts of sediment upstream. Steep concrete aprons slope toward the downstream side. The crossings appear to range from 8-15 feet in height above the downstream substrate. Crossing #6 has a small culvert just under the road surface, but all crossings appear to convey moderate and high stream flows over the crossing surface and down the apron. Crossings #4 and #5 appeared to be in poor condition with significant scour occurring on the downstream side and adjacent banks. Crossing #6 appeared to be in fair condition with moderate undercutting on the downstream side.

#4,5,6- The height of each crossing and steep concrete apron will likely produce excessive jump heights and stream velocities during migration flows that would present extremely difficult or impossible upstream passage conditions for adult steelhead.

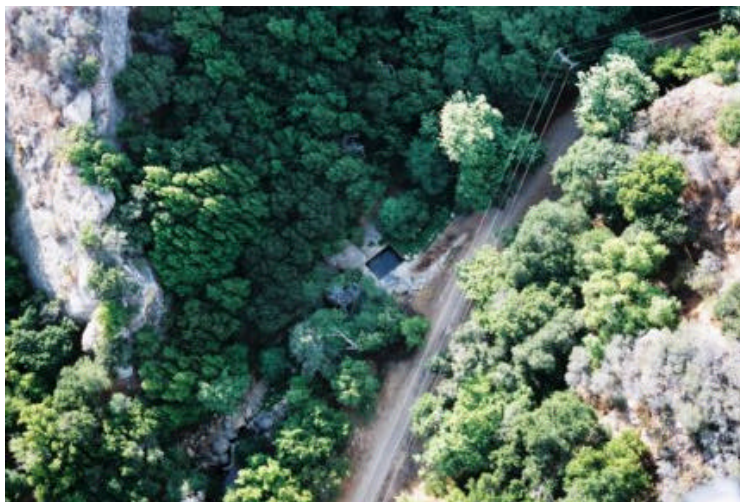
Location: Approximate elevation 350 feet

Condition: The condition of this structure could not be determined.

Recommended Action: Work with the landowner to further assess fish passage, the condition of the dam, desirability, and feasibility of removing the structure if it is not functioning any purpose. If water diversions are still occurring at this site, assess the feasibility of modifying this structure or designing a different structure that allows water extraction along with salmonid passage.

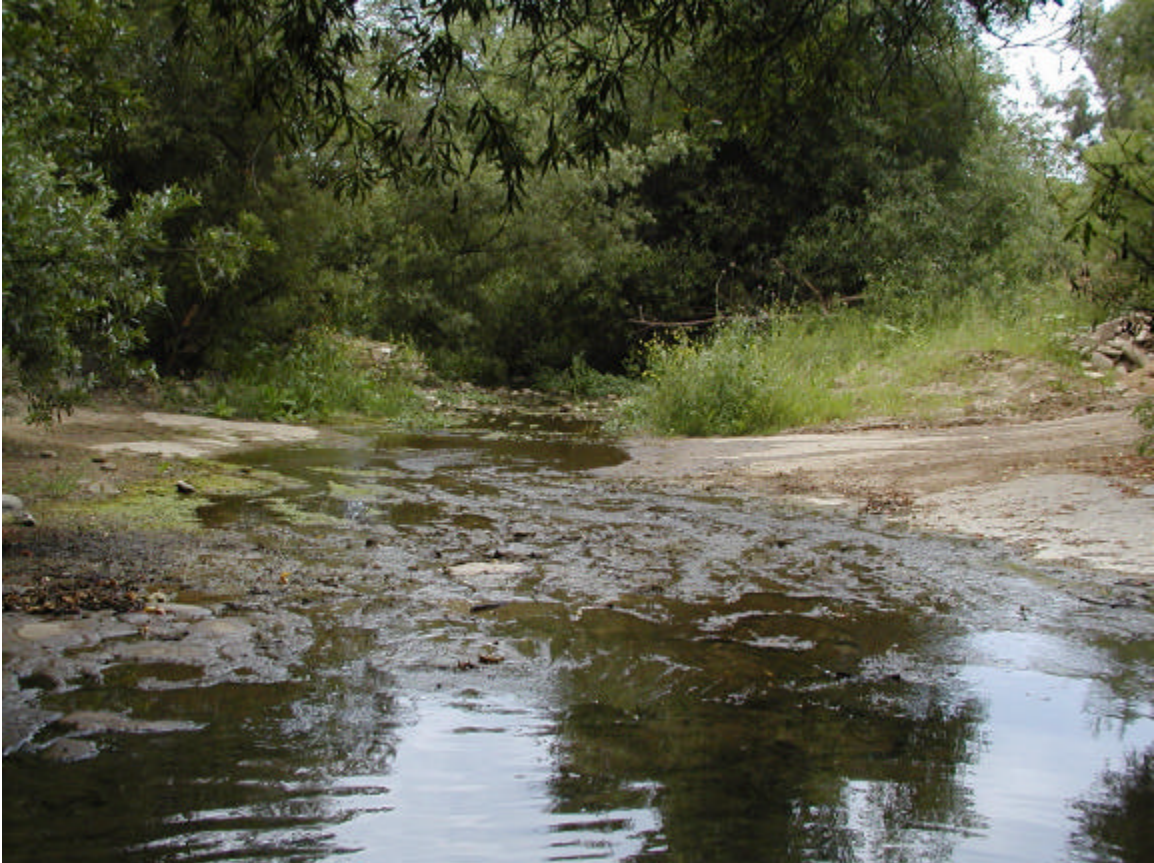
Location: Immediately downstream of the UPRR/Highway 101 Culvert

Diagnosis: The relatively flat slope and streambed level of this short crossing present a minimal to low degree of difficulty to upstream salmonid migration.

Recommended Action: No action is recommended at this crossing, but continued monitoring should occur to prevent future adverse fish passage situations. Modifications to the structure or downstream scour could alter the configuration of the crossing and change the severity to salmonid migration.

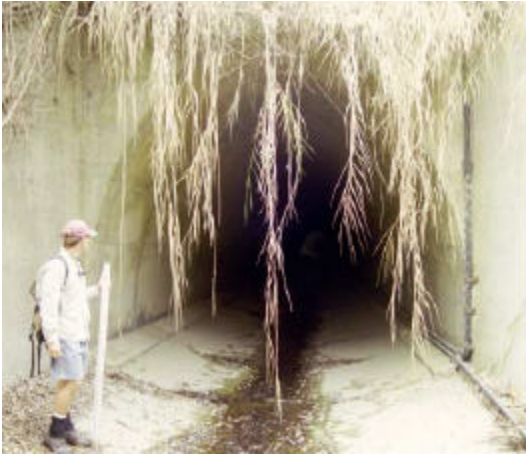
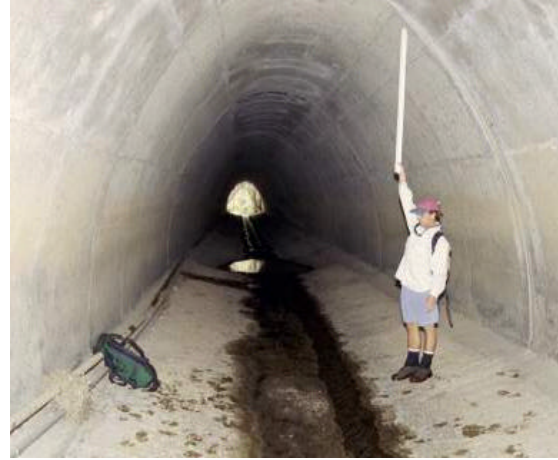
Location: UPRR/Highway 101 Culvert

Condition: Several holes through the concrete bottom of the CALTRANS section exist and the worn bottom is in poor condition overall. High-water marks were observed 7 feet up on the culvert wall indicate that storm flows have exceeded 60% of the culverts capacity.

Recommended Action: Apparently CALTRANS is currently planning a significant highway improvement project at their Arroyo Quemado Highway 101 crossing (pers. comm. Cesena). Proposed planning should include providing steelhead access upstream of Highway 101 to formally occupied steelhead habitat. See section 7.8 for additional discussion and recommended action for this CALTRANS Highway 101 culvert.

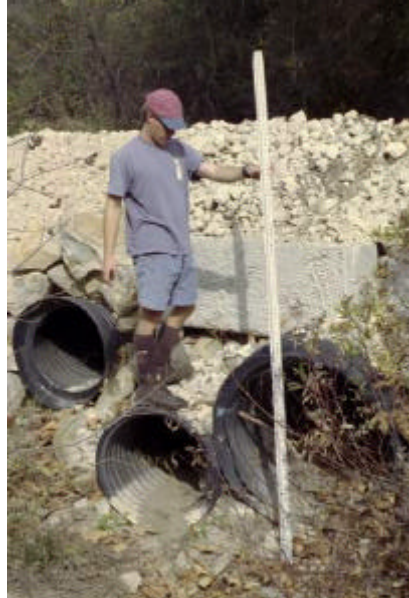
BR_AQ_3_DS

Description: This irregular culvert crossing consists of three corrugated plastic culverts, rock and boulder fill, concrete slabs, and metal pipes. The culverts each have different diameters measuring (from river-right to river-left) 2 feet 6 inches, 2 feet, and 3 feet. The culverts are approximately 23 feet in length and each is at, or near, streambed level.

Condition: The culverts are in extremely poor condition with several being smashed at the upstream end with holes completely through. The crossing is poorly constructed and at a high risk of failure. The metal bars used in the construction of this crossing present a significant risk to blocking the Highway 101 culvert downstream if/when this crossing fails during future high stream flows.

Diagnosis: During migration flows, salmonids could easily swim into the downstream end of these culverts, but the damaged condition at the upstream ends would present a highly degree of difficulty to swim or jump past. It is likely that during migration flows these culverts clog with debris and are impassable.

Recommended Action: The crossing should be replaced in the near future for safety considerations and this replacement should facilitate potential future steelhead passage. The 43-foot length across the channel at this spot is adequate to install a relatively cheap railroad car bridge that does not impact the streambed or impede upstream fish migration.

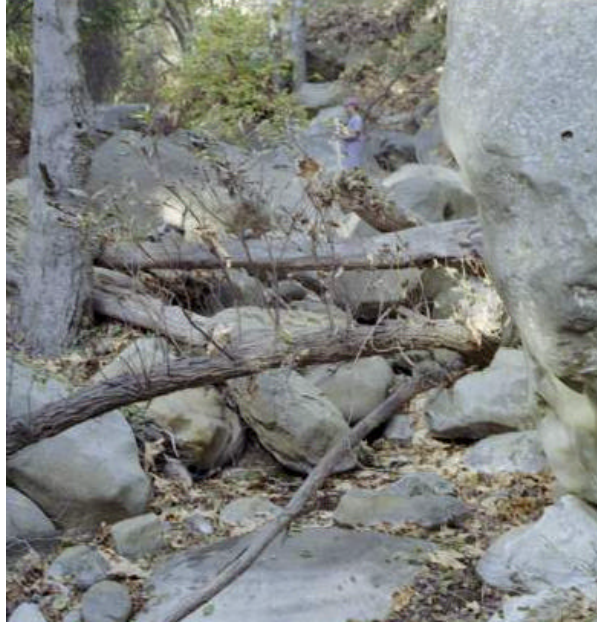
Description: This steep boulder cascade extended for several hundred feet with a measured sloped of 10.9%. Small pools and resting areas would be present throughout this reach with sufficient stream flow.

Diagnosis: The steepness of this reach would likely produce highly difficult passage conditions for upstream migrating steelhead during moderate and high stream flows and may be impassable depending on the boulder and pool configuration during each season.

Recommended Action: No recommended action for this natural feature.

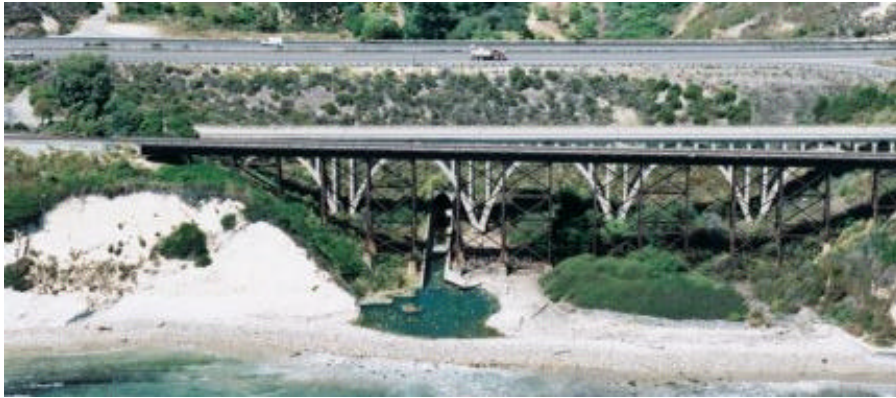
Description: This concrete arch culvert measured 15 feet 5 inches tall at center and 16 feet wide at the bottom of the walls. The shallow U-shaped bottom extended 334 feet under Highway 101 with a slope of approximately 1%. Downstream of the culvert, a concrete channel measuring 15 feet 9 inches wide and 167 feet long extends to the confined lagoon, which had a maximum depth of 4 feet 5 inches. The lagoon pool backwatered the concrete channel 18 inches near the downstream end and extends upstream 98 feet upstream into the concrete channel. The concrete channel was built to convey culvert flows past the UPRR railroad trestle supports that are adjacent to the channel.

Condition: The concrete appears to be in fair condition with moderate wear.

Diagnosis: While adult steelhead are consistently observed in the small lagoon pool downstream of the culvert, only one adult steelhead has been documented upstream of the culvert since the Highway was built (pers. comm. Hollister). See the Salmonid Documentation Table in section 6.0 for more information about salmonid sightings and two pictures of adult steelhead observed both downstream and upstream of the culvert. It appears that upstream steelhead passage is possible during moderate to high flow conditions when there is adequate water depth inside the mild sloping culvert and moderate water velocities are encountered. However, the window of opportunity for steelhead to pass upstream is very short and may not occur often, or at all, during a migration season with low stream flows. Excellent salmonid habitat conditions exist in Arroyo Hondo Creek upstream of the highway. This is the only anthropogenic barrier in on the creek and improving access at this culvert ensures access to all accessible habitat in the watershed.

Recommended Action: Shell oil reportedly has some money set aside for a fish passage project at this culvert (pers. comm. Lohmus). A short-term baffle project is being discussed for improving upstream passage at this culvert. Baffles will not ensure effective upstream passage and do not address the loss of most of the Arroyo Hondo lagoon. See section 7.8 for additional discussion and long-term recommended action for this CALTRANS Highway 101 culvert.

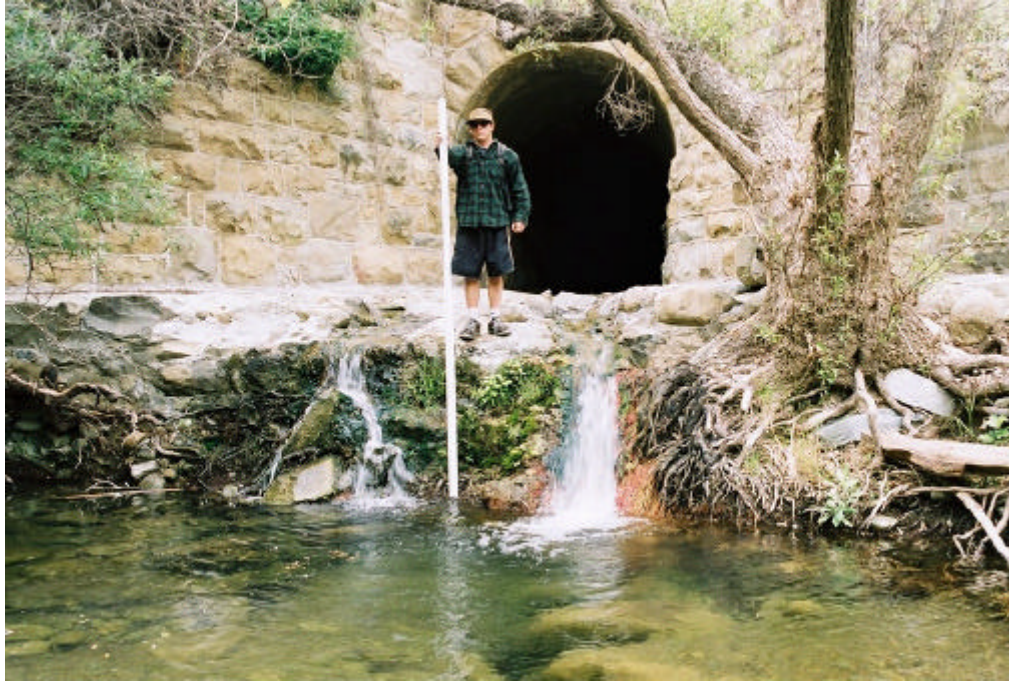
Description: The outlet of the UPRR arch culvert measured 11 feet 6 inches tall by 9 feet 10 inches wide. A stone bottom apron extended downstream 23 feet from the culvert outlet and flows dropped 3 feet 7 inches to the surface of the downstream pool, which measured 3 feet 11 inches. The UPRR culvert extends upstream approximately 100 feet with a mild slope. The CALTRANS box culvert extends over 300 feet upstream from the UPRR culvert with a moderate to steep slope and flat smooth concrete bottom.

Diagnosis: Adequate jump depth in the pool would allow a moderate to highly difficult jump onto the UPRR apron and swim into the culvert during moderate stream flows. Once inside the UPRR culvert upstream steelhead migration is impossible due to the excessive culvert length, lack of resting areas within the culvert, shallow water conditions during low flows, and accelerated velocities encountered in the CALTRANS culvert during high flows. Historic documentation of rainbow trout presence in San Onofre Creek exists. See the Salmonid Documentation Table in section 6.0 for more information. High quality salmonid habitat is present in the upper reaches of Corral Creek.

Recommended Action: See section 7.8 for additional discussion and recommended action for this CALTRANS Highway 101 culvert.

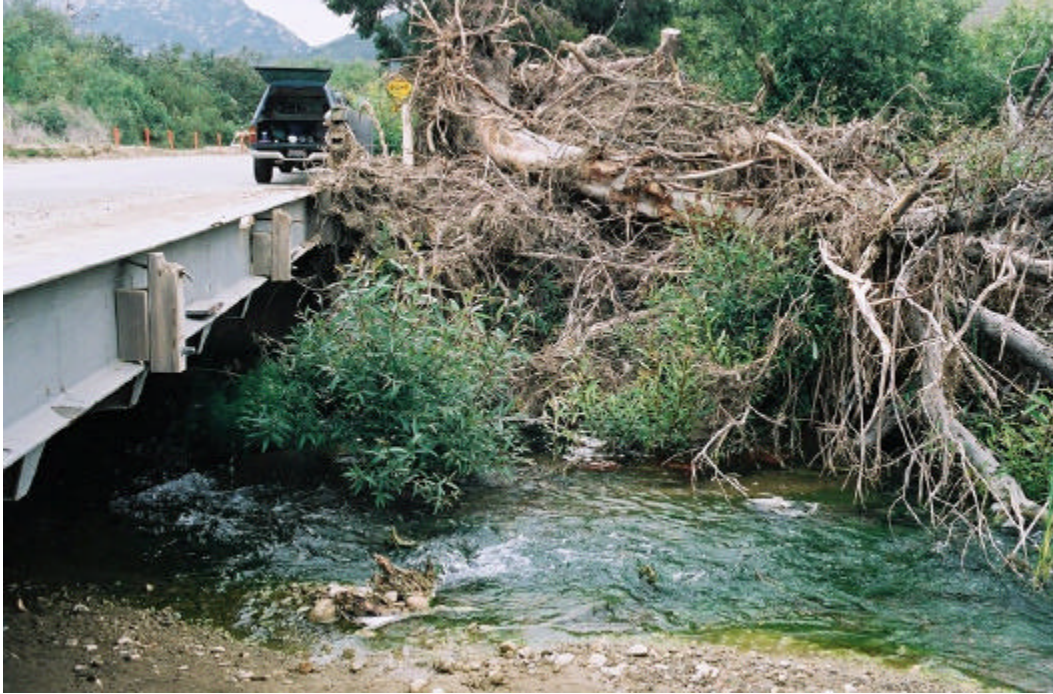
Description: The slightly elevated Gaviota State Beach Road, which crosses the lower Gaviota Creek flood plain from Highway 101 to the bridge, acts similar to a long, low-lying dam that focuses stream flows towards this undersized bridge. The steel beam and concrete covered bridge measured 80 feet long and 36 feet wide. The bridge is located on lower Gaviota Creek just upstream from the lagoon and approximately 0.35 mile upstream from the ocean. Moderate to high stream flows exceed the minimal flow capacity of the undersized bridge, which is highly susceptible to debris blockage, and pass over the road.

Condition: This bridge is extremely undersized and highly susceptible to debris and sediment blockage during elevated stream flow events. After only 4 years of use, the bridge is already experiencing significant wear and metal damage from bedload sediment and debris during high flows, and from heavy equipment trying to unclog the bridge and allow flows to pass underneath.

Recommended Action: Eliminating this bridge and rerouting the current Gaviota State Beach Road access is recommended for the following reasons:

- 1) This structure significantly impedes or completely blocks steelhead access to over 99% of the spawning and rearing habitat found in Gaviota Creek, depending on the blockage extent during migration season. There are many impediments upstream of this bridge that are extremely flow sensitive in terms of their barrier severity to steelhead. It is essential that steelhead are not held up at this bridge for parts of the migration season as this limits their window of opportunity to migrate past these upstream structures.

- 2) This crossing remains a significant safety hazard during high flows for Hollister Ranch residents, State Park users, and others using this road access. As reported in the March 8, 2001 Santa Barbara News Press, the inundation of this crossing and debris accumulation blocked vehicular passage for three days and limited medical help to a 911 emergency on Hollister Ranch.

- 3) The bridge and road are focusing stream flows toward the Gaviota State Park parking lot and causing major erosion and stream bank failure.

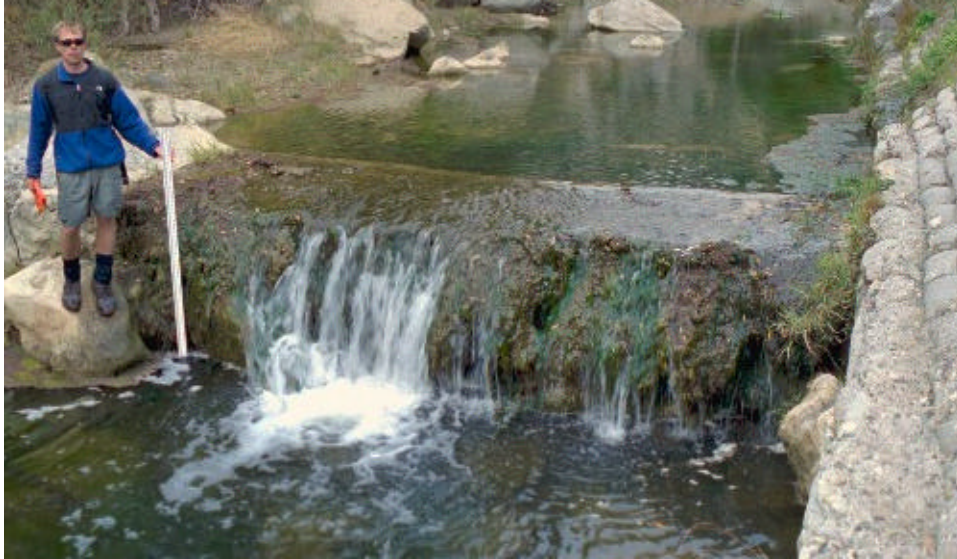
BR_GA_5,6

GA_6- A large pool measuring 6 feet 6 inches deep occurs on the upstream side of this grade control and the concrete structure is undermined 3 feet toward the downstream end. Failure of this grade control due to complete undermining is likely to occur in the near future. If removal is not feasible, notching the structure as described in GA_5 is recommended.

GA_5- If removal is not feasible, cut a notch approximately 3 feet wide and 5 inches deep at center. This action will provide passage benefits described above for GA_3.

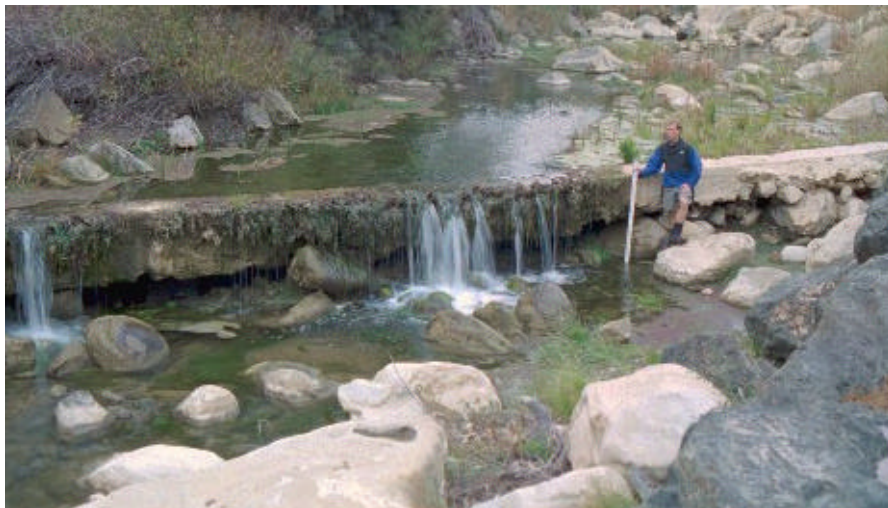
GA_9- This grade control is extremely undermined and at risk of failure. This is one of the most difficult grade controls for upstream steelhead migration due to stream flows landing on downstream boulders and the lack of a developed jump pool. If removal is not feasible, a notch approximately 4 feet wide and 7 inches deep should be cut at center and boulders downstream of this cut moved to allow pool development. Note: This type of action may further compromise the integrity of this already fragile structure.

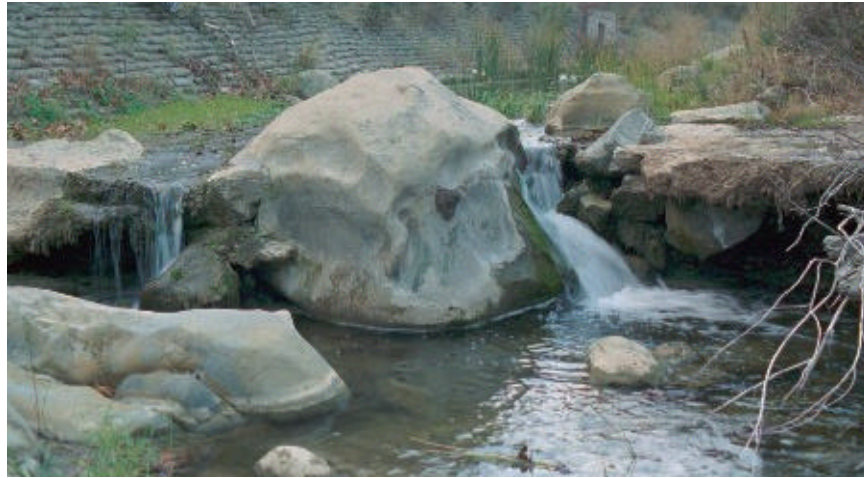
GA_10- A large boulder occurs at center of this grade control with adjacent damage and downstream erosion through the concrete. If removal is not feasible, the existing eroded chute to the river-left side of the boulder should be enhanced as a passage route by widening the chute and cutting a notch 2-3 feet wide and 8 inches deep at the top to concentrate flows down that route. Several medium sized boulders just downstream should be moved to enhance the jump pool downstream of the chute.

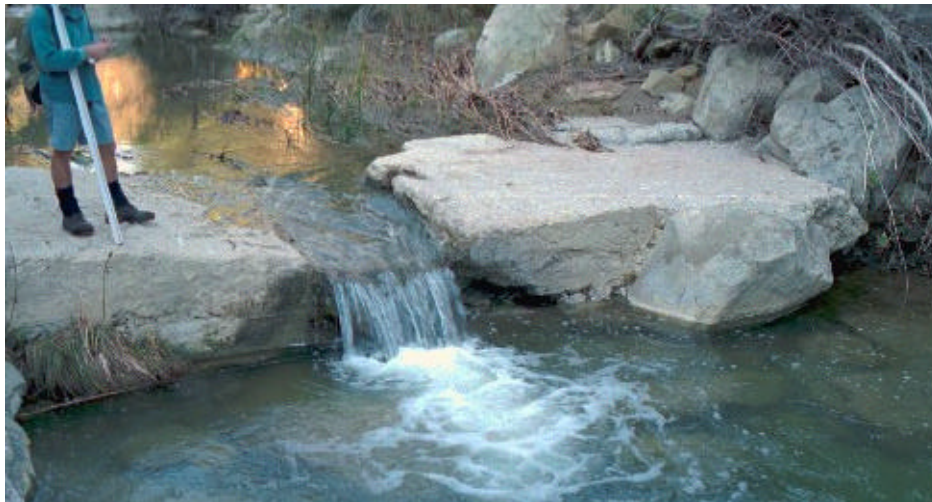
GA_11- Lower stream flows are concentrated across an eroded chute at the center of this grade control structure allowing sufficient downstream jump pool development and adequate water depth across the concrete surface. This situation is a good example of how other structures mentioned here could be “notched” to improve fish passage conditions. Continue to monitor this structure to ensure an adequate upstream passage configuration, especially the downstream pool depth.

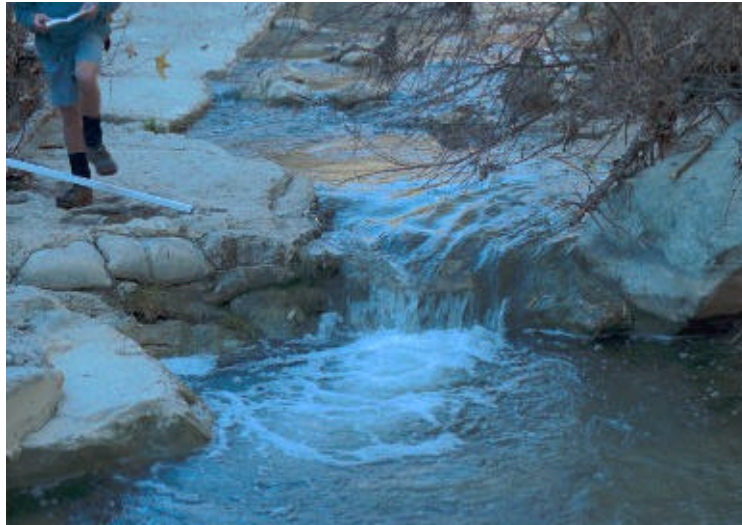
GA_12- This structure has sufficient downstream pool depth and flows are concentrated across the surface to allow upstream passage with a minimal to low degree of difficulty. Ensure that future changes in configuration of this structure do not increase the passage severity.

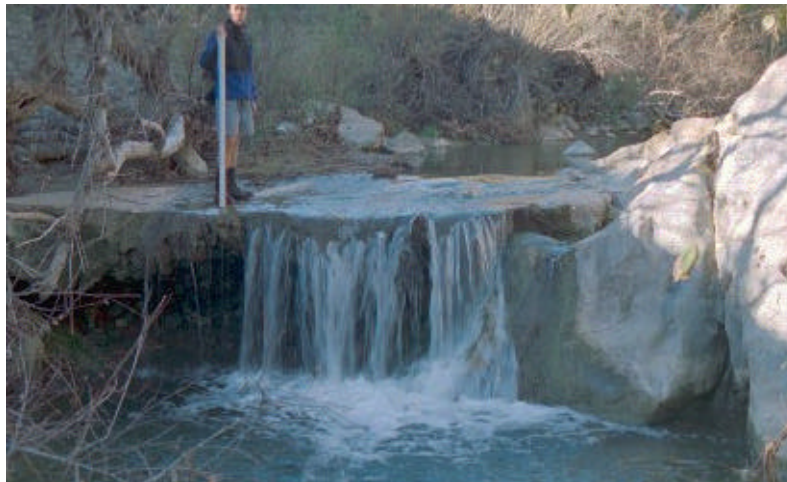
GA_13- Due to the significant jump height required at this site, upstream steelhead passage is dependant on the depth of the downstream pool. Flows are spread out over the surface of this structure and should be concentrated to direct attraction flows toward the deepest part of the pool and away from the exposed bedrock on the river-left side. Cutting a notch cut across the structure would accomplish this and provide needed depth across the surface of the concrete, but is likely not practical due to the thinness of the concrete. Scour from this structure has seriously undermined the adjacent river-right bank revetment and CALTRANS should assess removing this structure and stabilizing the bank revetment.

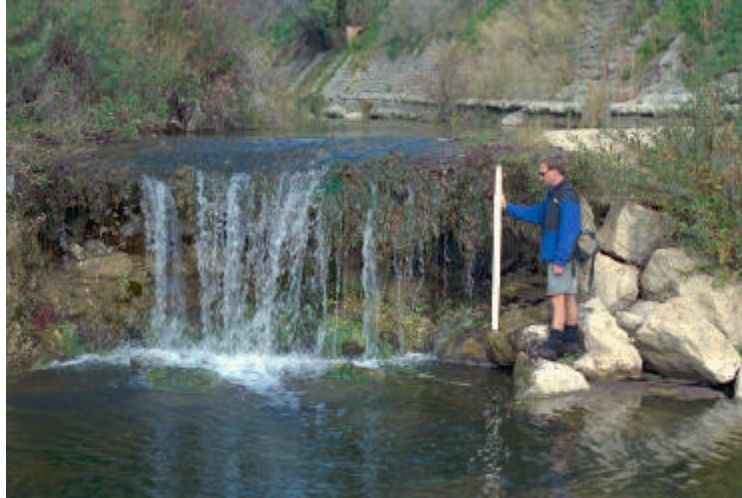
Description: This concrete grade control structure spans 26 feet across the creek and is anchored into a large boulder on the river-right side and CALTRANS bank revetment on the river-left side adjacent to Highway 101. The surface of the grade control measured 9 feet from upstream to downstream lip. The total height of the structure measured 6 feet 10 inches from the top of the structure to the surface of the downstream pool, which had a measured jump depth of 3 feet 7 inches.

Condition: The structure is in poor condition with significant concrete wear and downstream scour and bank erosion.

Recommended Action: This structure was modified in the mid 1990's with two downstream boulder weirs and creation of a slight depression and lip on the surface of the grade control. The

boulder weirs failed and no longer provide the desired backfilling effect for the downstream pool. Providing effective passage upstream of this site to productive spawning and rearing habitat in upper Gaviota Creek is critical for the persisting steelhead population. For a long-term management recommendations, as well as a long-term alternative to consider, see the recommended action for the BR_GA_2,3,5,6,9,10,11,12,13 write-up.

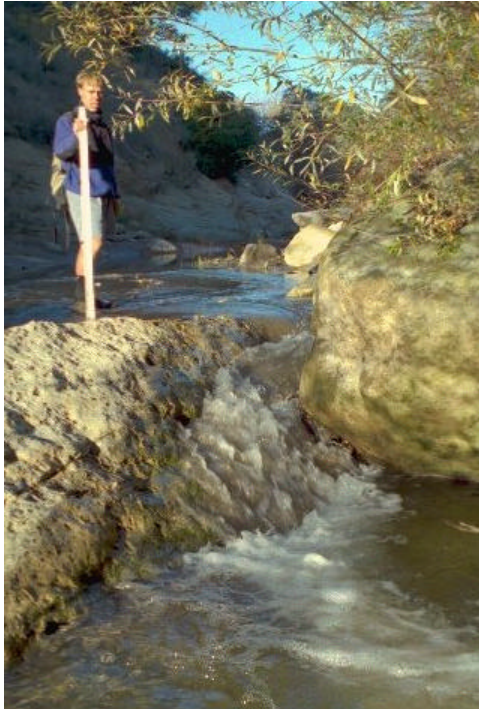
GA_14- This bedrock chute occurs where the adjacent river-right bedrock wall and a large boulder confine the stream flow, which drops down a 45 degree sloping bedrock chute to the downstream pool. The jump height from the downstream pool surface to the top of the chute measured 2 feet 6 inches. The jump depth of the downstream pool measured 2 feet. Sufficient jump depth will develop at this site during moderate and high migration flows to allow a moderately difficult jump over the chute.

Condition: The configuration of GA_14 may change with the mobility of the large boulder. GA_15 is stable.

Recommended Action: No actions recommended for these natural features.

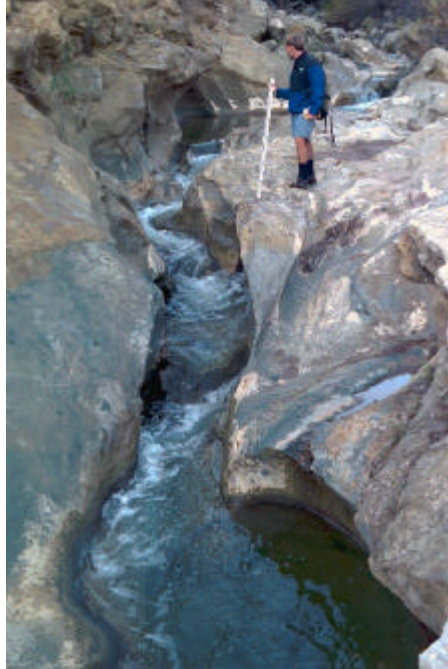
GA_15- This unique bedrock chute cuts a series of small drops and pools through 31 feet of bedrock with an overall slope measured at 10.7%. Sufficient water depth and adequate resting areas occur throughout this chute allowing moderately difficult upstream migration for adult steelhead.

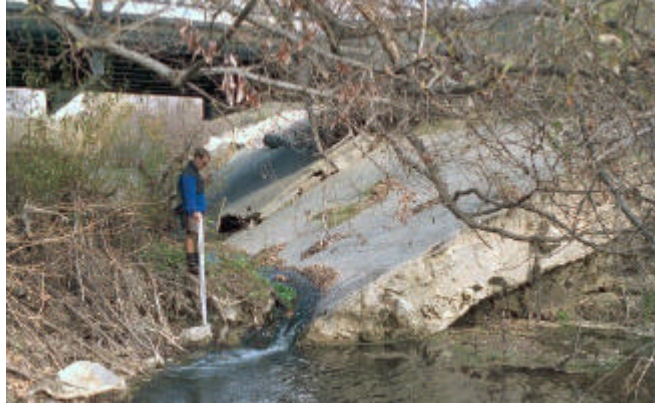
BR_GA_16

Description: A long, concrete bank revetment built by CALTRANS on the river-left side of the creek ends under a bridge that provides access from San Julian Road. The revetment confines the stream and produces a sloping drop under the bridge that is 2 feet in height and conveys stream flows into a large pool with a jump depth measured at 4 feet. The concrete bank revetment proceeds upstream past the West Fork Gaviota Creek confluence. This entire stream reach was historically the lower end of Las Cruces Creek, prior to the realignment of Gaviota Creek into Las

Condition: The concrete revetment is extremely damaged under the bridge and undermined at the downstream end. Scour had caused major erosion on the downstream river-left stream bank. The rest of the revetment and upstream riprap channel are in fair conditions with moderate wear and cracking.

Recommended Action: Continue to monitor and ensure that future damage or maintenance repairs do not increase the severity of upstream passage through this stream reach.

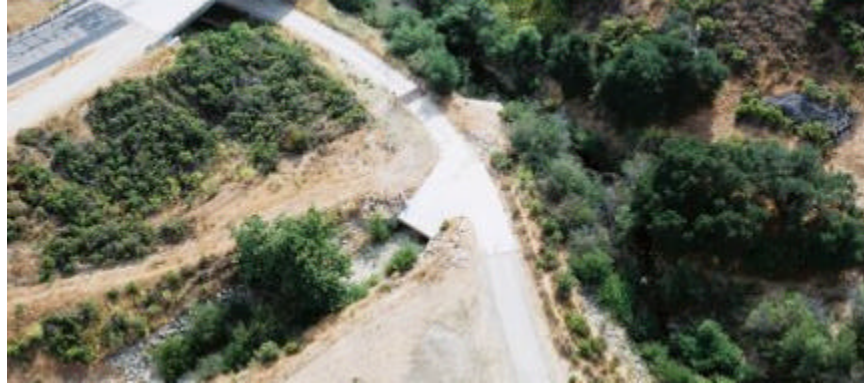
BR_GA_18

Description: Historically, Gaviota Creek flowed underneath the current site of the Highway 101 and Highway 1 Interchange along the existing southbound lanes of Highway 101 and into the main stem of Gaviota Creek near the West Fork Gaviota Creek confluence. In the late 1960's, the interchange project realigned Gaviota Creek to the west through the southern end of the low ridge separating Las Cruces and Gaviota Creek, just north of their former confluence and the current intersection. The stream was realigned through this low ridge and into Las Cruces Creek just upstream from the existing Highway 1 Bridges.

Condition: While the double box culvert appears to be in fair condition with minimal wear and downstream bank erosion, the realigned stream channel reach upstream has experience significant bank erosion and scour near the concrete grade control at the upstream end.

Recommended Action: This entire highway interchange needs to be addressed in a larger Gaviota Creek Watershed Restoration and Management Plan. The feasibility of reestablishing the natural Gaviota Creek channel in the future and realigning the highways away from, and off of,

the natural stream channel should be assessed. The original, natural stream channel will likely have the most prolific groundwater recharge that will maintain surface flows for the greatest duration, producing the most effective migration conditions for upstream and downstream migrating steelhead. Such a project should assess realigning the road infrastructure away from the natural stream channels and riparian habitat instead of realigning the streams away from the “ideal” highway locations on top of the natural stream channel. Additional easements may need to be purchased by CALTRANS in order to achieve such a plan. Historically, this area was a very unique meeting place of the three main tributaries of Gaviota Creek and migration intersection for both humans and native wildlife traveling between the ocean to the south, the Santa Ynez Valley to the north, the El Jaro basin to the west, and the Santa Ynez Mountains to the east.

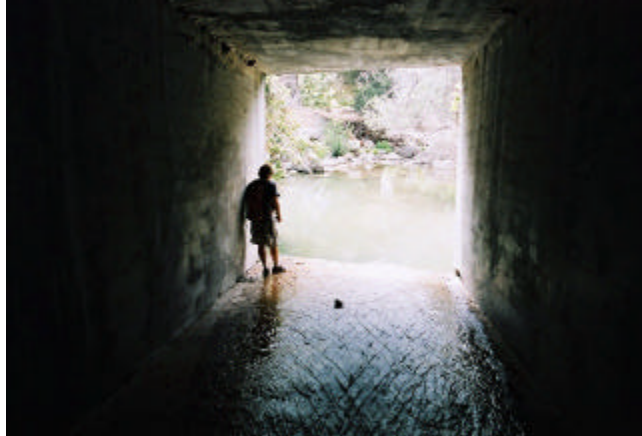
Description: This box culvert measured 197 feet 10 inches from the upstream to downstream end. The downstream end of the culvert dropped 2 feet 11 inches to the pool bottom downstream. The culvert measured 9 feet 10 inches wide and 10 feet 1 inch tall. A jump height of 7 inches was measured from the downstream pool surface to the culvert lip. Concrete wingwalls occur at the upstream and downstream end. The downstream 113 feet of the culvert had a measured slope of 11.3%. Upstream of this straight section, the culvert runs an additional 34 feet in a straight alignment and then makes a moderate left turn and runs an additional 50 feet to the culvert inlet. The combined upper two reaches had a measured slope of 3.6 %.

Condition: The culvert itself is in fair condition with significant damage occurring on the culvert bottom and walls in the lower 10 feet.

Diagnosis: The excessive length, smooth bottom, and steep slope of this culvert produce shallow flow conditions and/or excessive water velocities that prevent all upstream migration of salmonids during all flow conditions. This culvert was observed to be directly blocking upstream access to an adult steelhead while conducting a survey of this structure (see salmonid documentation table in section 6.0). The culvert prevents access to high quality habitat conditions in upper Gaviota Creek. Of all the 379 anthropogenic barriers identified in this report, this Highway 101 crossing was determined to provide the greatest accessible upstream habitat score (quality X quantity), with passage provided, of all barriers known to be directly blocking a current (2000-2002) steelhead population. This structure received the highest immediate priority ranking in the entire study area using the Immediate Keystone Barrier Priority Ranking method (See ranking method and table in section 8.0).

Recommended Action: Reliable, effective upstream steelhead passage at this site was determined to have the greatest immediate benefit to southern steelhead recovery in the study area and should be accomplished with the removal of the entire structure and bridge installation that does not impact the stream channel or impede steelhead passage. See section 7.8 for additional discussion and recommended action for this CALTRANS Highway 101 culvert.

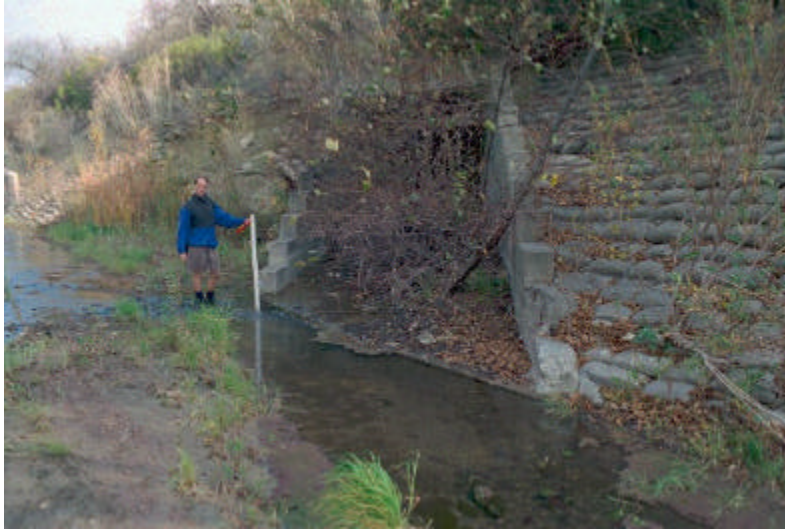
Description: This 10-foot by 10-foot box culvert measured 321 feet from the upstream to downstream end. Four distinct slope changes occur within the culvert. The downstream end of the culvert conveys water directly into Gaviota Creek (as shown in the picture). Alder and willow are growing on the lower end of the culvert and have backed up boulders and debris within the culvert. The deposited boulders created a pool that extended 67 feet into the culvert with a depth of 1 foot 3 inches. Salmonids were observed in this pool (see Salmonid Documentation Table in section 6.0). The downstream 150 feet of the culvert had a measured slope of less than 2%. The culvert then turns to the right and rises steeply with a 10% slope over 44 feet. The third section extends 64 feet at a slope of 6.3%. The upstream section measured 63 feet in length with a slope of 1.8%. Wingwalls occur at the culvert inlet.

Condition: The culvert itself is in fair condition with significant concrete wear occurring.

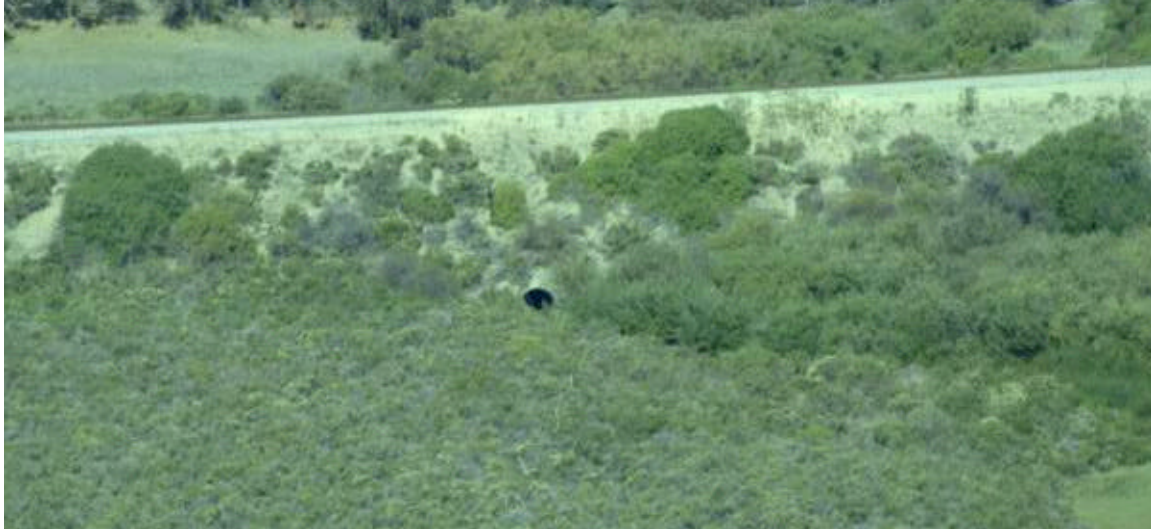
Description: Detailed information about this structure could not be obtained due to restricted access. Observations made from the air were limited. The culvert appears to be the standard UPRR construction found along the Gaviota Coast, consisting of cut stone blocks. See the Cojo Creek UPRR Culvert (BR_CO_1) description for additional information on a similar UPRR culvert. This culvert is relatively short because it only passes the train tracks on top of the narrow earth fill. The slope inside the culvert may be relatively flat due to its location just upstream of the Santa Anita Creek lagoon where the stream slope is mild.

Diagnosis: A fish passage assessment is needed to determine the severity of this structure to upstream migrating steelhead. Many UPRR culverts have mild slopes associated with them, worn stone bottoms that provide resting areas and velocity breaks, and by themselves allow upstream steelhead migration.

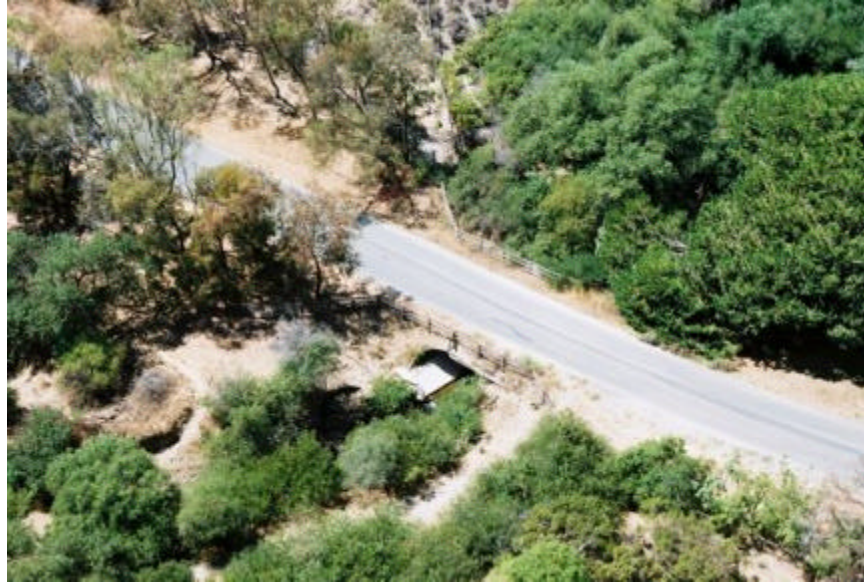
Description: Detailed information about this structure could not be obtained due to restricted access. Observations made from the air were limited. Only the downstream end of this structure was observed due to thick vegetation on the inlet side. The road crossing appears to consist of a metal arch culvert with a trapezoidal concrete channel conveying stream flows underneath it. The channel appears to have a smooth surface with flows spread out across its width. A vertical drop of approximately 1 foot exists from the downstream lip of the perched channel to the pool downstream.

Diagnosis: The jump into the culvert appears to be relatively easy during most flow conditions and migration into the culvert appears to be possible with a low to moderate degree of difficulty. The inlet configuration of the structure is unknown and the overall severity cannot be accurately determined.

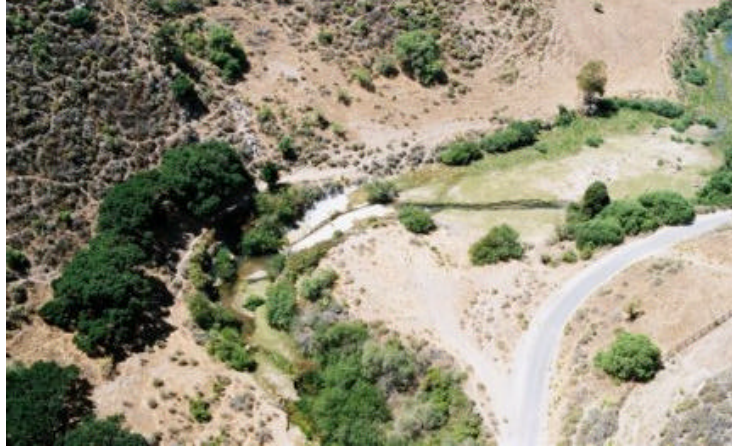
Location: Approximate elevation 45 feet

Description: Detailed information about this structure could not be obtained due to restricted access. Observations made from the air were limited. The former reservoir behind this concrete and earth-fill dam is completely filled with sediment. The collected sediment deposits extend several hundred feet upstream of the dam. A concrete spillway occurs on the west side of the dam and concentrates flows down a series of steps, which were reported to be a fishway built for upstream steelhead migration (pers. comm. Benech 2001). The overall height of the spillway was estimated at 25 feet from the downstream pool. The fishway does not appear to be maintained with vegetation and deposited sediments occurring throughout its length.

Condition/Sizing: This dam and reservoir are obsolete and do not appear to serve any of their original purposes. The fishway is not in functional condition. The structural integrity of the dam is not known.

Recommended Action: Work with the Hollister Ranch to assess the feasibility of removing this obsolete dam to provide unimpeded steelhead passage to the upper watershed. Gradual lowering of the dam's earthen center over several years in conjunction with selective sediment releases may be a cost effective way to eliminate this structure without severely disrupting the downstream and adjacent environment. Sediment behind the dam could also be removed and used for local projects requiring fill. Additional studies should be conducted to determine dam removal feasibility, alternatives, and the potential impacts of various options. Special care should be taken to prevent property damage and loss of habitat at the ecologically important lagoon. Modifying the existing structure for fish passage, including rehabilitating the existing fishway or building a different fishway, is not recommended due to the limited effectiveness of these structures in the low flowing streams of this area, susceptibility to clogging with debris, the dependence on maintenance, and ongoing costs.

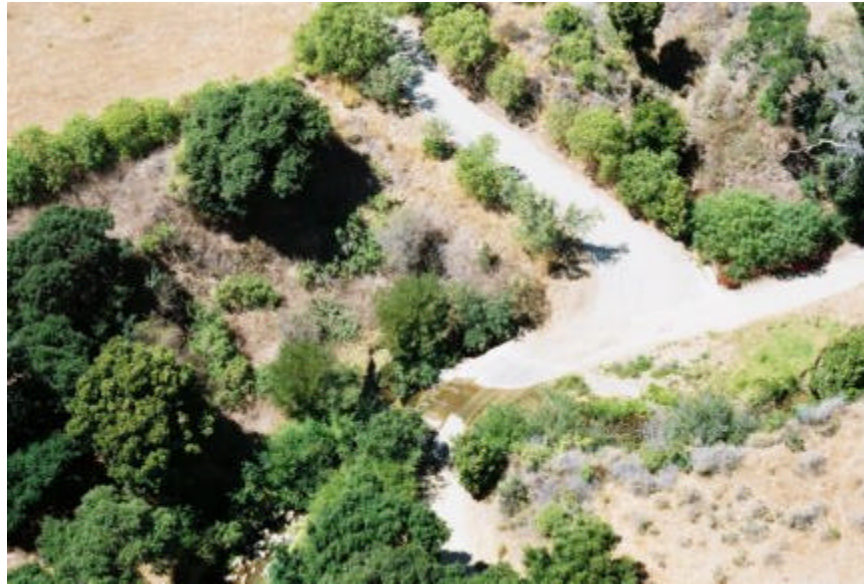
Location: Approximate elevation 105 feet

Description: Detailed information about this structure could not be obtained due to restricted access. Observations made from the air were limited. This road crossing has sediment backed up to top of the upstream side and carries stream flow over the top of the road. On the downstream side of the road, stream flows fall off a sloping apron onto the streambed below.

Condition/Sizing: Significant bank erosion is occurring downstream where the crossing concentrates flows. The crossing appears to convey all flows over the road or a culvert is buried with sediment.

Recommended Action: Work with Hollister Ranch Homeowners Association to improve fish passage at his crossing in conjunction with structures downstream. Assess the feasibility of installing a bridge or bottomless arch culvert at this site to provide unimpeded steelhead migration and improved vehicle access and safety.

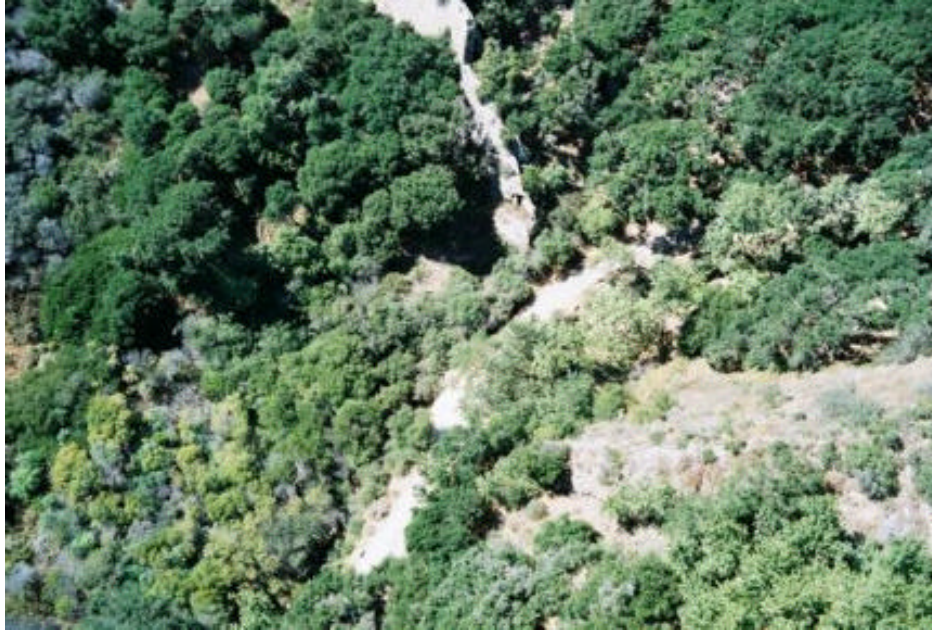
Location: Approximate elevation 160 feet

Description: Detailed information about this structure could not be obtained due to restricted access. Observations made from the air were limited due to the extensive riparian vegetation around the crossing. Only the road surface of the crossing spanning the creek was observed at this location.

Diagnosis: Stream flows were not observed on the road and suggest that water pass underneath this crossing, likely in a culvert. The severity this structure would impose on steelhead migration could not be determined.

Recommended Action: Work with Hollister Ranch Homeowners Association to assess fish passage at his crossing in conjunction with structures downstream. If fish passage is significantly impeded or blocked at this crossing, a bridge or bottomless arch culvert should be considered to provide unimpeded steelhead migration and improved access and safety.
