Steel head Assessment and Recovery Opportunities in Southern Santa Barbara County, California

**BY
Matt W. Stoecker
and
Conception Coast Project**

June 2002

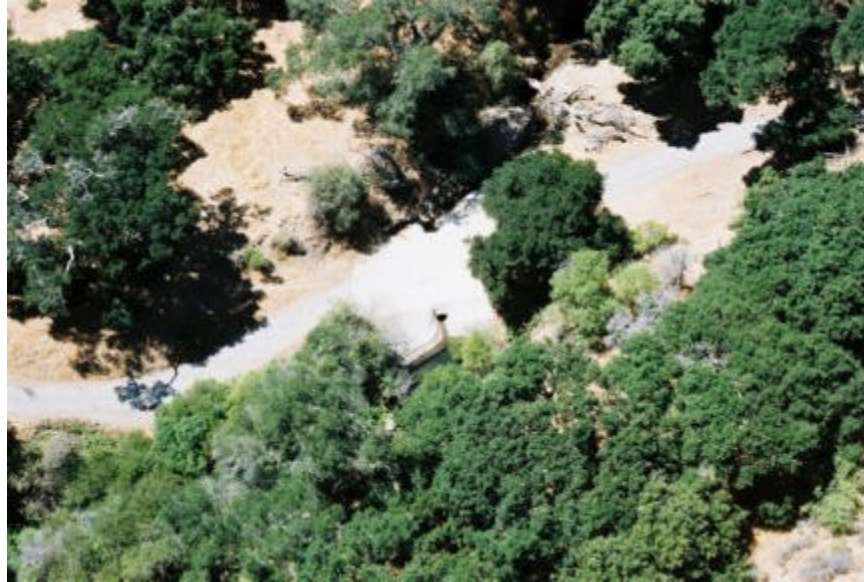
Location: Approximate elevation 200 feet

Description: Detailed information about this structure could not be obtained due to restricted access. Observations made from the air were limited. A small concrete channel upstream of the crossing carries low stream flows into a small culvert that conveys water under the concrete road crossing. Downstream of the culvert outlet, a steep apron extends approximately 4 feet into a large and fairly deep pool. Rainbow trout were observed in this pool in 2001 (see sighting table).

Condition/Sizing: The culvert is not sized for a 100-year flow. The crossing is constructed to carry high flows over the top. The downstream apron appears to be undercut.

Recommended Action: Investigate options with the Hollister Ranch Homeowners Association to replace this crossing and upstream channel with a bridge.

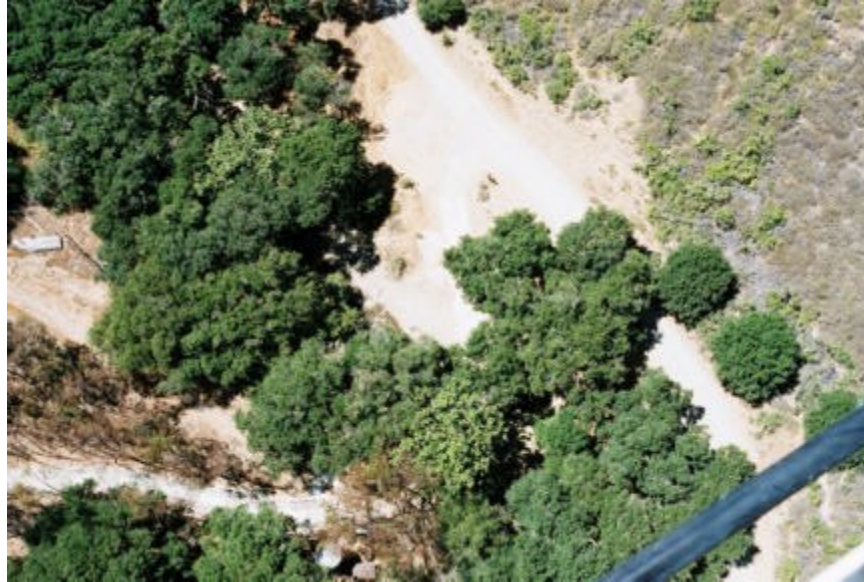
Location: Approximate elevation 240 feet

Description: Observations made from the air were limited due to the extensive riparian canopy covering the crossing. It appears that this crossing is a private driveway that heads west from the main Santa Anita Creek road.

Diagnosis: The impact of this crossing to potential upstream steelhead migration could not be determined.

Recommended Action: Work with the Hollister Ranch Homeowners Association to assess fish passage at this crossing in conjunction with structures downstream. If fish passage is significantly impeded or blocked at this crossing, assess options to replace the structure with a bridge.

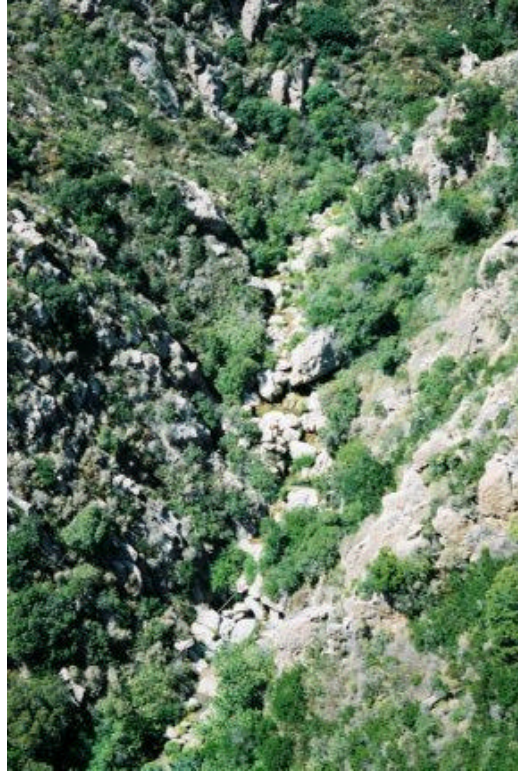
Location: Approximate elevation 400 feet

Description: Santa Anita Creek flows through a confined bedrock gorge as it passes through the Santa Ynez Mountain Range. The steep gorge contains massive boulders and exposed bedrock, which produce at least four significant waterfalls that exceed 8 feet in height. Two of the waterfalls in this reach appear to be 10 and 15 feet in height.

Diagnosis: This reach appears to be impassable due to the excessive height and complexity of these waterfalls. Several of the waterfalls do not have well-developed pools for jumping downstream. Large pools and excellent habitat conditions were observed within this reach though, and some of this habitat below the waterfalls was likely accessible to steelhead historically

Recommended Action: No recommended action for this natural feature.

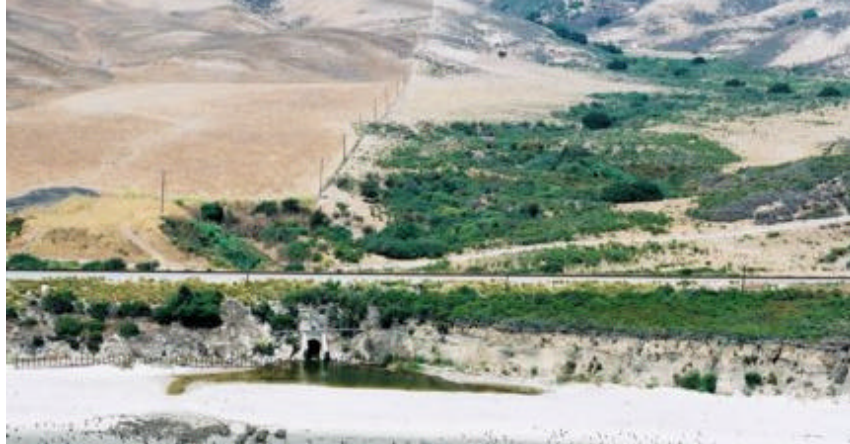
Location: UPRR crossing

Description: Detailed information about this structure could not be obtained due to restricted access. Limited observations were made from the air and from the legal limits of the beach. The railroad culvert is constructed of cut stone blocks with an inverted U-shape arch top and flat bottom. The stone bottom extends to the small lagoon downstream and appeared to be only 2 inches above the surface of the lagoon. The lagoon had an estimated 4-foot depth just downstream of the culvert. The overall length of the culvert was estimated between 100 and 125 feet and the relatively flat slope was 1% or less.

Condition/Sizing: The culvert itself is in fair condition with moderate wear of the stone blocks. Undercutting of the structure on the downstream side is likely, but was submerged from view by the lagoon.

Diagnosis: The stone blocks on the bottom of the culvert appeared to be worn with many grooves and pockets of water to provide velocity break for upstream migrating steelhead. The jump height into the culvert and pool depth/lagoon development is highly dependant on the seasonal sandbar formation. During the brief beach survey on 2001-08-12, conditions were suitable to allow low to moderately difficult upstream passage of adult and juvenile salmonids through the shallow water in the culvert.

Recommended Action: Along with other culverts that empty onto the sand beach, this culvert should be assessed during high stream flows to see if the sandbar continues to allow lagoon development for adequate jump pool depth and tolerable jump height into the culvert. If upstream passage is obstructed during high stream flows because of the lagoon configuration, this structure should be further assessed for potential fish passage improvements that are acceptable to UPRR requirements. Passage at this site is critical for Cojo steelhead potential with all spawning habitat, and all rearing habitat except for the lagoon, located upstream. While upstream migration may not be severely impeded, the culvert has likely reduced the extent of the original lagoon and may have limited its productivity for salmonid rearing and acclimation.

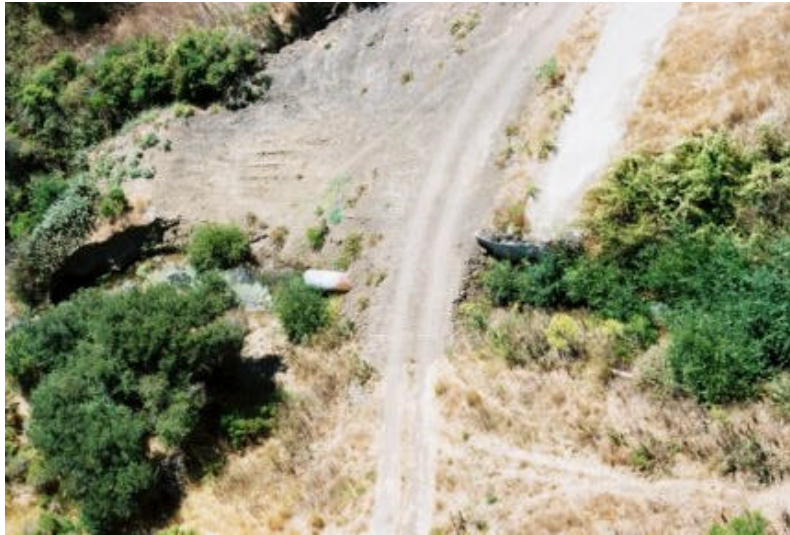
Location: Approximately 100 feet upstream from UPRR Culvert (BR_CO_1)

Description: Observations of this structure were made from the air, as access was restricted to this stream reach. A corrugated metal culvert and dirt-fill road crossing occur just downstream from a former concrete road, which apparently blew out at the former culvert location. The existing culvert appears to be 3 feet in diameter, approximately 25 feet in length, slightly elevated above the streambed at the outlet, and likely has a low to moderate slope at this low stream gradient reach near the creek mouth.

Condition/Sizing: The crossing is in poor condition with highly eroded banks and is covered with soil that is susceptible to washing out during moderate to high stream flows. The structure is not sized for a 100-year flow and likely is rebuilt after washing out following high stream flows. This culvert imposes a significant threat to blocking, and potentially leading to the failure of, the UPRR crossing 100 feet downstream.

Recommended Action: With almost the entire Cojo Creek watershed upstream of this culvert, it is critical to work with the landowner to remove this structure and provide alternative means of access across the creek at this site or elsewhere. Assess the feasibility of installing a bridge across the existing road site for unimpeded steelhead migration and improved sizing and safety.

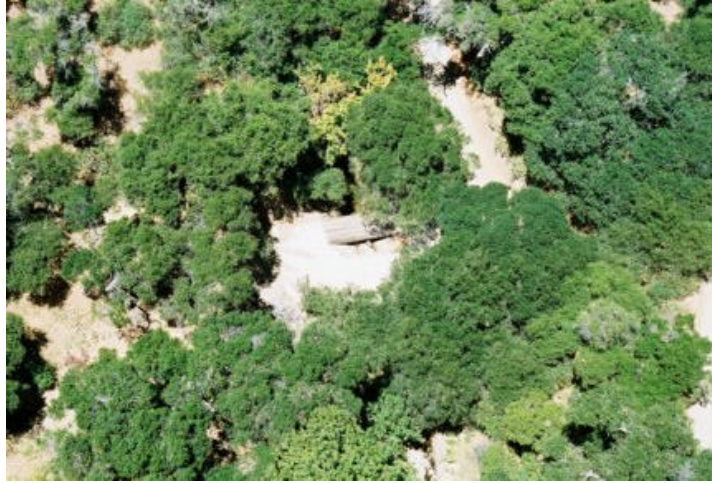
Location: Approximate elevations for barriers #3= 290', #4= 300', #5=320', #6= 360'

Description: Identification of these structures was made from the air, as access was restricted to this stream reach. Detailed information about these crossings was not obtained due to the thick riparian canopy limiting observations. Other crossings and structures may exist that were not observable. These four private crossings appear to vary in construction and consist of combinations of concrete surfaces, dirt fill, concrete culverts, wood decking, and corrugated metal pipe culverts.

Condition/Sizing: Determining the condition and sizing of these crossings was not possible from the air, but it appeared that most are constructed to carry high stream flows over the top of the crossings.

Recommended Action: This upper reach of Cojo Creek should be ground-surveyed to accurately determine all potential structures impeding steelhead migration and fish passage should be assessed at each structure encountered. The removal of crossings that severely impede or block upstream steelhead migration and replacement with bridges or large, embedded culverts should be assessed. Evaluate reducing the number of stream crossings in this reach by consolidating these crossings into a couple bridges that do not impact the stream or impede upstream steelhead migration and may provide improved access/safety for landowners.

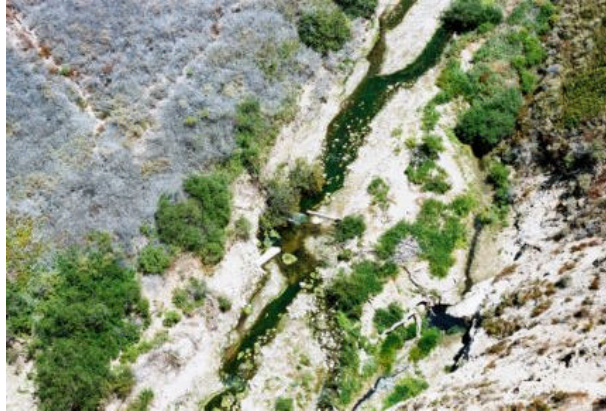
Location: 0.58 mile upstream from mouth

Description: The exact purpose of this structure was not determined by aerial survey or personal communication with Camm Swift, who surveyed lower Jalama Creek on VAFB property. This structure may have served as an old diversion dam, road crossing abutment, utility crossing protection, or other purpose. The structure is highly damaged and apparently not maintained to function any specific purpose at this time. A concrete curb approximately 25 feet in length and 1 to 2 feet thick spans one-third of the stream channel and is keyed into the river-right bank. A large portion of concrete, presumably once part of the structure, lays in the streambed approximately 15 feet downstream. According to Camm Swift, the total height of the structure is not greater than 2 feet 6 inches from the surface off the downstream pool, during lower flow conditions encountered. A concrete apron drops steeply from the curb and becomes less steep toward the downstream pool, which Camm estimated had a maximum depth of approximately 3 feet.

Condition: This obsolete structure appears to be significantly impacting downstream sediment and water movement causing high flows to cut around the concrete on the river-left side forming a side-channel and small island. This side-channel appears to be accelerating the significant bank erosion adjacent to the channel during high flows. The structure is in extremely poor condition.

Diagnosis: It appears that adequate pool depth exists downstream of the structure to allow a moderately difficult jump for adult steelhead to the upstream side during migration flows. In years with prolonged low stream flow, this structure may significantly block or impede upstream passage of adult steelhead. CDFG personnel observed an adult steelhead upstream of this structure in August 1994 (see sighting table).

Recommended Action: Because this structure is located downstream of all Jalama Creek tributaries and most of the main stem, has no apparent purpose, and is in extremely poor condition, it should be removed to improve upstream passage for adult and juvenile steelhead (and other native fish species) and to minimize further bank erosion on the adjacent river-left bank. It is likely that VAFB personnel could easily remove this structure in one day, or a matter of seconds.

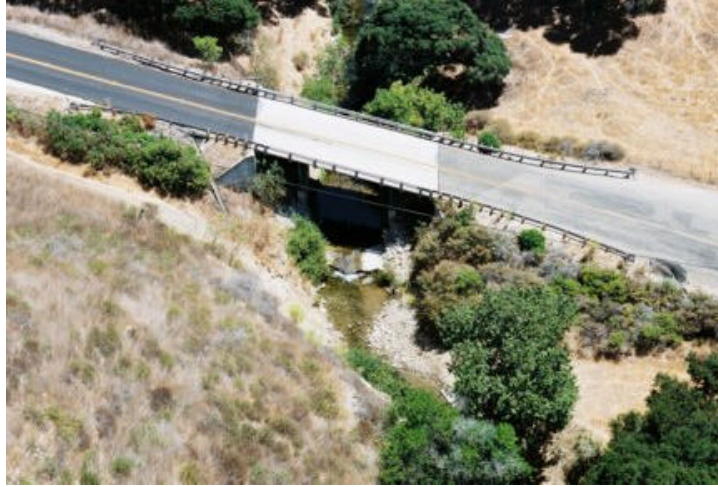
Location: Downstream-most Jalama Road Bridge

Description: Due to access restrictions, general observations of this structure were made from the Jalama Road bridge. A mild sloping concrete apron extends approximately 9 feet downstream from under the downstream side of the bridge. Flows fall vertically off the downstream end of the apron approximately 1 foot 6 inches into the pool downstream, which had a maximum depth of between 2 to 3 feet. The overall height of the apron is less than 3 feet from the pool surface.

Condition/Sizing: The apron is in poor condition with significant wear, concrete cracking, and undercutting on the downstream side.

Diagnosis: Due to the sufficient depth of the downstream pool, mild slope of the apron, and low overall height, this structure presents a moderate degree of difficulty. During low flow conditions the shallow depth of the apron may impede passage.

Recommended Action: Upstream passage for juveniles and improved ease of access for adults could be obtained with the removal or modification of this apron. Work with SBCPWRD to obtain more detailed information about the apron and assess fish passage options with the road district. Assess the desirability of the structure with SBCPWRD and possibility of lowering the structure, shortening the apron length, or removing the apron and stabilizing the adjacent banks.

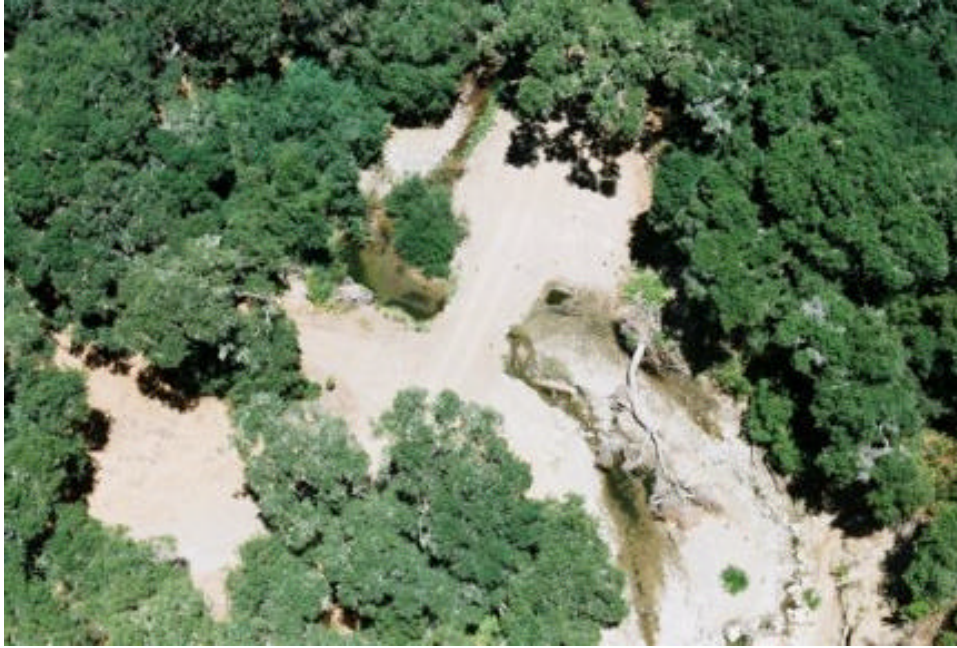
Location: Approximate elevations: #3=455', #4=500', #5=615'

Description: Detailed information about these three structures was not attainable from the air survey. These crossings are almost identical in construction with corrugated metal culverts passing under the dirt-fill road.

Condition/Sizing: The structures do not appear to be sized for a 100-year flow and are likely rebuilt following large storm flows.

Recommended Action: Work with the landowner to assess the severity of these structures and investigate alternative means of access across the creek at these sites or elsewhere if passage is significantly impeded. A larger diameter culvert that is embedded in the substrate could provide a quick, easy, and inexpensive fix for fish passage.

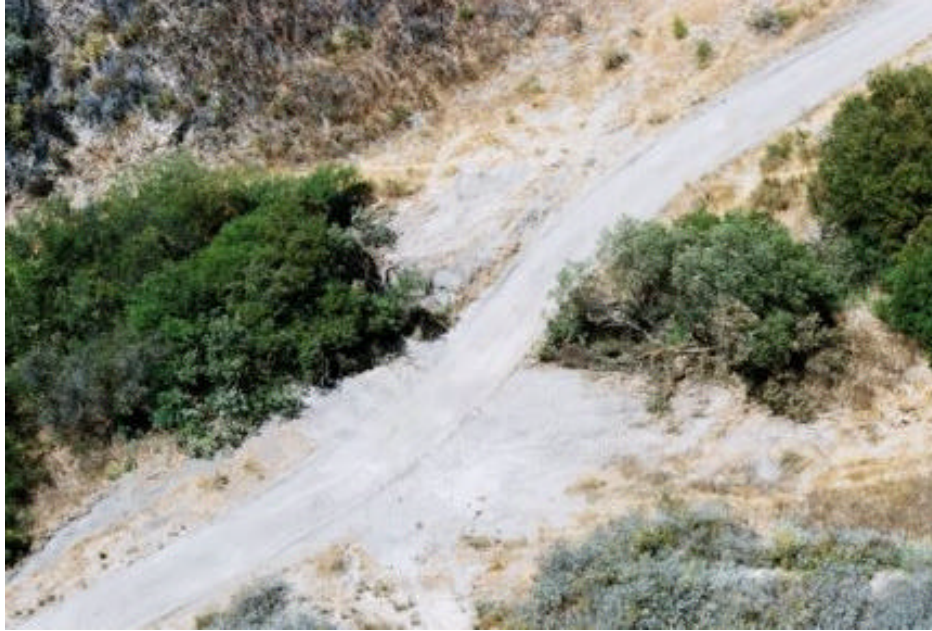
Location: Approximate elevation 170 feet

Description: Culvert and dirt-fill crossing. Detailed information about this structure was not attainable from the air survey.

Condition/Sizing: The crossing appears to be recently built or modified with significant damage to adjacent riparian vegetation. The structure is probably not sized for a 100-year flow and likely is rebuilt following a wash out associated with high stream flows.

Recommended Action: See recommended action for BR_JA_EA_1.

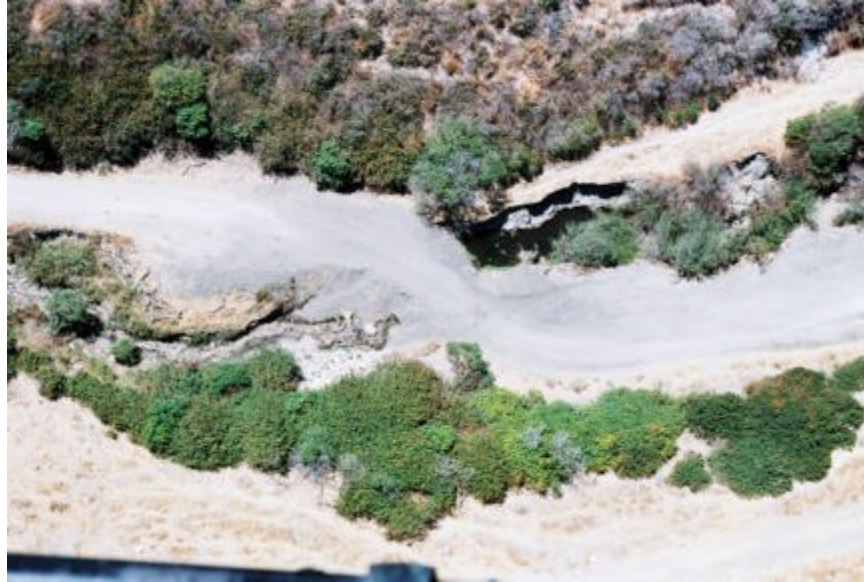
Location: Approximate elevation 395 feet

Description: Detailed information about this structure was not attainable from the air survey. The crossing has a corrugated metal culvert passing under a dirt-fill road.

Condition/Sizing: Major bank erosion occurs on the upstream banks and water is backed up behind this crossing. The structure does not appear to be sized for a 100-year flow.

Diagnosis: The downstream end of the culvert appears to be at streambed level. Knowledge about the slope of the culvert and conditions at the upstream end of the culvert are needed to accurately determine if this crossing is impassable. In a best case scenario the crossing would significantly impede upstream passage of adult steelhead.

Recommended Action: Work with the landowner to further assess fish passage at this crossing. If passage significantly impeded, work with the landowner to assess alternative means of access across the creek at this site or elsewhere.

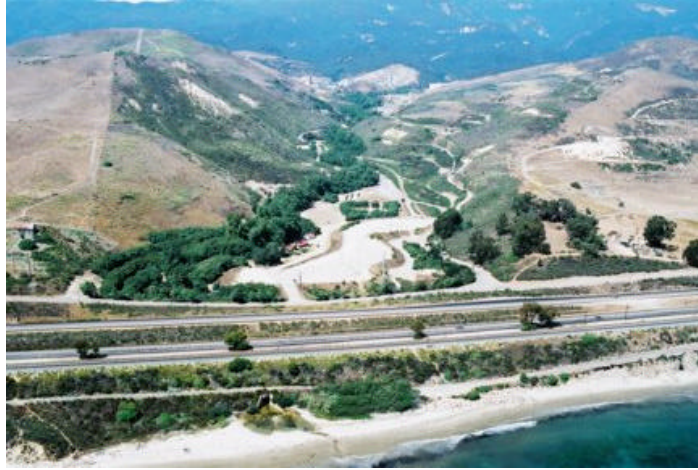
*Figure 7.8a
Highway 101 and UPRR culvert crossing at Corral Creek*

The above air photograph shows the UPRR/Highway 101 culvert crossing at the mouth of Corral Creek. The UPRR culvert empties onto the beach. The CALTRANS culvert extends several hundred feet on the upstream end and prevents all upstream steelhead migration. No adult steelhead have been observed upstream of the highway since completion of the culvert and the rainbow trout population that became isolated upstream appears to have been extirpated from the watershed as recently as the early 1990's.

This recommended action can be accomplished by removing the entire culvert and excavating a large V-shape into the existing highway crossing dirt fill, stabilizing the stream banks using biotechnical techniques, naturalizing the streambed underneath, and installing a wide-span bridge that does not adversely impact the stream channel. Refugio Carpinteria, Maria Ygnacio, San Jose, and Dos Pueblos Creeks are all examples of CALTRANS Highway 101 bridges that allow upstream steelhead migration. The picture below of the Highway 101 and UPRR crossing of Refugio Creek shows what removal of the culvert and bridge installation would look like.

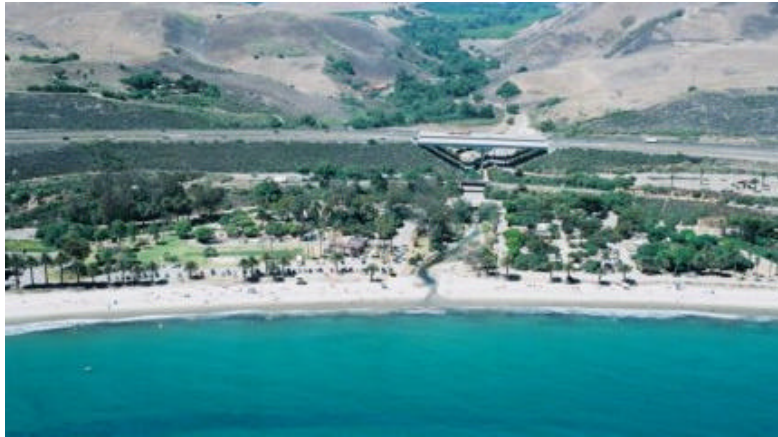
Figure 7.8b

Highway 101 Bridge allowing upstream steelhead passage on Refugio Creek
